[Docket No. 99–SW–80–AD; Amendment 39–12983; AD 2002–25–07]

Airworthiness Directives; Bell Helicopter Textron Canada Limited Model 206L, L–1, L–3, and L–4 Helicopters

ACTION: Final rule.

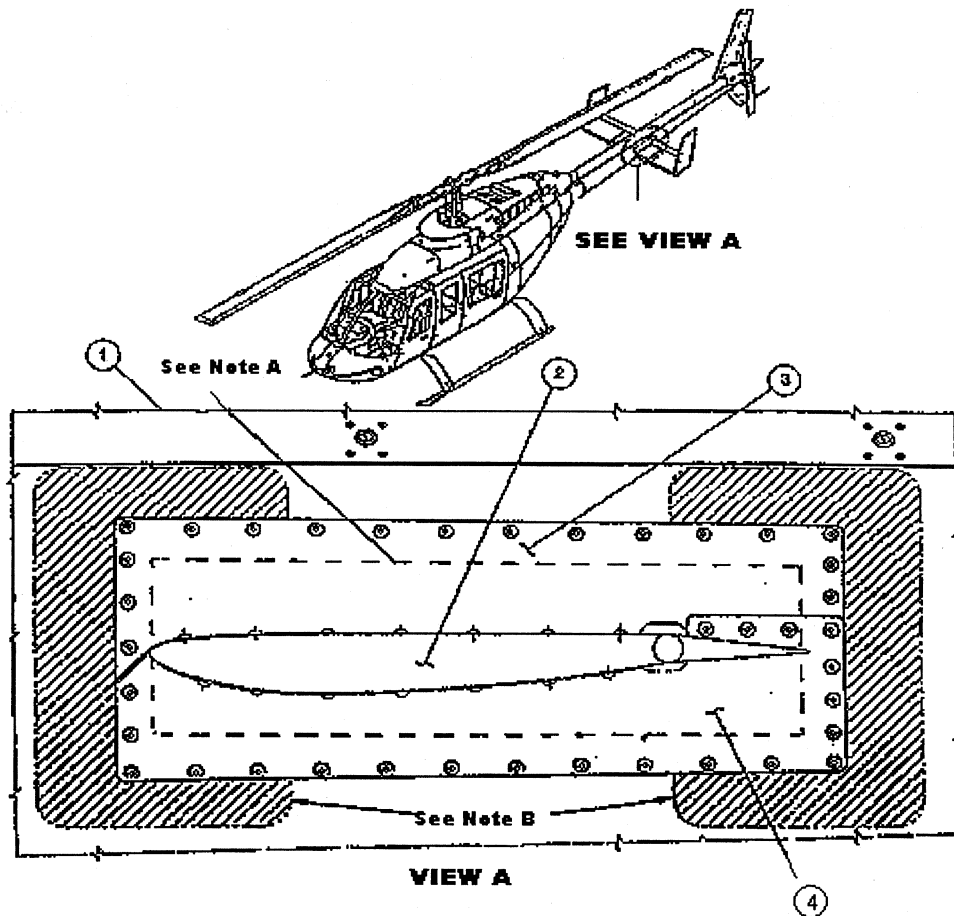
Figure 1**BILLING CODE 4910-13-C**

(a) Before further flight and thereafter at intervals not to exceed 10 hours time-in-service (TIS) until accomplishing a one-time fluorescent-penetrant inspection (FPI) required by paragraph (c)(2) of this AD, visually inspect for a crack in the tailboom using a 10-power or higher magnifying glass in the shaded areas as depicted in Figure 1 of this AD:

- A. Inspect entire edge of stabilizer opening on both sides of the tailboom.
- B. Inspect for a crack in these two areas on both sides of the tailboom

(2) Perform a one-time FPI of the edges of the tailboom skins for any crack around the left and right horizontal stabilizer openings as shown in Figure 1 of this AD. Remove paint and primer to inspect the edges and

exterior skin surface in the skin area at least 3/4 inch around the edges of the horizontal stabilizer openings as shown in Figure 1 of this AD.

(2) Visually inspect the entire edge of the horizontal stabilizer opening on both sides of the tailboom for any crack using a 10-power or higher magnifying glass as shown in Figure 1 of this AD.

(g) If a crack is found during any check or inspection required by this AD, before further flight, replace the cracked tailboom with an airworthy tailboom modified according to the requirements of paragraph (e) of this AD or with an airworthy tailboom, P/N 206-033-004-181.
