# Appendix C1

## SEM/EDS Data for Unused and Test #2, Day-30 Aluminum Coupons

This appendix shows SEM/EDS results for the metal aluminum coupons in three different exposure categories: (1) unused, (2) suspended or unsubmerged, and (3) submerged. *Unused* refers to the coupon condition that existed before being subjected to ICET test conditions. *Suspended* or *unsubmerged* refers to coupons located above the water level of the solution during ICET tests. Suspended coupons contacted the solution only during the 4-hour spray period at the start of the test. In addition, the surface of the suspended coupons may also be affected by moisture in the test chamber gas space. *Submerged* refers to the coupons that were immersed in the test solution for the entire test.

The coupon samples were collected on March 7, 2005 (the date Test #2 was shut down), and were examined by SEM/EDS on March 21, 2005. The aluminum coupon samples were dried in air before being coating with carbon for SEM examination. SEM results illustrate the surface condition of the aluminum coupons. In addition, EDS results provide spectra and semiquantitative elemental analyses of the coupon surface and the corrosion an

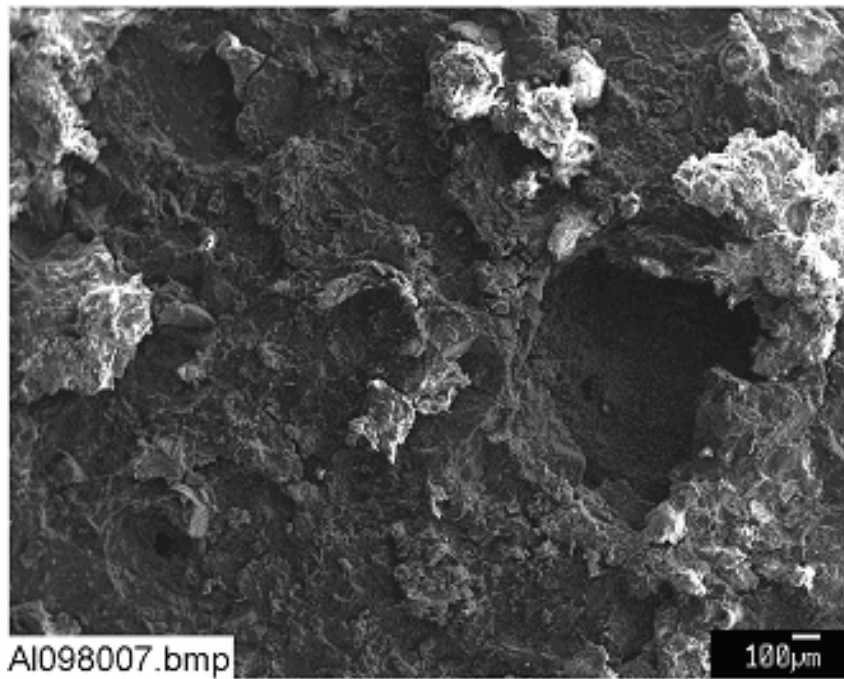
Figure C1-10. SEM image at 40× magnification for a Test #2, Day-30 submerged aluminum coupon. (AI098007)

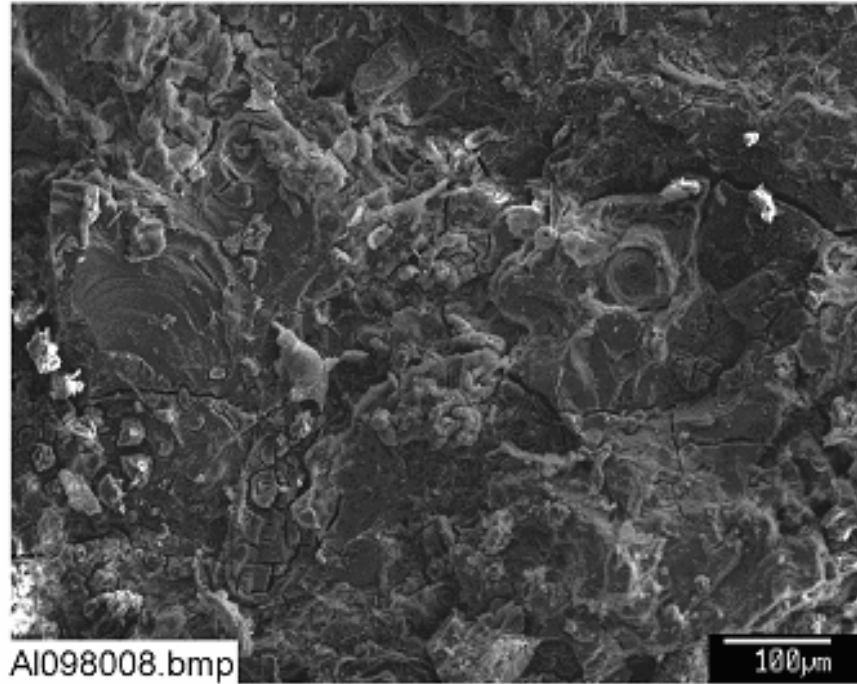
Figure C1-11. SEM image at 150× magnification for a Test #2, Day-30 submerged aluminum coupon. (A1098008)

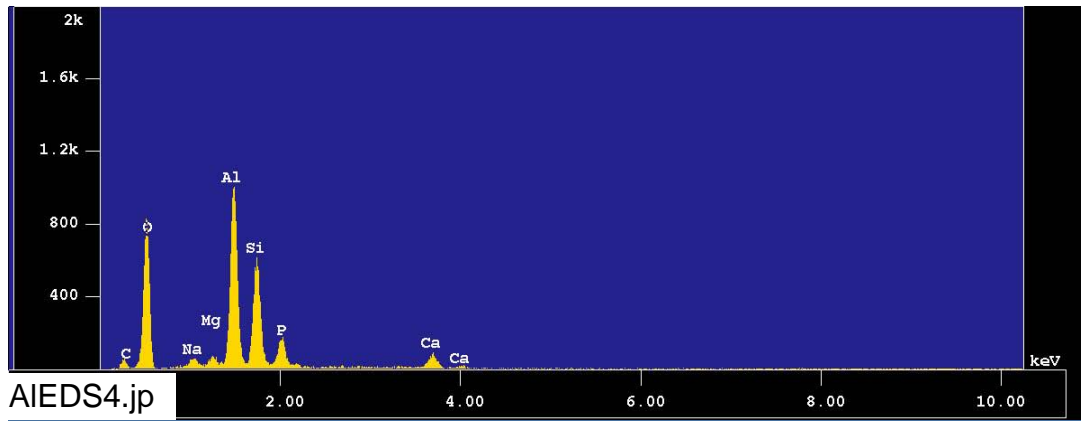
Figure C1-13. EDS counting spectrum for the smooth corrosion product shown on the surface of an aluminum coupon in Figure C1-11. (AIEDS4)

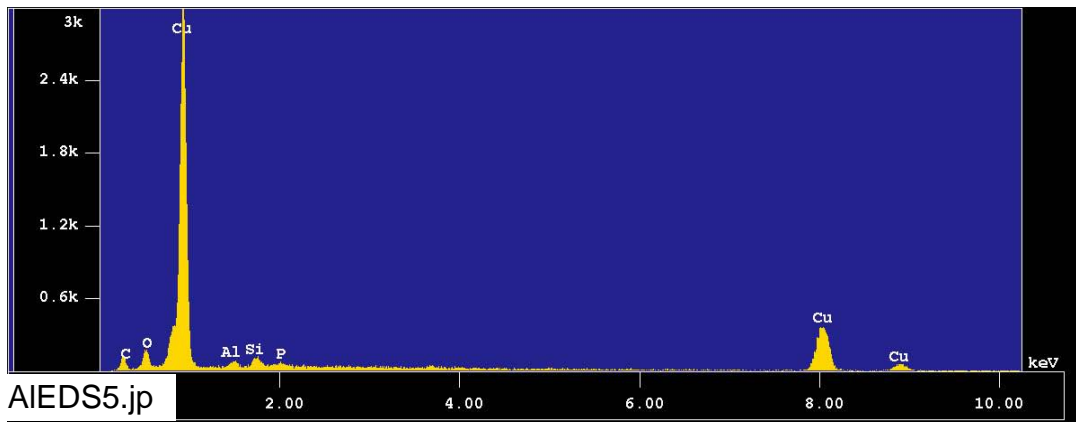
Figure C1-16. EDS counting spectrum for the crystal corrosion product, as shown as white granules in Figure C1-15. (AlEDS5)

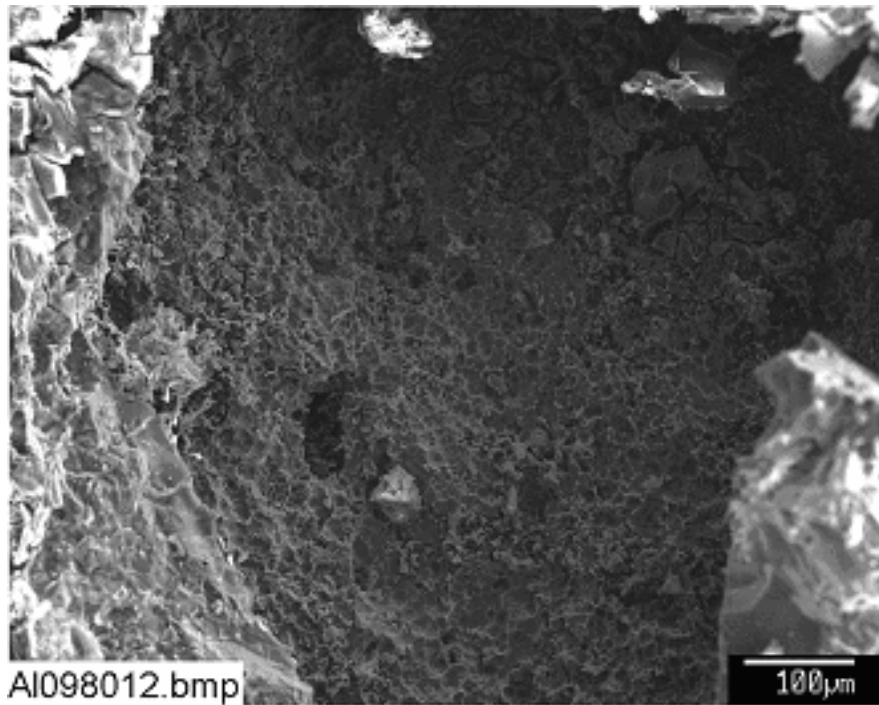
Figure C1-17. SEM image at 150× magnification for a Test #2, Day-30 submerged aluminum coupon showing a hole or defect in the corrosion layer. (Al098012)

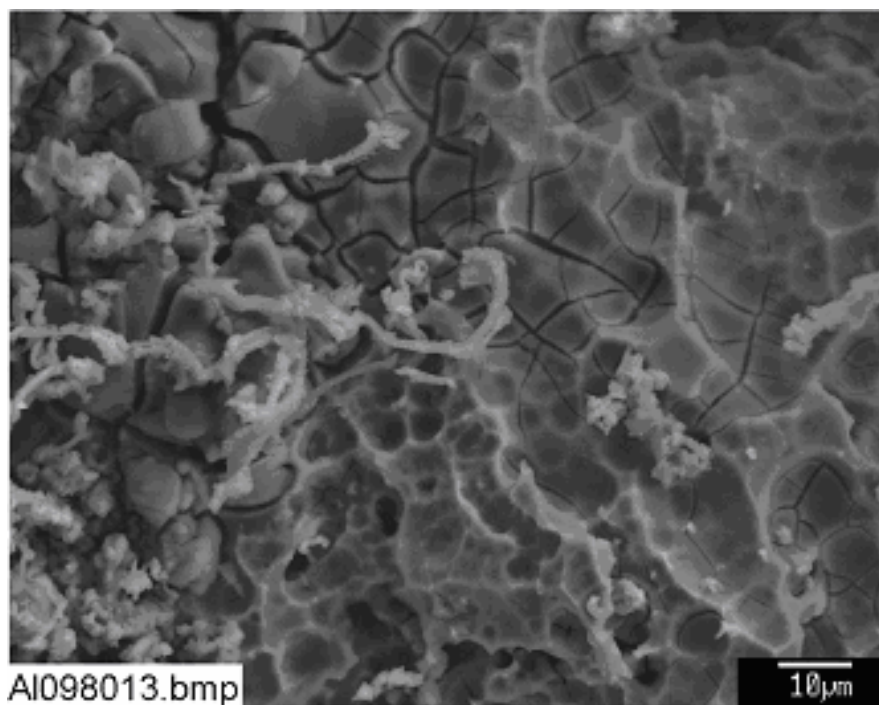
Figure C1-18. SEM image close-up (1000×) of the surface within the corrosion gap shown in Figure C1-17 on a submerged aluminum coupon. (Al098013)

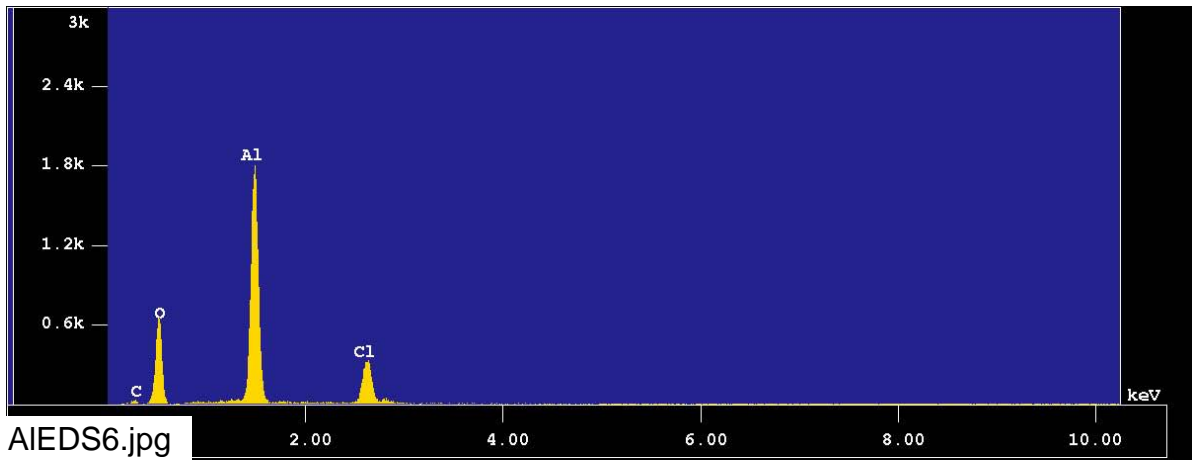
Figure C1-19. EDS counting spectrum for the wormlike corrosion product shown in Figure C1-18. (AIEDS6)

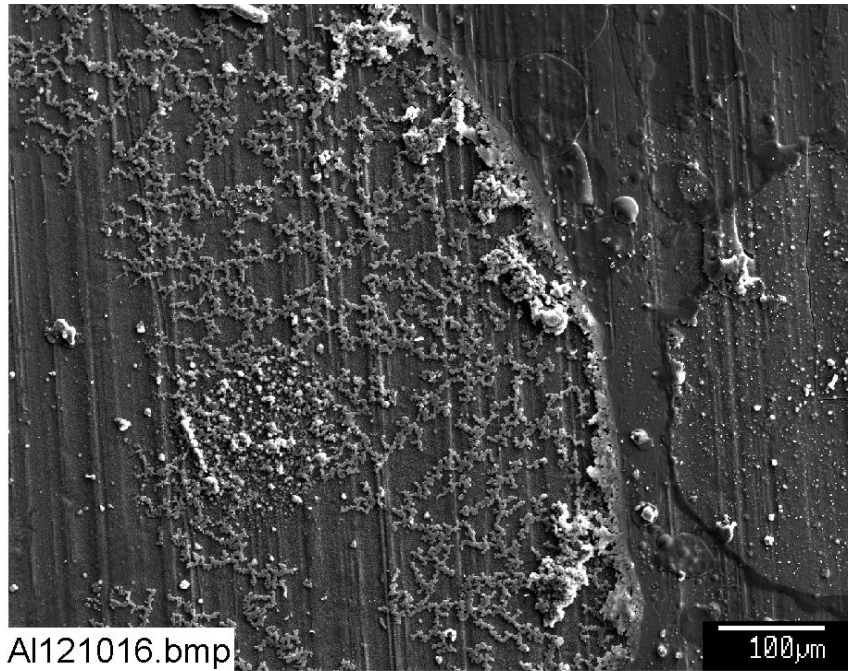
Figure C1-22. SEM image at 150× magnification for the circular corrosion patches shown in Figure C1-21 for a Test #2, Day-30 unsubmerged aluminum coupon. (Al121016)

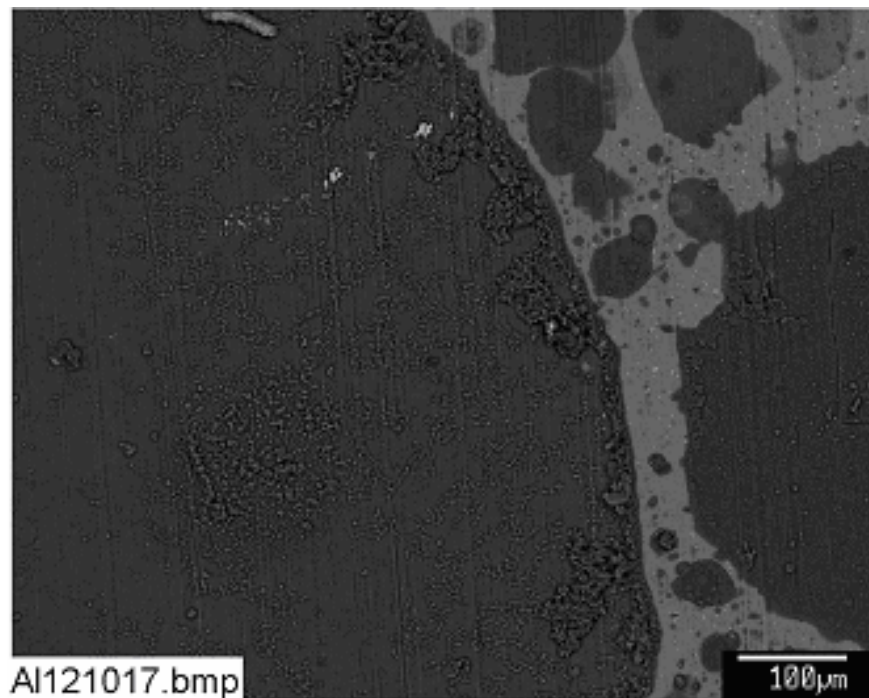
Figure C1-24. Backscattered SEM image at 150× magnification for the circular corrosion patches shown in Figure C1-21 for a Test #2, Day-30 unsubmerged aluminum coupon. (Al121017)

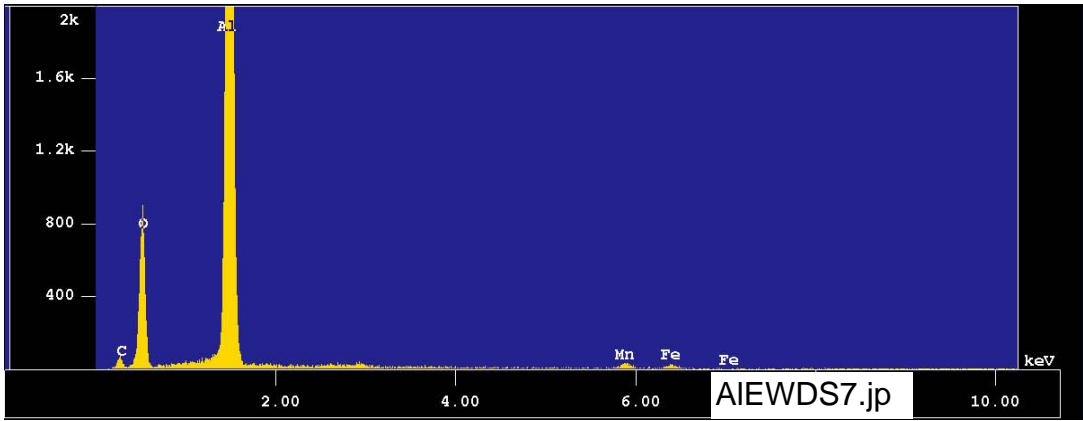
Figure C1-25. EDS counting spectrum for the dark patch shown in Figure C1-24. (AIEWDS7)

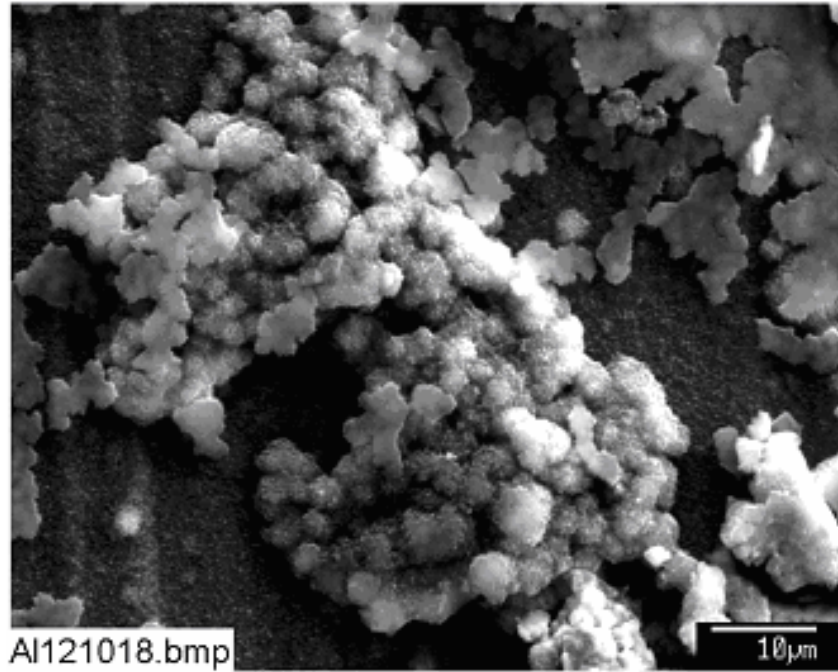
**Figure C1-28. SEM image close-up (1000×) of wormlike crystals shown in Figure C1-22 for a Test #2, Day-30 unsubmerged aluminum coupon. (Al121018)**

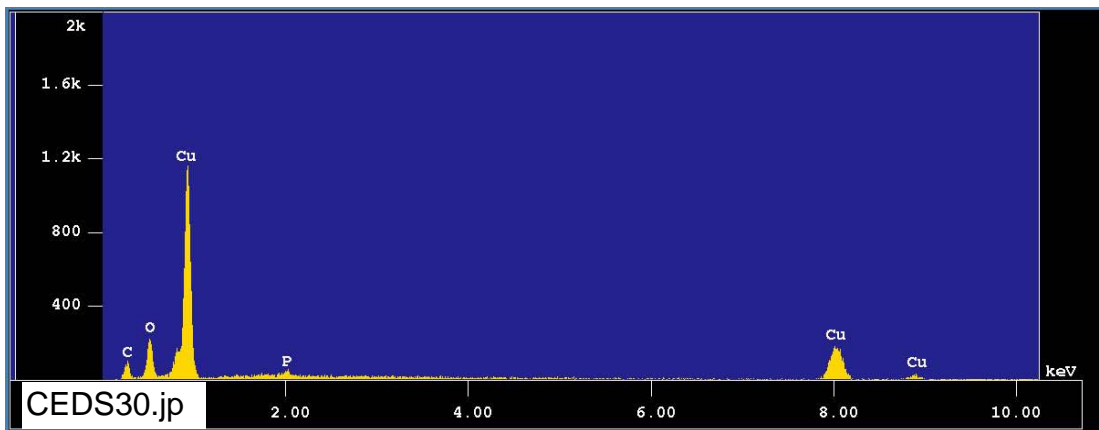
Figure C2-8. EDS counting spectrum for one of the dark spots shown in Figure C2-7. (CEDS30)

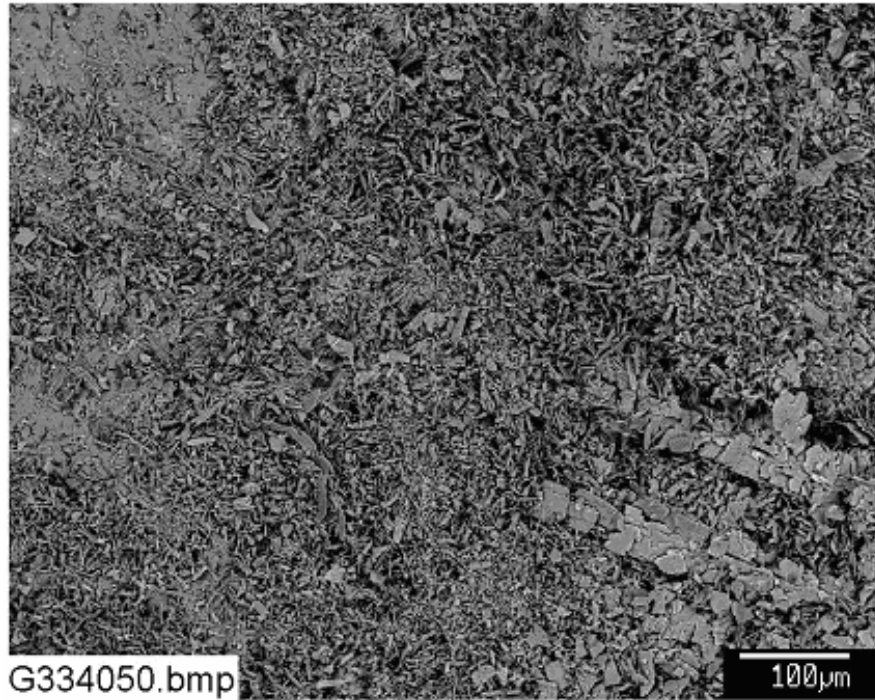
Figure C3-10. Backscattered SEM image for a Test #2, Day-30 submerged GS coupon. (G334050)

Figure C3-11. EDS counting spectrum on fiberlike crystals shown in Figure C3-10. (GEDS29)

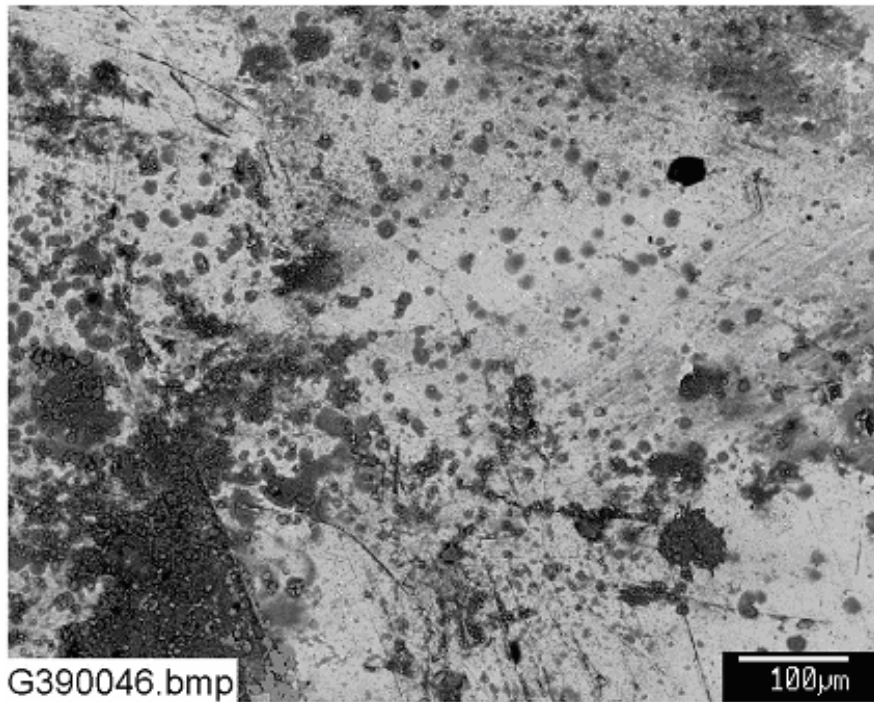
Figure C3-15. Backscattered SEM image for a Test #2, Day-30 unsubmerged GS coupon. (G390046)

Figure C3-16. EDS counting spectrum on the dark spots shown in Figure C3-15. (GEDS27)

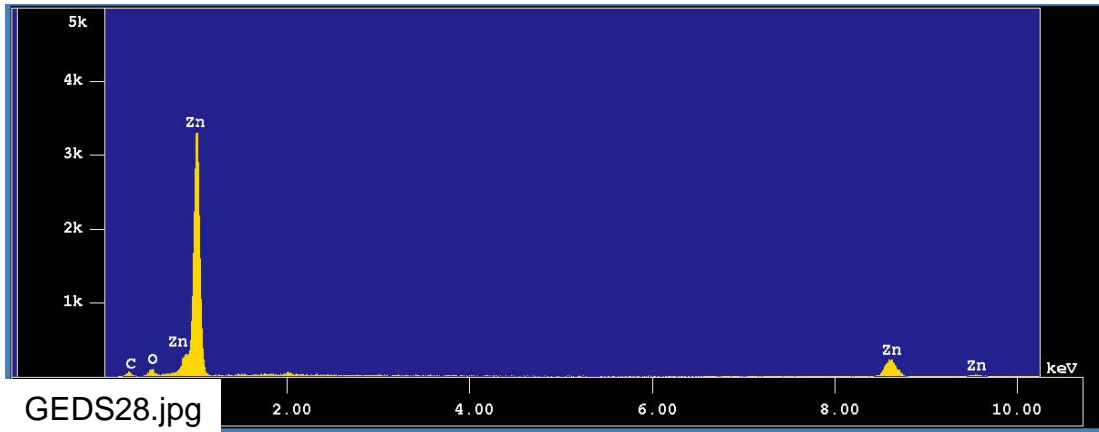
Figure C3-17. EDS counting spectrum on the light surface shown in Figure C3-15. (GEDS28)

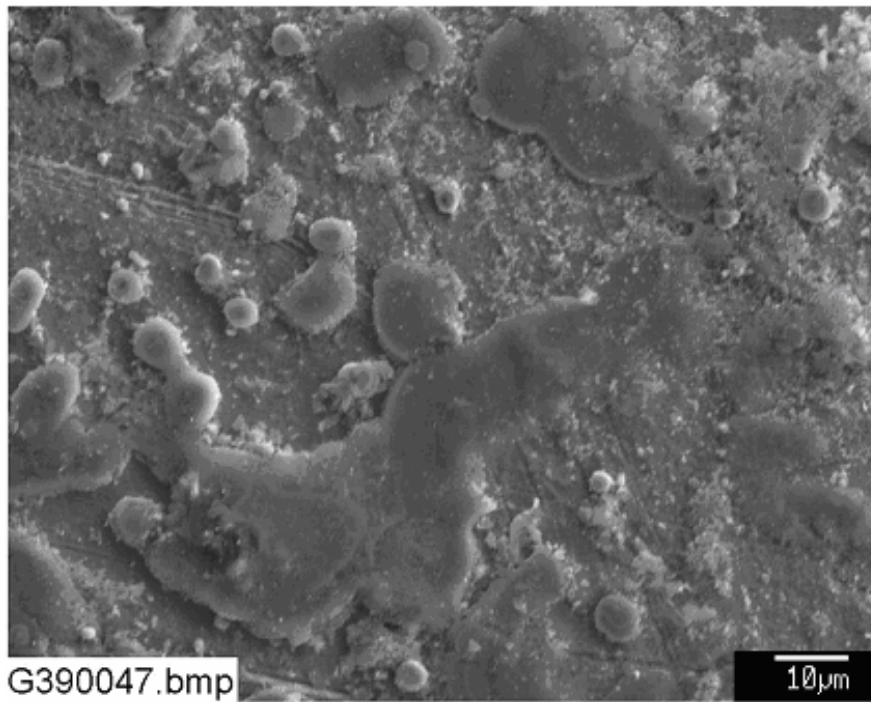
Figure C3-18. SEM image at 1000× magnification for a Test #2, Day-30 unsubmerged GS coupon. (G390047)

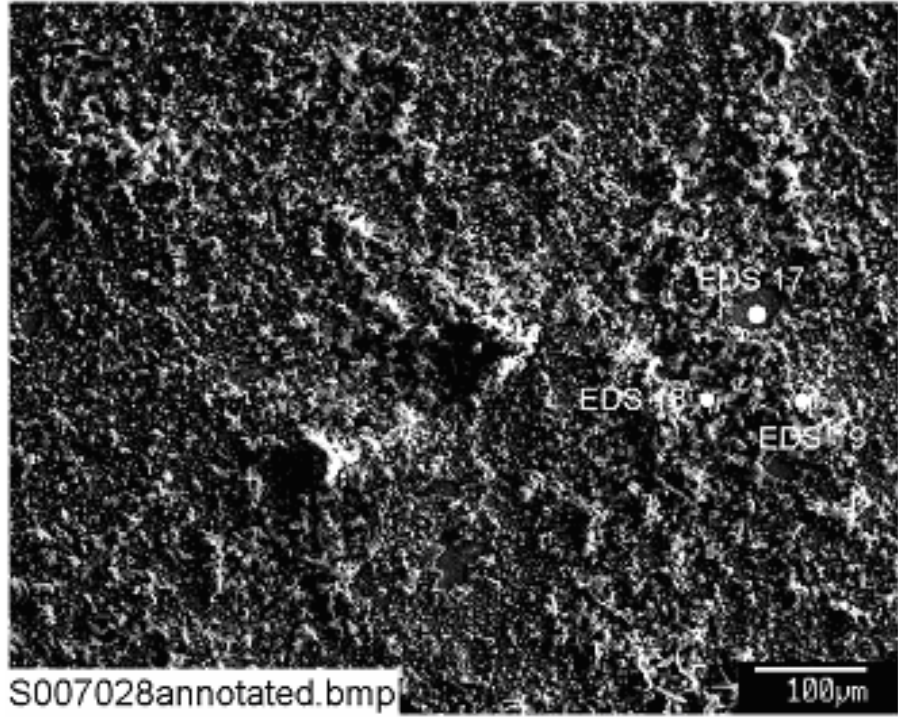
Figure C4-7. SEM image for the corrosion surface of a Test #2, Day-30 submerged steel coupon. (S007028annotated)

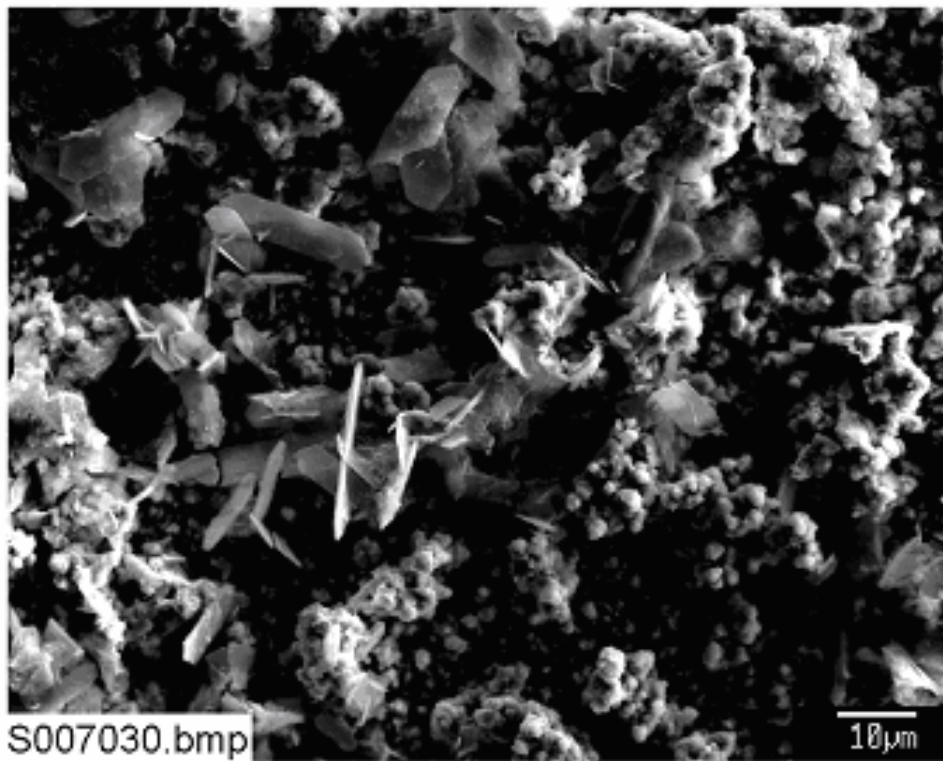
Figure C4-10. SEM image for the corrosion surface of a Test #2, Day-30 submerged steel coupon. (S007030)

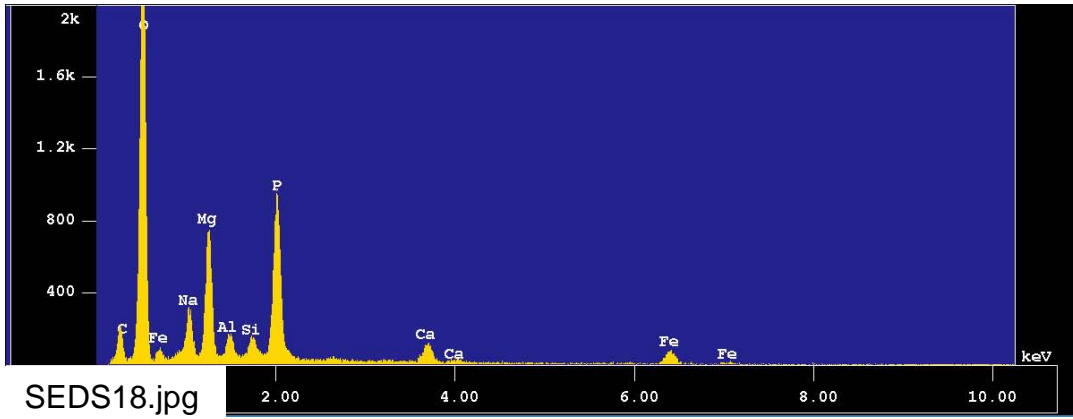
Figure C4-11. EDS counting spectrum for the thin crystals shown in Figure C4-10. (SEDS18)

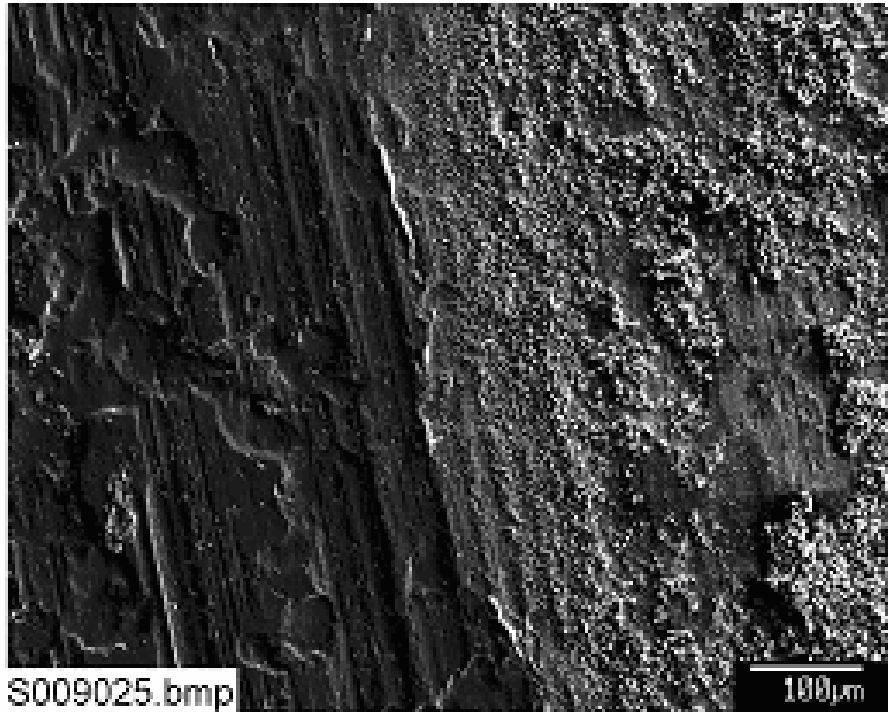
Figure C4-21. SEM image for a Test #2, Day-30 unsubmerged steel coupon (S009025). The image shows the interface between badly corroded (right) and less corroded surface (left).

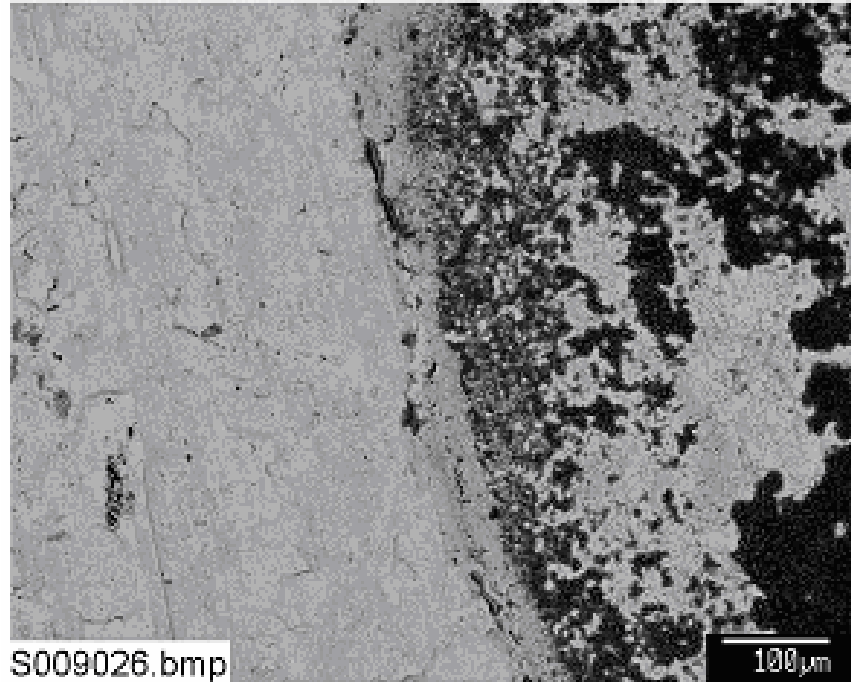
Figure C4-22. Backscattered SEM image for a Test #2, Day-30 unsubmerged steel coupon (S009026). It shows the same area as shown in Figure C4-21.

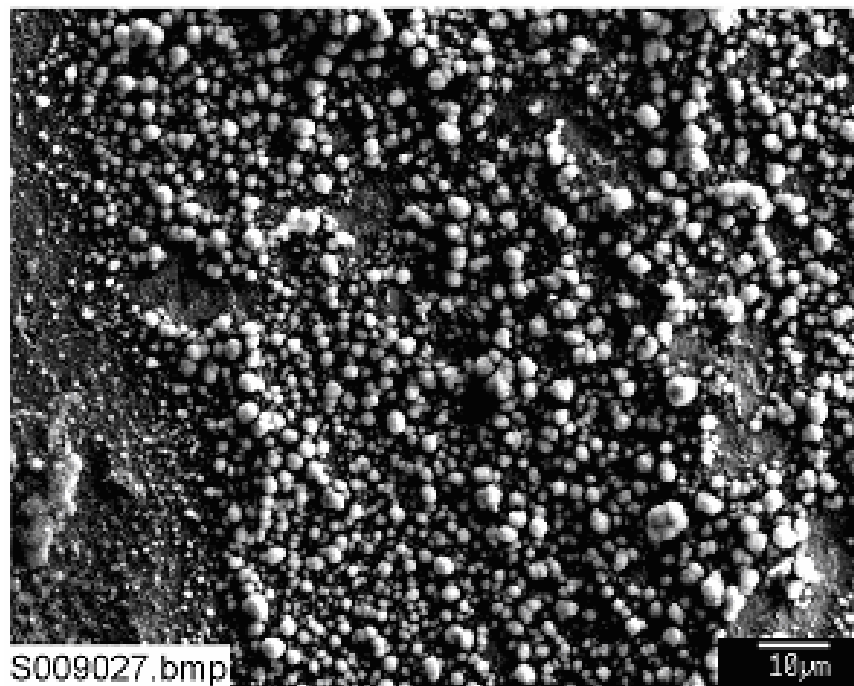
Figure C4-23. SEM image for a corroded area of a Test #2, Day-30 unsubmerged steel coupon. (S009027)

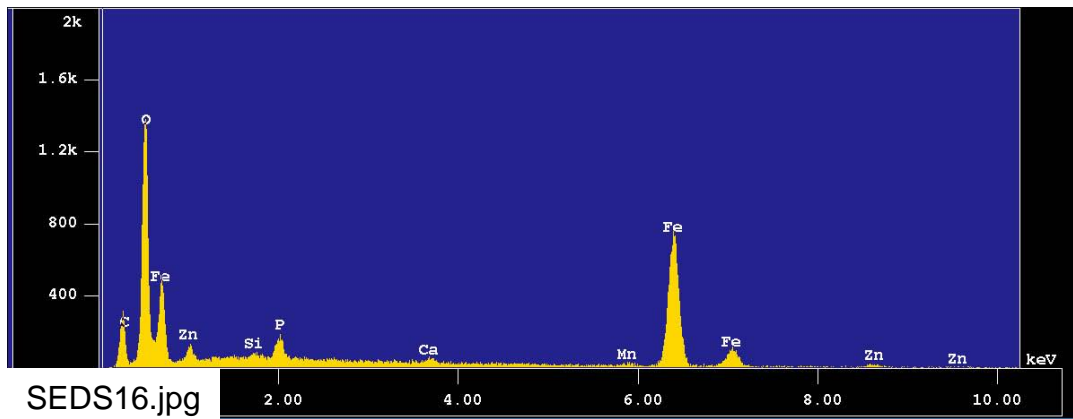
Figure C4-24. EDS counting spectrum for a clump of round corrosion crystals shown in Figure C4-23. (SEDS16)
