NIOSH HEALTH HAZARD EVALUATION REPORT

**HETA #2005-0126 and #2005-0138-3004
International Marine Terminal
Scotia Prince Cruises and Department of Homeland
Security, U.S. Customs and Border Protection
Portland, Maine**

May 2006

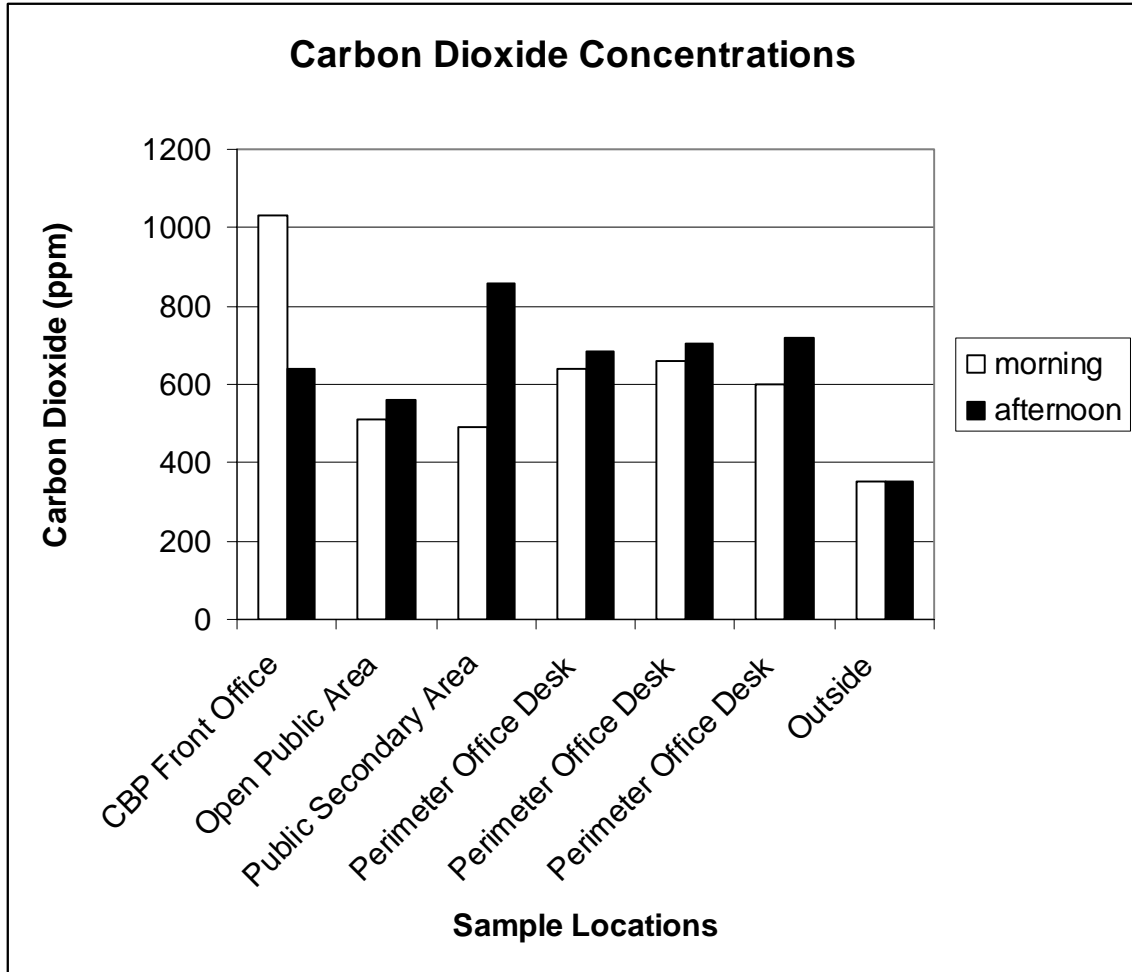
Figure 1
Indoor Environmental Quality Measurements – Carbon Dioxide
U.S. Customs and Border Protection, IMT
Portland, Maine
HETA 2005-0126, 2005-0138-3004
March 10, 2005

Figure 1 shows the range of CO₂ concentrations in the CBP area. CO₂ ranged from 490 to 1030 ppm in the morning and from 545 to 860 ppm in the afternoon on March 10, 2005. CO₂ levels in the front office area were near the ANSI/ASHRAE-recommended maximum concentration of 700 ppm plus outdoor concentration (350 ppm) in the morning. The remaining CO₂ concentrations were within acceptable ranges according to the ANSI/ASHRAE guidelines. Figure 2 presents the temperature ranges (70°F to 75°F) obtained during the same time frame. These temperatures are considered in the acceptable range in conjunction with a RH of 50%. Figure 3 gives the relative humidity ranges (13%-18%) for the sampling period. These values are fairly low but not uncommon during the heating season.

4. Ventilation should be provided to any CBP area offices that serve as interview areas. ASHRAE recommends supplying 17 cfm/person of combined air (5 cfm/person of outdoor air) to these areas.¹¹ The bathroom exhaust systems need to be repaired and operational to meet local building codes.
