DISASTER ACCIDENT REPORT FACTS

U.S. Department of Labor ! Occupational Safety and Health Administration ! Kansas City Region VII No. 15

ACCIDENT SUMMARY

Accident Type: Electrical Shock

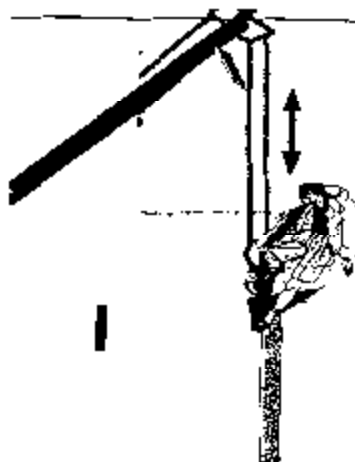
The employee was holding the discharge hose of a cement pumper truck when the boom came into contact with a 12,000 volt overhead power line. The employee received an electrical shock, causing him to fall onto the concrete floor approximately 7 feet below. The impact of the fall caused the death.

1. Provide proper fall protection for employees working at the top of forms.

2. Employer should notify the electrical utility company that he is working in the area and request a shutdown of the high voltage line. If unable to shutdown the employer should request that the utility company provide conductors, insulator covers, or blankets.
