MISCELLANEOUS ELECTRICAL VOLUMES II

FIST VOLUMES 3-18 THROUGH 3-28

**Engineering Division
Facilities Engineering Branch
Denver Office**

BUREAU OF RECLAMATION

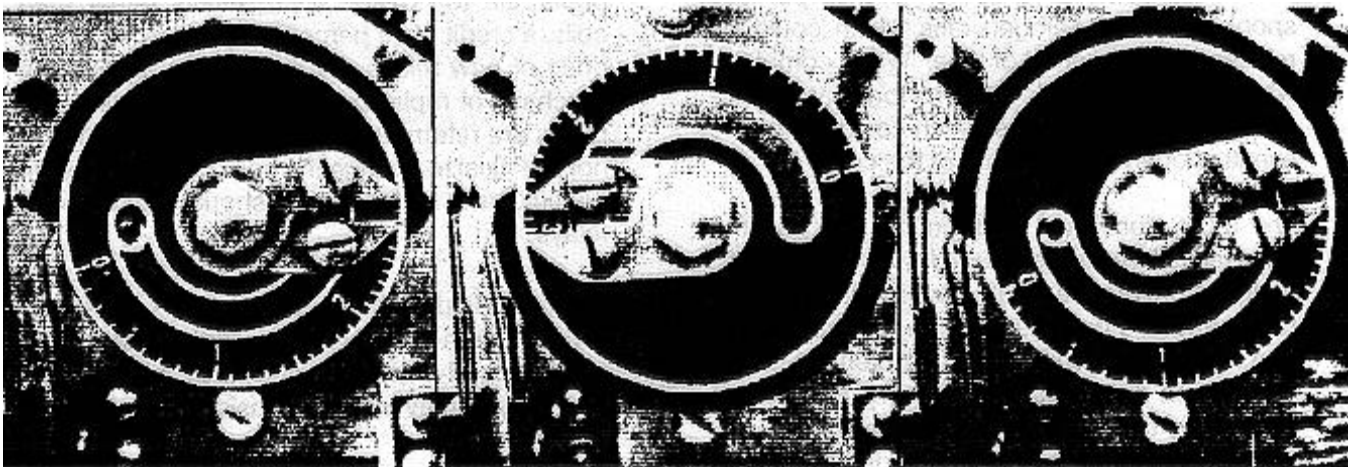
Figure 1

At one of our facilities, false tripping has been attributed to overtravel in a General Electric Type RPM timer relay. The cam assembly overtraveled while resetting, and this allowed the TU2 contact to close. This happened just as the fault was reestablished and allowed the backup distance relay to trip without delay.

Some newer RPM relays are provided with a cam to maintain the TU2 contacts closed, after its time delay, until the RPM is deenergized. When a long-time delay is required, the back edge of the cam is near the TU2 contacts at the reset position; and any overtravel during resetting can cause the cam to bump the TU2 contacts closed.

At locations where this is found to be a problem, a small portion of the cam's surface can be removed from the back edge. Only that portion of the cam that is causing the problem should be removed, since a shorter time delay setting may be required in the future.

All type RPM relays should be checked to see that this problem does not exist during the next scheduled routine test.
