Atmospheric Hazards

FACE 84-11: Fire At A Wastewater Treatment Plant

FACE 84-13: Two Confined Space Fatalities During Construction of a Sewer Line

FACE 85-23: Use of Sulfuric Acid Results in Two Deaths in Waste Water Holding Tank in Pennsylvania

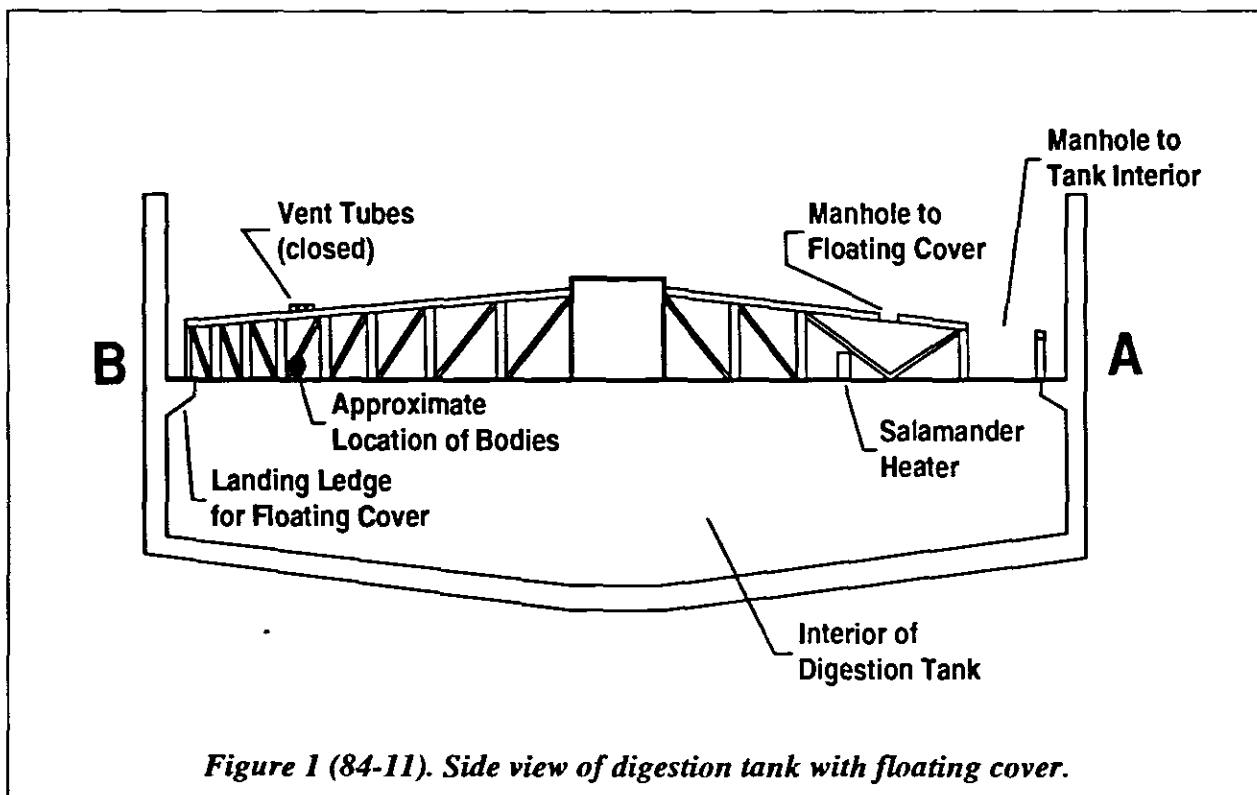
The floating circular cover consisted of a confined space of approximately 6,400 cubic feet with a five-foot ceiling height at the apex (see Figure 1). The only entry into the cover was through a 30-inch diameter manhole located approximately ten feet from the apex. Due to the cold and windy winter weather, the carpenters built a temporary roof (2 by 4 studs covered with 8 to 10 mil. plastic sheeting) over the floating cover.
