[Docket No. 2002-SW-25-AD; Amendment 39-13709; AD 2003-13-15 R1]

Airworthiness Directives; Schweizer Aircraft Corporation Model 269A, 269A-1, 269B, 269C, and TH-55A Helicopters

ACTION: Final rule.

2003-13-15 R1 Schweizer Aircraft Corporation: Amendment 39-13709. Docket No. 2002-SW-25-AD. Revises

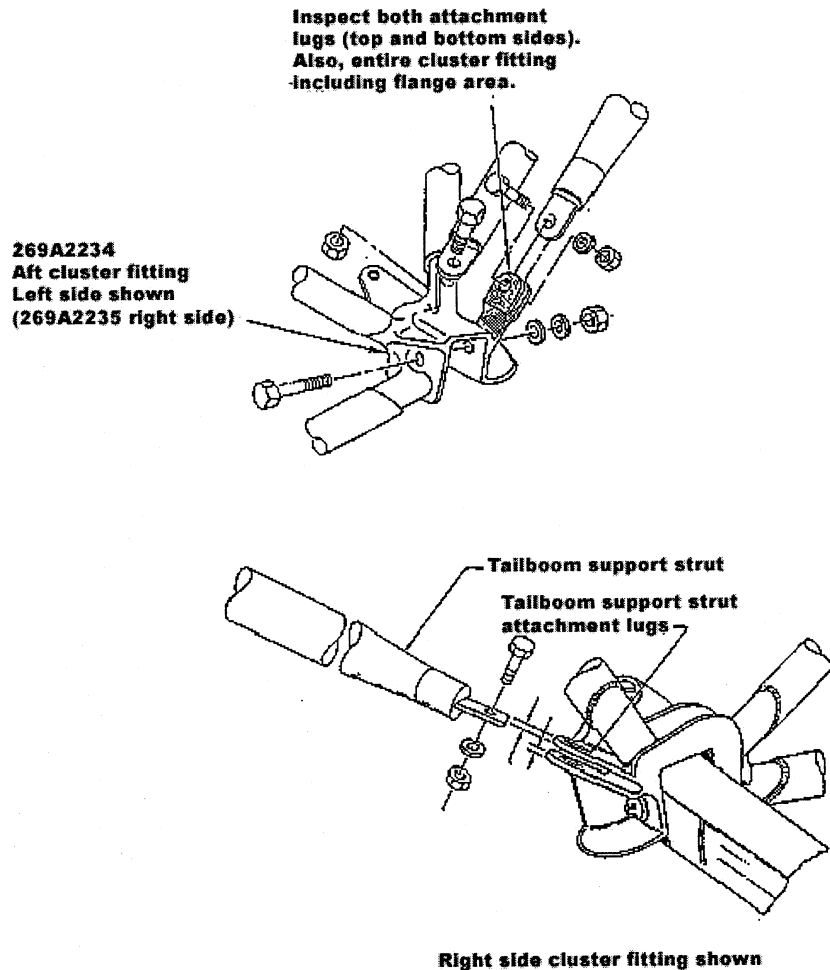
Figure 1

(1) Using paint remover, remove paint from the lugs on each cluster fitting. Wash with water and dry. The tailboom support strut must be removed prior to the paint stripping.

(2) Dye-penetrant inspect the lugs on each cluster fitting. See the following Figure 1:

(3) If a crack is found, before further flight, replace the cracked cluster fitting with an airworthy cluster fitting.
