[Docket No. 2004-NE-07-AD; Amendment 39-13579; AD 2004-08-10]

Airworthiness Directives; Engine Components Incorporated (ECi) Reciprocating Engine Cylinders

2004-08-10 Engine Components

Incorporated (ECi): Amendment 39-13579. Docket No. 2004-NE-07-AD.

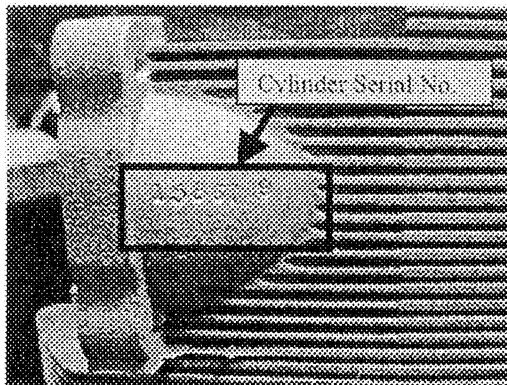
Figure 1.

(i) Determine the SN of the cylinder by looking in the engine records or by inspecting the cylinder for a SN on the intake port boss (see Figure 1) or on the flat area next to the head to barrel junction (see Figure 2). Disregard any dash numbers that might follow the four digit SN.

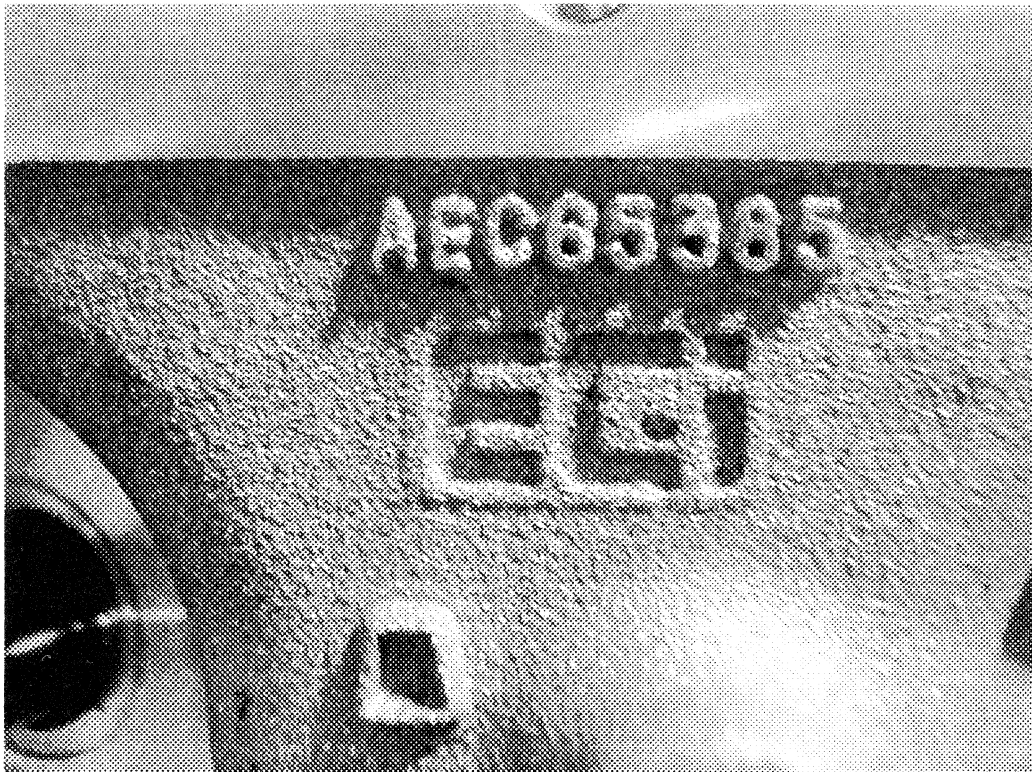
(iii) If the casting has AEC65385, and an "O" under the ECI logo, the cylinder is P/N AEC631397. See Figure 3.

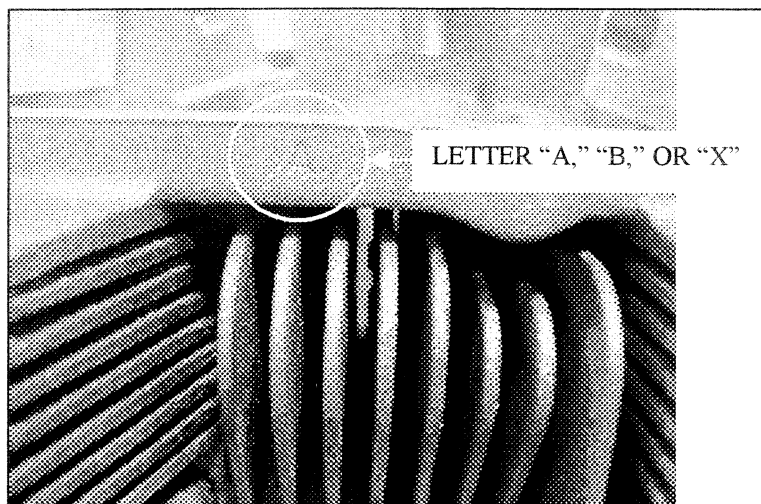
(ii) If there is a letter "A," "B," or "X" stamped on the flange of the rocker box, no further action is required. See Figure 4.

(iii) If there is no letter "A," "B," or "X" stamped on the flange of the rocker box, replace the cylinder before further flight.
