[Docket No. 2003-SW-21-AD; Amendment 39-13424; AD 2004-01-10]

#### **Airworthiness Directives; Eurocopter Deutschland Model MBB-BK-117 A-1, A-3, A-4, B-1, B-2, and C-1 Helicopters**

#### 2004-01-10 Eurocopter Deutschland:

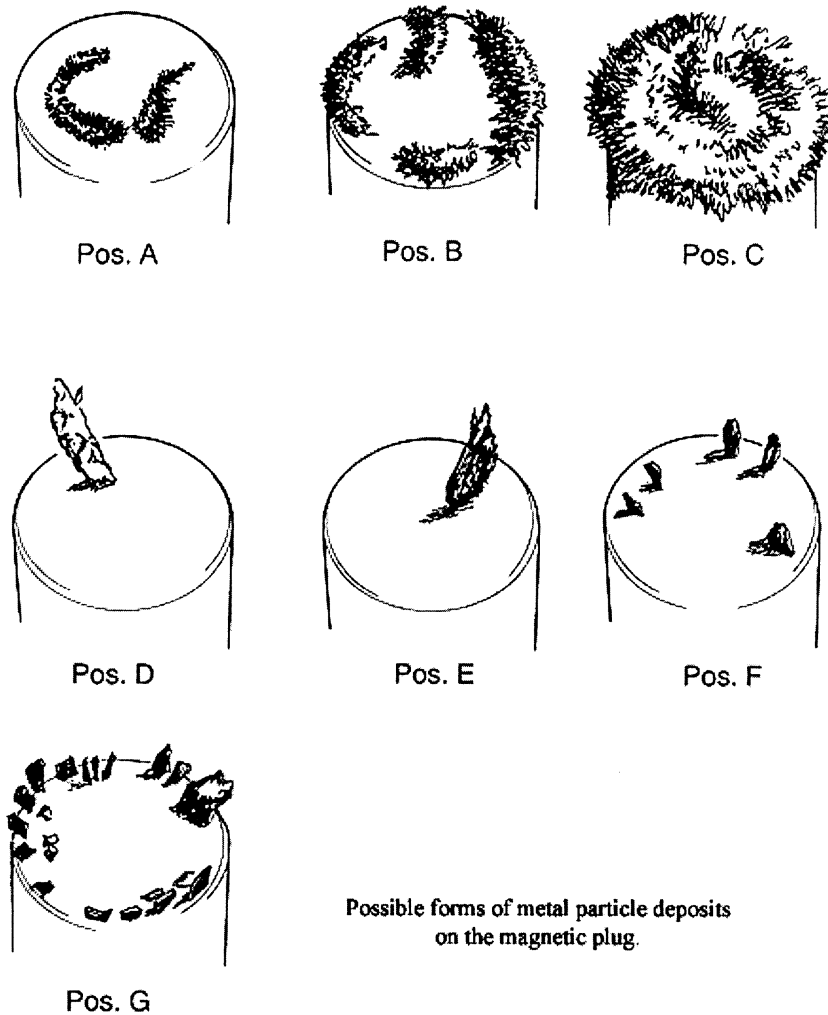
(a) Until you do paragraph (b) of this AD, before the first flight of each day, inspect the magnetic plugs of the TR transmission and INT gearbox for metal particles deposits by reference to Figure 1 of this AD.

(1) If you find a small amount of fine fuzz as shown in "Pos. A" of Figure 1 of this AD, clean the magnetic plug and reinstall it after ensuring that the O-ring is correctly positioned and there is no other damage.

(2) If you find an amount of fuzz as depicted in "Pos. B" or "Pos. C" or metal chip(s) as depicted in "Pos. D" through "Pos. G" or a combination of both fuzz and chips, do paragraph (b) of this AD.

(b) No later than February 23, 2004, replace bearing, P/N 4639310006 with S/N 3246 through 3598, with an airworthy bearing or replace the affected TR transmission or INT gearbox with an airworthy TR transmission and INT gearbox that does not contain the affected bearing.
