Airworthiness Directives; Schweizer Aircraft Corporation Model 269A, 269A-1, 269B, 269C, and TH-55A Helicopters

ACTION: Notice of proposed rulemaking (NPRM).

Schweizer Aircraft Corporation: Docket No. 2002-SW-25-AD. Revises AD 2003-13-15, Amendment 39-13217.

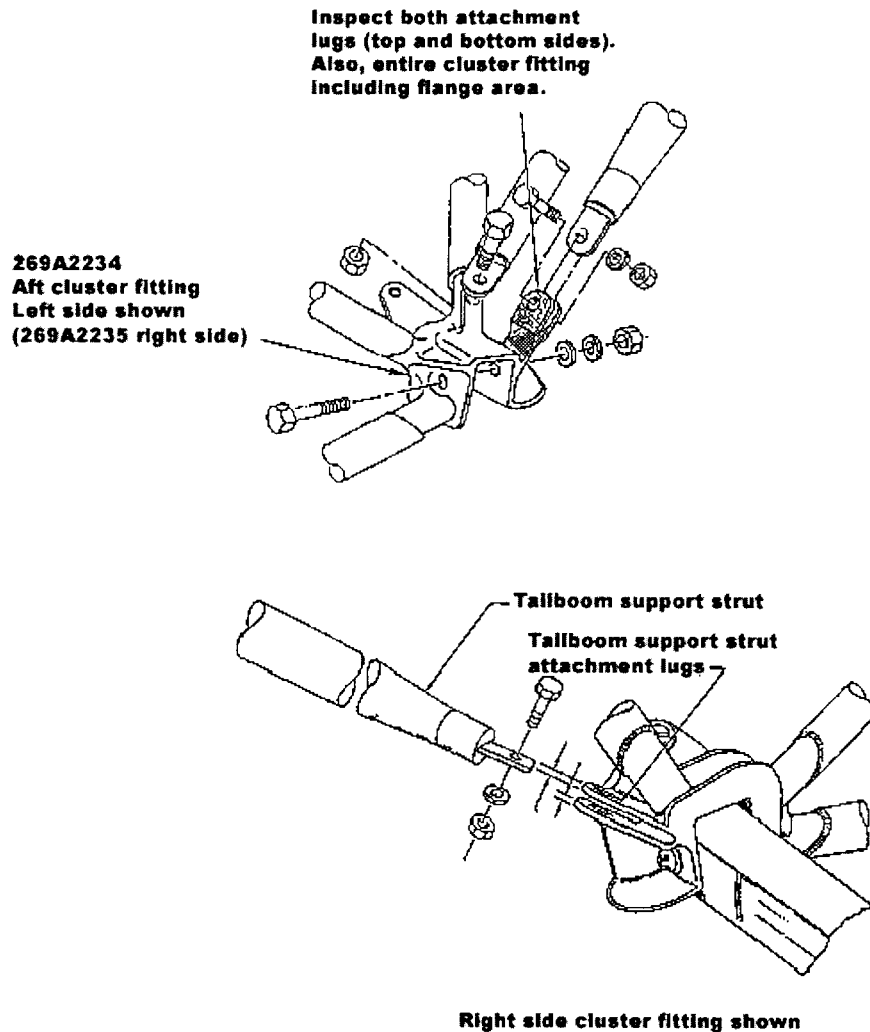
Figure 1

(2) Dye-penetrant inspect the lugs on each cluster fitting. See the following Figure 1:

(3) If a crack is found, before further flight, replace the cracked cluster fitting with an airworthy cluster fitting.
