[Docket No. 2003-SW-38-AD]

Airworthiness Directives; Eurocopter Deutschland Model MBB-BK 117 A-1, A-3, A-4, B-1, B-2, and C-1

ACTION: Notice of proposed rulemaking (NPRM).

Eurocopter Deutschland: Docket No. 2003–SW–38–AD.

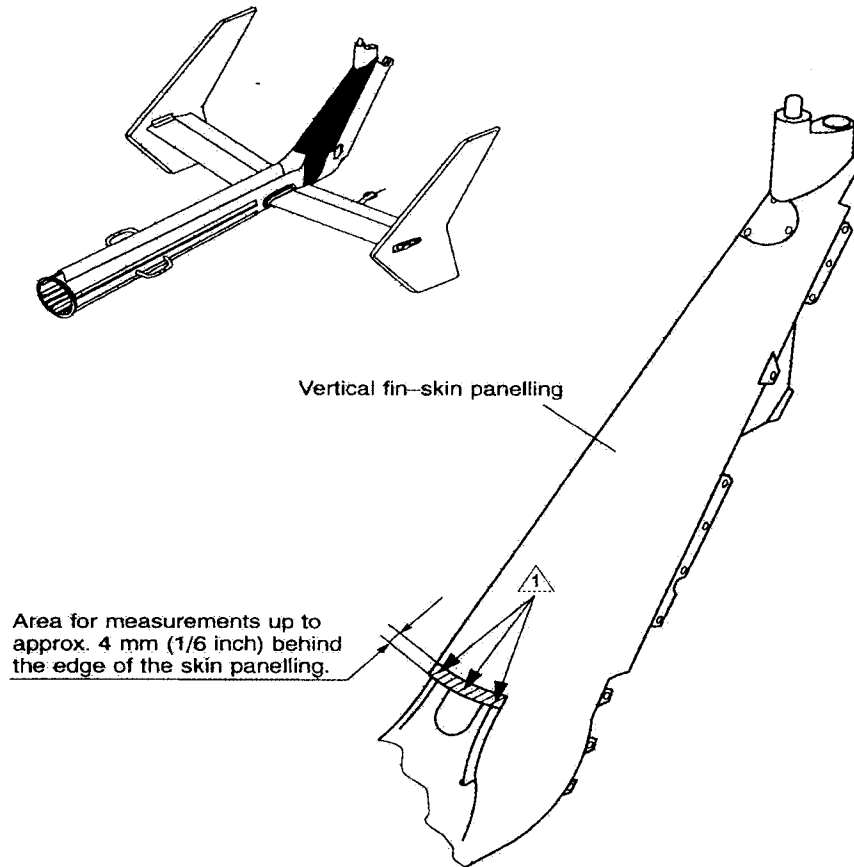
Vertical Fin-Skin Panelling
Figure 1

Model A-1 up to B-2, serial number (S/N) all, and Model C-1, S/N 7500 up to 7545. The LBA advises that during tail boom production, metal sheeting of 0.6-millimeter (mm) thickness was found instead of the specified 0.8-mm thickness for the skin paneling of several tail booms.

(a) Using external calipers, measure the wall thickness, including primer coating, of the skin paneling of the vertical fin at the locations shown in Figure 1 of this AD.

- △ 1 Measurements are to be taken at at least three locations on the skin panel of the vertical fin. Care has to be taken that the external calipers are held squarely to the skin panel wall while measurements are being taken, since tilting of the calipers can lead to false results. If the panel thickness, including the primer coating, is at least 0.778 mm (0.03063 inch) at every measured location, no further action is necessary.

(b) If the wall thickness, including the primer coating, of the panelling is less than 0.778 millimeter (0.03063 inch) at any of the measured locations, replace the vertical fin with an airworthy part before further flight.
