**DEPARTMENT OF TRANSPORTATION****Federal Aviation Administration****14 CFR Part 39**

[Docket No. 2002-SW-25-AD]

**Airworthiness Directives; Schweizer Aircraft Corporation Model 269A, 269A-1, 269B, 269C, and TH-55A Helicopters****AGENCY:** Federal Aviation Administration, DOT.**ACTION:** Notice of proposed rulemaking (NPRM).

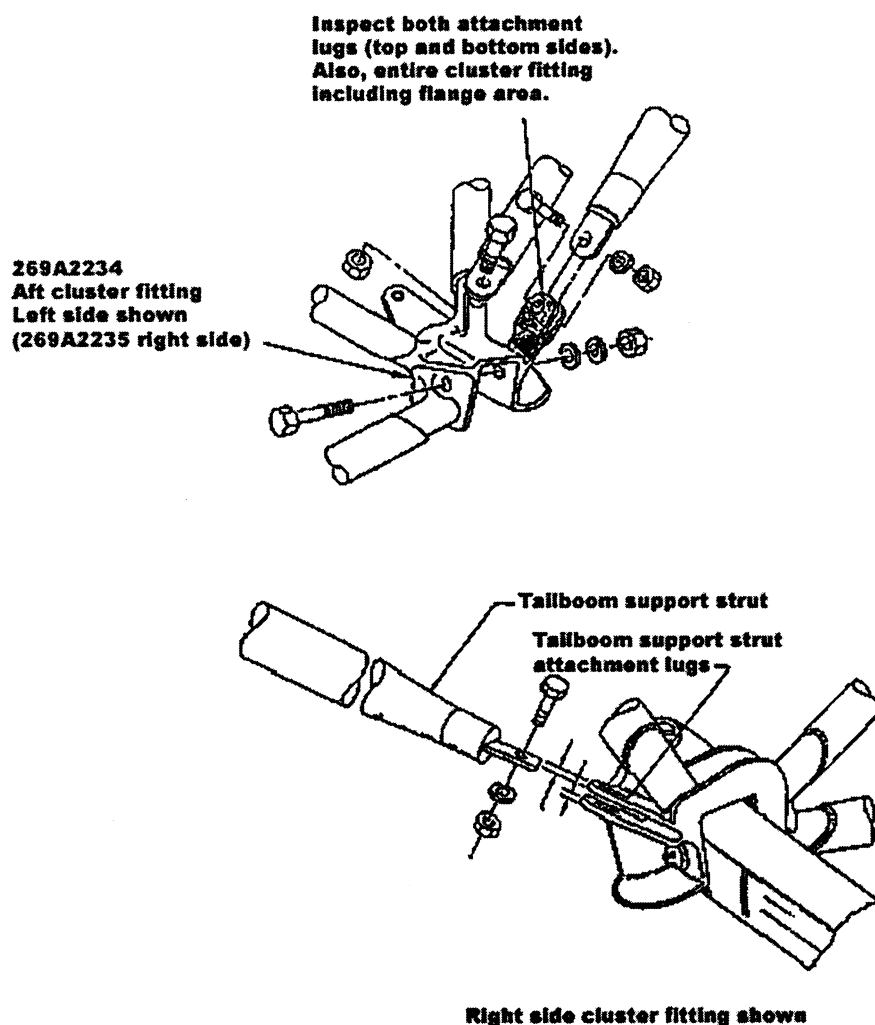
**Figure 1**

(2) Dye-penetrant inspect the lugs on each cluster fitting. See the following Figure 1:

(3) If a crack is found, before further flight, replace the cracked cluster fitting with an airworthy cluster fitting.
