[Docket No. 2003-SW-20-AD; Amendment 39-13181; AD 2003-08-53]

Airworthiness Directives; Eurocopter France Model SA-365N1, AS365-N2, AS 365 N3, and SA-366G1 Helicopters

2003-08-53 Eurocopter France:

Applicability: Model SA-365N1, AS365-N2, AS 365 N3, and SA-366G1 helicopters, with a tail rotor blade (blade), part number 365A33-2131-all dash numbers; 365A12-0010-all dash numbers; or 365A12-0020-00, -01, -02, or -03; installed, certificated in any category.

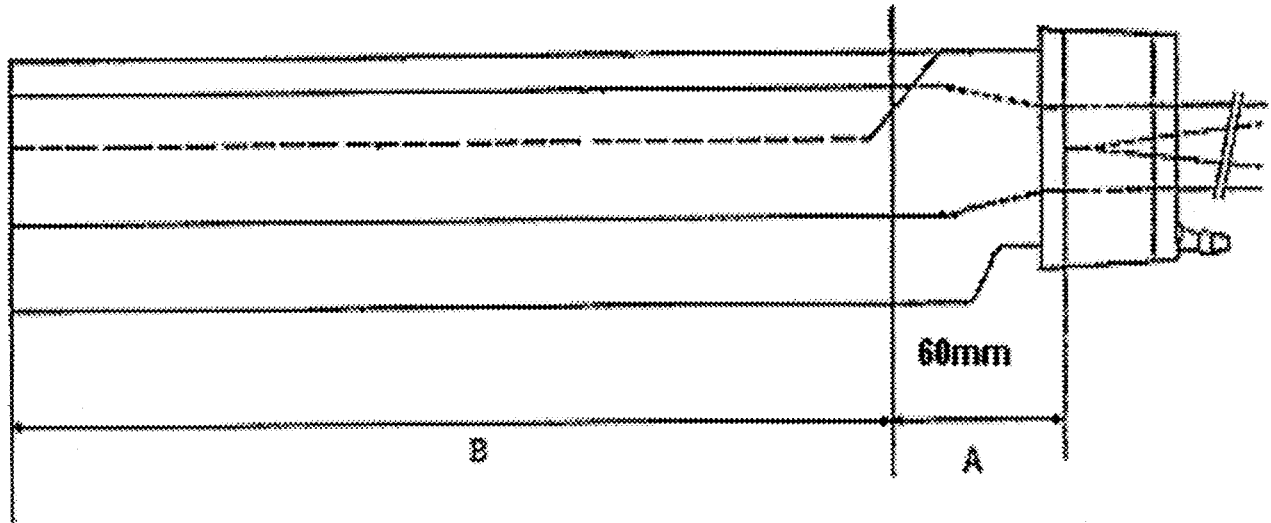
(a) Within 10 hours time-in-service (TIS) and thereafter before the first flight of each day, visually check each blade for a crack, blister, or wrinkling. An owner/operator (pilot), holding at least a private pilot certificate, may perform the visual check and must enter compliance into the aircraft maintenance records in accordance with 14 CFR sections 43.11 and 91.417(a)(2)(v)). See Figure 1 as follows:

(1) Zone A: If a blister is detected on the blade suction face, conduct a tapping test inspection on the whole blade for bonding separation.

(2) Zone B: If a crack, wrinkling, or a blister is found, replace the blade with an airworthy blade before further flight.

(i) For blades, P/N 365A33-2131-all dash numbers, 365A12-0010-all dash numbers, and 365A12-0020-00, and -01, if bonding separation or a crack is found, replace the blade with an airworthy blade before further flight.

(ii) For blades, P/N 365A12-0020-02, and -03, if bonding separation exceeds 900 mm² in a 30 x 30 mm square or if there is a crack, replace the blade with an airworthy blade before further flight.

(2) Thereafter, at intervals not to exceed 25 hours TIS, conduct a tapping test inspection for bonding separation on blades, P/N 365A12-0020-02 or 365A12-0020-03, in Zone A as depicted in Figure 1 of this AD.

(3) Thereafter, at intervals not to exceed 100 hours TIS or 200 cycles, whichever occurs first, conduct a tapping test inspection for bonding separation on blades, P/N 365A12-0020-02 or 365A12-0020-03, in Zone B as depicted in Figure 1 of this AD. If a crack, wrinkling, or a blister is found, replace the blade with an airworthy blade before further flight.
