[Docket No. 2003-SW-17-AD; Amendment 39-13215; AD 2003-08-51]

Airworthiness Directives; MD Helicopters, Inc. Model 369A, D, E, H, HE, HM, HS, F, and FF Helicopters

2003-08-51 MD Helicopters, Inc.:
Amendment 39-13215. Docket No. 2003-SW-17-AD.

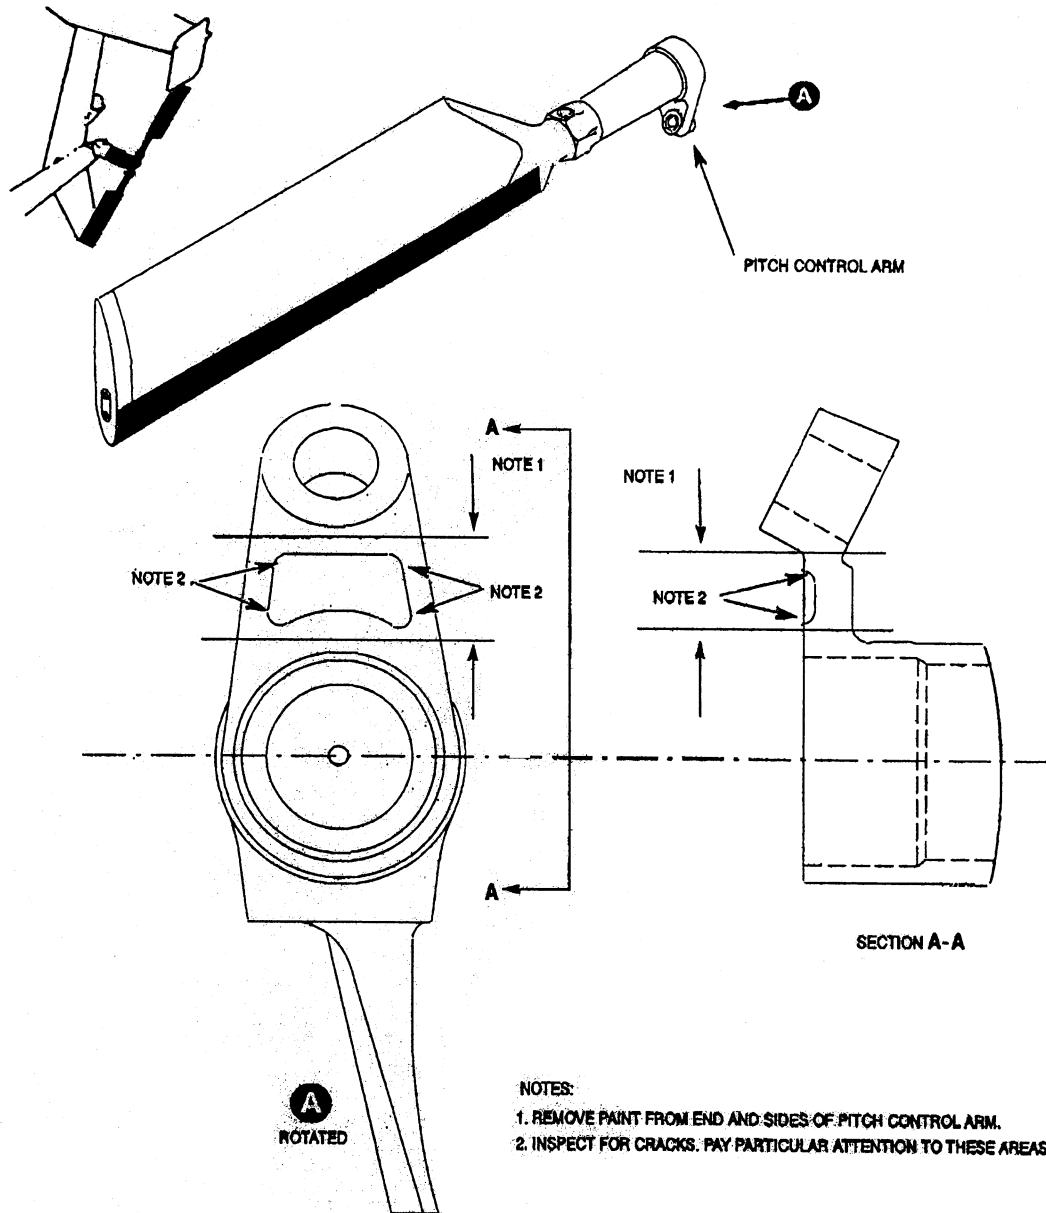
Figure 1. Tail Rotor Blade Assembly Inspection

(b) Before further flight, perform a one-time visual inspection of each pitch horn for a crack or corrosion in the area indicated by Note 2 in Figure 1 of this AD. Paint removal in accordance with Note 1 of Figure 1 of this AD is not required for the visual inspection.

repair facility may be issued only upon completion of an eddy current surface scan of each affected pitch horn (see Figure 1 of this AD). Paint removal in accordance with Note 1 of the Figure 1 of this AD IS required for the surface scan. If a crack is found,

remove the tail rotor blade and replace it with an airworthy tail rotor blade before further flight.
