[Docket No. 2003-SW-06-AD; Amendment 39-13064; AD 2003-04-15]

Airworthiness Directives; Sikorsky Aircraft Corporation Model S-76A, B, and C Helicopters

2003-04-15 Sikorsky Aircraft Corporation: Amendment 39-13064. Docket No. 2003-SW-06-AD.

Applicability: Model S-76A, B, and C helicopters, certificated in any category.

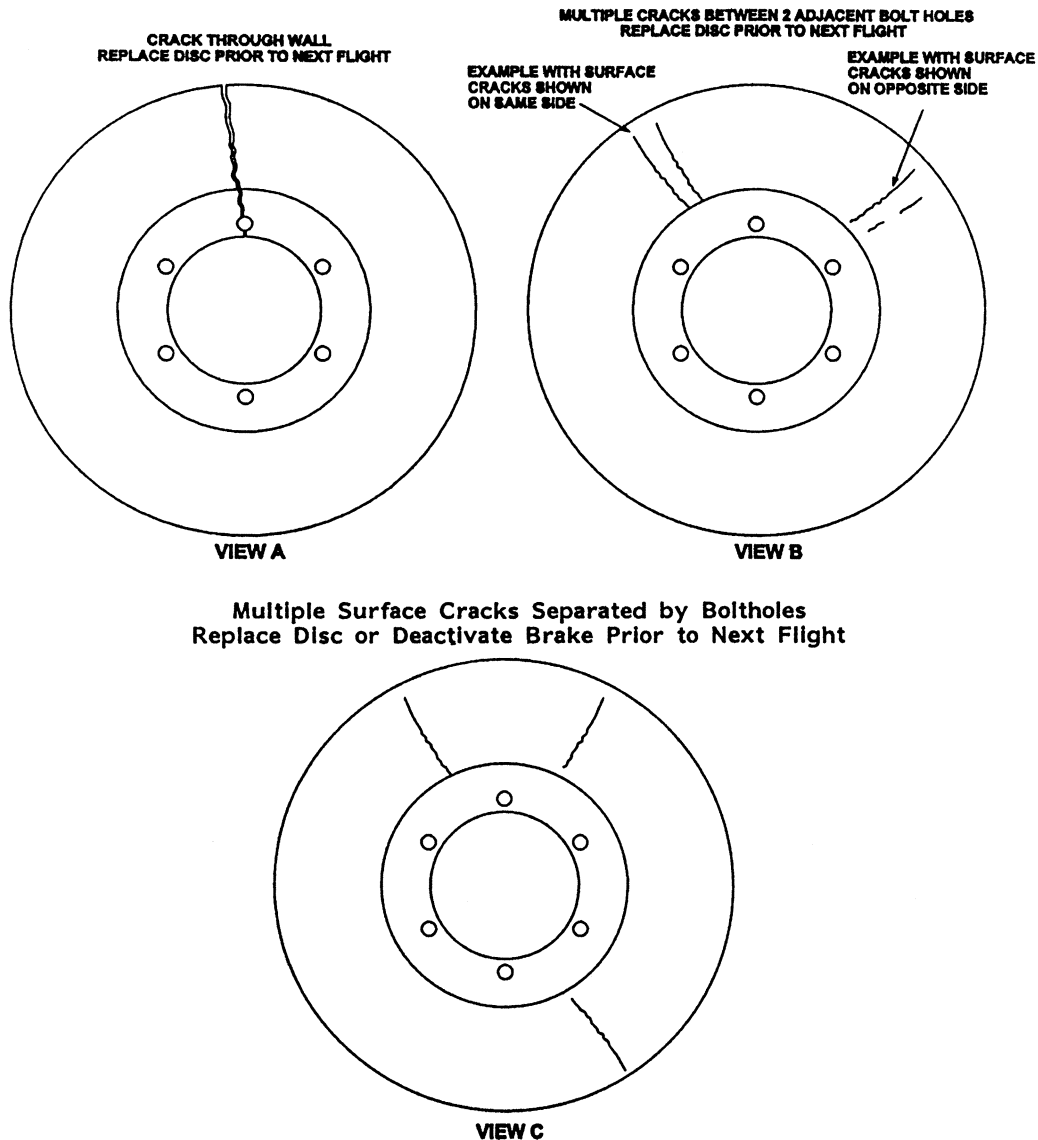
**RBD INSPECTION LIMITS
FIGURE 1.**

(b) Before the first flight of the next day following any day in which the RBD was used, visually inspect each RBD, P/N 76363-09103-104, for a crack, and perform the following actions. See Figure 1.

(1) If you find a crack through the entire RBD thickness as shown in Figure 1, View A, replace the RBD with an airworthy RBD, other than P/N 76363-09103-104, before further flight.

(2) If you find two or more surface cracks between adjacent boltholes as shown in Figure 1, View B, replace the RBD with an airworthy RBD, other than P/N 76363-09103-104, before further flight.

(3) If you find a surface crack or surface cracks separated by the boltholes as shown in Figure 1, View C, replace the RBD with an airworthy RBD, other than P/N 76363-09103-104, or deactivate the RBD before further flight.

Note 3: Short "glazing" cracks are not a cause for rejection.

(c) Replace PHC RBD, P/N 76363-09103-104, with an airworthy RBD on or before May 31, 2003, or within 60 days after the effective date of this AD, whichever occurs later. Any replacement RBD, P/N 76363-09103-104, is not airworthy.
