[Docket No. 2000-SW-12-AD]

Airworthiness Directives; Eurocopter France Model AS350B, B1, B2, B3, BA, C, D, D1, and AS355E, F, F1, F2, and N Helicopters

ACTION: Supplemental notice of proposed rulemaking; reopening of comment period.

Eurocopter France: Docket No. 2000–SW–12–AD.

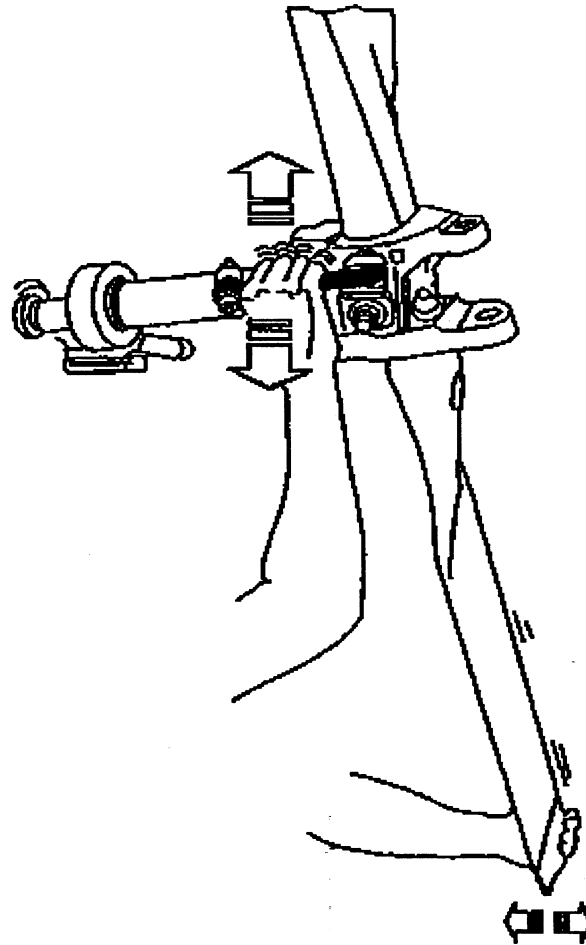
Figure 1: Manual Check for Play of the Tail Rotor Pitch Control Rod

(a) Before the first flight of each day, place the tail rotor pedals in the neutral position. If the helicopter is fitted with a tail rotor load compensator, discharge the accumulator as described in the rotorcraft flight manual. Check the bearing for play on the helicopter, by observation and feel, by slightly moving the tail rotor blade in the flapping axis while monitoring the bearing for movement. See the following Figure 1 of this AD:

(1) If the Teflon cloth is coming out of its normal position within the bearing, totally or partially, or if there is discoloration or scoring on the bearing, the bearing is unairworthy.

(b) If a pilot or mechanic detects play, a mechanic must remove the control rod from the helicopter, and using a dial indicator, measure the bearing wear according to the following and as shown in Figures 2 and 3 of this AD:

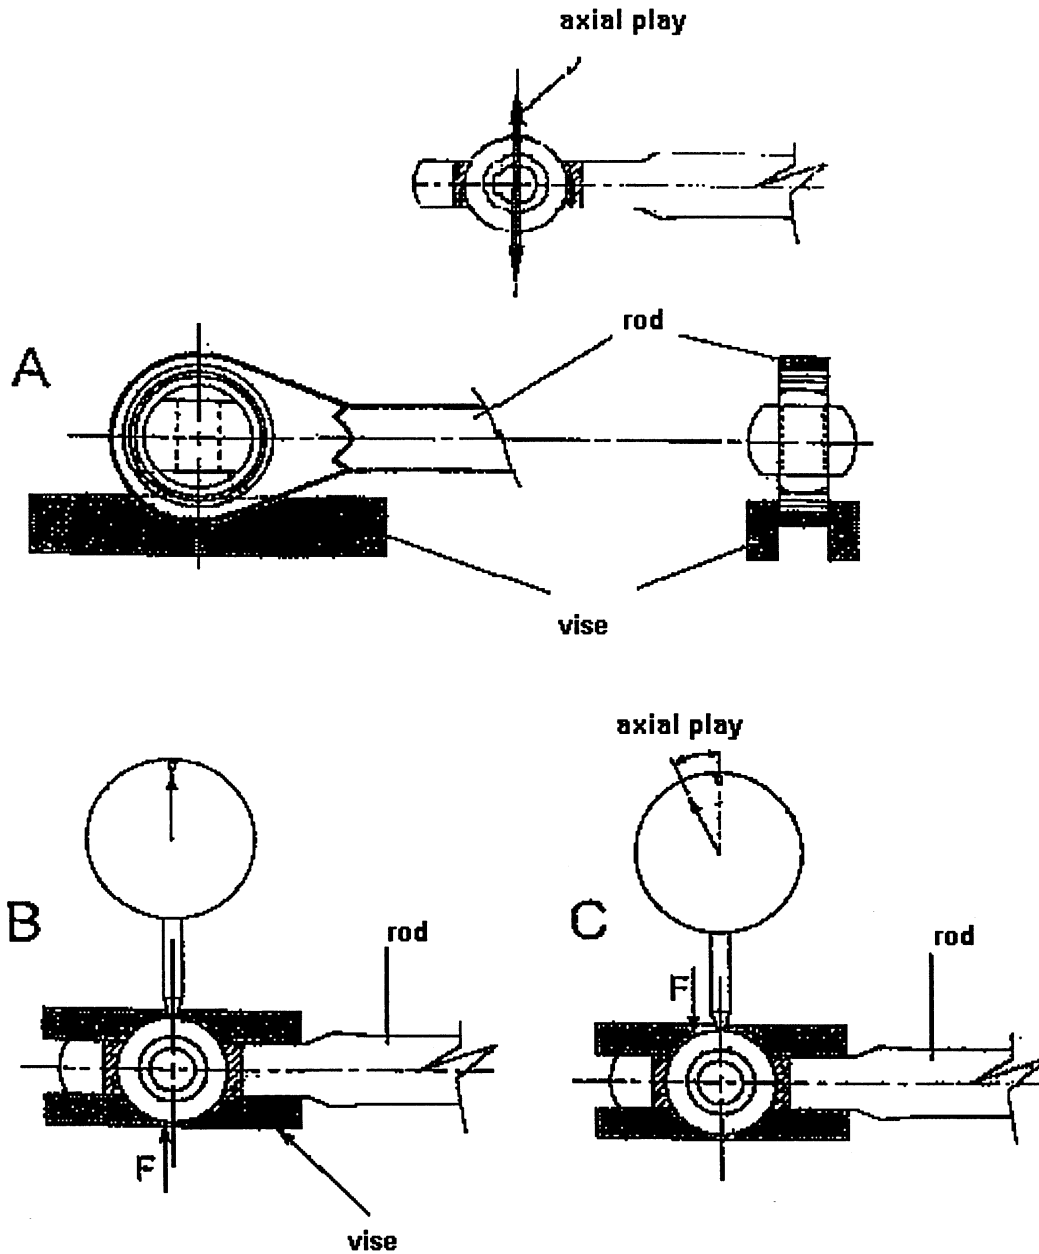
Figure 2: Measurement of the Axial Play (A) of the Bearing

(3) Using a dial indicator, take axial play readings by moving the spherical bearing in the direction F (up and down) as shown in Figure 2 of this AD.

(8) If the radial play exceeds 0.008 inch or axial play exceeds 0.016 inch, replace the

(2) Mount the control rod in a vise as shown in Figure 2 of this AD.

control rod with an airworthy control rod before further flight.
