[Docket No. 2003-CE-43-AD; Amendment 39-13328; AD 2003-20-10]

**Airworthiness Directives; Raytheon Aircraft Company Beech Models 1900, 1900C, and 1900D Airplanes**

**2003-20-10 Raytheon Aircraft Company:**  
Amendment 39-13328; Docket No. 2003-CE-43-AD.

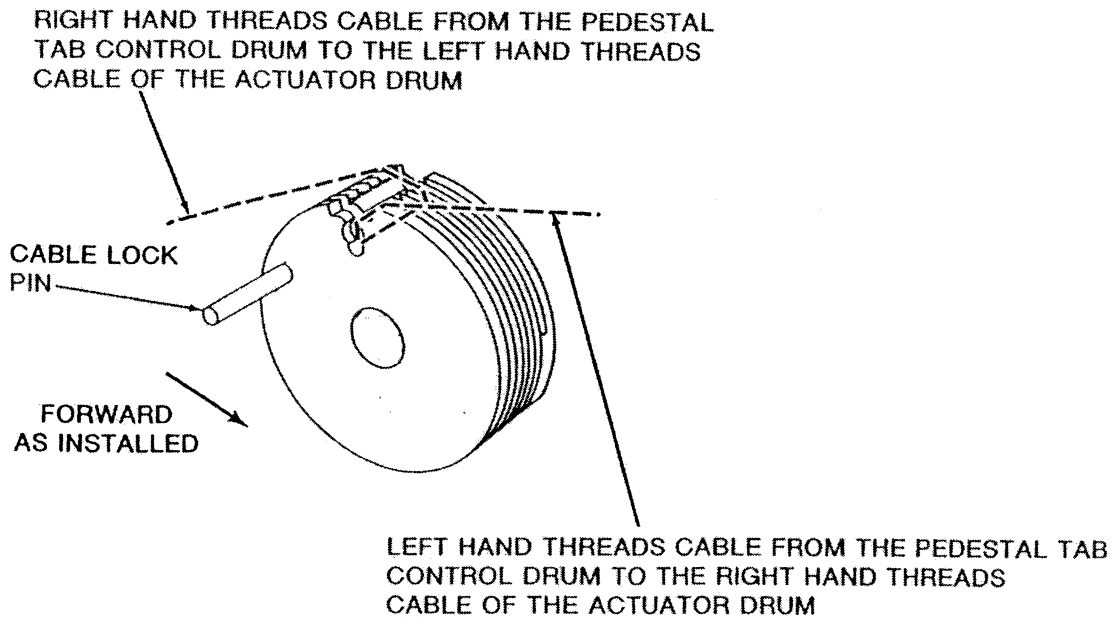
Figure 1

- The figures in the applicable maintenance manuals depict the elevator trim cable drum at 180 degrees from the installed position and show the open, keyed side of the drum instead of the flat side of the drum. Following these figures when installing the control cables on the forward control cable drum could reverse the action of the elevator manual trim system; and
- The existing procedure can be enhanced by visually confirming the trim wheel position and the trim tab position are consistent. Such a check would detect and correct any problems with the elevator trim system installation before problems occur during operation.

Although the figures (figure 9 for the 1900/1900C and figure 201 for the 1900D) in the existing maintenance manuals are incorrectly depicted, following the step-by-step written instructions in the existing procedure and referring to the orientation of the parts removed would result in the correct installation and action of the elevator trim system.

Actions	Compliance	Procedures
<p>(1) Using pen and ink, mark the applicable figure in the maintenance manual as referenced below. The depiction in the referenced figures is incorrect for the elevator trim drum only and depicts the cable drum at 180 degrees from the installed position and shows the open, keyed side of the drum instead of the flat side of the drum. Insert corrected figure (Figure 1 of this AD) into the applicable maintenance manual and identify it accordingly:</p> <ul style="list-style-type: none"> <li>(i) Figure 9 of Chapter 27-10-00 of the Model 1900/1900C Airliner Maintenance Manual (114-590021-7B) Clearly note in pen that existing portion of Figure 9 is correct for the aileron trim drum only and insert corrected figure (Figure 1 of this AD) marked in pen as correct for the elevator trim drum only; or</li> </ul>	<p>Before the next time you have maintenance done on the elevator trim system.</p>	<p>As specified in Raytheon Safety Communiqué No. 234, dated September 2003.</p>

Actions	Compliance	Procedures
<p>(ii) Mark out Figure 201 of Chapter 27-30-04 of the Model 1900D Airliner Maintenance Manual (125-590000-15). Insert corrected figure (Figure 1 of this AD)</p> <p>(2) Incorporate the applicable temporary revision into the maintenance manuals as follows:</p> <p>(i) Temporary Revision No. 27-5 to the Model 1900/1900C Airliner Maintenance Manual: Revised ELEVATOR TRIM OPERATIONAL CHECK; or</p> <p>(ii) Temporary Revision No. 27-9 to the Model 1900D Airliner Maintenance Manual: Added MANUAL ELEVATOR TRIM OPERATIONAL CHECK.</p> <p>(3) Do the elevator trim operational check that is specified in the applicable maintenance manual and temporary revisions to the maintenance manual as referenced in paragraph (e)(2) of this AD</p>	<p>Before the next time you have maintenance done on the elevator trim system.</p> <p>Prior to further flight after each time you have maintenance done on the elevator trim system.</p>	<p>As specified in Raytheon Safety Communiqué No. 234, dated September 2003.</p> <p>As specified in Raytheon Safety Communiqué No. 234, dated September 2003; and Temporary Revision No. 27-5 to the Model 1900/1900C Airliner Maintenance Manual: Revised ELEVATOR TRIM OPERATIONAL CHECK; or Temporary Revision No. 27-9 to the Model 1900D Airliner Maintenance Manual: Added MANUAL ELEVATOR TRIM OPERATIONAL CHECK, both dated September 12, 2003, as applicable.</p>
