#### 14 CFR Part 39

[Docket No. FAA-2004-19969; Directorate Identifier 2004-SW-43-AD; Amendment 39-13923; AD 2004-26-11]

#### Airworthiness Directives; Bell Helicopter Textron Canada Model 222, 222B, 222U, 230, and 430 Helicopters

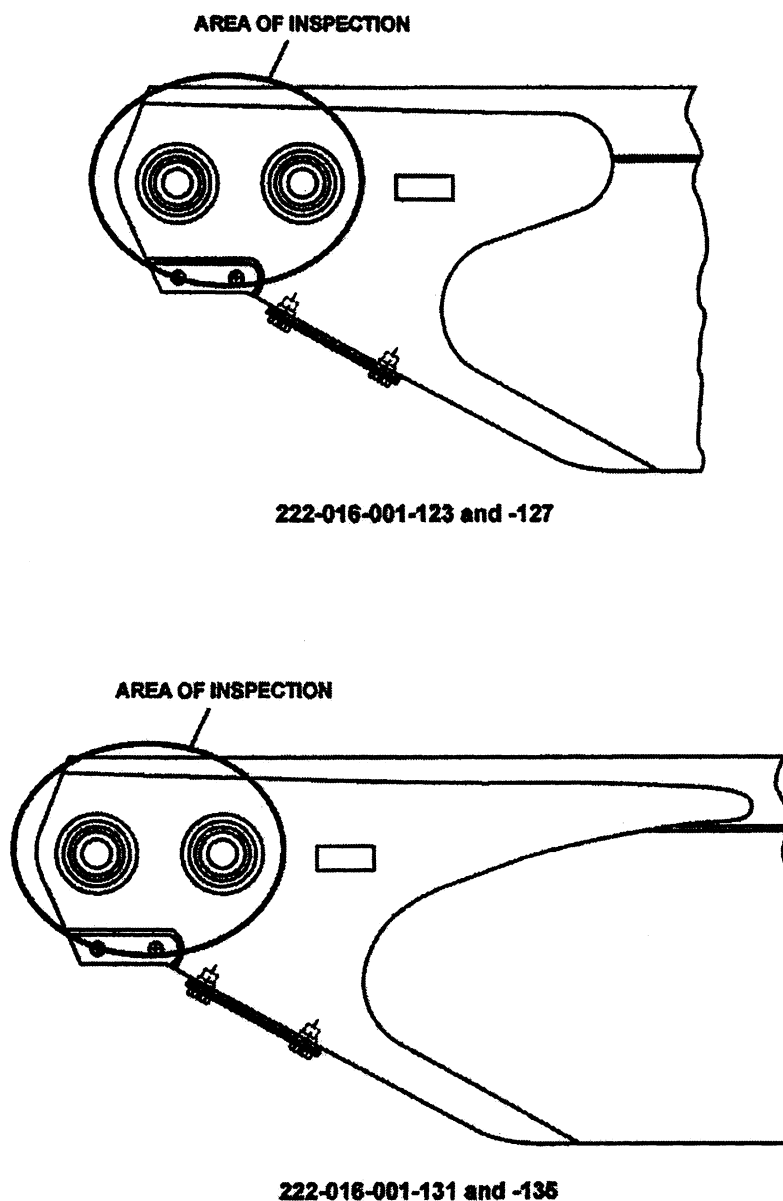
**Figure 1. Blade inspection area**

Transport Canada, the airworthiness authority for Canada, notified the FAA that an unsafe condition may exist on the specified BHTC model helicopters. Transport Canada advises of the discovery of cracked blades during scheduled inspections on three occasions. Two cracks originated from the outboard feathering bearing bore underneath the flanged sleeves. The third crack started from the inboard feathering bearing bore. Investigation found that the cracks originated from either a machining burr or a corrosion site in the bearing bore underneath the flanged sleeves.

- (a) Within 3 hours time-in-service (TIS) and at intervals not to exceed 3 hours TIS, clean and visually check both sides of each blade for a crack in the paint in the areas shown in Figure 1 of this AD. An owner/operator (pilot), holding at least a private

wiping down both surfaces of each blade in the inspection area depicted in Figure 1 of this AD using aliphatic naphtha (C-305) or detergent (C-318) or equivalents. Using a 10X or higher power magnifying glass, visually inspect both sides of the blade in the areas depicted in Figure 1 of this AD.

(i) If a crack is found, before further flight, replace the blade with an airworthy blade.

(ii) If no crack is found in the blade surface, refinish the blade by applying one coat of MIL-P-23377 or MIL-P-85582 Epoxy Polyamide Primer so that the primer overlaps

the existing coats just beyond the abraded area. Let the area dry for 30 minutes to 1 hour. Then, apply one sealer coat of Polyurethane MILC85285 TYI CL2, color Number 27925 (semi-gloss white) per Fed. Std. 595. Reinstall the blade.
