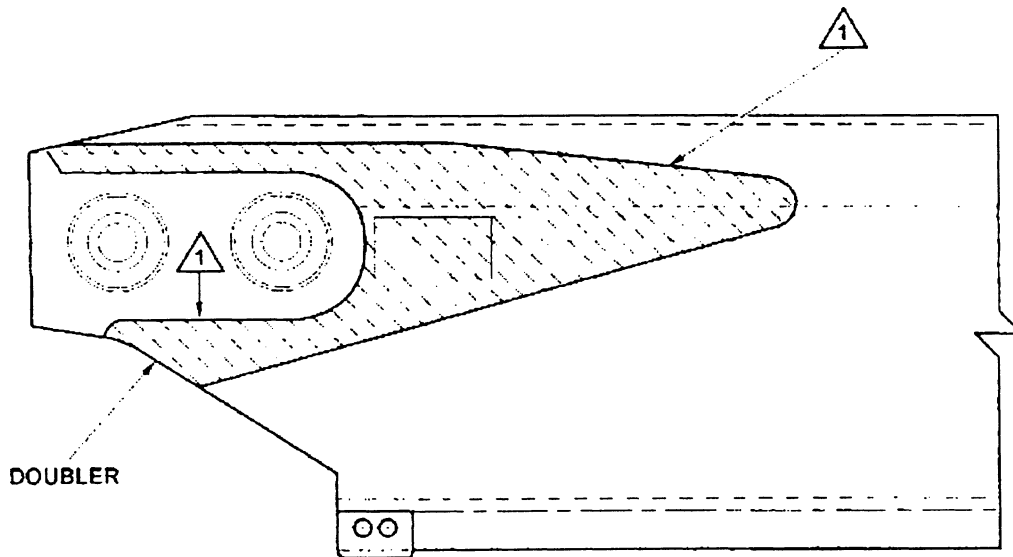
(a) Before the first flight of each day, clean each blade and visually check the blade root doublers for an edge void or de-bond on both sides of each blade as depicted in Figure 1 of this AD. An owner/operator (pilot), holding at least a private pilot certificate, may perform this visual check and must enter compliance with this paragraph into the helicopter maintenance records by following 14 CFR sections 43.11 and 91.417(a)(2)(v).

1 Inspect the doubler for an edge void or de-bond on both sides of each blade.

(b) If an edge void or a de-bond is found, before further flight, replace the blade with an airworthy blade with a serial number other than those to which this AD applies.
