DEPARTMENT OF TRANSPORTATION**Federal Aviation Administration****14 CFR Part 39**

[Docket No. FAA-2005-22481; Directorate Identifier 2004-NM-176-AD]

Airworthiness Directives; Bombardier Model CL-600-2B19 (Regional Jet Series 100 & 440) Airplanes**AGENCY:** Federal Aviation Administration (FAA), Department of Transportation (DOT).**ACTION:** Notice of proposed rulemaking (NPRM).

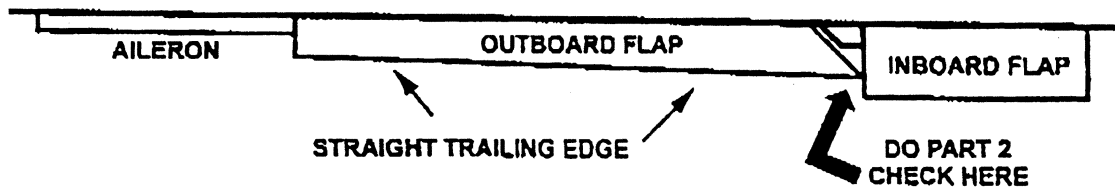
Figure 1. Normal/Abnormal Outboard flap Configuration in Take-off Position”

NORMAL/ABNORMAL OUTBOARD FLAP CONFIGURATION IN TAKE-OFF POSITION

Note: View looking forward on left wing trailing edge (right side opposite).

1. NORMAL

A normal outboard flap has a straight trailing edge, and the inboard corner is slightly above (*i.e.* higher) than the inboard flap.

2. ABNORMAL

The following are indications of an outboard flap with a twist, skew or abnormal deformation:

- Noticeable curve in the trailing edge
- Buckled top or bottom surface
- Higher than normal position of the inboard trailing edge corner

(b) An external visual check must be accomplished to detect any twisting, skewing, or abnormal deformation of the flaps, using the information given in Figures 1 and 2.

2. Carry out an external visual check of each outboard flap for evidence of twisting, skewing, or abnormal deformation. (Reference Figures 1 and 2.)

B. Visually check each flap for evidence of twisting, skewing, or abnormal deformation.

2. If there is evidence of twisting, skewing, or abnormal deformation, replace both actuators and any discrepant flap panel with new or serviceable components. In addition,

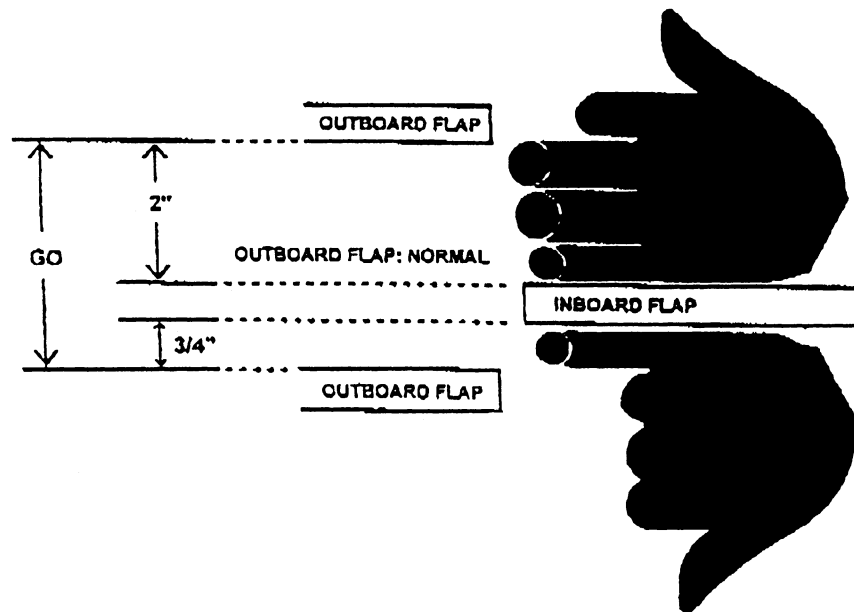
1. FLAPS AT 8 DEGREES

OUTBOARD FLAP GO/NO-GO CRITERIA IN TAKE-OFF POSITION

- NOTE 1. These criteria are applicable for any size of hand.
2. View looking forward on left wing trailing edge (right side opposite).

If the outboard flap position is outside the "GO" range as shown below further flight is prohibited.

IMPORTANT: *If the outboard flap position is outside the 'GO' range, as shown in figure 2., further flight is prohibited until required maintenance actions have been accomplished.*

Whenever the outboard flap position indicator is outside the ‘GO’ range as shown in Figure 2, or whenever directed to do so by the Maintenance Procedure above, perform the following procedures:

A. Interrogate the flap electronic control unit (FECU) per Fault Isolation Manual, Section 27–50–00, ‘Flaps Fault Isolation,’ and rectify as applicable.
