[Docket No. FAA-2004-19960; Directorate Identifier 2004-CE-47-AD; Amendment 39-14153; AD 2005-13-16]

#### Airworthiness Directives; The New Piper Aircraft, Inc. PA-34 Series Airplanes

**2005–13–16 The New Piper Aircraft, Inc.:**  
Amendment 39–14153; Docket No. FAA–2004–19960; Directorate Identifier 2004–CE–47–AD.

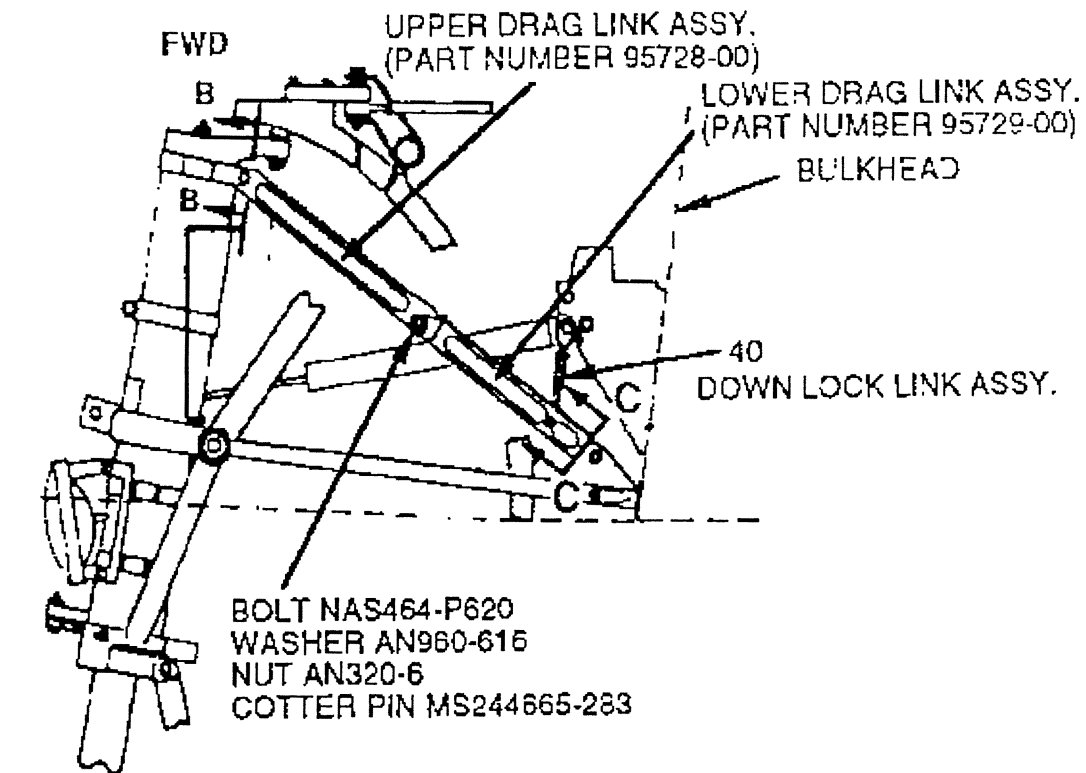
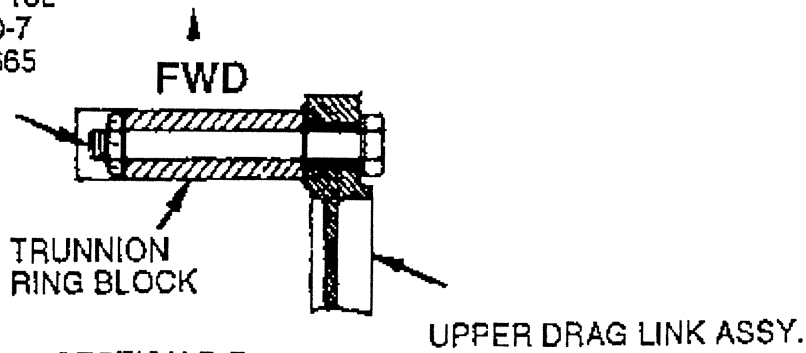
Figure 1.

SECTION B-B  
\*UPPER\* DRAG LINK - TO -  
GEAR CONNECTION

| Actions | Compliance | Procedures |
|---|---|---|
| <p>(1) Replace the bolt and stack up that connects the upper drag link to the nose gear trunnion with new parts (or FAA-approved equivalent part numbers (P/N)) of the following:</p> <ul style="list-style-type: none"> <li>(i) Piper P/N 400 274 (AN7-35) bolt;</li> <li>(ii) Piper P/N 407 591 (AN960-716L) washer, as applicable;</li> <li>(iii) Piper P/N 407 568 (AN960-716);</li> <li>(iv) Piper P/N 404 396 (AN320-7) nut; and</li> <li>(v) Piper P/N 424 085 cotter pin.</li> </ul> <p>(2) Do the inspections, replacements, and other corrective actions specified in Table 1 "Specified Maintenance" of Piper Service Bulletin No. 1123A, dated November 30, 2004.</p> <p>(3) Do any necessary corrective actions as a result of the actions specified in Table 1 "Specified Maintenance" of Piper Service Bulletin No. 1123A, dated November 30, 2004.</p> | <p>Within the next 100 hours time-in-service (TIS) after January 28, 1994 (the effective date of AD 93-24-14), unless already done within the last 400 hours TIS before January 28, 1994 (compliance with AD 93-24-14). Repetitively replace thereafter at intervals not to exceed 500 hours TIS. Continue to repetitively replace until the actions in paragraphs (e)(2) and (e)(3) of this AD begin.</p> <p>Within the next 100 hours TIS after August 8, 2005 (the effective date of this AD), unless already done. Repetitively inspect thereafter at the intervals referenced in the Inspection Time column of the <i>INSTRUCTIONS</i> paragraph in Piper Service Bulletin No. 1123A, dated November 30, 2004.</p> <p>Before further flight after any action required by paragraph (e)(2) of this AD.</p> | <p>Follow Figure 1 of this AD.</p> <p>Follow The New Piper Aircraft, Inc. Service Bulletin No. 1123A, dated November 30, 2004.</p> <p>Follow The New Piper Aircraft, Inc. Service Bulletin No. 1123A, dated November 30, 2004.</p> |
