Hazardous Materials and Environmental Assessment Report

Destruction Island, Washington

January 2000

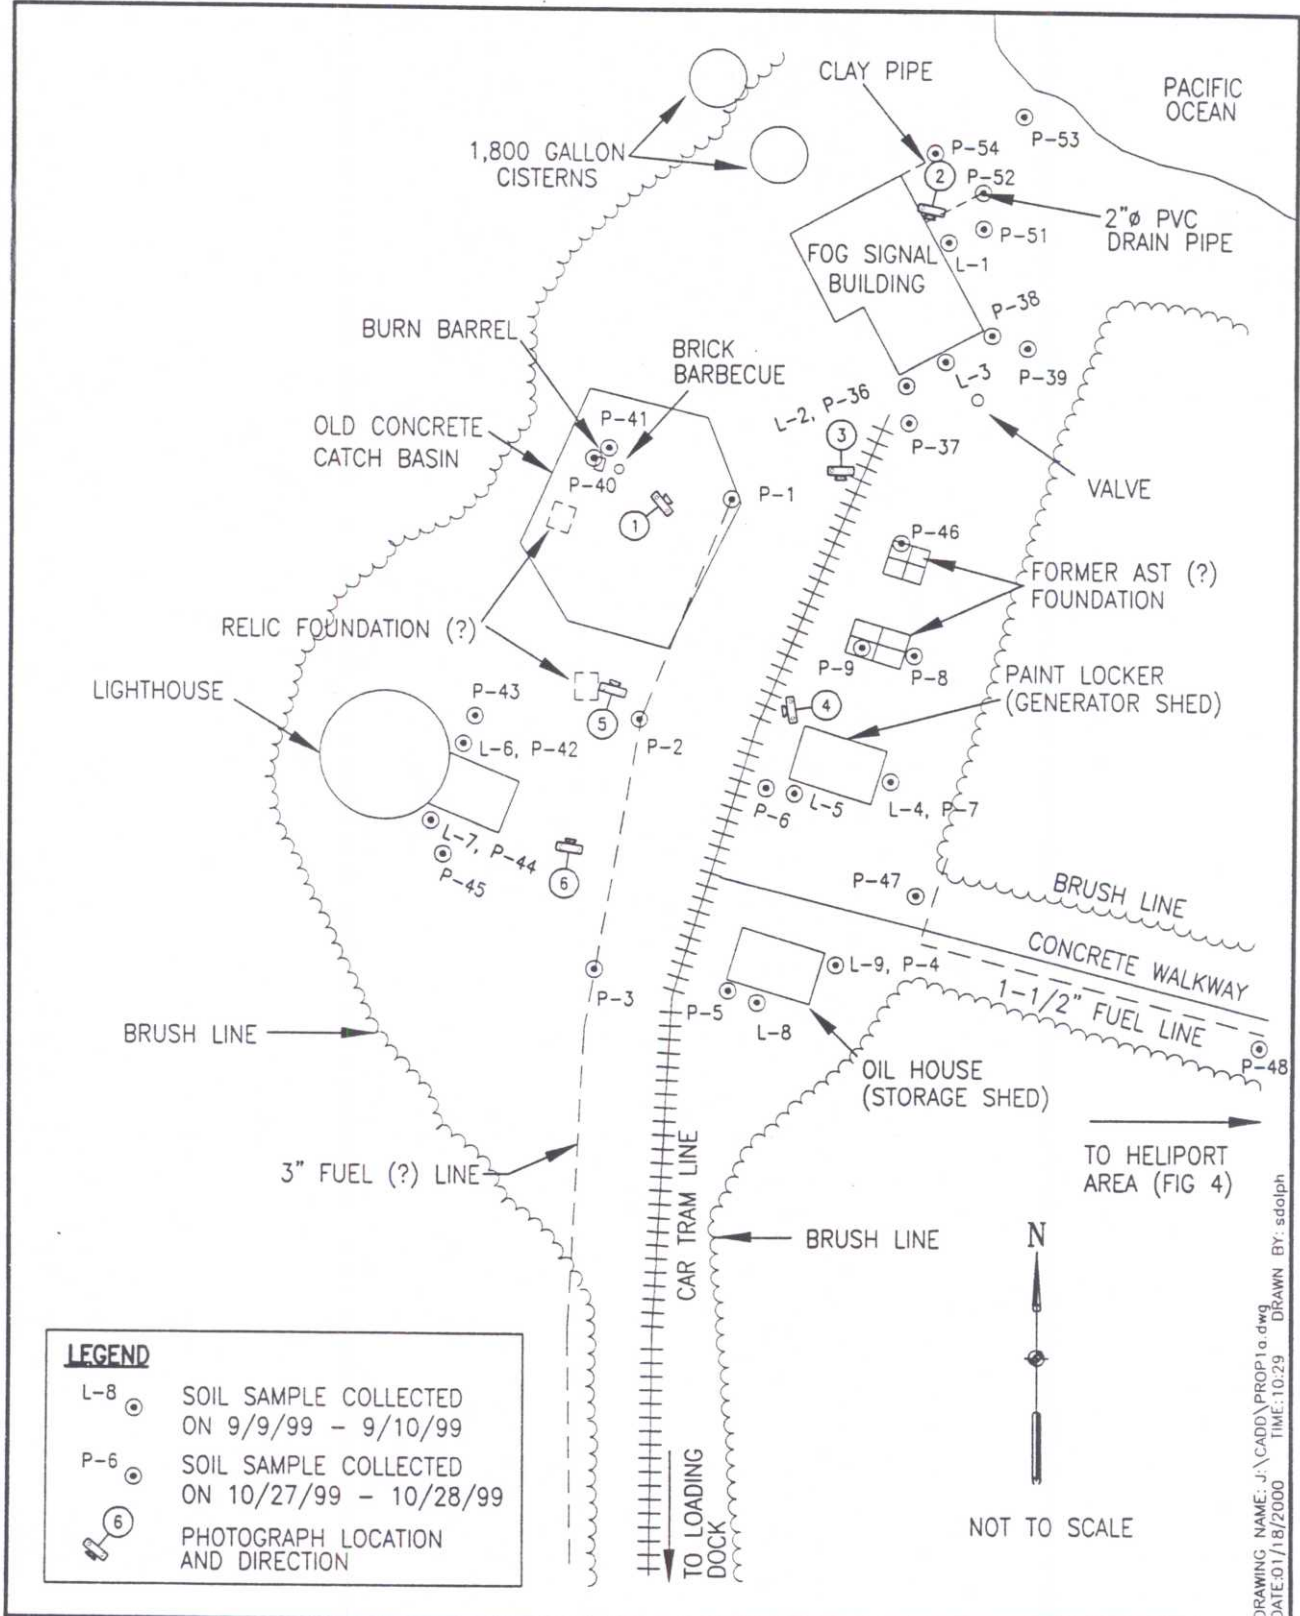
Figure 2a. Soil Sample Locations - Lighthouse Area

Soil sample locations for the Lighthouse Area are presented on Figure 2a, and analytical laboratory data is summarized on both Table 2 (numerical sample list) and Table 3 (samples listed by area). State of Washington Model Toxics Control Act (MTCA) cleanup levels are also presented at the bottoms of Tables 2 and 3 for comparison with analytical data obtained from the site. Analytical laboratory reports are presented in Appendix B.

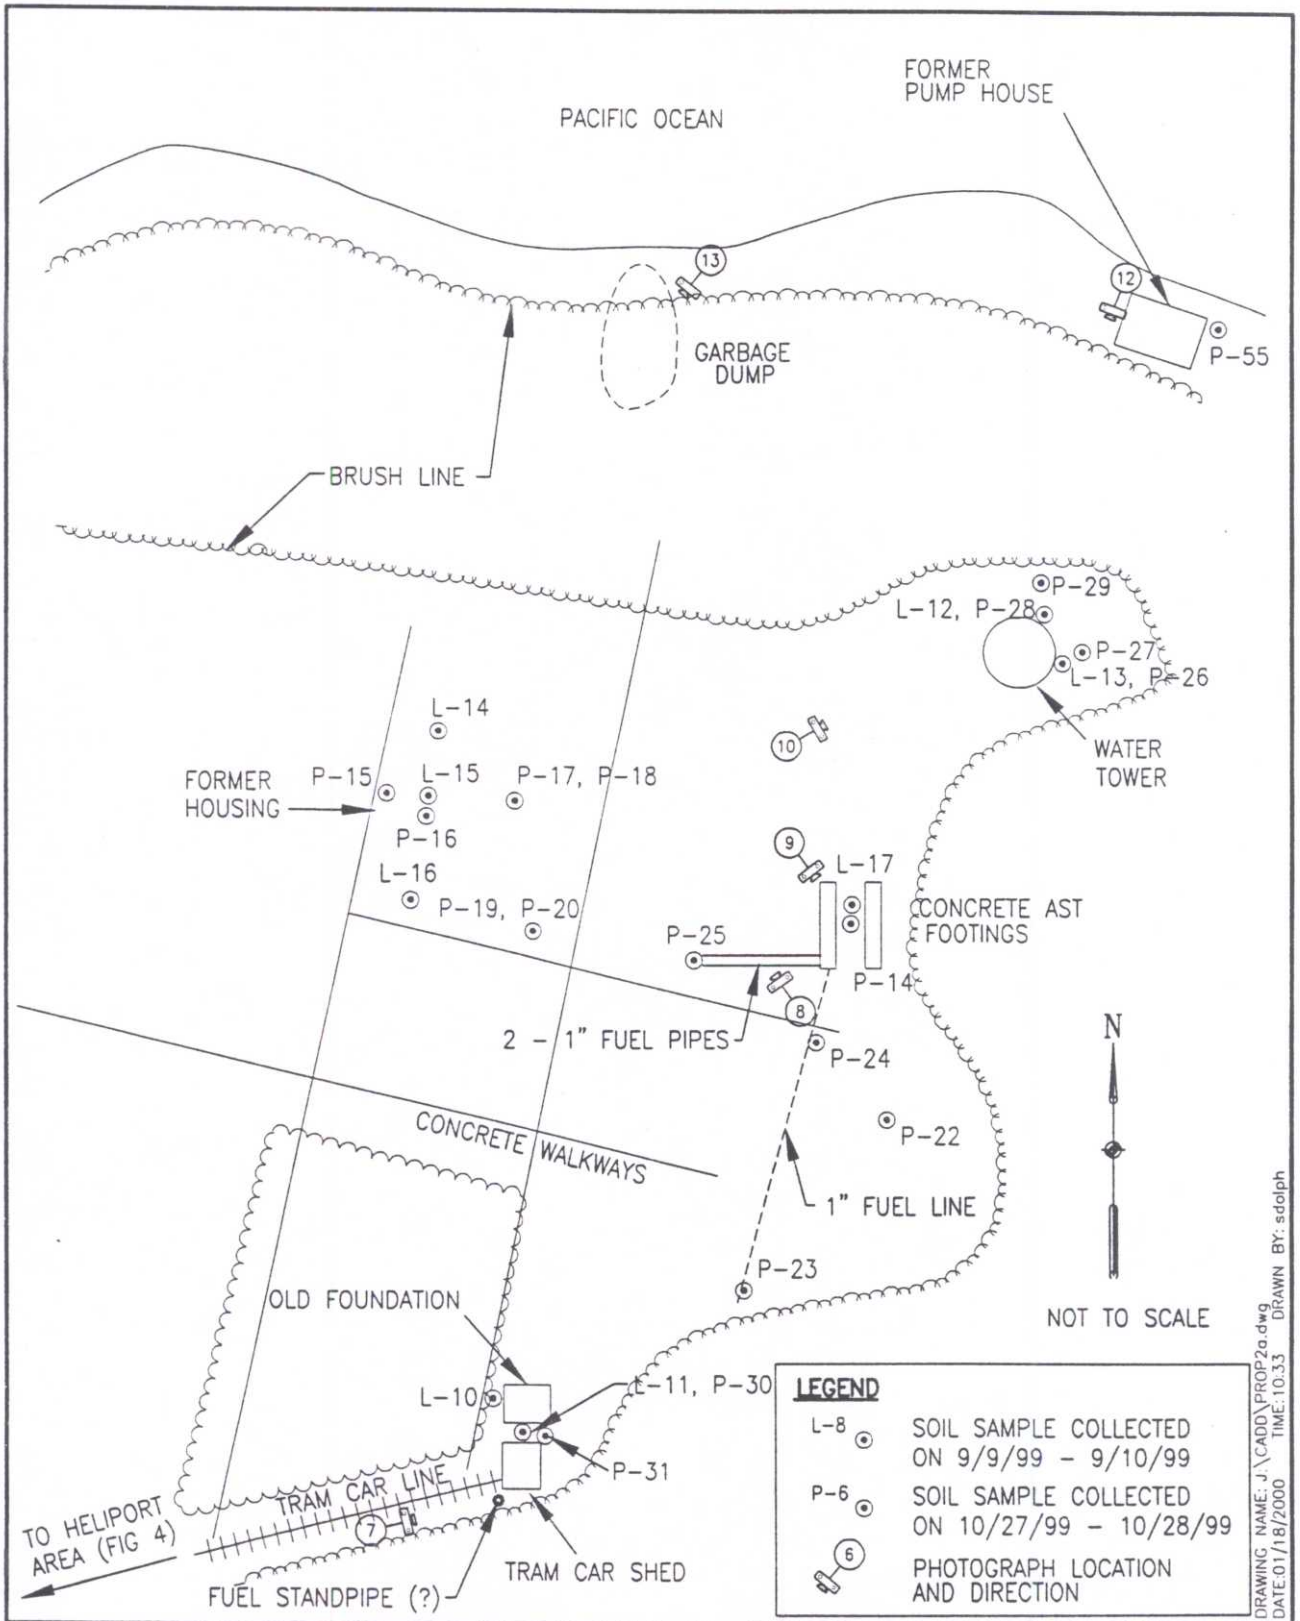
Figure 3a. Soil Sample Location - Water Tower Area

Soil sample locations for the Water Tower Area are presented on Figure 3a, and analytical laboratory data is summarized on both Table 2 (numerical sample list) and Table 3 (samples listed by area). State of Washington Model Toxics Control Act (MTCA) cleanup levels are also presented at the bottoms of Tables 2 and 3 for comparison with analytical data obtained from the site. Analytical laboratory reports are presented in Appendix B.

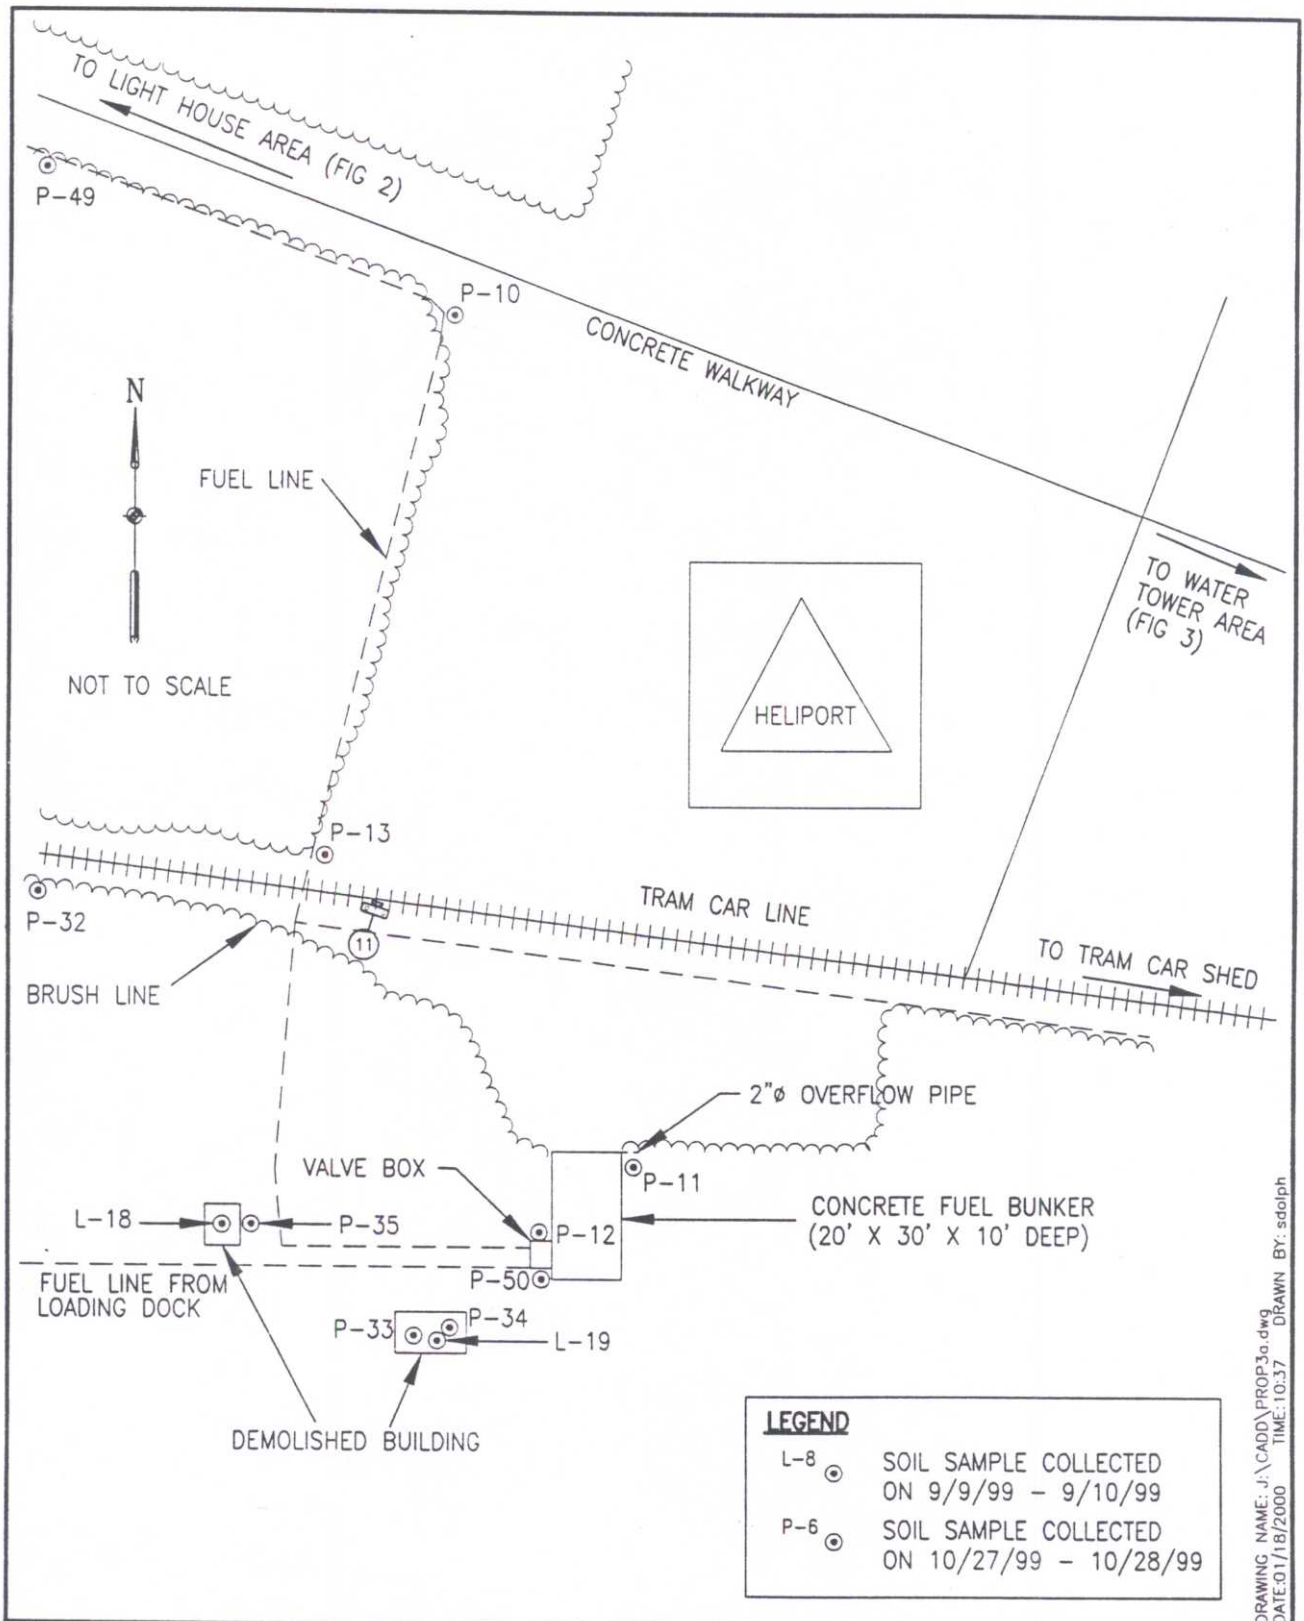
Figure 4a. Soil Sample Locations - Heliport Area

Soil sample locations for the Heliport Area are presented on Figure 4a, and analytical laboratory data is summarized on both Table 2 (numerical sample list) and Table 3 (samples listed by area). Analytical laboratory reports are presented in Appendix B.

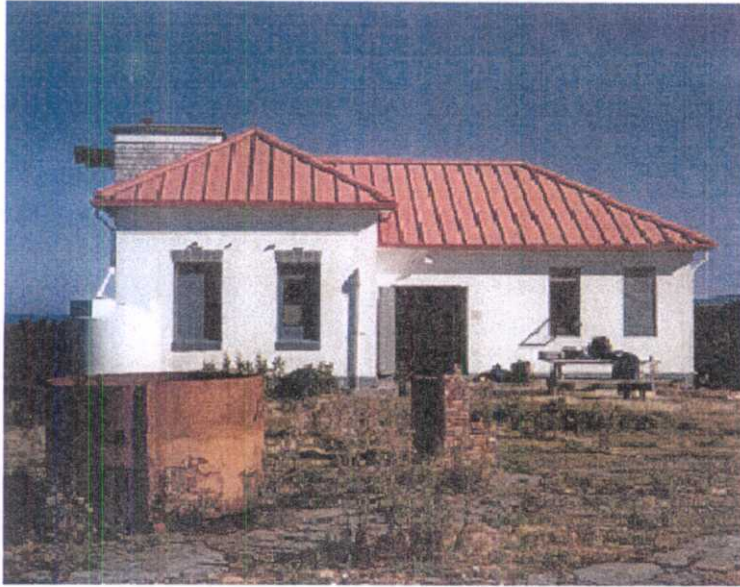
Photograph 1: Fog Signal Building.

Fog Signal Building (Photographs 1 and 2)—Surface soil samples L-1, L-2, L-3, P-37, P-51, P-53 and P-54 contained levels of lead above MTCA Method A cleanup levels that ranged from

301 milligram per kilogram (mg/kg) (Sample P-53) to 4,910 mg/kg (Sample L-3). Samples P-36 and P-38 collected at a depth of 1-foot below ground surface had lower lead concentrations of 141 mg/kg and 29.5 mg/kg, respectively. Surface soil samples P-37 and P-39 collected approximately 6-feet from the Fog Signal building also had lead concentrations above state cleanup levels of 621 mg/kg and 463 mg/kg, respectively. The only other metal concentration above state cleanup levels in the Fog Signal Building Area was a cadmium concentration of 3.32 mg/kg detected in sample P-52.

Samples P-51 and P-54 were collected beneath the outlets of drainpipes behind the Fog Signal Building. Both samples contained lube oil-range petroleum hydrocarbons above state cleanup levels that were 5,930 mg/kg and 596 mg/kg, respectively. No obvious staining of soils or odors were noted in the field at either sample location. Samples P-51 and P-38 contained diesel range petroleum concentrations above state cleanup levels.

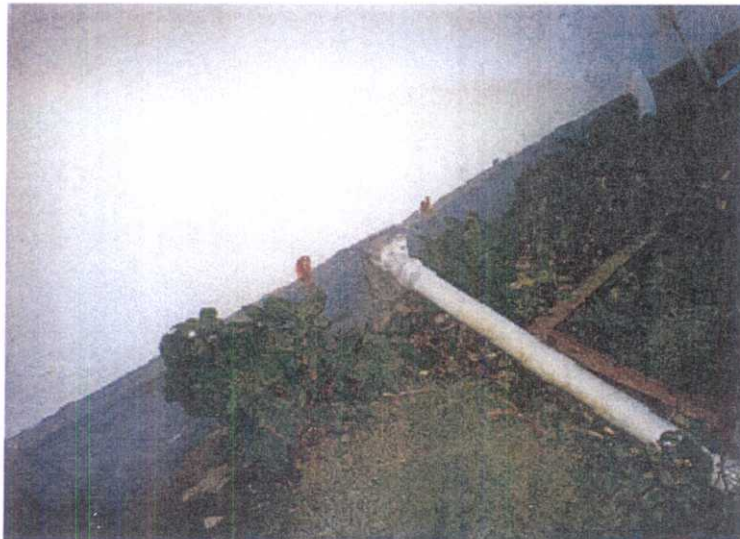
Photograph 2: Drain Line in Back of Fog Signal Building.

Former AST Locations (Photograph 2)—Surface soil sample P-46 collected around what appears to be a former AST foundation contained lead above state cleanup levels of 1,530 mg/kg. Arsenic was also above state cleanup levels in samples P-8 and P-46 and ranged from 22 mg/kg to 450 mg/kg, respectively. Cadmium was found in sample P-46 above state cleanup levels (3.23 mg/kg). Surface soil sample P-46 contained diesel- and lube-oil range petroleum above state cleanup levels.

The elevated cadmium concentration detected in sample P-51 was from a soil sample collected beneath a 2-inch PVC drainpipe outlet from the Fog Signal Building. Additional samples would have to be collected and analyzed to assess the limit of cadmium contamination in this area. Other areas such as the Paint Locker, Oil House Building, the Burn Barrel, the Fuel line near the lighthouse and the former AST location all contained elevated levels of cadmium which may be due to past disposal practices.

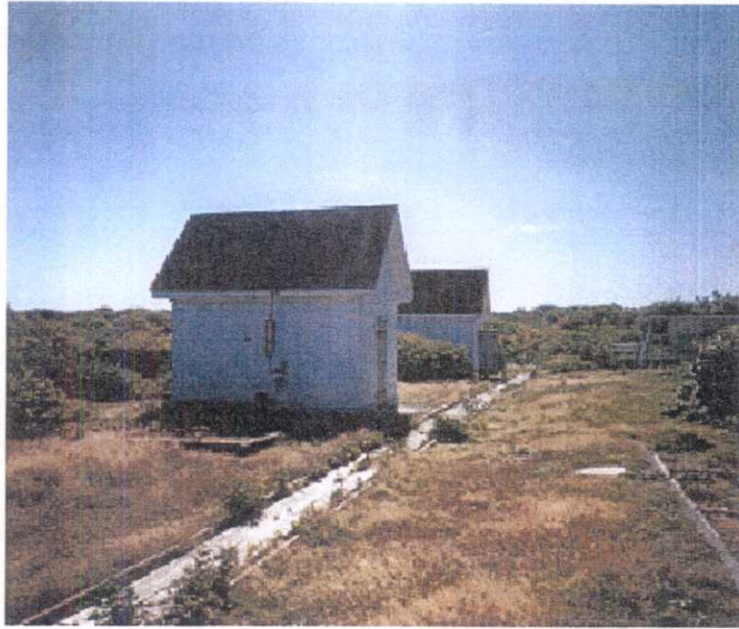
Photograph 3: Former AST Foundations, Paint Locker and Oil House (in background).

Paint Locker Building (Photograph 3)—Surface soil samples L-4, L-5, and P-6 collected around the Paint Locker Building contained 6,990 mg/kg, 1,500 mg/kg, and 692 mg/kg of lead, respectively. Sample P-7 collected at a depth of 1-foot below ground surface had a relatively low concentration of 238 mg/kg. The only other metal concentration in the Paint Locker Building Area above state cleanup levels was a cadmium concentration of 2.65 mg/kg in sample P-6.

Samples P-6 and P-7 were collected at depths of 0.5 and 1.0 feet, respectively, and contained diesel- and lube oil-range petroleum above state cleanup levels. Sample P-6 was collected near the southwest corner of the building and had a diesel-range petroleum concentration of 271 mg/kg and a lube oil range concentration of 256 mg/kg. Sample P-7 was collected on eastside of the building beneath a drainpipe and had a diesel range petroleum concentration of 280 mg/kg and a lube oil range concentration of 884 mg/kg.

Oil House Building (Photograph 3)—Surface soil samples L-9 and P-5 collected around the Oil House Building contained lead concentrations above state cleanup levels of 1,730 mg/kg and 755 mg/kg, respectively. The only other metal concentration above state cleanup levels in the Oil House Building Area was a cadmium concentration of 2.66 mg/kg in sample P-5.

Samples P-4 and P-5 collected at depths of 1.0 and 0.5 feet, respectively, contained diesel- and lube oil-range petroleum hydrocarbons above state cleanup levels.

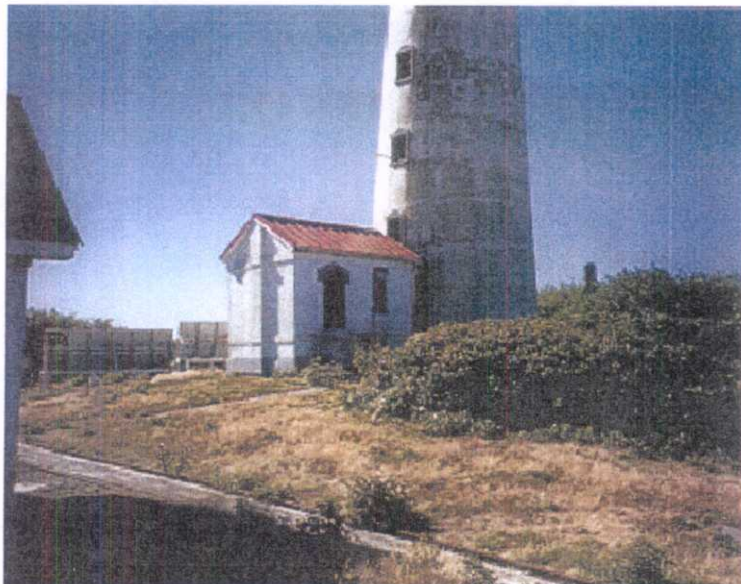
Photograph 4: Lighthouse.

Lighthouse Building and Area (Photograph 4)—Surface soil samples L-6, L-7, P-1, P-3, P-40, P-41, P-42, P-43, P-44, and P-45 collected around the Lighthouse House Building contained lead concentrations above state cleanup levels that ranged from 600 mg/kg (Sample P-1) to 14,700 mg/kg (Sample P-3). Arsenic concentrations above state cleanup levels were found in samples P-1, P-40, and P-41 that ranged from 45.5 mg/kg to 162 mg/kg. Cadmium concentrations above state cleanup levels were found in samples P-3, P-40, and P-41 at concentrations that ranged from 2.04 mg/kg to 20.2 mg/kg. Sample P-40 consisted of burned debris found inside the burn barrel (Photograph 5).

An elevated concentration of lead was present in paint sample L-23 collected from the Lighthouse interior. Two other samples (L-21 and L-22) did not contain elevated levels of lead in paint samples collected from the Lighthouse interior.

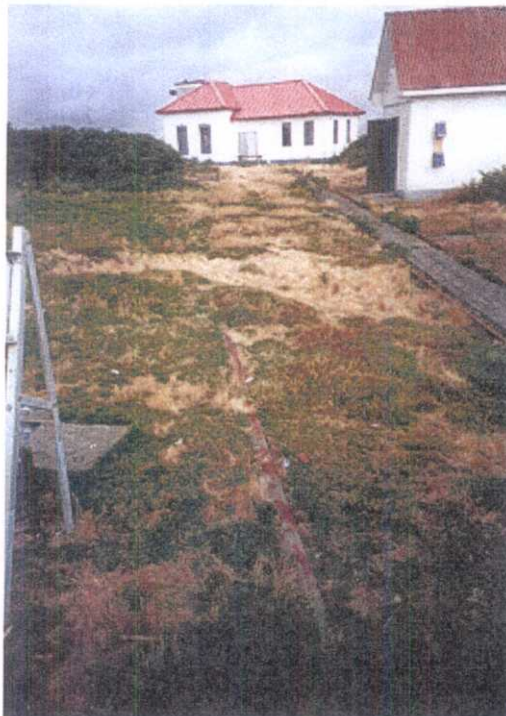
Photograph 6: Fuel Line(?) in Lighthouse Area.

Samples P-1, P-3, P-40, P-41, P-48 and P-49 had diesel- and/or lube oil-range petroleum above state cleanup levels (Photograph 6). Sample P-1 was collected at the end of the 3-inch fuel line and had a diesel-range petroleum concentration of 277 mg/kg. Sample P-3 was collected along the fuel pipeline across from the Oil House and had a diesel range petroleum concentration of

1,360 mg/kg and a lube oil range concentration of 529 mg/kg. Samples P-48 and P-49 were collected along the fuel line that connected the Lighthouse Area to the concrete fuel bunker in the Heliport Area had levels of lube oil-range petroleum above state cleanup levels. Sample P-40 was collected in the burn barrel and had a diesel-range petroleum concentration of 1,030 mg/kg and a lube-oil range petroleum concentration of 5,490 mg/kg. Sample P-41 was collected along the fuel pipeline across from the Oil House and had a diesel range petroleum concentration of 1,110 mg/kg and a lube oil range concentration of 507 mg/kg.

Elevated levels of either diesel and /or lube oil range petroleum were detected at the Fog Signal, Paint Locker, Oil House buildings, and along the fuel line in the Lighthouse Area. The petroleum hydrocarbon contaminated soil may be due to past leaks or spills in the fuel line and/or poor fuel handling practices.

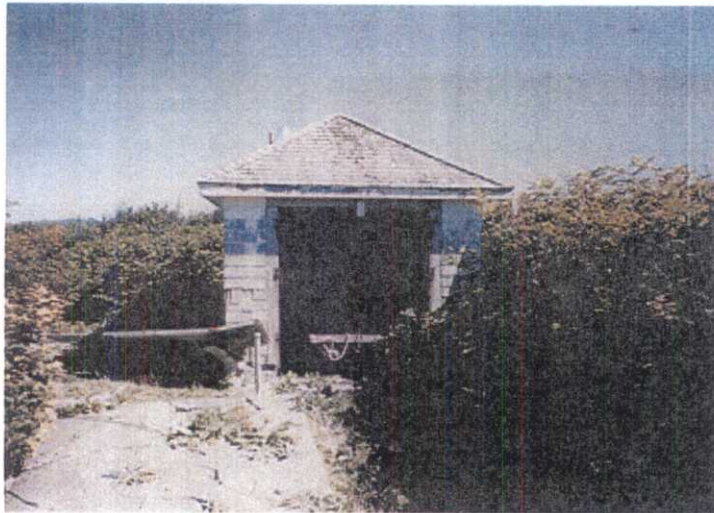
Photograph 7: Tram Car Shed.

Tram Car Shed (Photograph 7)—Surface soil samples L-10, L-11 and P-31 collected around the Tram Car Shed contained lead above state cleanup levels ranging from 2,140 mg/kg to 5,080 mg/kg.

Elevated lead concentrations were found in surface soil samples around the tramcar shed. Samples collected at a depth of one foot contained much lower lead concentrations indicating the lead may be restricted to surface soils. Surface soil sample P-31 collected six feet from the tramcar shed also contained elevated concentrations of lead suggesting that weathered lead paint chips from the tramcar shed and other buildings in the area have been mechanically removed to at least that distance. Another building probably existed in the tram car shed area. Surface soil sample L-10 was collected adjacent to a former concrete foundation and contained an elevated concentration of lead.

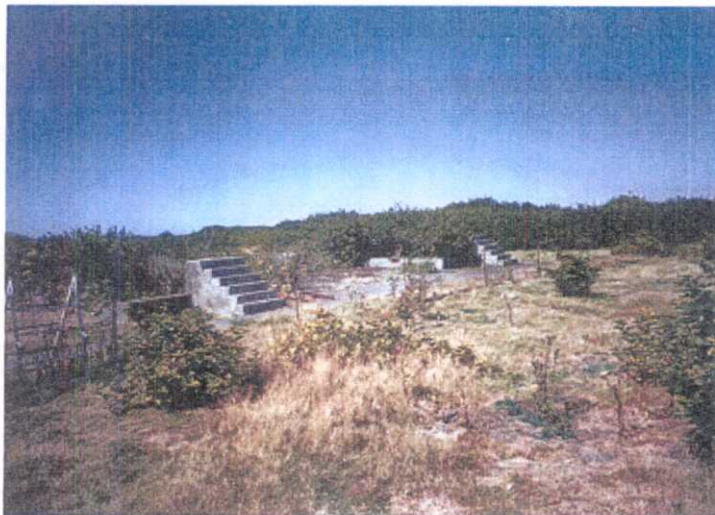
Photograph 8: Former Housing Area.

Demolished Housing Area (Photograph 8)—Surface soil samples L-14, L-15, L-16, P-15, P-16, P-18, and P-20 collected in and around the Demolished Housing Area contained lead above state cleanup levels that ranged from 312 mg/kg (Sample P-20) to 51,200 mg/kg (Sample P-15). Cadmium above state levels was found in samples P-15 and P-16 at concentrations of 12.6 mg/kg to 3.9 mg/kg, respectively.

Elevated levels of lead were also detected in samples from the demolished housing in the Water Tower Area. The samples consisted of burned wood, brick and other debris inside the former house foundations. There is probably a concrete bottom to each former house that acts as containment for the debris. However, we did not detect the floor of the foundation. Sample P-15 contained a lead concentration of 51,200 mg/kg and was collected in native soil at a depth of one foot just west of the demolished building foundation. The soil in the vicinity of the former AST Area, the Pump House, and the Water Tower contained elevated lead concentrations. Samples P-26 and P-28 collected at a depth of one foot near the water tower suggest that lead concentrations may be restricted to surface soils in this area.

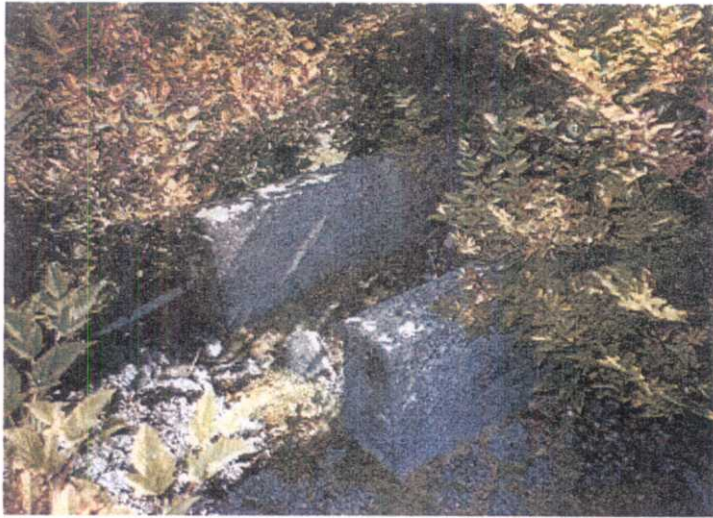
Photograph 9: Concrete Footings for Former AST.

Former AST Area (Photograph 9)—Surface soil samples L-17, P-22, and P-24 collected around a former AST area contained lead above state cleanup levels that ranged from 1,040 mg/kg (Sample P-22) to 2,100 mg/kg (Sample L-17). Cadmium above state cleanup levels was found in samples P-23 and P-24 at concentrations of 2.31 mg/kg to 2.43 mg/kg, respectively.

Surface soil sample P-14 contained diesel-range concentration above state cleanup levels of 1,160 mg/kg.

An elevated level of diesel range petroleum was found in sample P-14 at the former AST location in the Water Tower area. This contamination may be due to past fuel handling and storage practices.

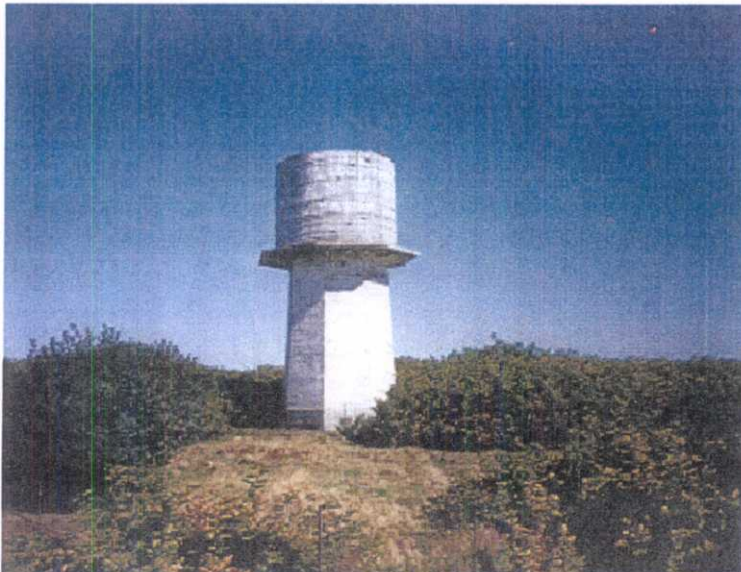
Photograph 10: Water Tower.

Water Tower Building Area (Photograph 10)—Surface soil samples L-12, L-13, P-27, P-28, and P-29 collected around Water Tower Building area contained lead above state cleanup levels that ranged from 265 mg/kg (Sample P-28) to 4,450 mg/kg (Sample L-13). Arsenic, cadmium and petroleum hydrocarbon analyses were not conducted on soils in the water tower building area.

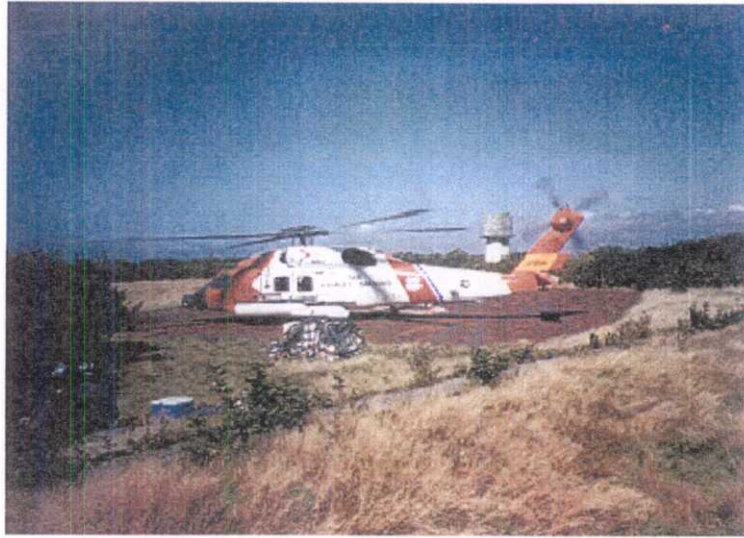
Photograph 11: Helipad Area.

The Heliport Area consists of interlocking metal grating used as a landing zone, a concrete fuel bunker for storing fuel for heating and generator use, and two demolished buildings. A fuel line from the landing dock connects to the fuel bunker and an out going line splits and connects to the Oil House (generator) in the Lighthouse area and an AST near the demolished housing in the Water Tower Area.

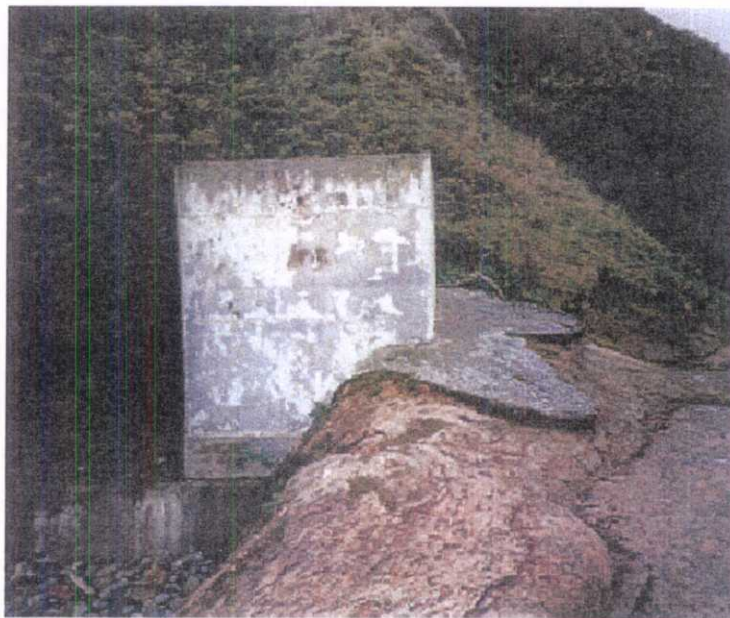
Photograph 12: Pump House.

Pump House Building Area (Photograph 12)—A surface soil sample (P-55) from the pump house building contained a lead concentration of 554 mg/kg, which is above state cleanup levels. Arsenic, cadmium and petroleum hydrocarbon analyses were not conducted on soils in the pump house building area.

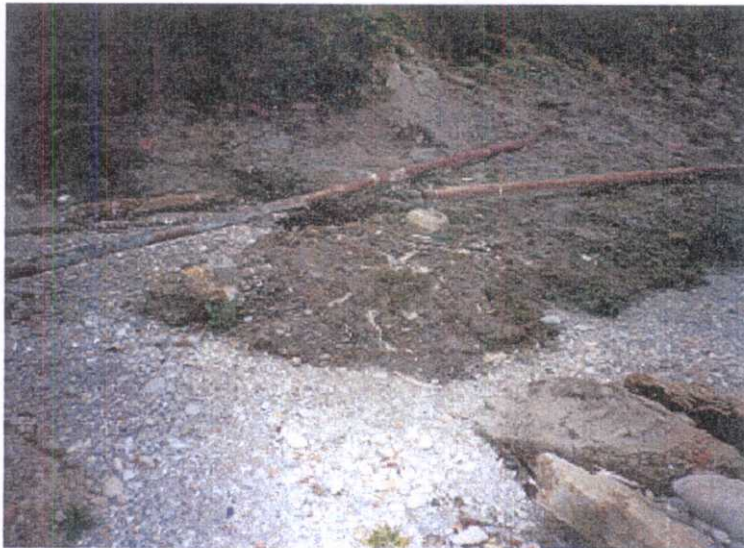
Photograph 13: Debris on Beach Below Garbage Dump Area.

Island residents previously used an area north of the Water Tower as a garbage dump. Household wastes and other debris were reportedly dumped on the steep slope above the beach for disposal (Foster and Wheeler, 1997). This area is now covered with thick, hummocks of grass covering loose soils and is very unstable. No samples were collected at this area due to slope instability and lack of observable wastes. Further inspection of the area should include additional safety precautions such as ropes and harnesses for field personnel.

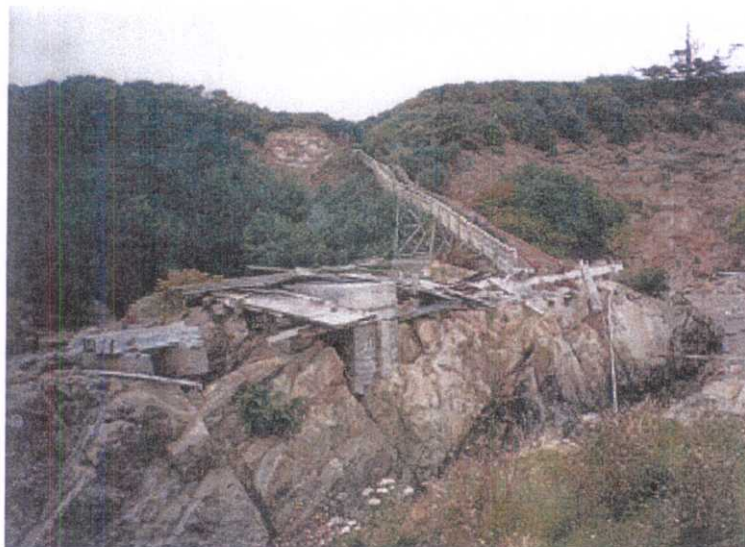
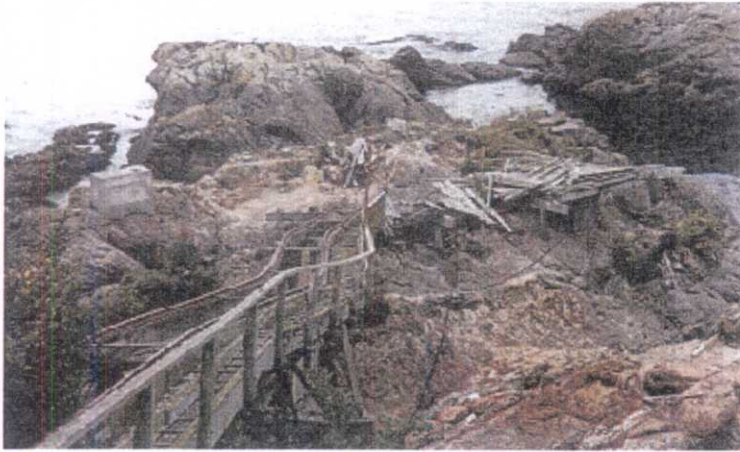
No samples were collected from Landing Dock area materials. Wood planking, pipes, cables and other debris were observed and represent a physical hazard (Photographs 14 and 15).
