# **Monitoring of Slash Piles Burned in Stream Environment Zones: 2003 and 2008**

**USDA Forest Service**

**Lake Tahoe Basin Management Unit**

**Denise Downie, Forest Soil Scientist  
August, 2008**

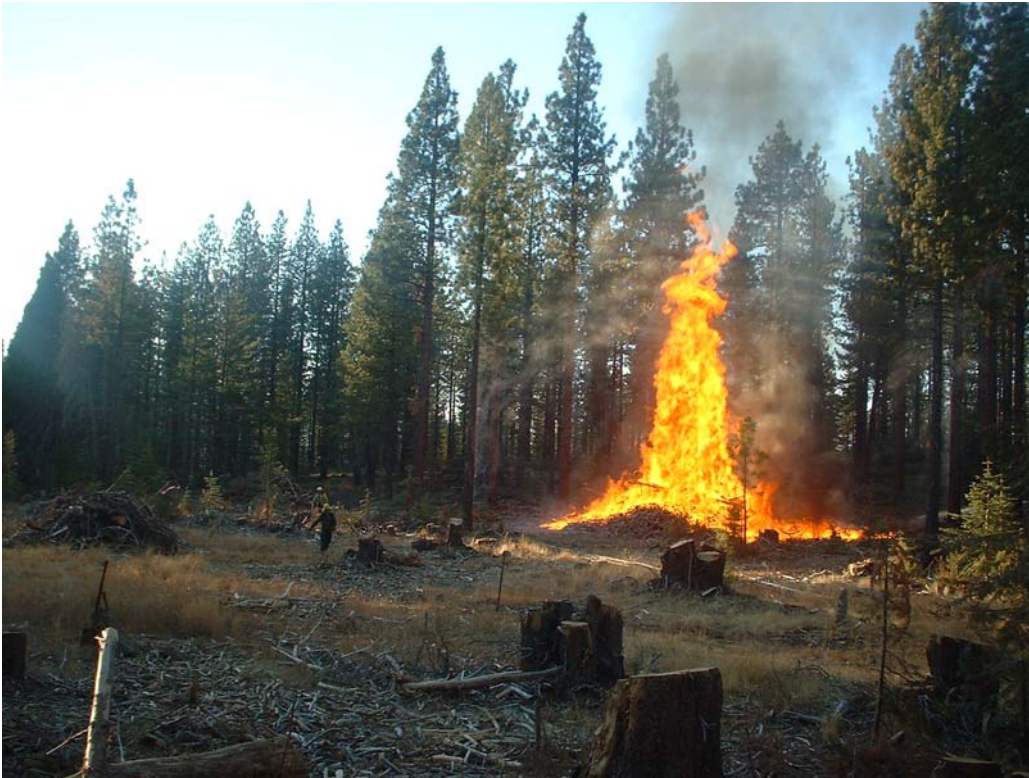
The monitoring questions do not address the relationship of slash pile size and burn impacts. Larger piles and larger fuel size classes tend to burn hotter and longer, resulting in a greater likelihood of more severe impacts. Pre-burn information about pile size and fuel size was not collected, but a photo of one pile during burning is included.

Photo 1.. Pioneer 15 during burning, fall 2002..

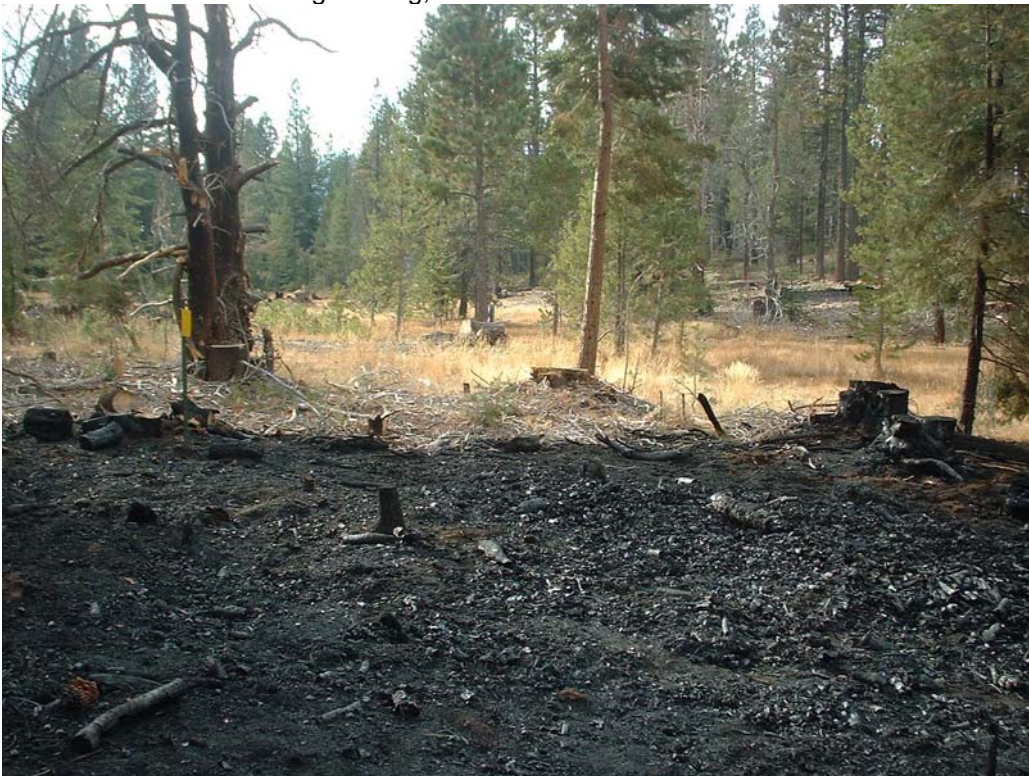
Photo 2. Pioneer 15 the day after burning, fall 2002

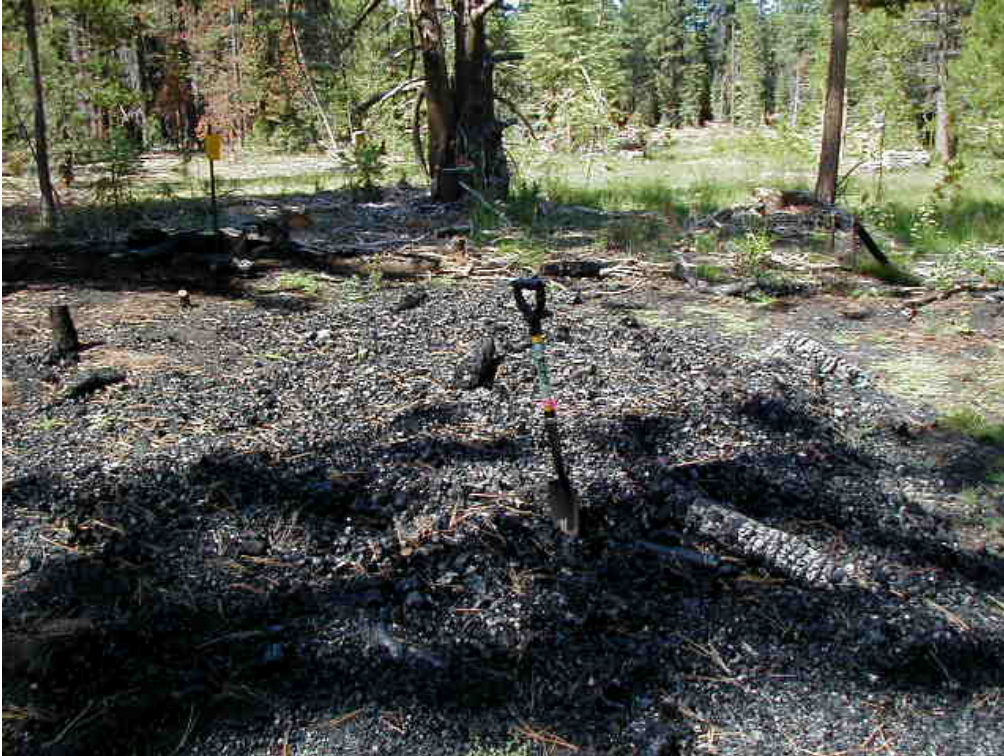
Photo 3. Pioneer Unit 15, July 2003.

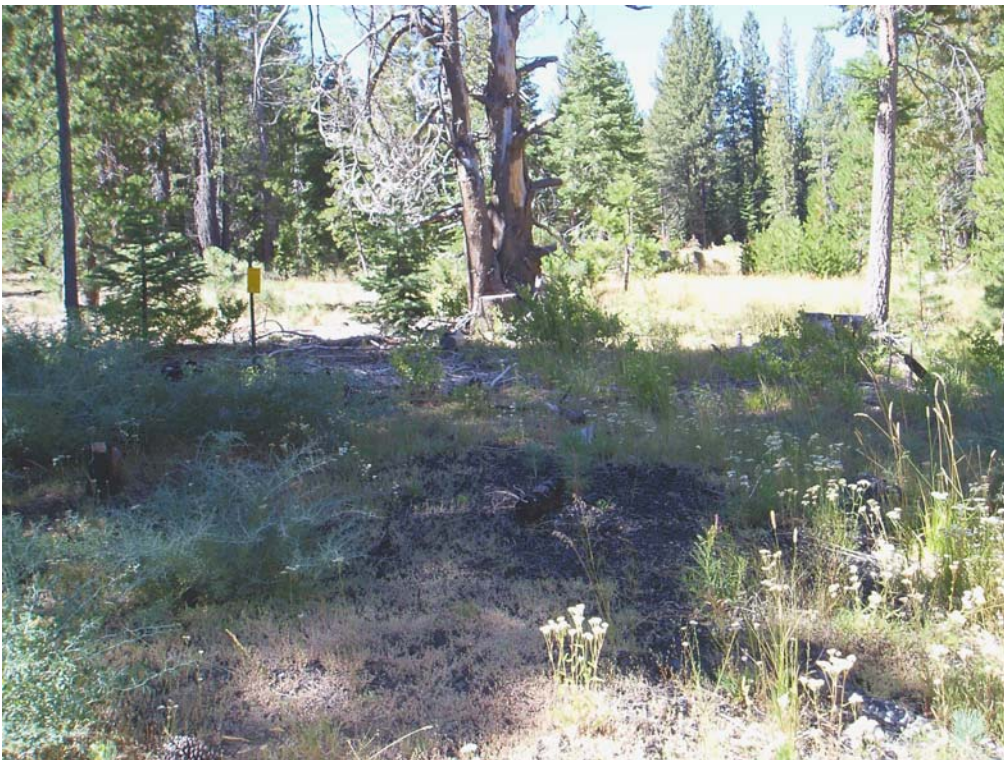
Although this is qualitative monitoring based on a small sample size, the results suggest that burning piles in SEZs may have relatively slight impacts on soil, vegetation, and water quality, especially if pile size is controlled in order to limit soil temperature. However, the photos from Pioneer Unit 15 suggest that even large, hot pile burns may revegetate well in SEZs, which are some of our more resilient ecosystems. Erosion would likely be a concern on steeper slopes than those observed in this analysis.

Photo 4. Pioneer Unit 15, August 2008

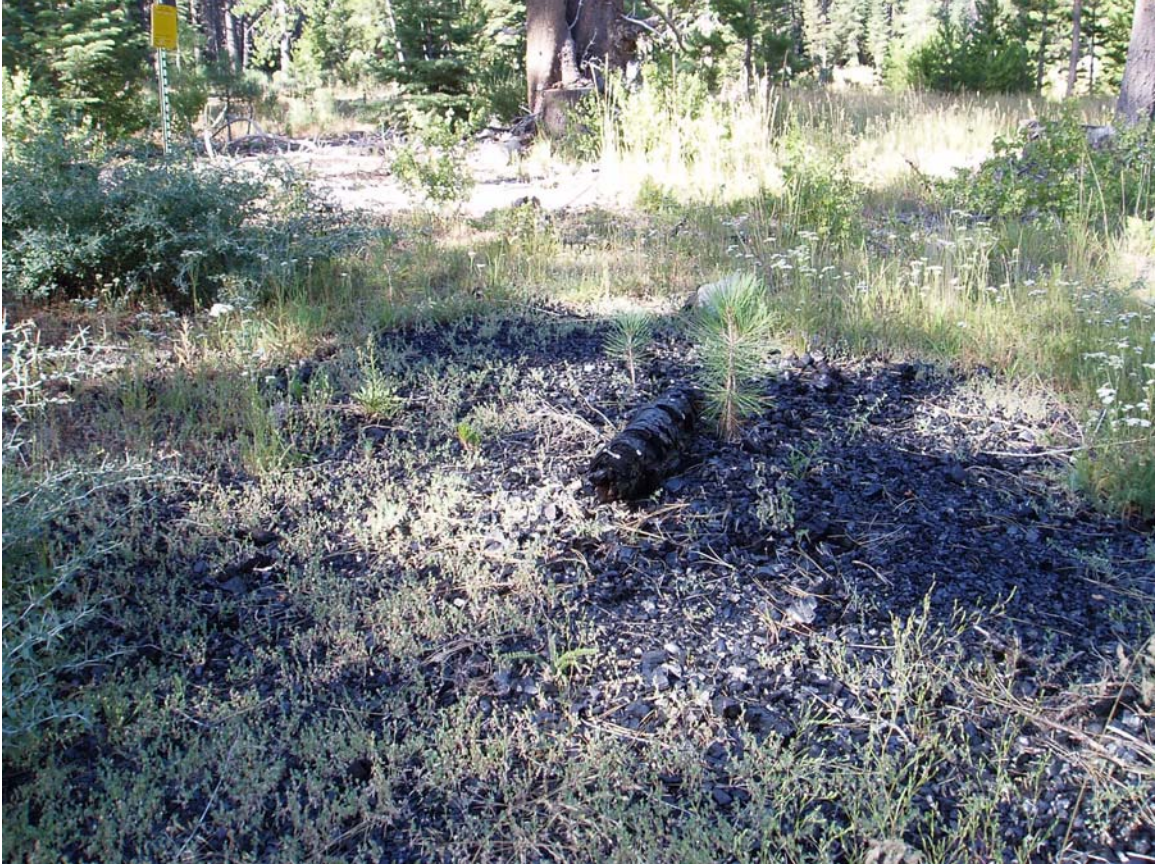
Photo 5. . Pioneer 15, middle of burn footprint, August 2008.

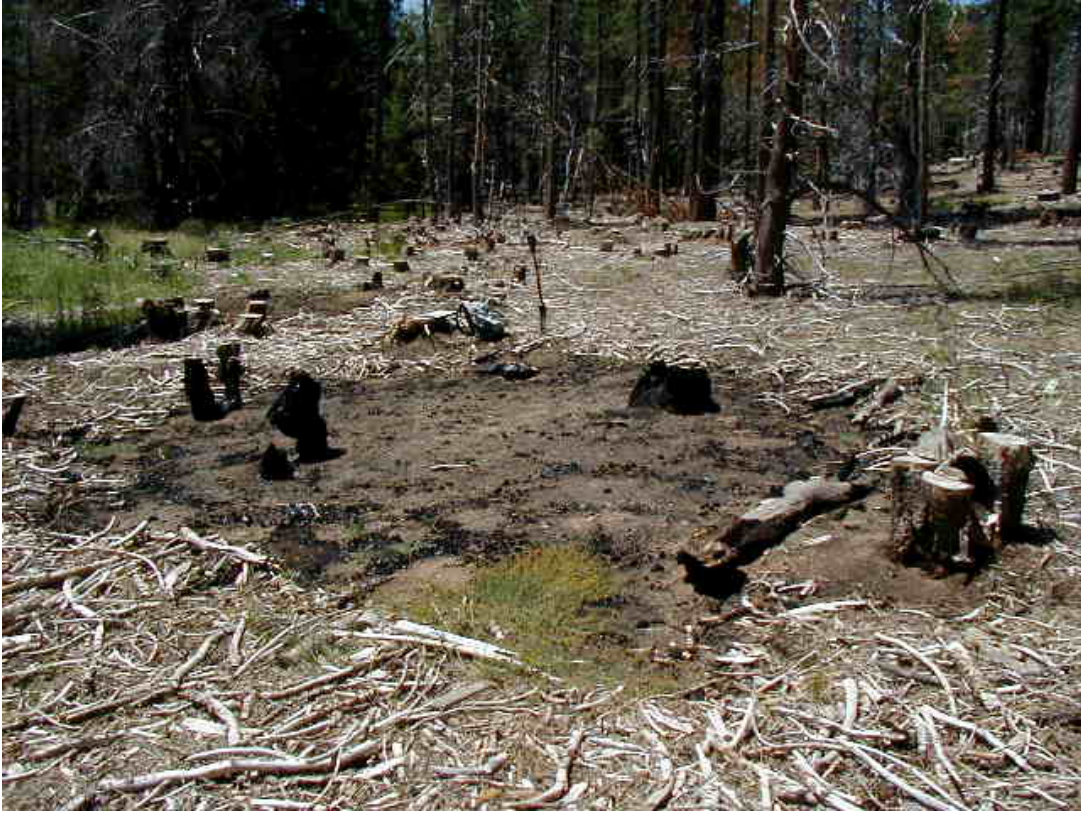
Photo 6. Pioneer 11, downstream pile, July 2003

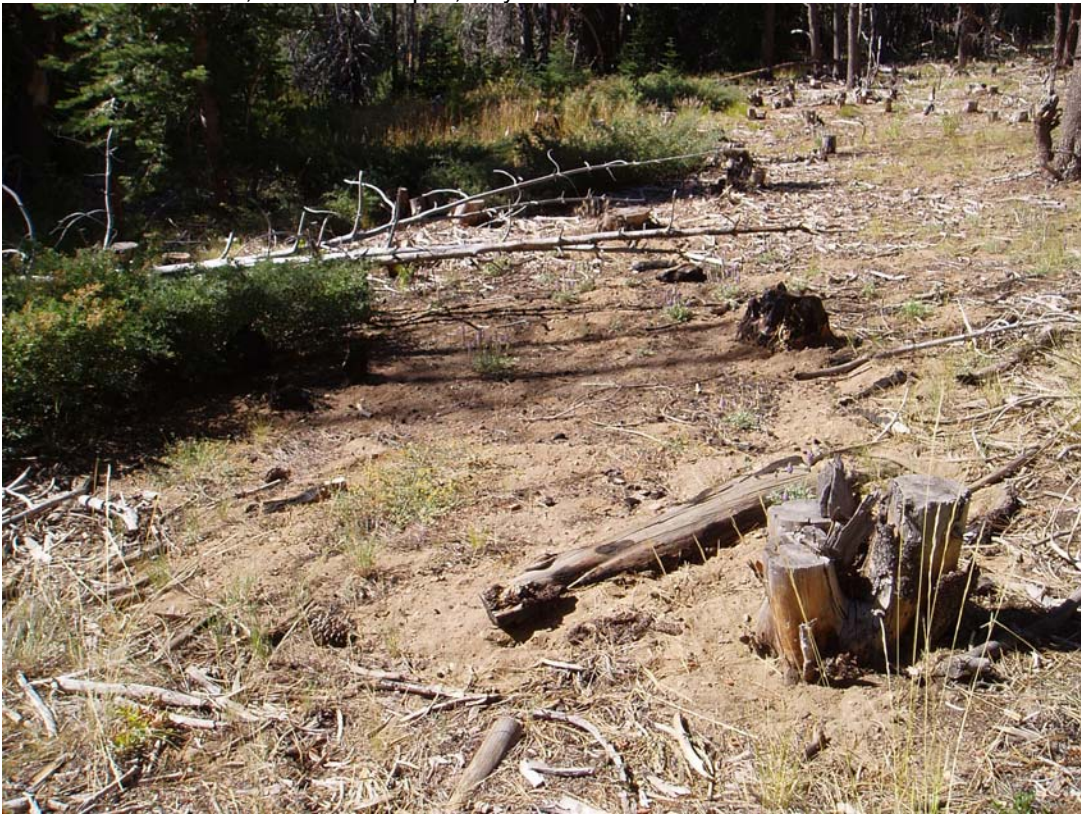
Photo 7. Pioneer 11, downstream pile, August 2008.

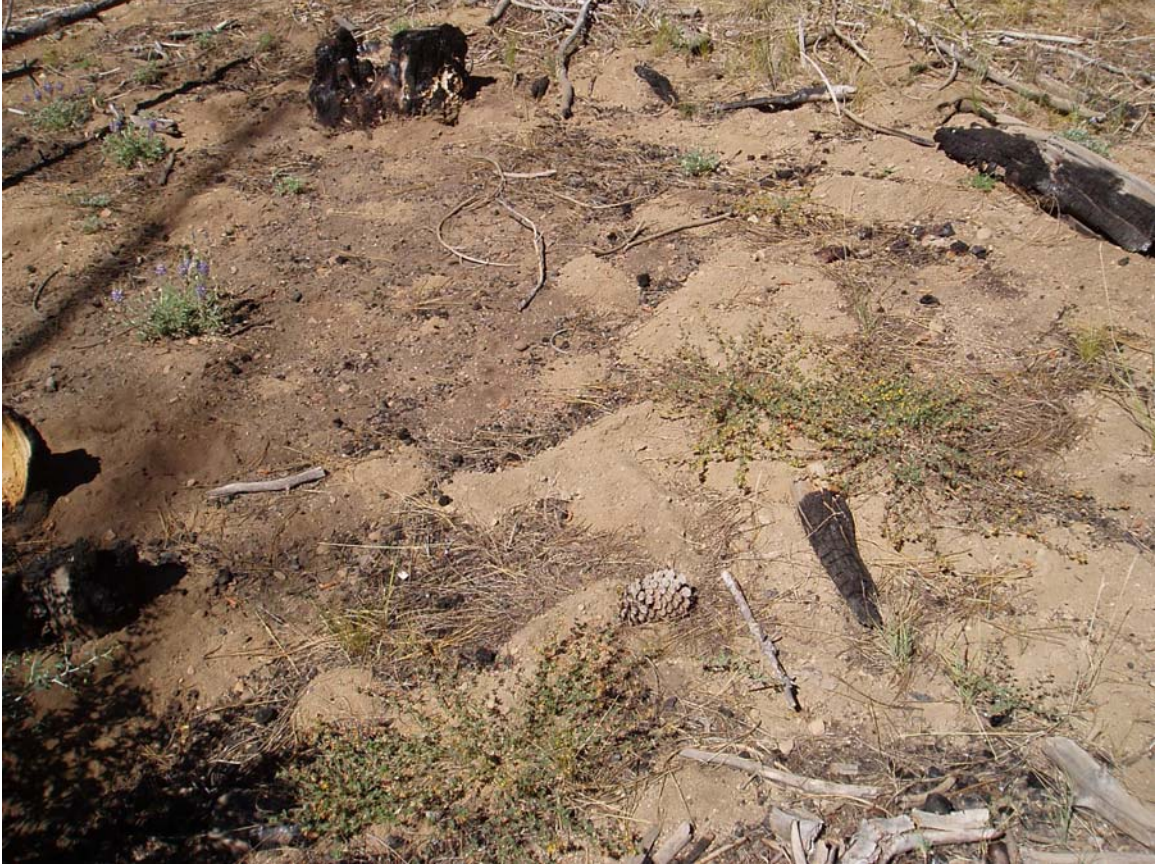
The degree of vegetative recovery suggests that sterilization did not occur. Vegetative canopy cover ranged from 10% to 85%, with four of the seven sites having 75% to 85% vegetative cover. On the site with 10% cover, about 60% of the burn footprint exhibited evidence of soil disturbance by burrowing animals (photo). Burrowing activity was

Photo 8. Pioneer 11, downstream pile, disturbance from burrowing.

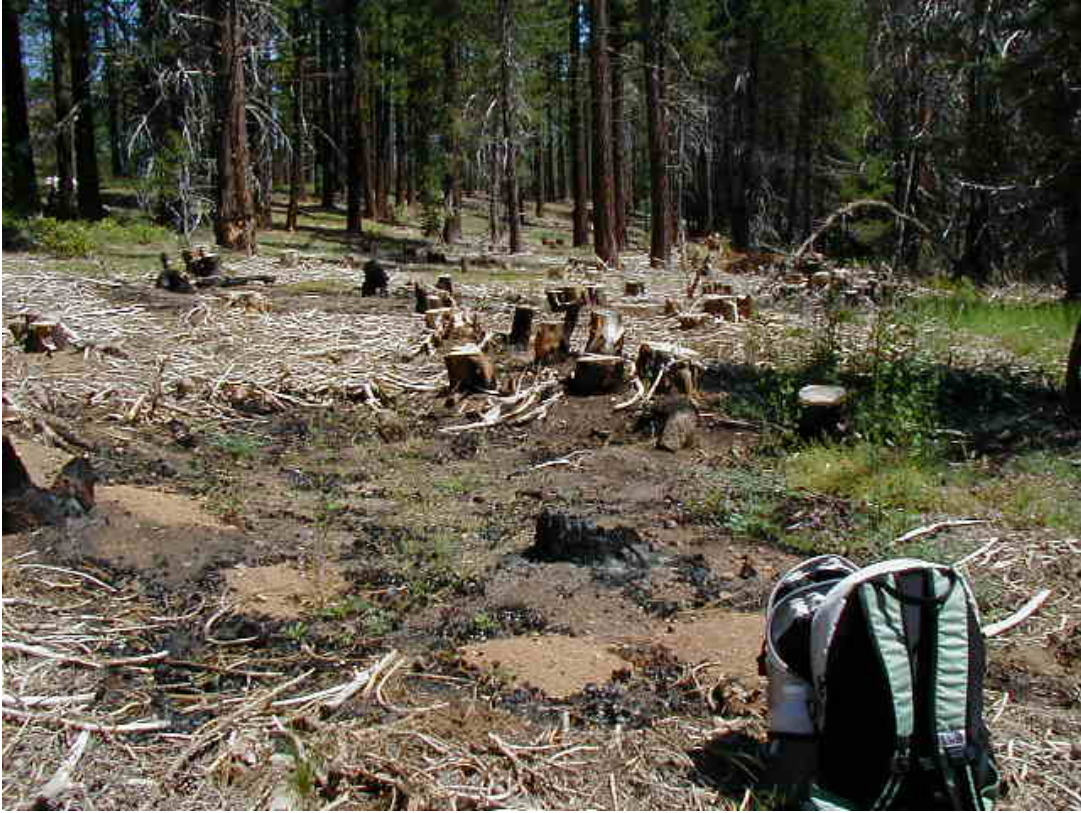
Photo 9. Pioneer Unit 11, middle pile, July 2003.

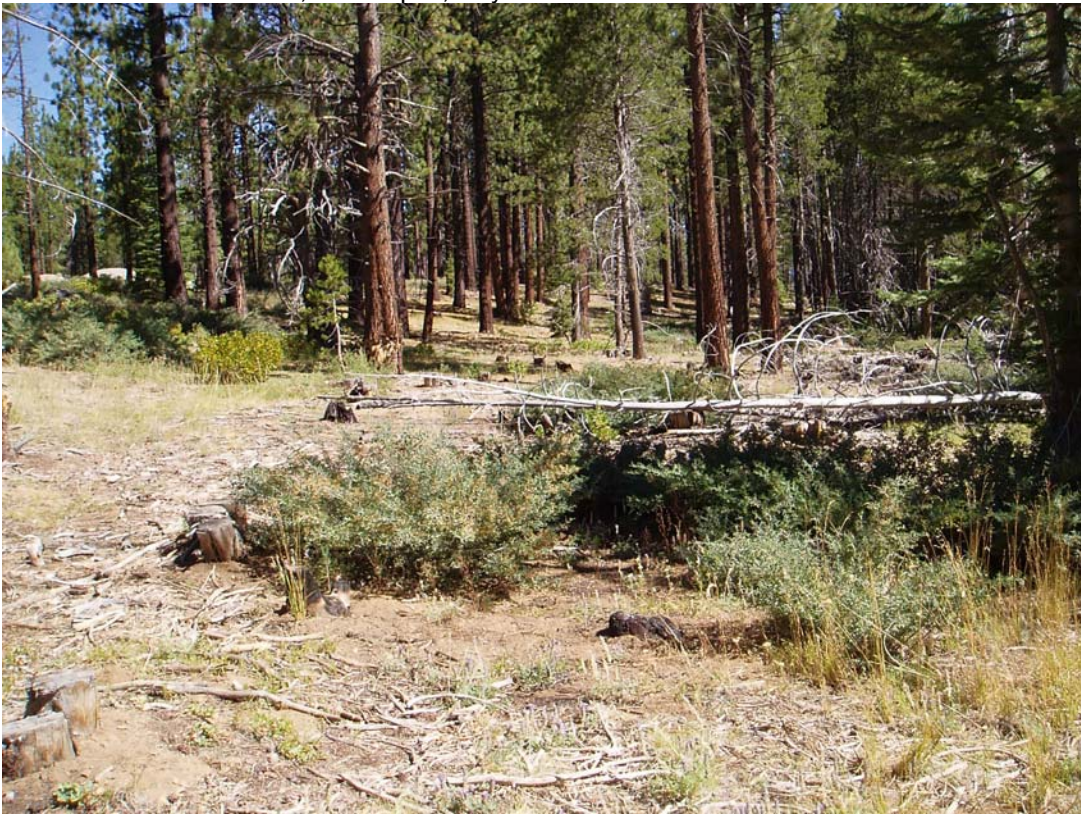
Photo 10. Pioneer Unit 11, middle pile, August 2008.

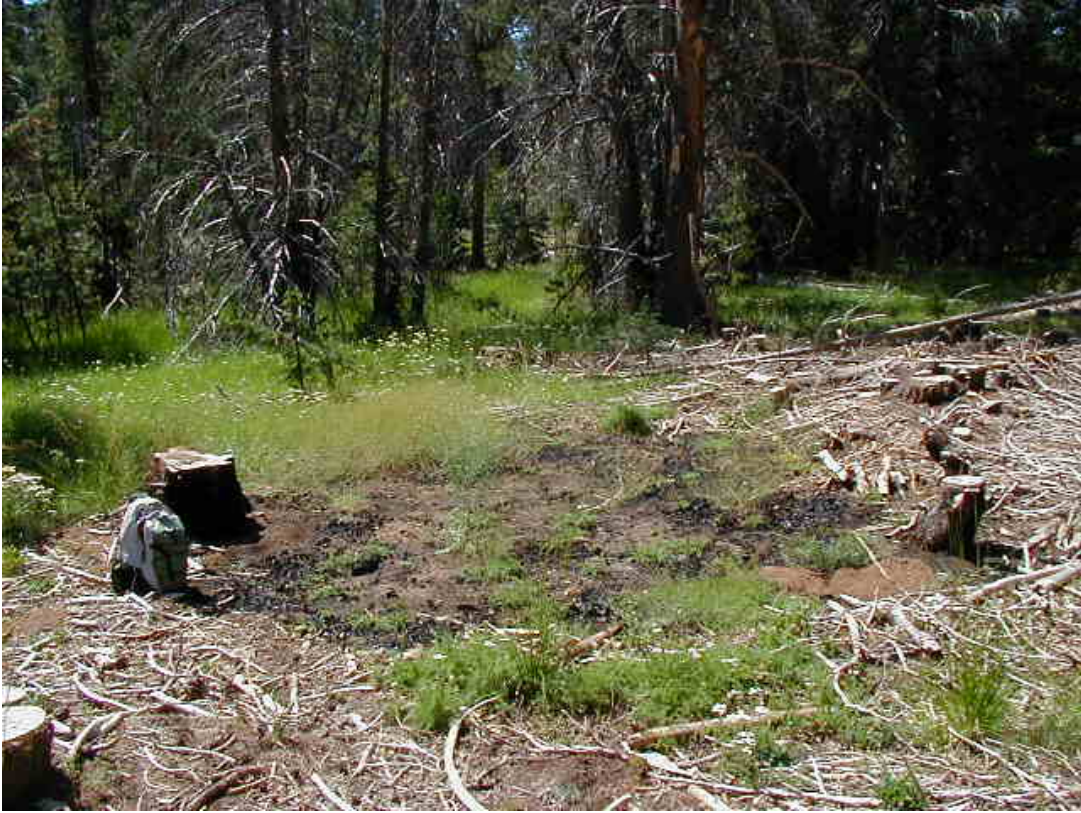
Photo 11. Pioneer 11, upstream pile, July 2003.

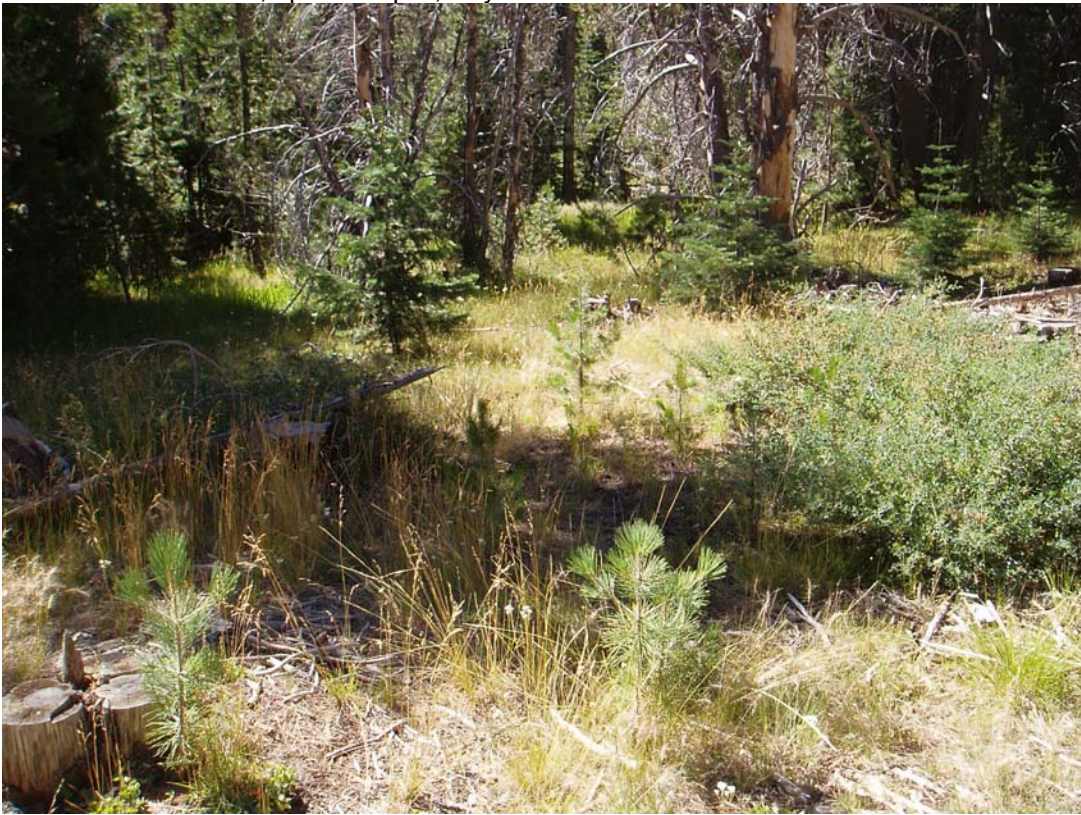
Photo 12. Pioneer 11, upstream pile, August 2008.

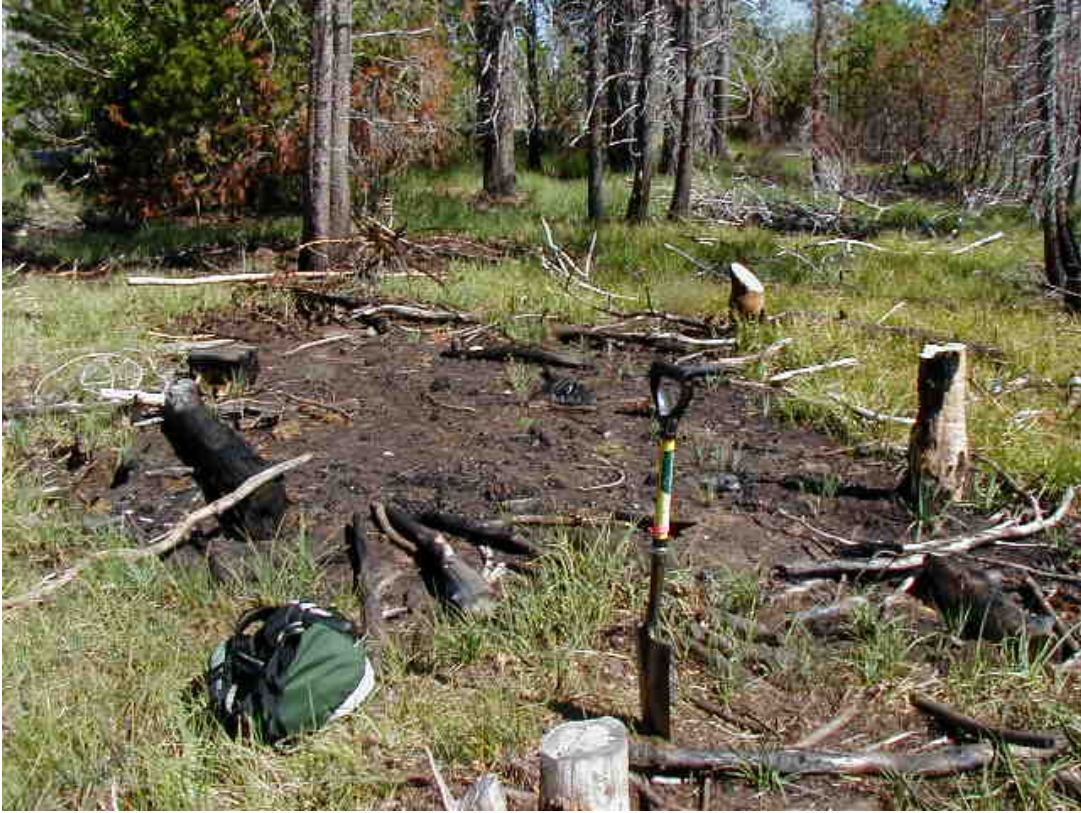
Photo 13. Baldwin3, near road, July 2003.

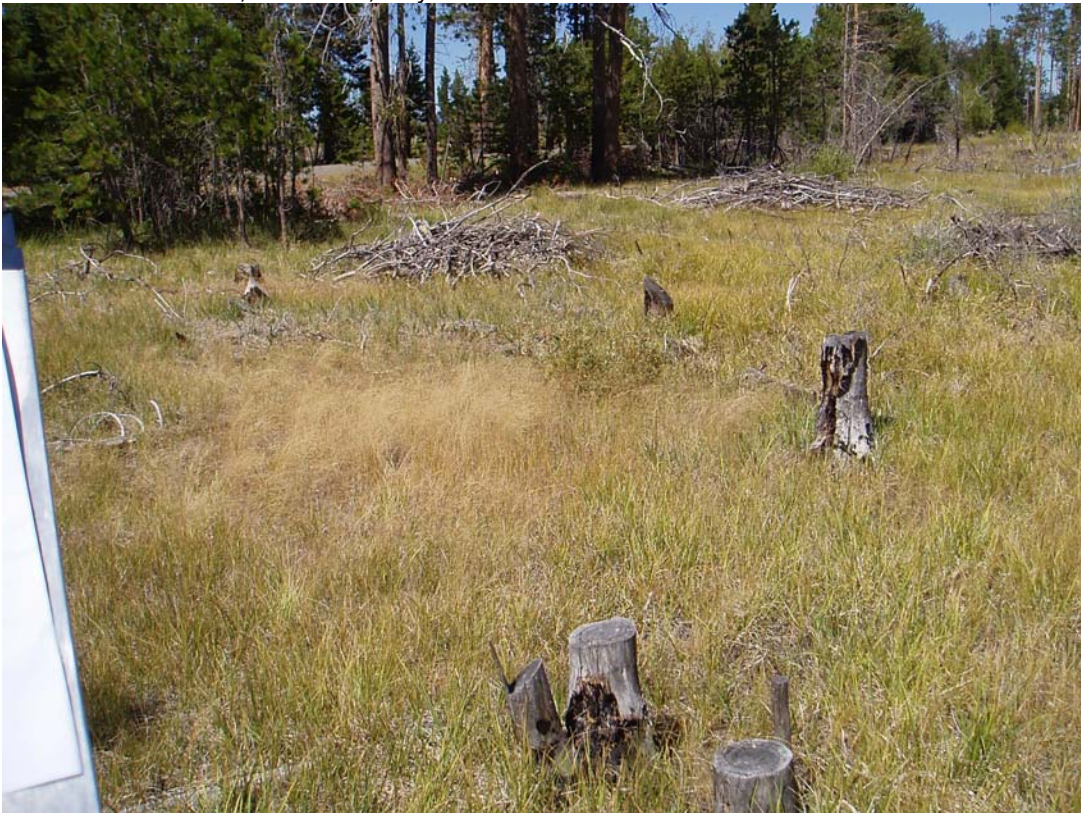
Photo 14. Baldwin3, near road, August 2008.

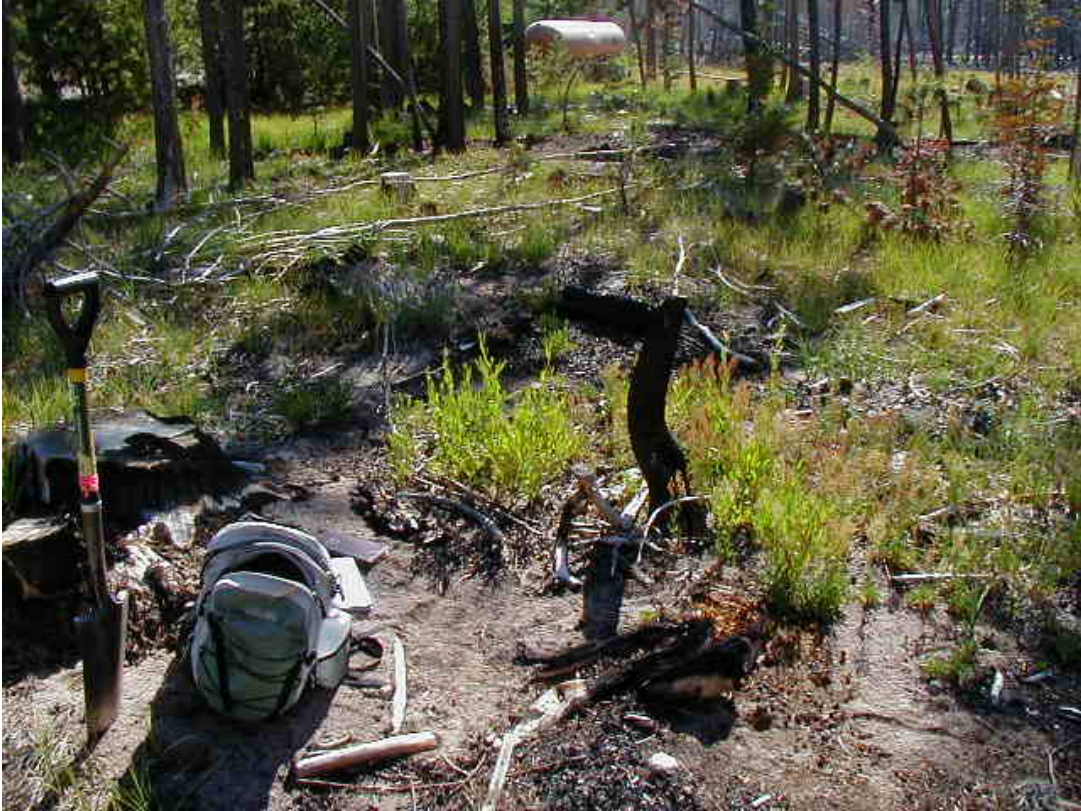
Photo 15. Baldwin 1, near shed, by road, July 2003.

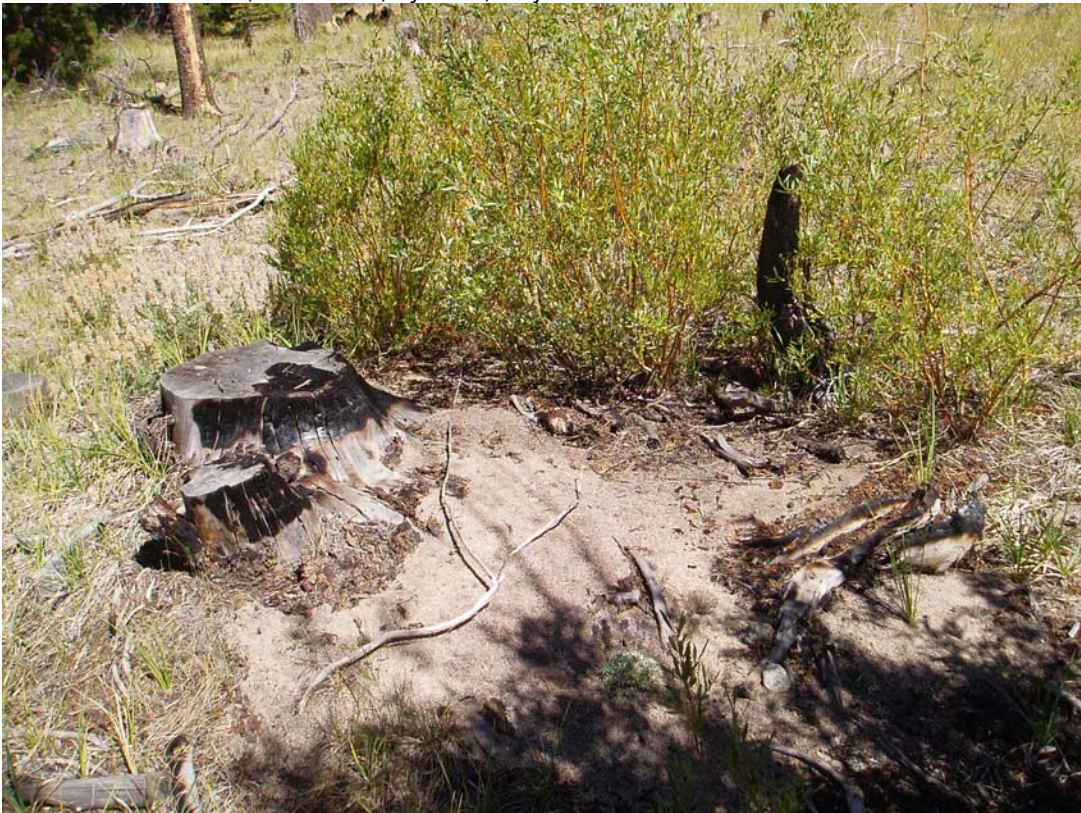
Photo 16. Baldwin 1, near shed, by road, August 2008.

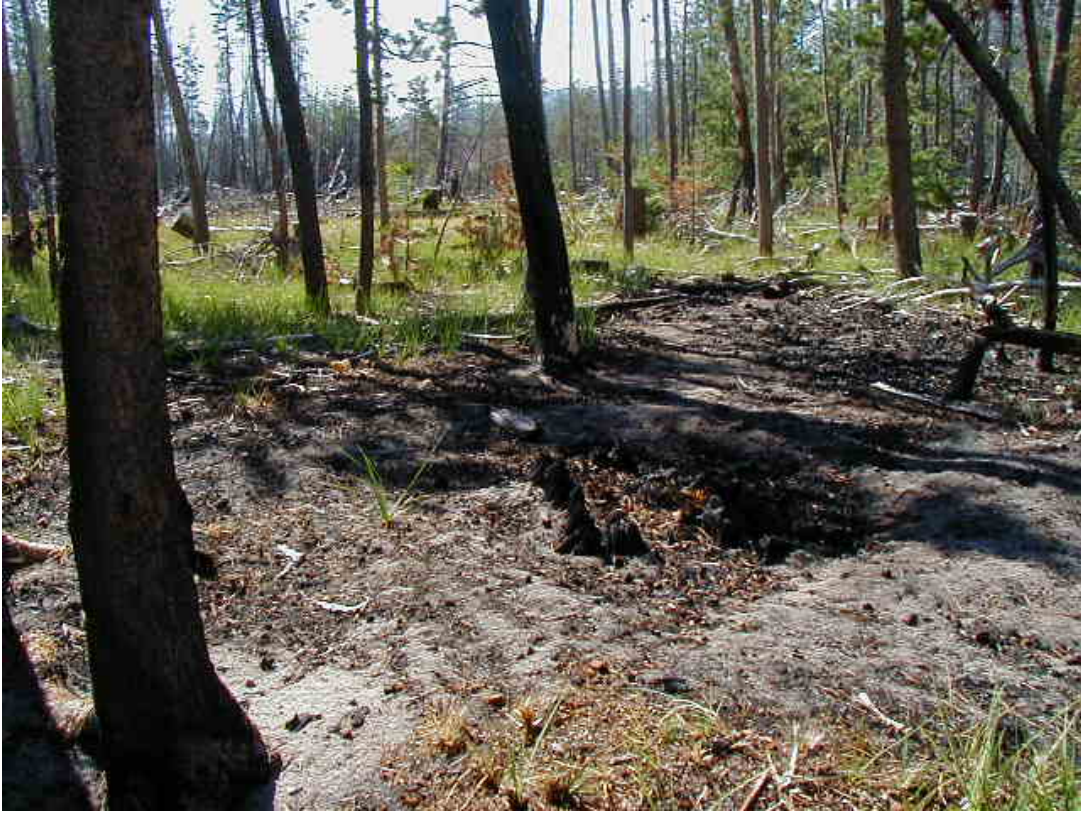
Photo 17. Baldwin 2, July 2003.

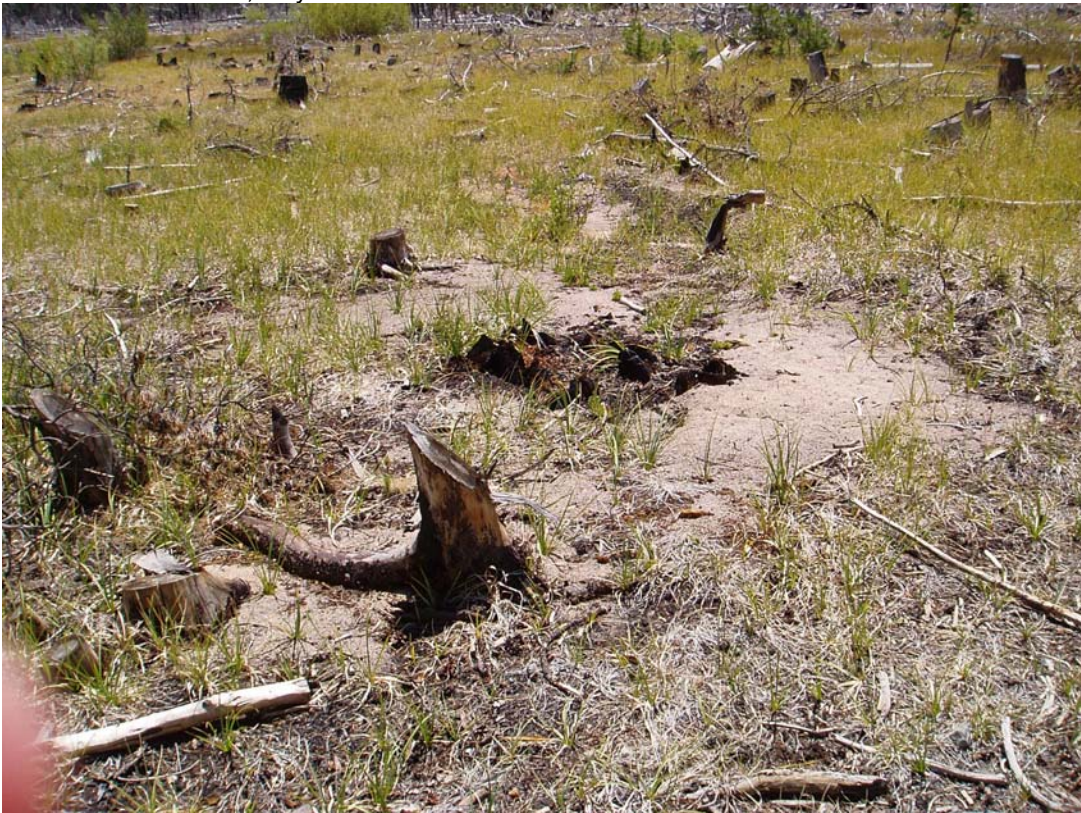
Photo 18. Baldwin 2, August 2008.

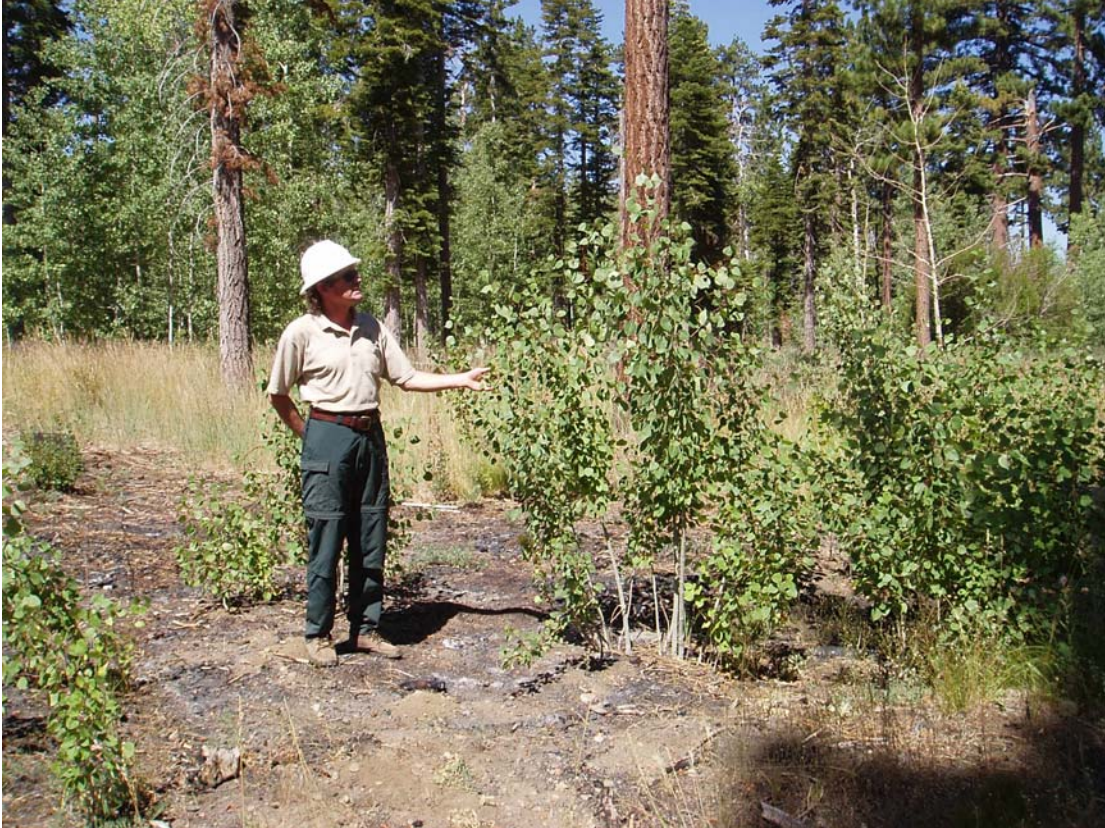
Photo 19. Cathedral, adjacent to road, August 2008.

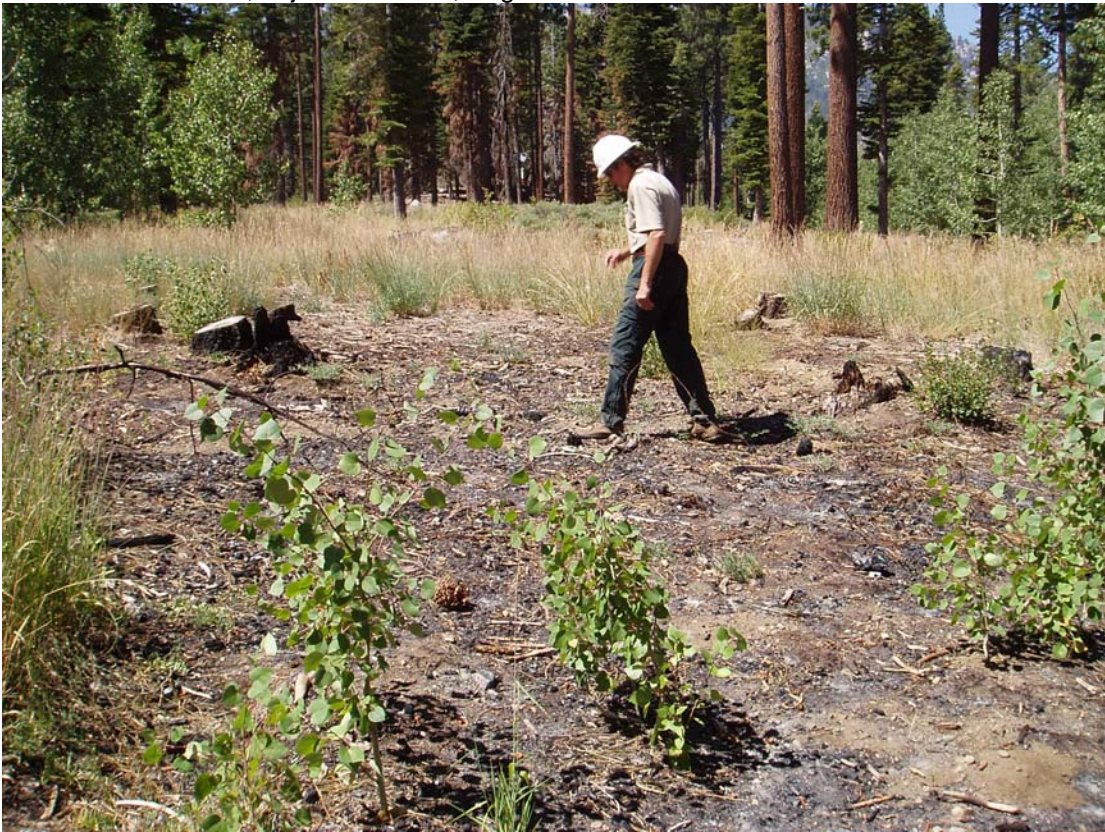
Photo 20. Cathedral, adjacent to road, August 2008 (area to left of Photo 19).
