## DEPARTMENT OF TRANSPORTATION

[Docket No. FAA-2007-28688; Directorate Identifier 2005-SW-21-AD]

#### Airworthiness Directives; Bell Helicopter Textron Canada Model 430 Helicopters

**ACTION:** Notice of proposed rulemaking (NPRM).

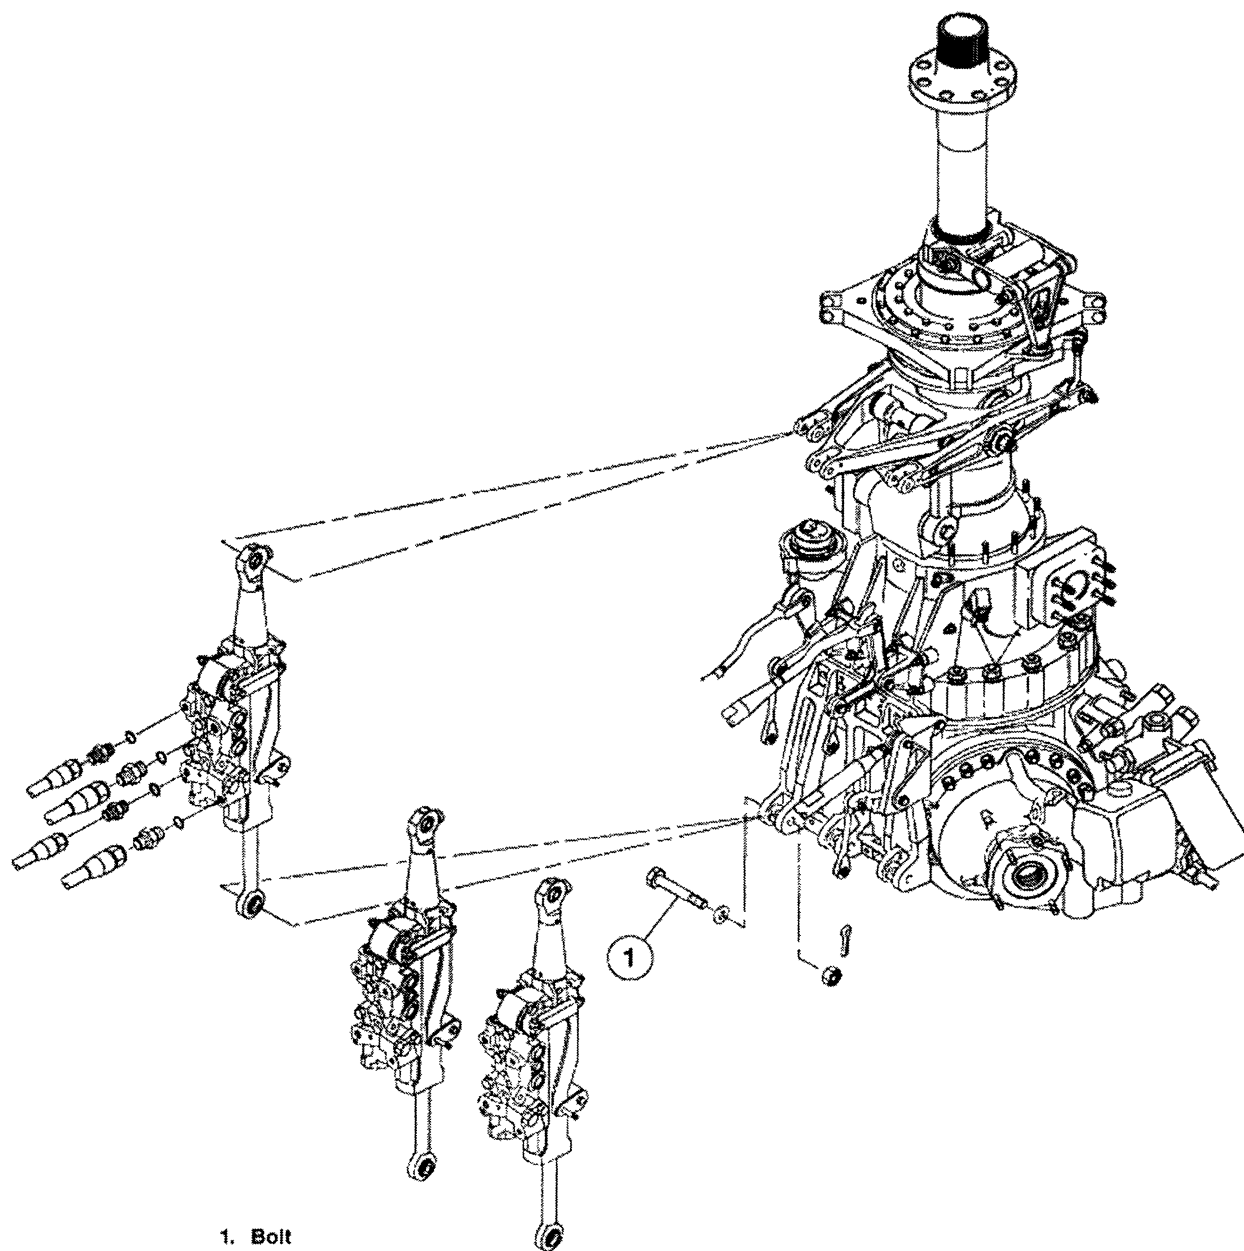
Note: Only the right servo lower attach bolt (1) is shown. The collective and left cyclic servo lower attach bolts are also to be replaced. (This AD does not apply to the same part-numbered bolts at the upper end of each servo.)

- (a) Within 150 hours time-in-service (TIS), replace all three affected bolts, as depicted for one of these bolts in Figure 1 of this AD, with airworthy, zero-time bolts, P/N 50-047C8-31.
