DEPARTMENT OF TRANSPORTATION**Federal Aviation Administration****14 CFR Part 39**

Airworthiness Directives; CFM International, S.A. CFM56-7B Series Turbofan Engines

ACTION: Notice of proposed rulemaking (NPRM).

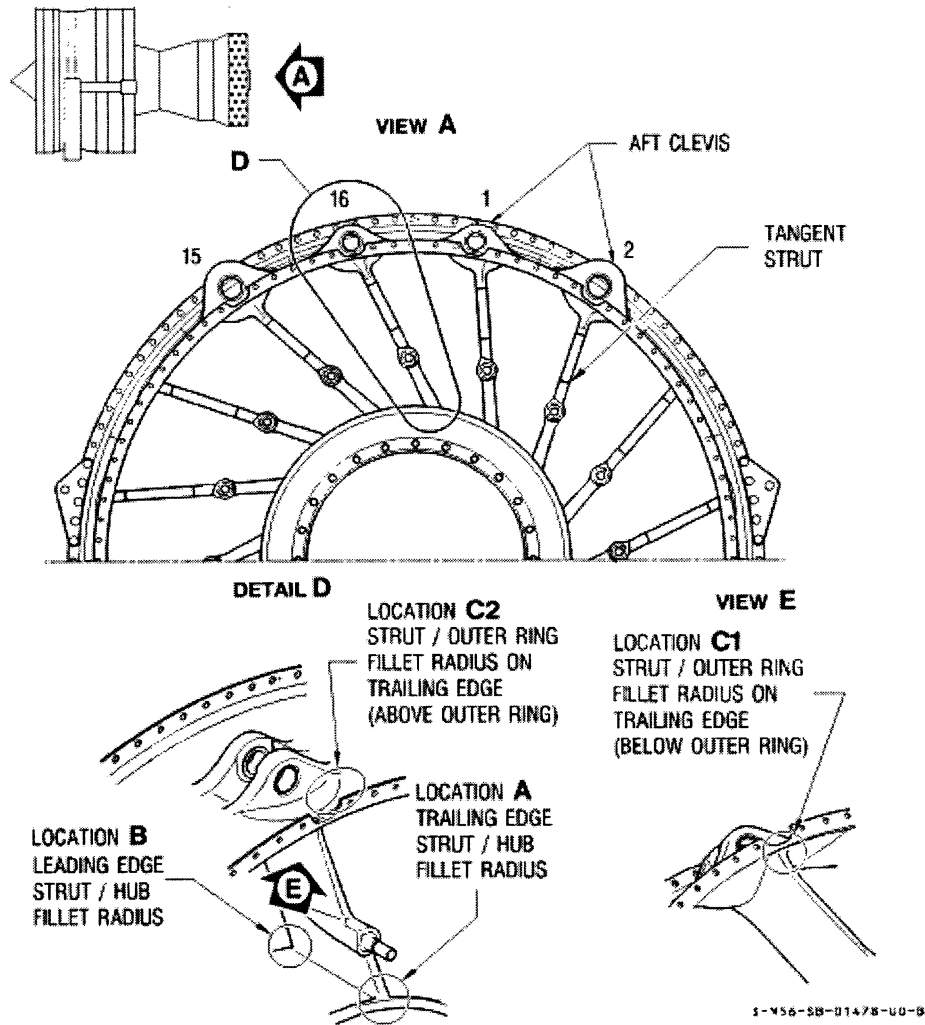
Figure 805,

manufacturer that shows the need to identify an initial threshold for inspecting certain TRFs. We are proposing this AD to prevent failure of the TRF from low-cycle fatigue cracks. Failure of the TRF could result in engine separation from the airplane, which could lead to loss of control of the airplane.

Figure index No.	Inspection location	Inspection threshold (cycles since new)	Inspection intervals (cycles)	Inspection reference
805	Strut/outer ring fillet radius on trailing edge (A).	25,000* for -7B SAC (except business jet) engine models.	Refer to Figure 806* for -7B SAC commercial applications.	Refer to SB 72-0579*.
	Strut/outer ring fillet radius on leading edge (B).	19,000* for -7B SAC business jet engine models.	Refer to Figure 807* for -7B SAC business jet applications.	
	Strut/outer ring fillet radius on trailing edge (C1 below outer ring).			
	Strut/outer ring fillet radius on trailing edge (C2 above outer ring).

Turbine Rear Frame with Tangential struts P/ N 340-166-205-0, 340-166-206-0, 340-166-207-0, 340-166-208-0, 340-166-209-0, 340-166-210-0—Areas to Be Inspected
