[Docket No. FAA-2005-22481; Directorate Identifier 2004-NM-176-AD; Amendment 39-14647; AD 2006-12-21]

Airworthiness Directives; Bombardier Model CL-600-2B19 (Regional Jet Series 100 & 440) Airplanes

2006-12-21 Bombardier, Inc. (Formerly Canadair): Amendment 39-14647. Docket No. FAA-2005-22481; Directorate Identifier 2004-NM-176-AD.

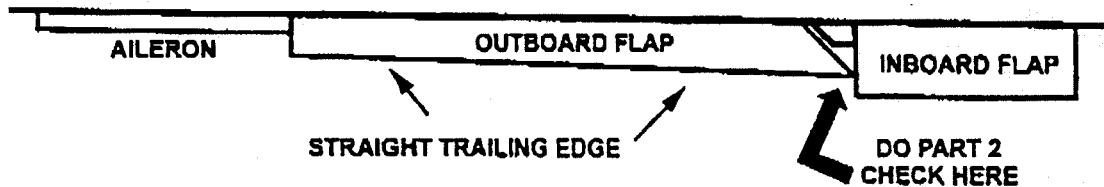
Figure 1. Normal/Abnormal Outboard flap Configuration in Take-off Position"

1. NORMAL

A normal outboard flap has a straight trailing edge, and the inboard corner is slightly above (i.e. higher) than the inboard flap.

The following are indications of an outboard flap with a twist, skew or abnormal deformation:

- Noticeable curve in the trailing edge
- Buckled top or bottom surface
- Higher than normal position of the inboard trailing edge corner
