[Docket No. FAA–2008–0490; Directorate Identifier 2008–SW–26–AD; Amendment 39–15509; AD 2008–10–03]

#### Airworthiness Directives; Bell Helicopter Textron Model 204B, 205A, 205A–1, 205B, 210, 212, 412, 412CF, and 412EP Helicopters

**2008-10-03 Bell Helicopter Textron:**  
Amendment 39-15509. Docket No. FAA-2008-0490; Directorate Identifier 2008-SW-26-AD.

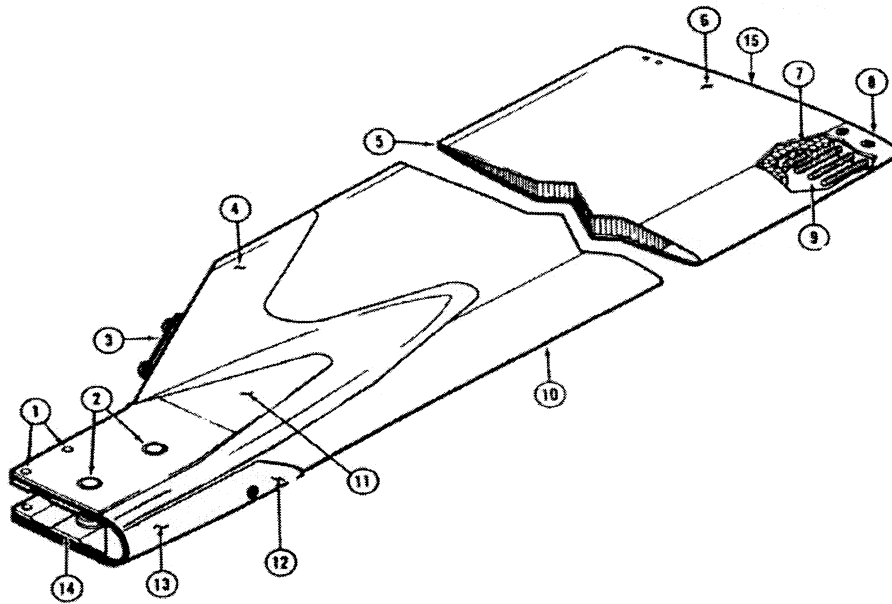
T/R Blade Assembly  
Figure 1

(2) Using a 3-power or higher magnifying glass and a bright light, visually inspect the T/R blade skins, leading edge spar, doublers, grip plates, and trailing edge for a crack, corrosion (may be indicated by blistering, peeling, flaking, bubbling, or cracked paint) and any other damage (including a nick, scratch, or dent). See Figure 1 of this AD. Pay particular attention to both sides of the T/R blade in the area located 16 to 26 inches from the T/R blade tip (blade station 25 to 35—the T/R blade tip is located at blade station 51) and to the inboard blade butt area near the attachment of the external balance weights

and screws. Also pay particular attention to any blade surface that was snagged by the

cloth, as that may be an indication of a crack or paint chip that could lead to corrosion.

(1) Replace any T/R blade that has a crack with an airworthy blade.

(2) Replace any T/R blade that has any corrosion, nick, scratch, dent, or other damage that exceeds any maximum repair limit with an airworthy blade.

(3) Repair or replace with an airworthy blade any T/R blade that has any corrosion, nick, scratch, dent or other damage that is within the maximum repair limits.
