VIRGINIA ELECTRIC AND POWER COMPANY
NORTH ANNA POWER STATION UNITS 1 AND 2
NRC BULLETIN 2002-02 – REACTOR PRESSURE VESSEL HEAD AND VESSEL
HEAD PENETRATION NOZZLE INSPECTION PROGRAMS
REQUEST FOR ADDITIONAL INFORMATION

Response to Request for Additional Information
NRC Bulletin 2002-02

North Anna Power Station Units 1 and 2

**Virginia Electric and Power Company
(Dominion)**

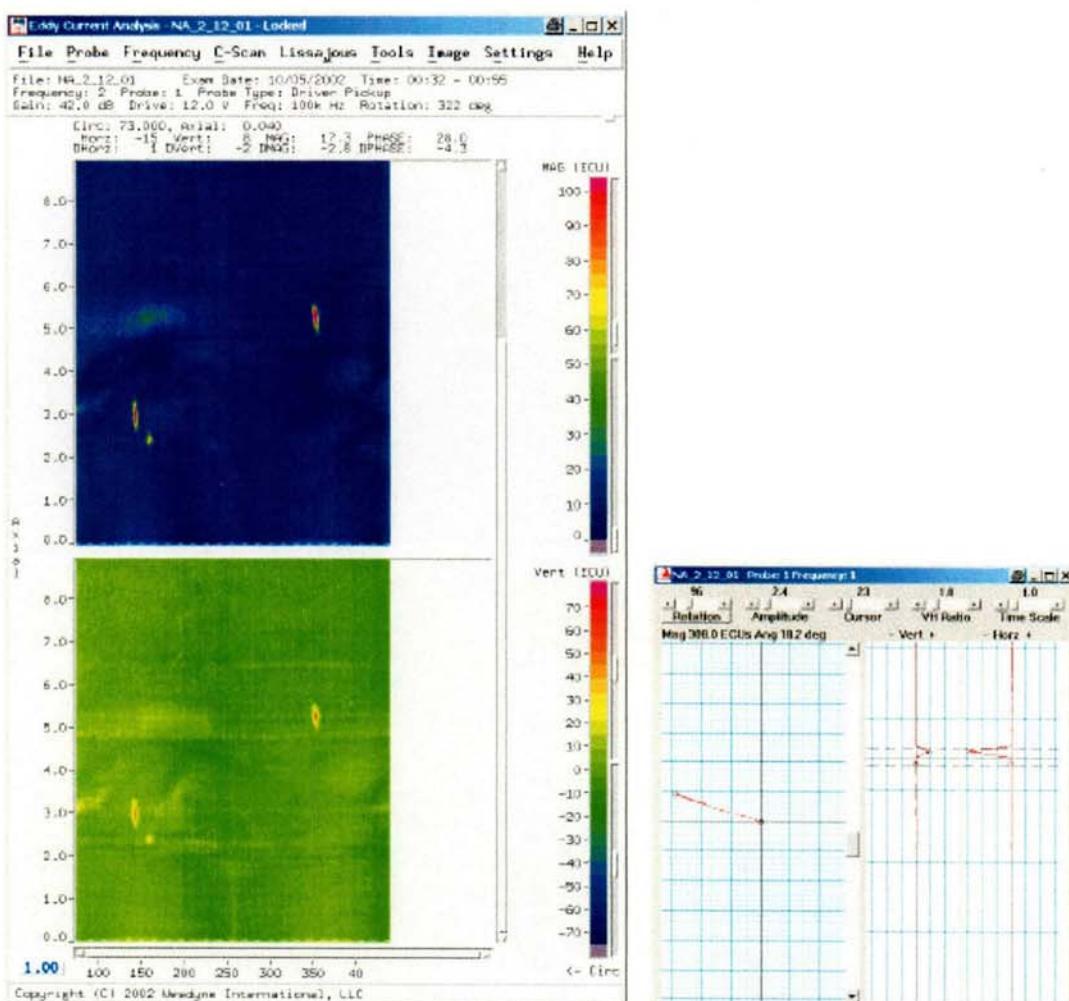
CRDM Open Penetration Inspection – Indications in CRDM No. 12

Indication No.	Amplitude 400kHz [ECU]	Phase 400kHz [Dgr.]	Axial Start [inch]	Axial End [inch]	Circ. Start [Dgr.]	Circ. End [Dgr.]	Axial Length [inch]	Circ. Length [inch]	Comment
1	232	15	2.68	3.44	143	143	0.76	N/A	Axial
2	159	17	2.28	2.56	160	160	0.28	N/A	Axial
3	308	18	5.04	5.56	353	353	0.52	N/A	Axial

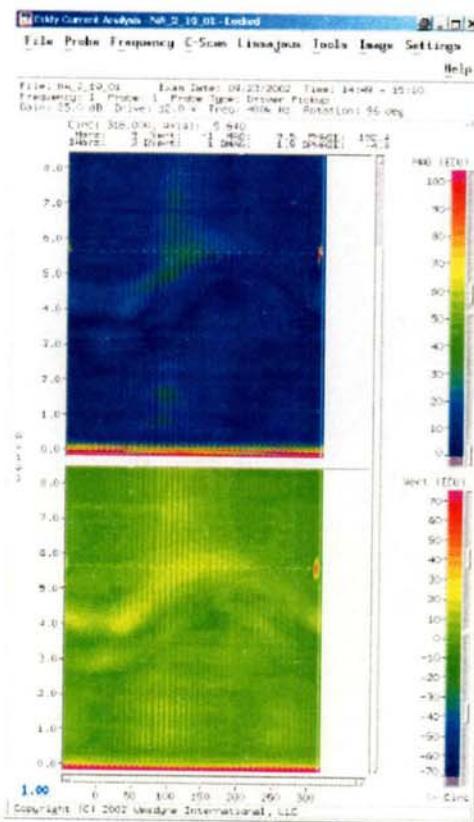
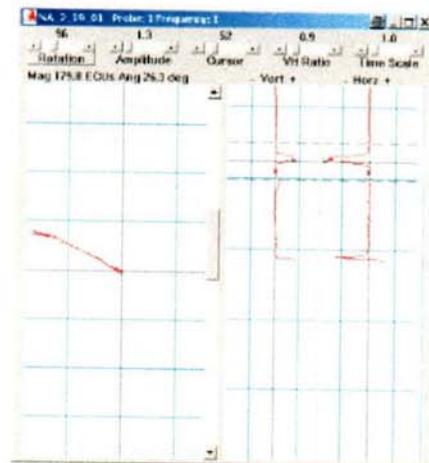
CRDM Open Penetration Inspection – Indications in CRDM No. 19

Indication N0.	Amplitude [ECU]	Phase [Dgr.]	Axial Start [inch]	Axial End [inch]	Circ. Start [Dgr.]	Circ. End [Dgr.]	Axial Length [inch]	Circ. Length [inch]	Comment
1	180	26	5.40	6.20	26	26	0.80	N/A	Axial

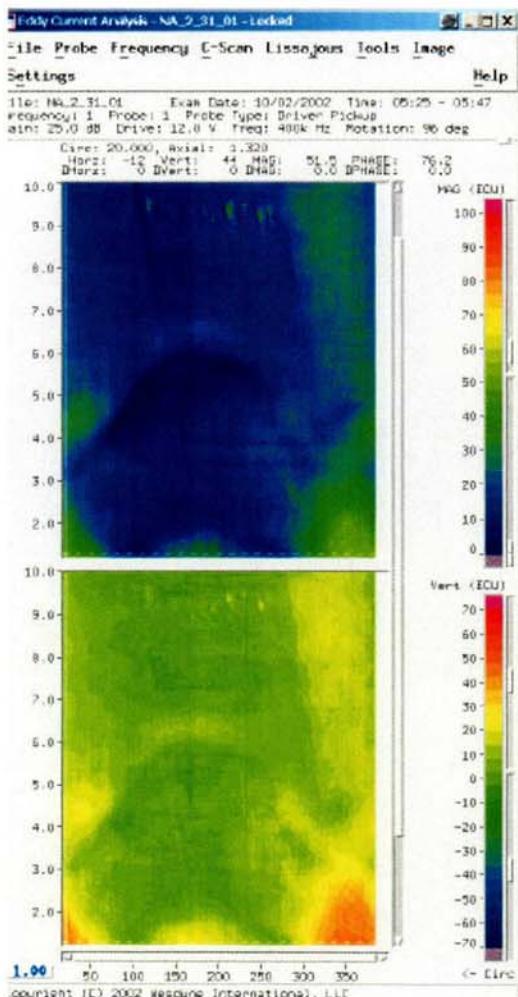
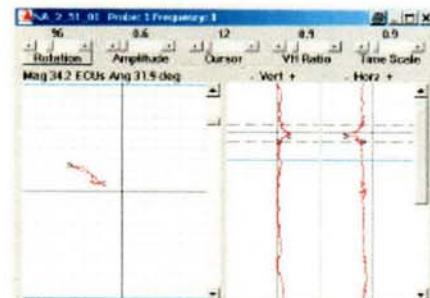
CRDM Open Penetration Inspection – Indications in CRDM No. 31

Indication No.	Amplitude 400kHz [ECU]	Phase 400kHz [Dgr.]	Axial Start [inch]	Axial End [inch]	Circ. Start [Dgr.]	Circ. End [Dgr.]	Axial Length [inch]	Circ. Length [inch]	Comment
1	34	32	9.12	9.60	115	263	0.48	N/A	PV

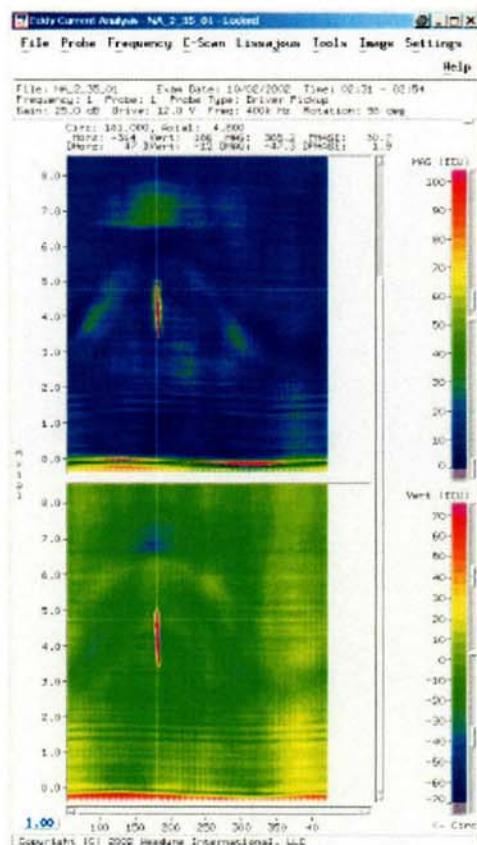
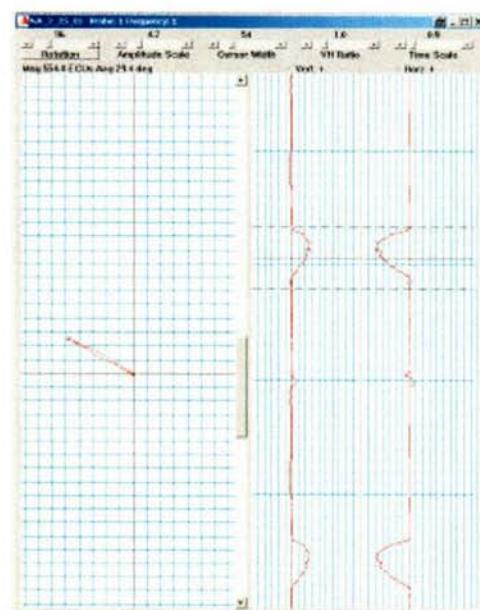
CRDM Open Penetration Inspection – Indications in CRDM No. 35

Indication No.	Amplitude 400kHz [ECU]	Phase 400kHz [Dgr.]	Axial Start [inch]	Axial End [inch]	Circ. Start [Dgr.]	Circ. End [Dgr.]	Axial Length [inch]	Circ. Length [inch]	Comment
1	558	29.5	3.44	5.240	181	181	1.8	N/A	Axial

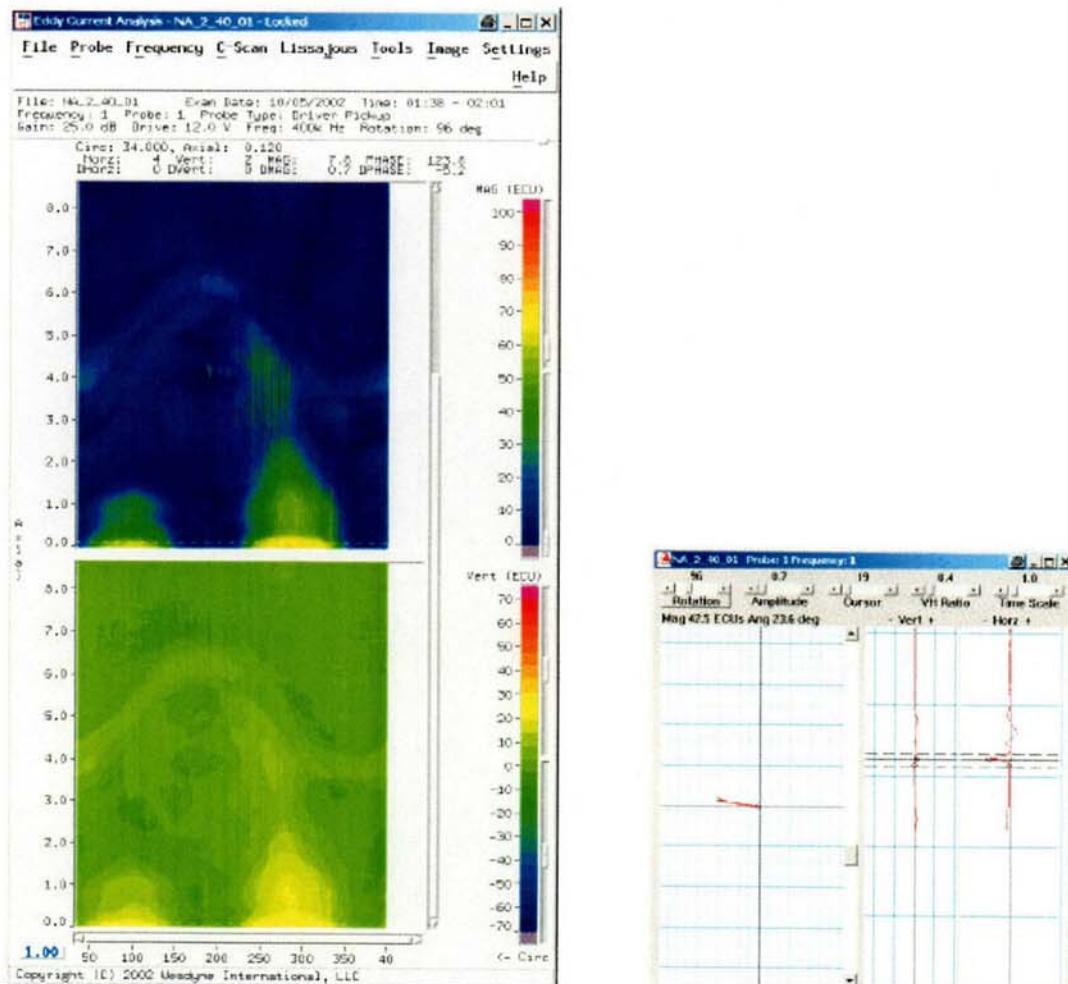
CRDM Open Penetration Inspection – Indications in CRDM No. 40

Indication No.	Amplitude 400kHz [ECU]	Phase 400kHz [Dgr.]	Axial Start [inch]	Axial End [inch]	Circ. Start [Dgr.]	Circ. End [Dgr.]	Axial Length [inch]	Circ. Length [inch]	Comment
1	42	24	4.20	4.48	188	188	0.28	N/A	Axial
2	31	25	4.00	4.28	210	210	0.28	N/A	Axial

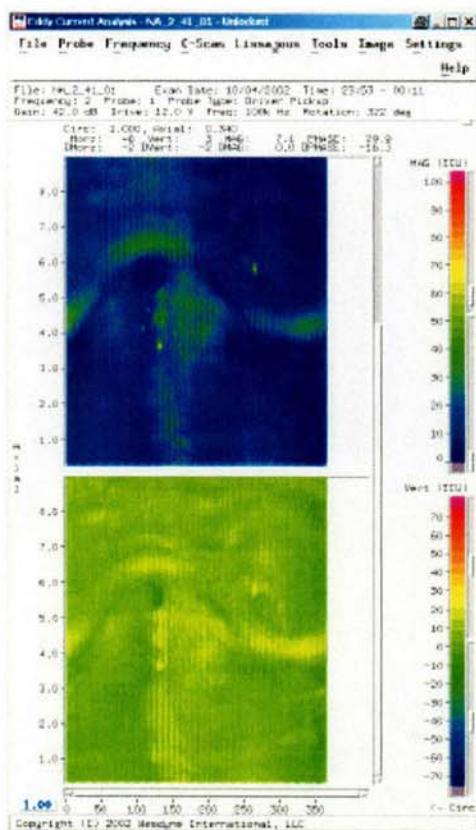
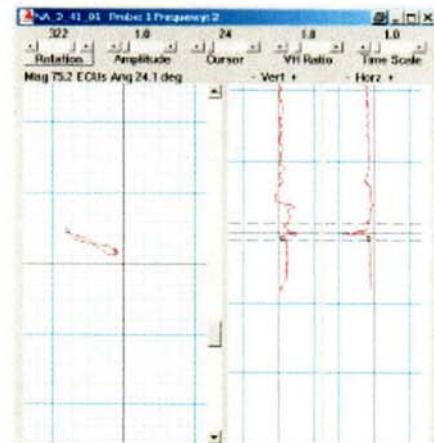
CRDM Open Penetration Inspection – Indications in CRDM No. 41

Indication No.	Amplitude 400kHz [ECU]	Phase 400kHz [Dgr.]	Axial Start [inch]	Axial End [inch]	Circ. Start [Dgr.]	Circ. End [Dgr.]	Axial Length [inch]	Circ. Length [inch]	Comment
1	28	21.5	3.98	4.22	107	107	0.24	N/A	Axial
2	22	25	4.62	4.82	114	114	0.20	N/A	Axial
3	75	24	3.50	3.78	131	131	0.28	N/A	Axial
4	30	17	4.30	4.66	127	127	0.36	N/A	Axial
5	19	23	3.94	4.22	154	154	0.28	N/A	Axial
6	82	30	5.62	6.02	265	265	0.40	N/A	Axial

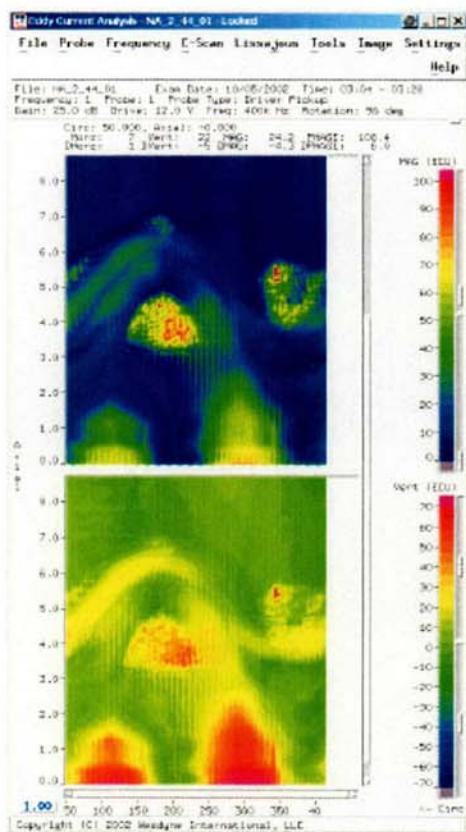
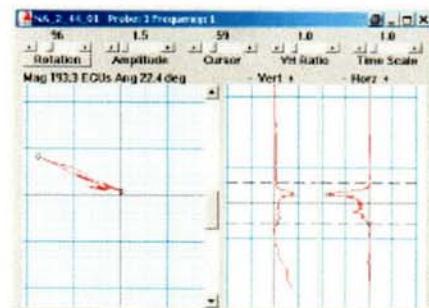
CRDM Open Penetration Inspection – Indications in CRDM No. 44

Indication No.	Amplitude 400kHz [ECU]	Phase 400kHz [Dgr.]	Axial Start [inch]	Axial End [inch]	Circ. Start [Dgr.]	Circ. End [Dgr.]	Axial Length [inch]	Circ. Length [inch]	Comment
1	107	23	3.12	4.92	133	244	1.80	2.68	M-Axial
2	193	22	3.76	5.80	326	71	2.04	2.54	Axial
3	19	15	6.60	7.00	157	198	0.40	1.00	Axial

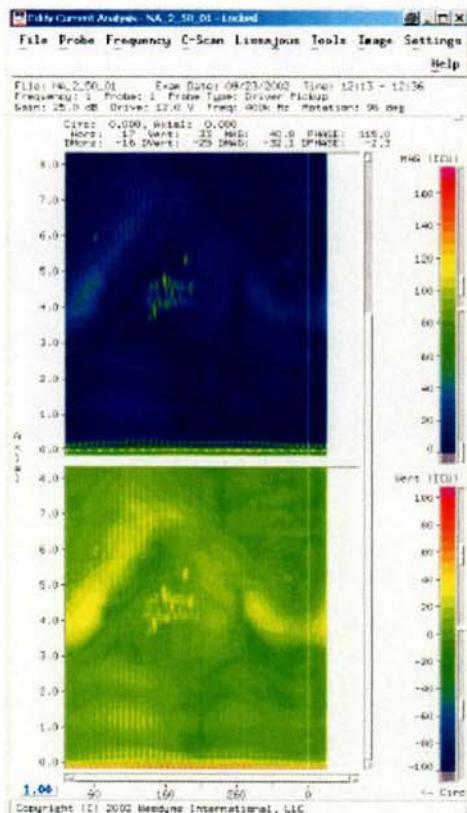
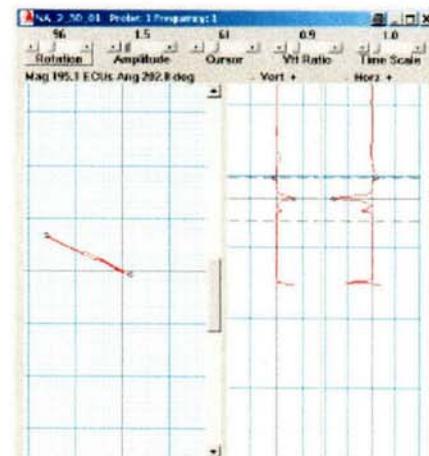
CRDM Open Penetration Inspection – Indications in CRDM No. 50

Indication No.	Amplitude 400kHz [ECU]	Phase 400kHz [Dgr.]	Axial Start [inch]	Axial End [inch]	Circ. Start [Dgr.]	Circ. End [Dgr.]	Axial Length [inch]	Circ. Length [inch]	Comment
1	54	26	6.08	6.40	68	68	0.32	N/A	Axial
2	132	24	3.76	5.08	152	152	1.32	N/A	Axial
3	163	24	4.04	5.36	166	166	1.32	N/A	Axial
4	126	24	4.00	5.32	177	177	1.32	N/A	Axial
5	146	24	4.04	6.04	196	196	2.00	N/A	Axial
6	61	23	5.12	5.52	343	343	0.40	N/A	Axial

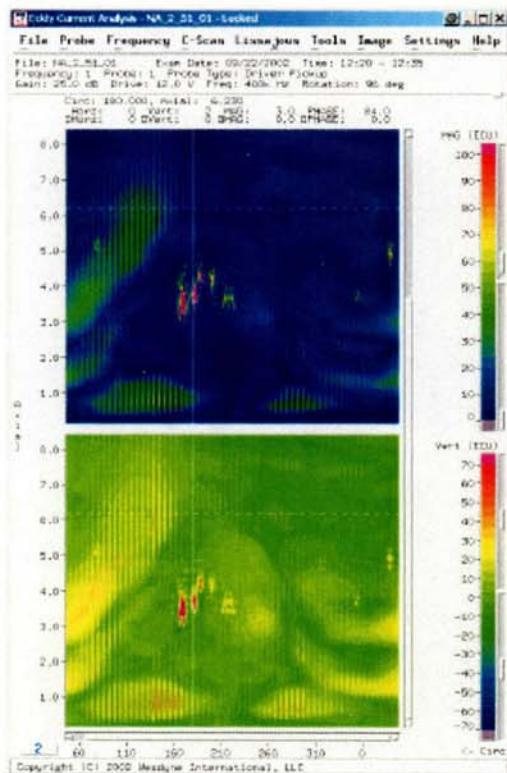
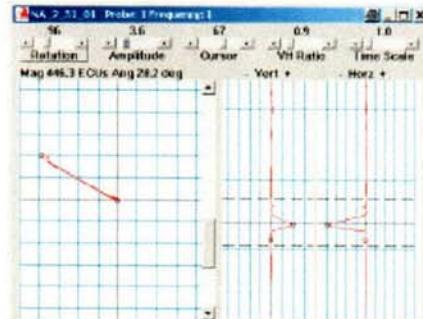
CRDM Open Penetration Inspection – Indications in CRDM No. 51

Indication No.	Amplitude 400kHz [ECU]	Phase 400kHz [Dgr.]	Axial Start [inch]	Axial End [inch]	Circ. Start [Dgr.]	Circ. End [Dgr.]	Axial Length [inch]	Circ. Length [inch]	Comment
1	71	37	4.95	5.39	73	73	0.44	N/A	Axial
2	446	28	2.99	3.87	166	166	0.88	N/A	Axial
3	298	26	3.35	4.15	178	178	0.80	N/A	Axial
4	238	24	3.91	4.75	184	184	0.84	N/A	Axial
5	119	22	3.75	4.47	196	196	0.72	N/A	Axial
6	102	29	3.59	4.03	210	217	0.44	N/A	Multi Axi
7	52	17	4.87	5.03	313	313	0.16	N/A	Axial
8	73	33	3.75	4.03	351	351	0.28	N/A	Axial
9	74	23	4.83	5.35	25	25	0.52	N/A	Multi Axi

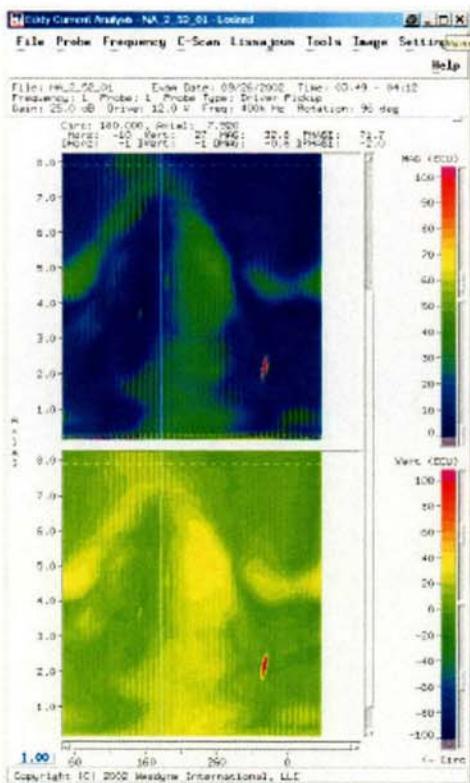
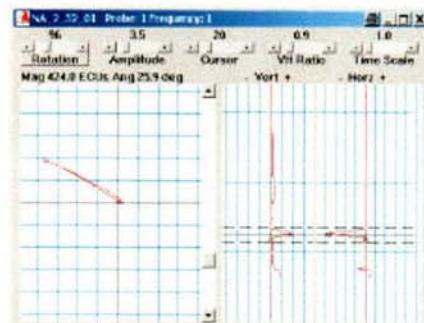
CRDM Open Penetration Inspection – Indications in CRDM No. 52

Indication No.	Amplitude [ECU]	Phase [Dgr.]	Axial Start [inch]	Axial End [inch]	Circ. Start [Dgr.]	Circ. End [Dgr.]	Axial Length [inch]	Circ. Length [inch]	Comment
1	424	26	1.76	2.64	328	328	0.88	N/A	Axial
2	43	29	4.32	4.92	189	189	0.60	N/A	Axial
3	57	29	3.44	4.00	151	151	0.56	N/A	Axial

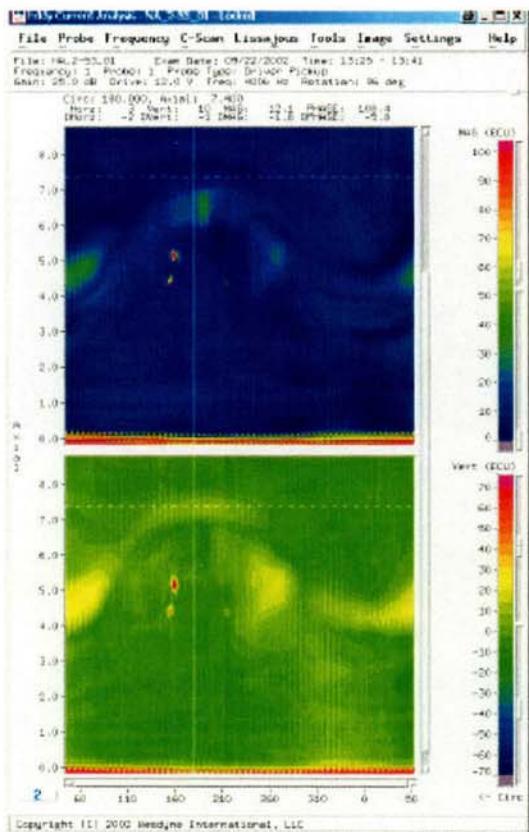
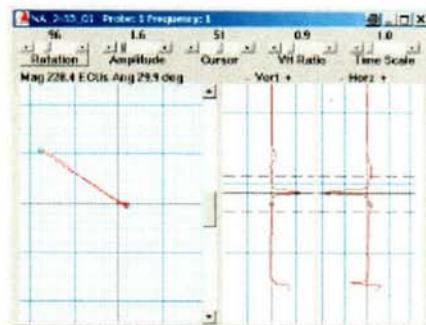
CRDM Open Penetration Inspection – Indications in CRDM No. 53

Indication No.	Amplitude [ECU]	Phase [Dgr.]	Axial Start [inch]	Axial End [inch]	Circ. Start [Dgr.]	Circ. End [Dgr.]	Axial Length [inch]	Circ. Length [inch]	Comment
1	171	28	4.56	5.00	154	154	0.44	N/A	Axial
2	228	30	5.40	5.96	159	159	0.56	N/A	Axial
3	56	31	4.56	4.96	214	214	0.40	N/A	Axial

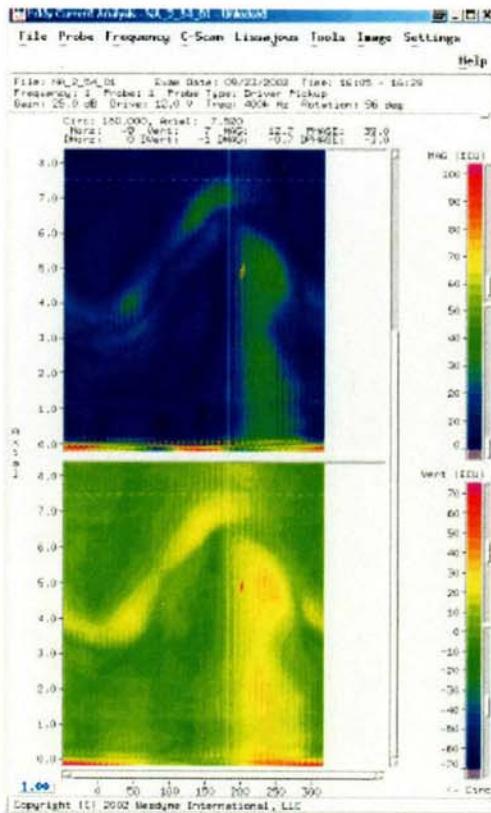
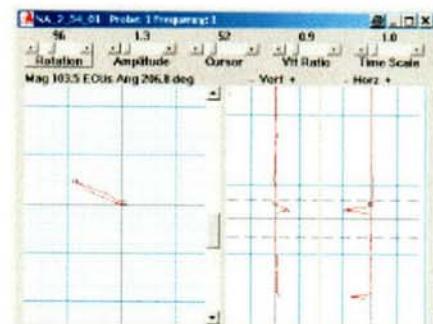
CRDM Open Penetration Inspection – Indications in CRDM No. 54

Indication No.	Amplitude 400kHz [ECU]	Phase 400kHz [Dgr.]	Axial Start [inch]	Axial End [inch]	Circ. Start [Dgr.]	Circ. End [Dgr.]	Axial Length [inch]	Circ. Length [inch]	Comment
1	109	28	4.60	5.20	200	200	0.60	N/A	Axial

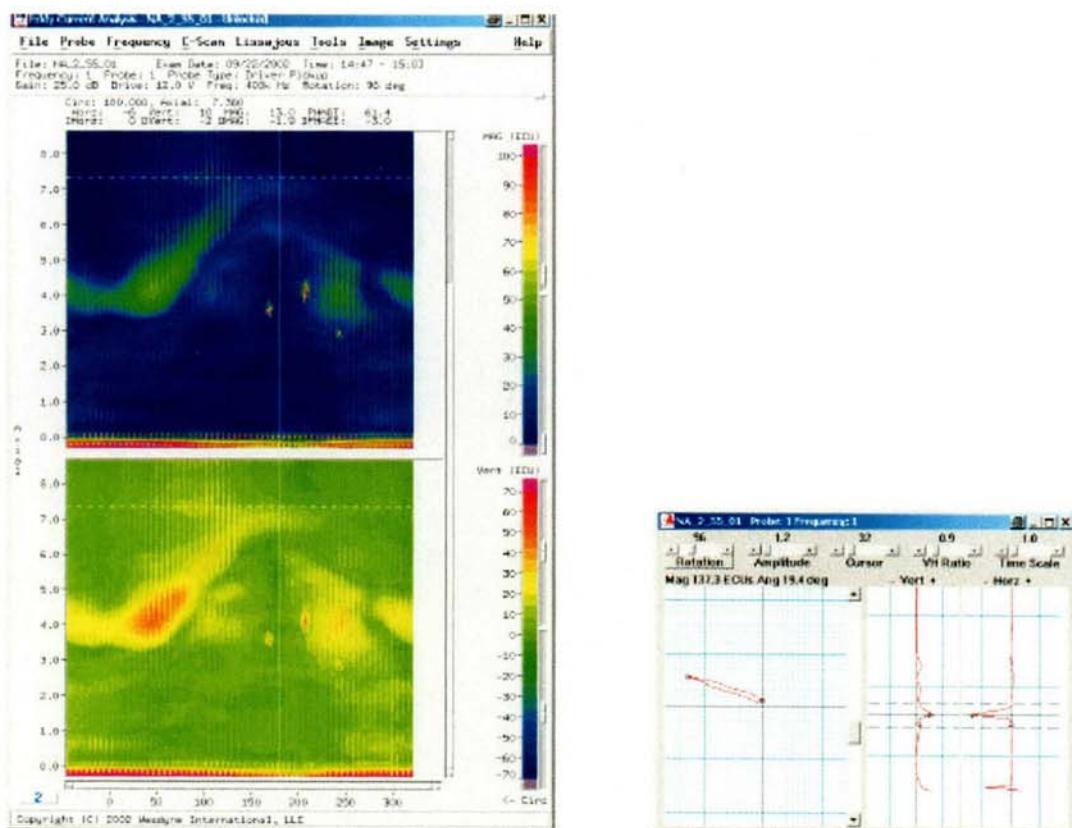
CRDM Open Penetration Inspection – Indications in CRDM No. 55

Indication No.	Amplitude 400kHz [ECU]	Phase 400kHz [Dgr.]	Axial Start [inch]	Axial End [inch]	Circ. Start [Dgr.]	Circ. End [Dgr.]	Axial Length [inch]	Circ. Length [inch]	Comment
1	128	22	3.56	4.16	169	169	0.60	N/A	Axial
2	137	19	4.16	4.88	207	207	0.72	N/A	Axial
3	83	28	3.04	3.32	241	241	0.28	N/A	Axial

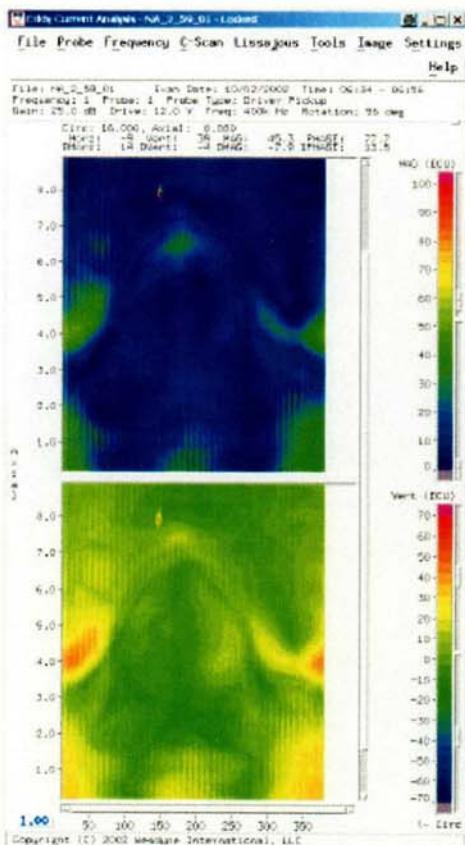
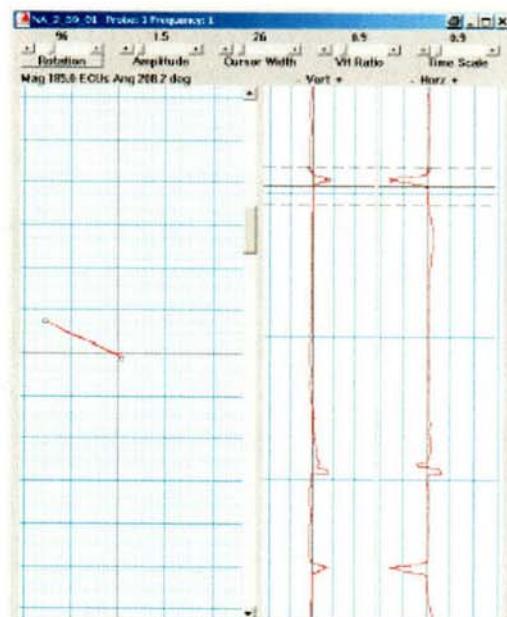
CRDM Open Penetration Inspection – Indications in CRDM No. 59

Indication No.	Amplitude 400kHz [ECU]	Phase 400kHz [Dgr.]	Axial Start [inch]	Axial End [inch]	Circ. Start [Dgr.]	Circ. End [Dgr.]	Axial Length [inch]	Circ. Length [inch]	Comment
1	186	25	7.64	8.28	146	146	0.64	N/A	Axi

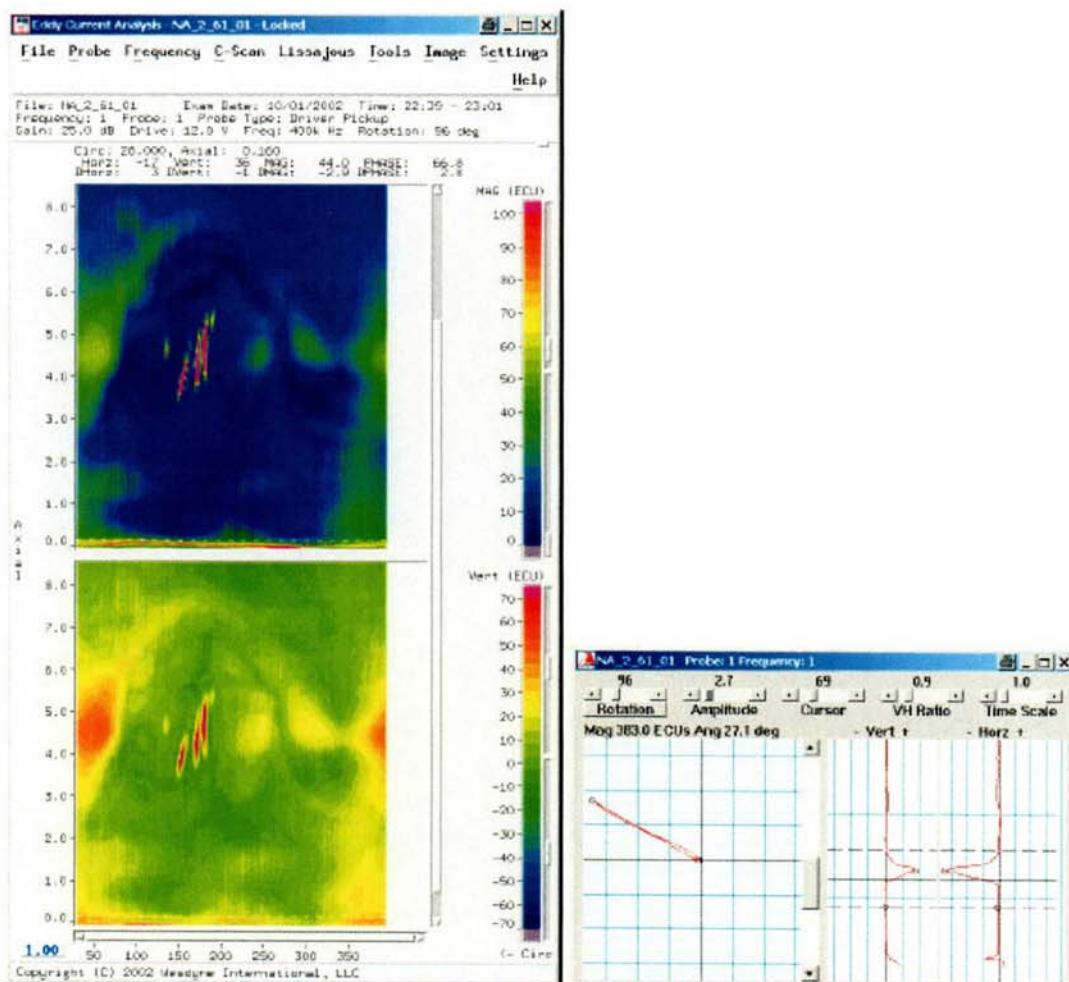
CRDM Open Penetration Inspection – Indications in CRDM No. 61

Indication No.	Amplitude 400kHz [ECU]	Phase 400kHz [Dgr.]	Axial Start [inch]	Axial End [inch]	Circ. Start [Dgr.]	Circ. End [Dgr.]	Axial Length [inch]	Circ. Length [inch]	Comment
1	81	28.5	4.32	5.12	134	134	0.80	N/A	Axial
2	330	25.4	3.32	5.08	147	164	1.76	0.41	Axial
3	383	27	3.52	5.32	170	170	1.80	N/A	Axial
4	320	24	3.80	5.64	179	179	1.84	N/A	Axial
5	75	26	4.96	5.72	188	188	0.76	N/A	Axial

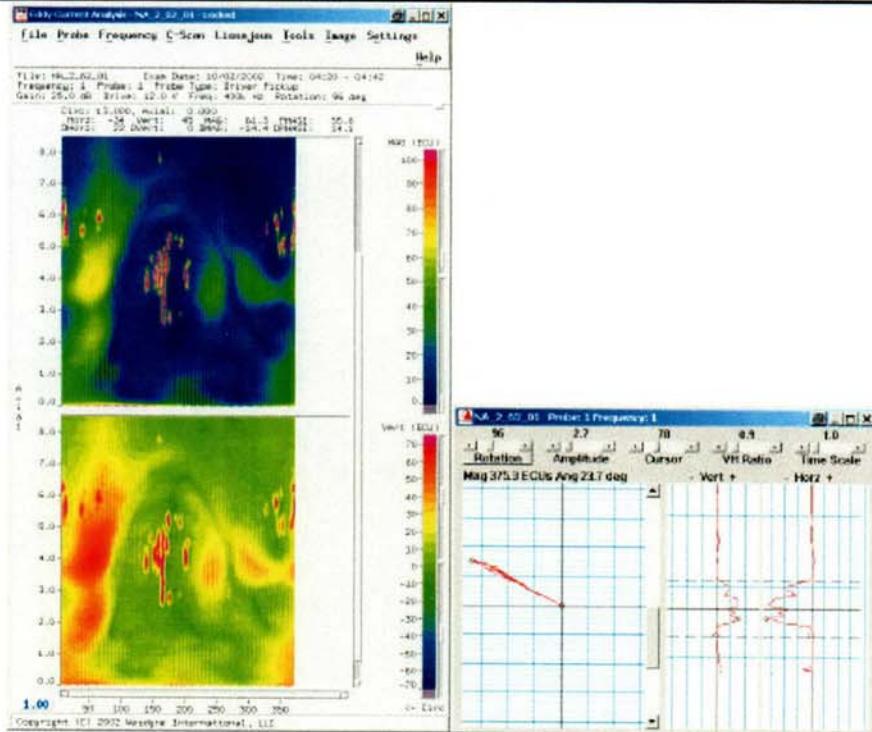
RPVH CRDM Penetration Eddy Current Inspection
CRDM Open Penetration Inspection – Indications in CRDM No. 62

Indication No.	Amplitude 400kHz [ECU]	Phase 400kHz [Dgr.]	Axial Start [inch]	Axial End [inch]	Circ. Start [Dgr.]	Circ. End [Dgr.]	Axial Length [inch]	Circ. Length [inch]	Comment
1	224	28	4.68	6.92	5	14	2.24	0.21	Axial
2	100	21	5.20	6.36	35	43	1.16	0.19	Axial
3	138	29.5	5.40	6.52	59	68	1.12	0.22	Axial
4	224	24	3.52	4.60	139	139	1.08	N/A	Axial
5	140	22	4.36	4.84	147	147	0.48	N/A	Axial
6	336	24	3.44	5.00	159	159	1.56	N/A	Axial
7	375	24	2.44	5.20	165	165	2.76	N/A	Axial
8	314	26	4.04	5.64	171	174	1.60	0.07	Axial
9	205	24	2.52	3.04	176	176	0.52	N/A	Axial
10	80	26	5.16	5.48	185	185	0.32	N/A	Axial
11	53	28	2.72	3.12	191	191	0.40	N/A	Axial
12	168	24	4.92	5.56	192	192	0.64	N/A	Axial
13	272	28.5	3.64	4.72	200	203	1.08	N/A	Axial
14	39	21	4.92	5.52	318	321	0.60	0.07	Axial
15	129	21	5.32	5.88	328	328	0.56	N/A	Axial
16	223	23	4.52	6.32	343	347	1.80	0.09	Axial
17	186	22	4.64	5.52	353	353	0.88	N/A	Axial
18	106	25	5.88	6.32	351	351	0.44	N/A	Axial

19	93	25	7.60	7.92	159	159	0.32	N/A	Axial

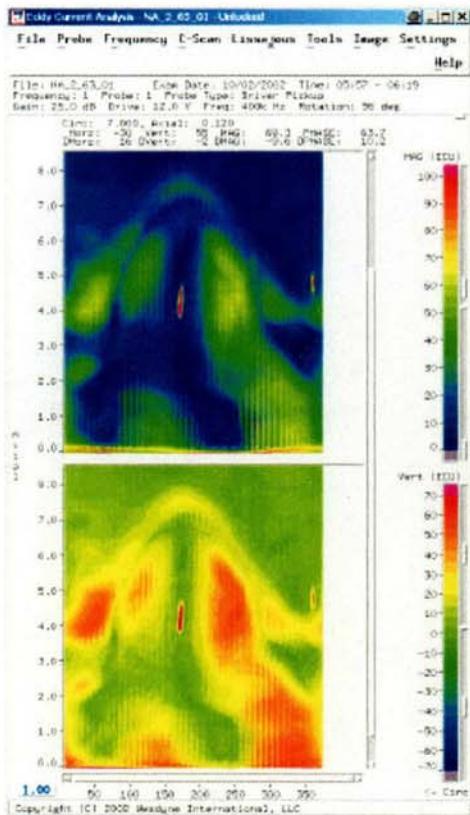
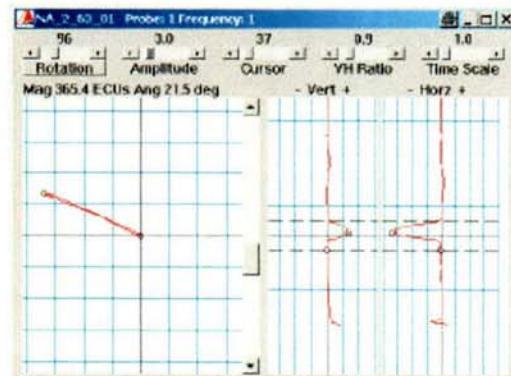
CRDM Open Penetration Inspection – Indications in CRDM No. 63

Indication No.	Amplitude 400kHz [ECU]	Phase 400kHz [Dgr.]	Axial Start [inch]	Axial End [inch]	Circ. Start [Dgr.]	Circ. End [Dgr.]	Axial Length [inch]	Circ. Length [inch]	Comment
1	365	21.5	3.80	4.80	172	172	1.00	N/A	Axial
2	117	24	4.48	5.24	360	360	0.76	N/A	Axial

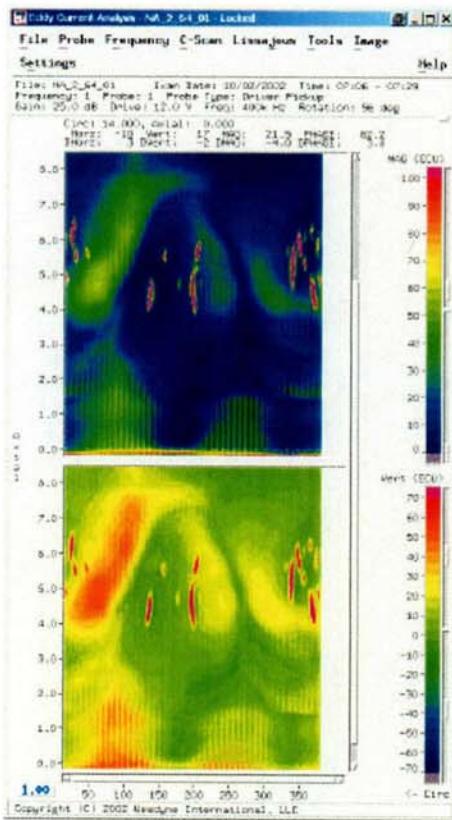
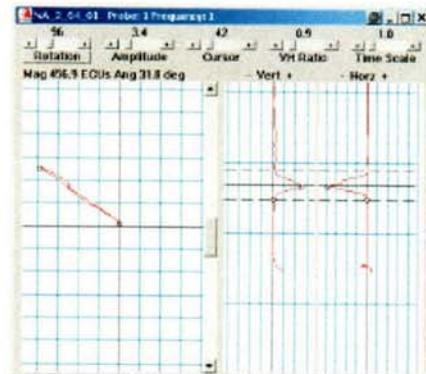
CRDM Open Penetration Inspection – Indications in CRDM No. 64

Indication No.	Amplitude 400kHz [ECU]	Phase 400kHz [Dgr.]	Axial Start [inch]	Axial End [inch]	Circ. Start [Dgr.]	Circ. End [Dgr.]	Axial Length [inch]	Circ. Length [inch]	Comment
1	141	31.5	5.96	6.60	5	5	0.64	N/A	Axial
2	403	33	4.04	5.20	9	9	1.16	N/A	Axial
3	98	31	5.48	6.36	15	15	0.88	N/A	Axial
4	116	23	4.80	5.24	17	17	0.44	N/A	Axial
5	321	29	5.60	6.80	24	24	1.20	N/A	Axial
6	150	27	5.32	6.04	29	29	0.72	N/A	Axial
7	67	21	5.40	6.00	45	45	0.60	N/A	Axial
8	376	28	3.92	5.04	136	136	1.12	N/A	Axial
9	121	29	5.40	5.92	155	155	0.52	N/A	Axial
10	69	30	4.44	4.96	176	176	0.52	N/A	Axial
11	457	32	3.96	6.04	196	202	2.08	0.15	Axial
12	438	27	4.36	6.04	338	338	1.68	N/A	Axial
13	247	32	5.72	6.48	347	347	0.76	N/A	Axial
14	165	27	5.12	5.84	355	355	0.72	N/A	Axial

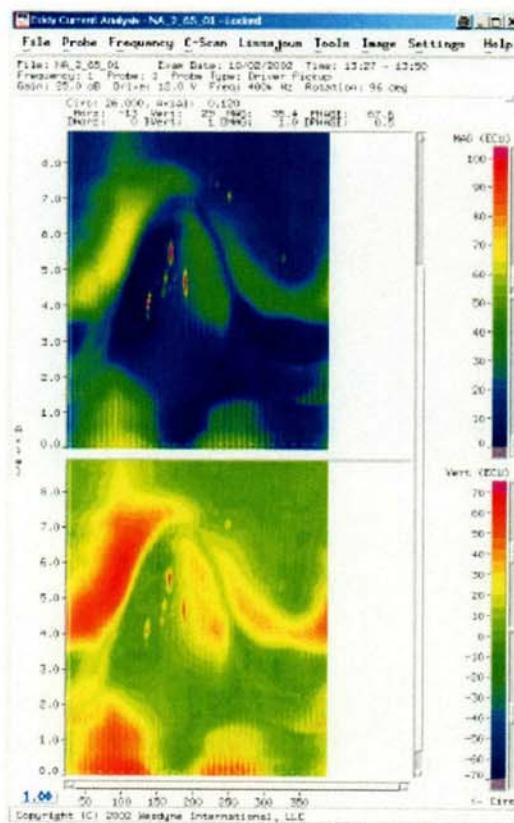
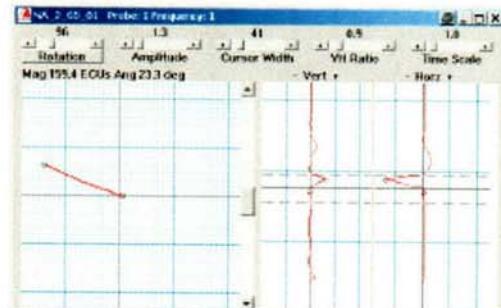
CRDM Open Penetration Inspection – Indications in CRDM No. 65

Indication No.	Amplitude 400kHz [ECU]	Phase 400kHz [Dgr.]	Axial Start [inch]	Axial End [inch]	Circ. Start [Dgr.]	Circ. End [Dgr.]	Axial Length [inch]	Circ. Length [inch]	Comment
1	134	26	3.52	4.56	135	135	1.04	N/A	Axial
2	94	26	5.12	4.28	159	159	0.84	N/A	Axial
3	159	23	4.92	6.00	166	166	1.08	N/A	Axial
4	95	30	4.16	5.20	186	186	1.04	N/A	Axial
5	24	24	7.48	7.68	222	222	.20	N/A	Axial
6	40	24	7.40	7.68	231	231	0.28	N/A	Axial
7	89	22	6.76	7.48	248	248	0.72	N/A	Axial
8	43	23	5.28	5.72	325	325	0.44	N/A	Axial
9	13	7	5.48	5.72	8	8	0.24	N/A	Axial

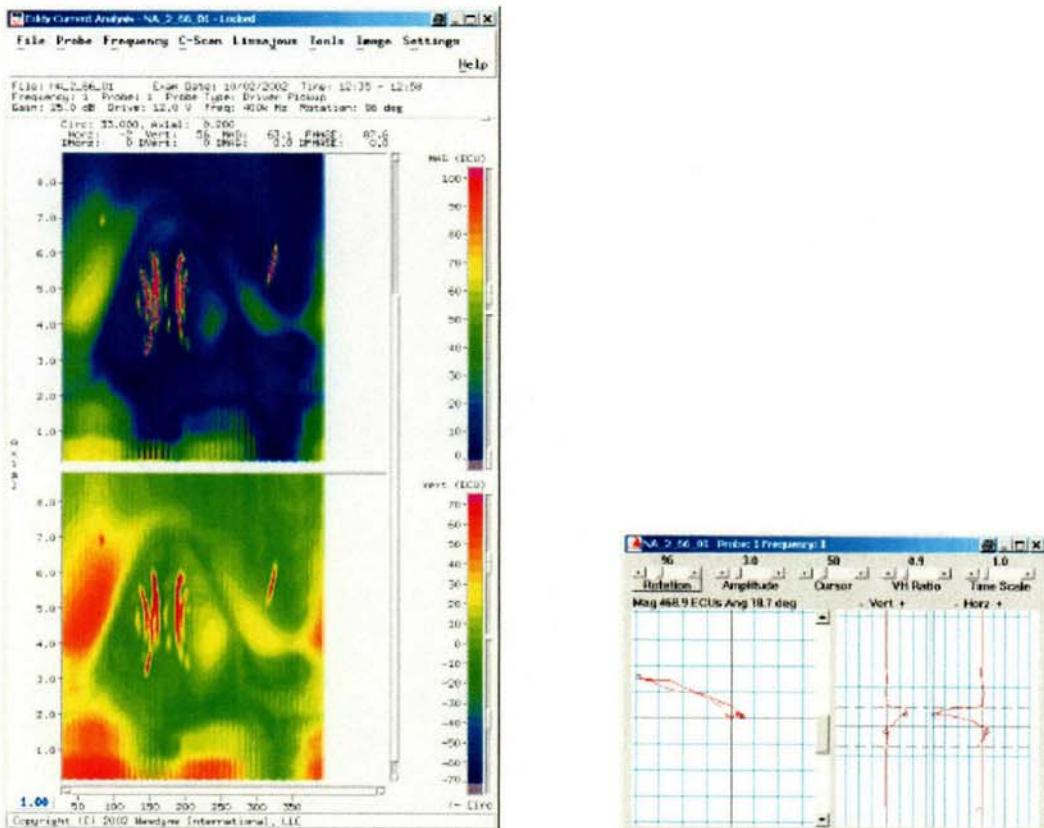
CRDM Open Penetration Inspection – Indications in CRDM No. 66

Indication No.	Amplitude 400kHz [ECU]	Phase 400kHz [Dgr.]	Axial Start [inch]	Axial End [inch]	Circ. Start [Dgr.]	Circ. End [Dgr.]	Axial Length [inch]	Circ. Length [inch]	Comment
1	89	29	6.76	7.20	83	83	0.44	N/A	Axial
2	123	26	4.20	5.08	134	134	0.88	N/A	Axial
3	308	22.5	4.04	5.64	137	148	1.6	0.26	Axial
4	469	19	3.12	6.12	142	164	3.00	0.29	Axial
5	104	24.5	4.52	5.32	171	171	0.80	N/A	Axial
6	88.5	29	3.60	4.28	176	176	0.68	N/A	Axial
7	369	23	3.33	6.24	185	185	2.92	0.31	Axial
8	58	30	3.20	3.80	202	202	0.60	N/A	Axial
9	278	23.5	5.16	6.40	315	326	1.24	0.26	Axial

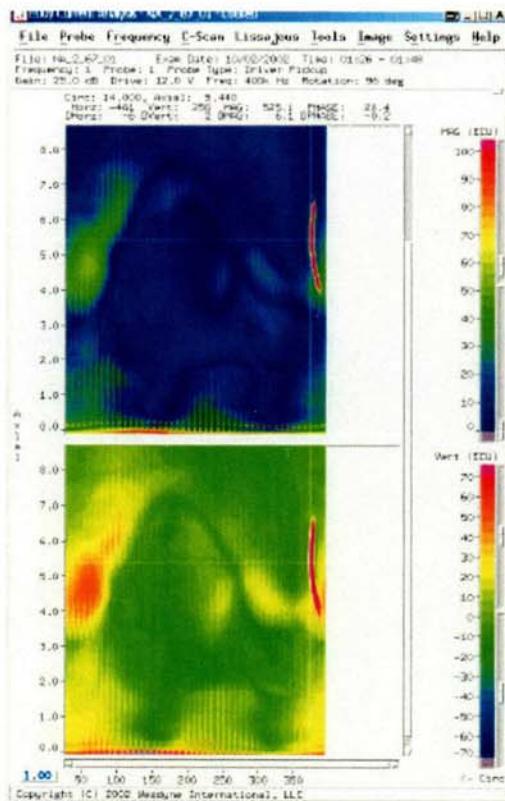
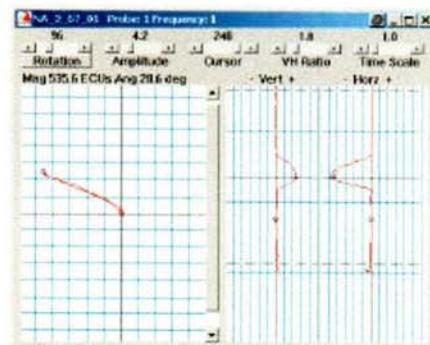
CRDM Open Penetration Inspection – Indications in CRDM No. 67

Indication No.	Amplitude 400kHz [ECU]	Phase 400kHz [Dgr.]	Axial Start [inch]	Axial End [inch]	Circ. Start [Dgr.]	Circ. End [Dgr.]	Axial Length [inch]	Circ. Length [inch]	Comment
1	535	14	3.88	6.84	24	17	2.96	.165	AXI
