St Lucie Unit 1-18
RVHP Inspection Results
and Issues
October 12, 2002

St. Lucie Unit 1 RVHP Exam Results

St Lucie Unit 1-18
RVHP Inspection Results
and Issues
October 10, 2002

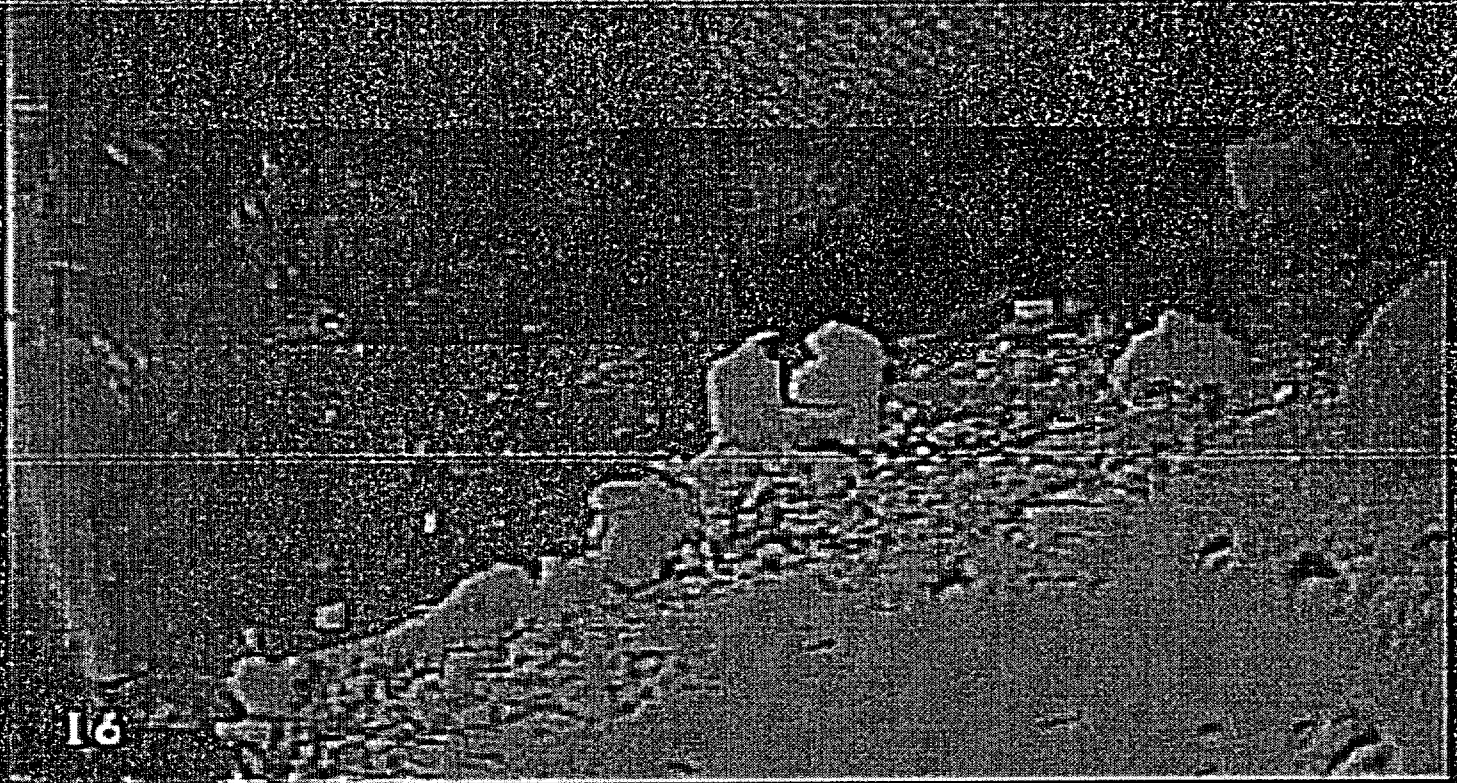
NOZZLE 2 QUAD B

Area of
lack of coverage.

- Nozzle 2 approach
 - Missing 24° of UT data
 - We have a bounding deterministic evaluation to address a 180° circ crack at the weld root plane
 - No evidence of wastage or leakage.
 - Viewed 360° around the area.
 - 1 quadrant obstructed by insulation - making an attempt to clear
- Due to the excellent results with the rest of the RVHPs we conclude this penetration is not cracked or leaking and has reasonable certainty to have margin against ejection.
- If insulation can not be cleared FPL is complete with this penetration.

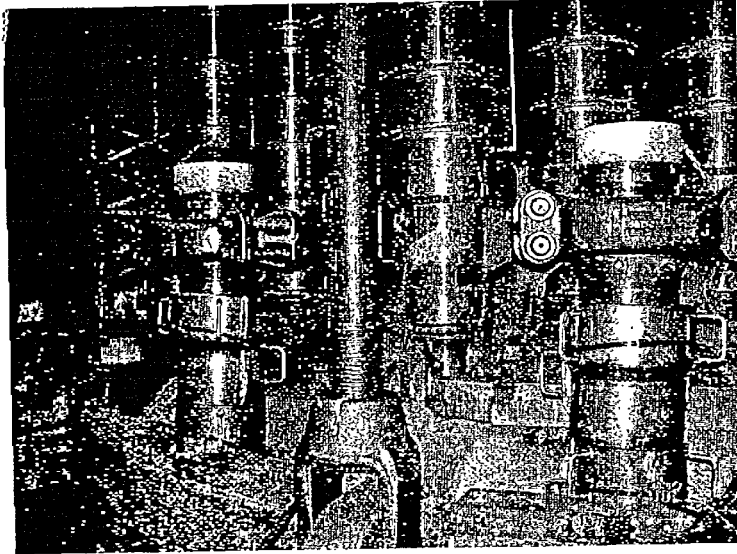
- All 78 penetrations reached in all 4 quadrants
 - No wastage or evidence of boric acid leakage
 - Difficult exam due to the close fitting insulation and asbestos collars
 - Some debris noted- asbestos - not relevant, not significant compared to the EPRI Visual Guidelines report.
 - Will clean/remove debris from representative sample

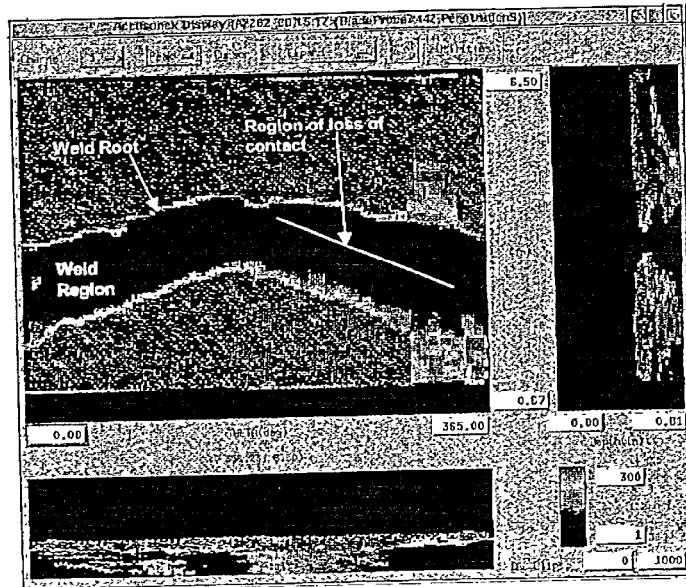
- Typical limited coverage area
- Material adjacent to weld root and above fully interrogated
- Region that safety significant circ flaws could be is addressed
