Docket No. 50-336
B18802

Millstone Nuclear Power Station, Unit No. 2
Supplemental Response to NRC Bulletin 2001-01
Circumferential Cracking of Reactor Pressure Vessel Head Penetration Nozzles

ERC 25203-ER-02-0005
Reactor Vessel Head Penetration Inspection Plan
for Ultrasonic Examination of Interference Fit

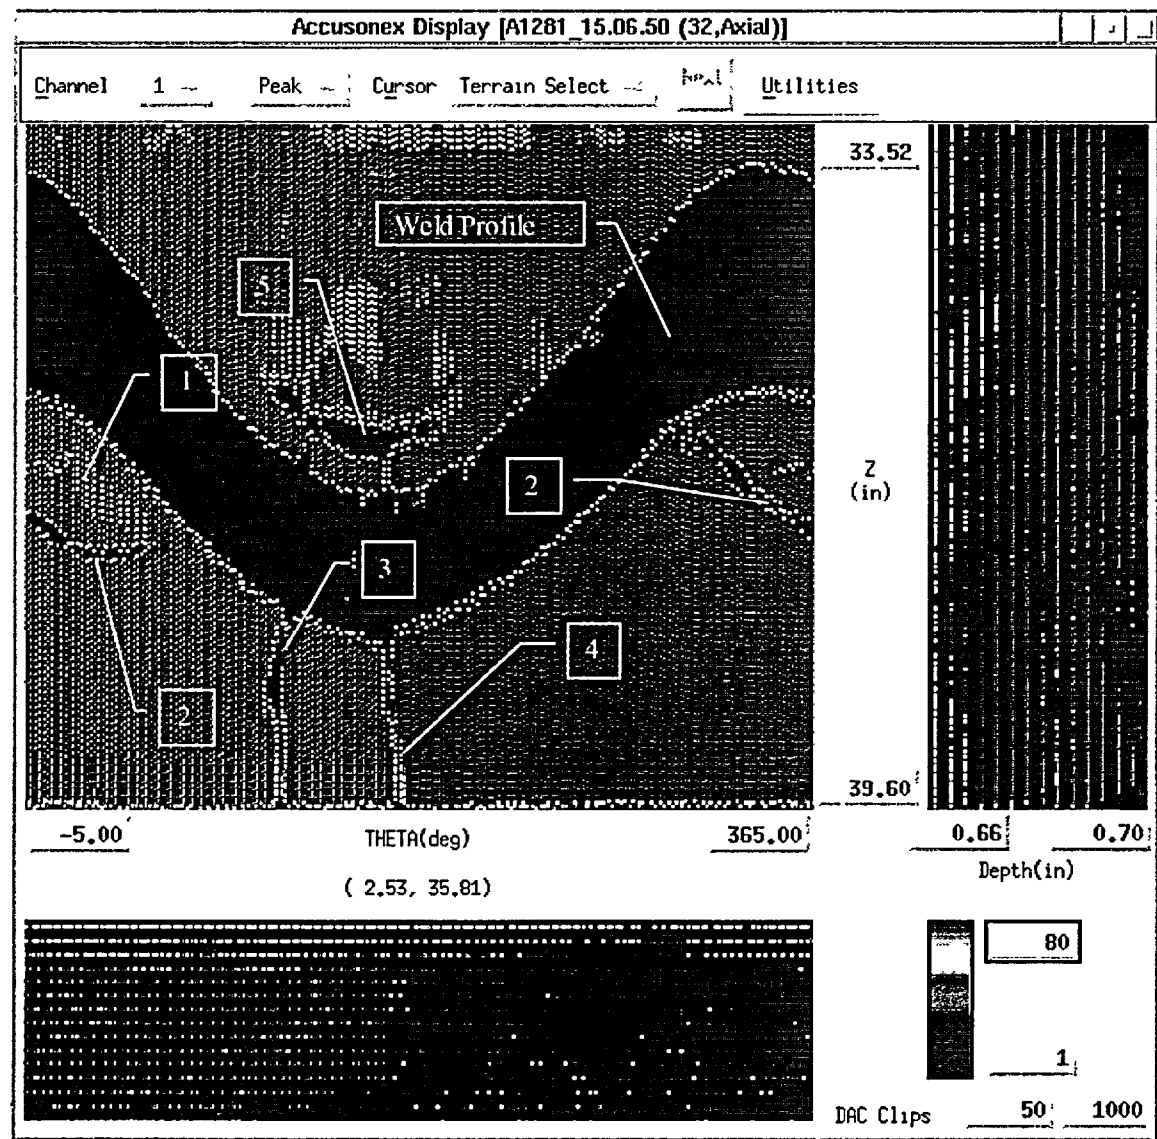
On Figure 1 (below), the analyst selected a slice of information (time/distance), which best illustrated the parameters of interest (cracks in relation to the weld). The areas of high energy are colored red and the areas of low energy are colored black. The large sinusoidal shape in the middle of the display is the weld. Note the total loss of back reflection in the area of the weld, indicating that the sound energy was allowed to propagate into the weld. The sound energy is also not reflected toward the receiving transducer at this point in time in the location of the four cracks labeled 2 through 5.

The small, vertical, multi-colored bar code in the bottom right corner of the illustration is set with a color range of 1 through 80.

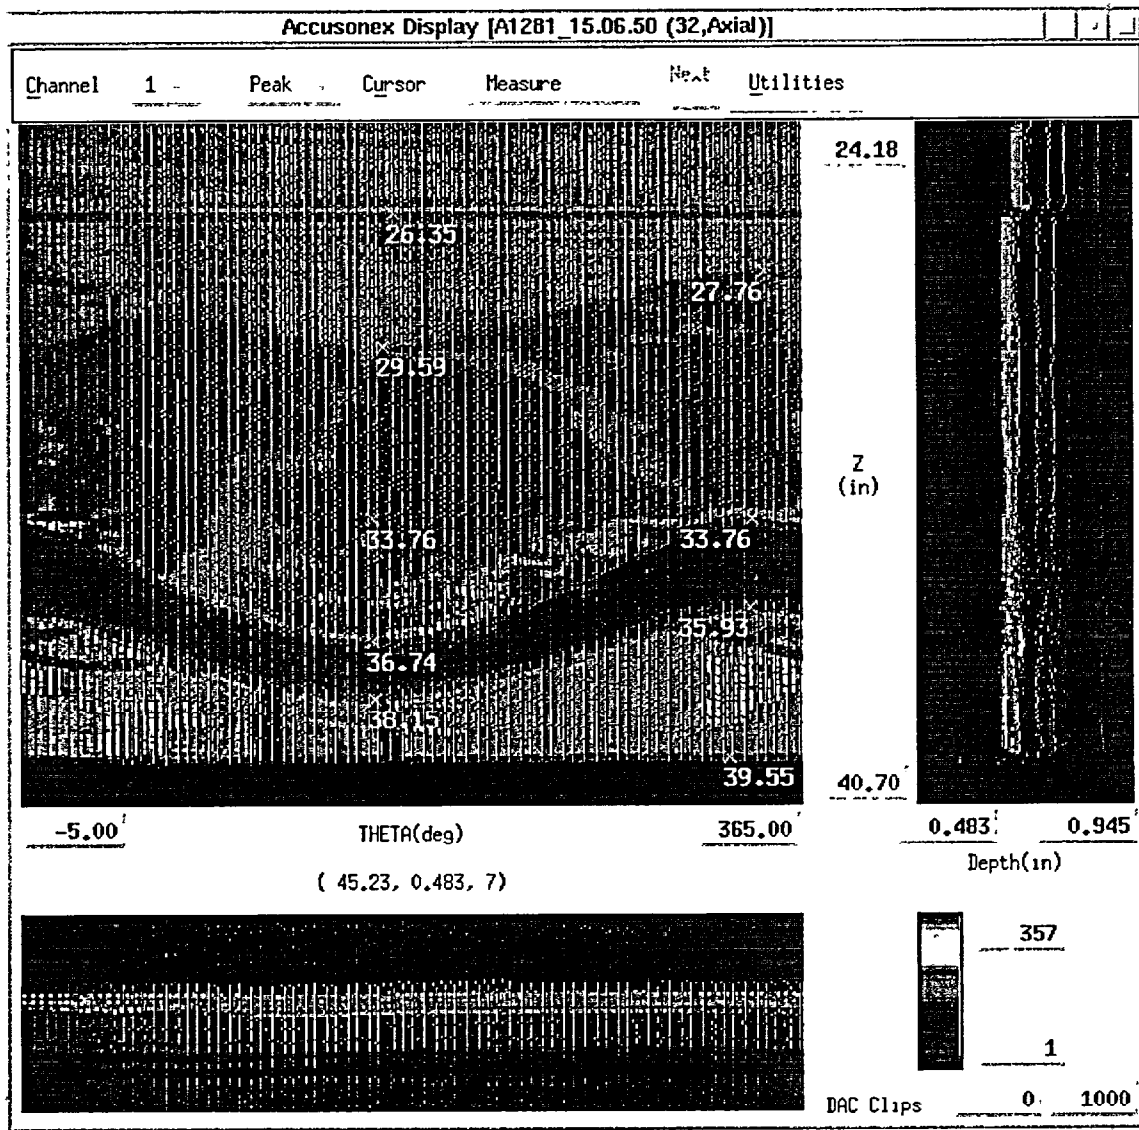
Figure 2

Figure 2, is the same penetration. In this illustration, the primary area of interest was to measure the location of the top of the vessel head, interference fit, and weld, before starting the repair. Location 26.35 is a transition area where there is a geometry change in the tube, above the top of the vessel head. Location 27.76 is the top of the vessel head on the uphill side of the nozzle and location 29.59 is the top of the vessel head on the downhill side of the nozzle. Note how the rise and fall of the vessel head conforms to the rise and fall of the weld indicating the geometry of the vessel head curvature. The area between location 29.59 and location 33.76 is the interference fit. The general area between the top and bottom of the interference fit has less sound energy reflected than any other area in this illustration other than the weld. Location 39.55 is the bottom of the nozzle. The area between 39.55 and the bottom of the weld is a metal to air interface.

Although the color scheme was set to optimize the other parameters, two distinct areas of high reflection are visible through the interference fit. These two areas are the RCS leak paths through the interference fit.

Note the color settings on the color bar code are 1 through 357.

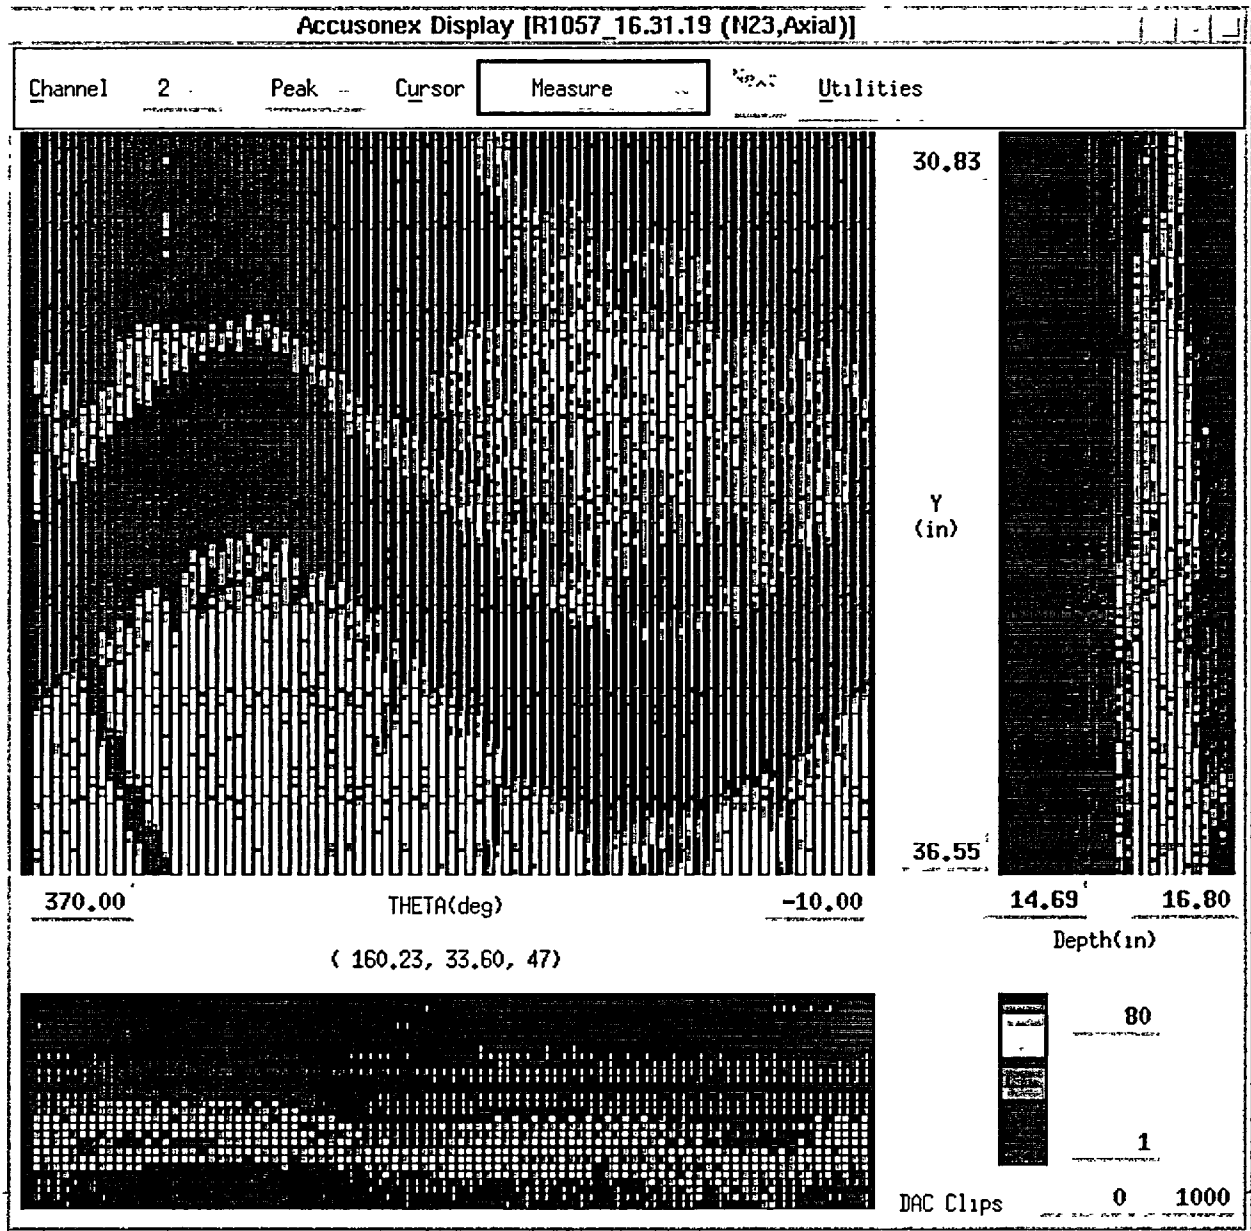
Figure 3 and Figure 4 are both of another power station. Although a different color scheme was used for both of these illustrations, the leak path is clearly visible through the interference fit portion of the annular region above the weld. The area between the low side of the weld and the interference fit has a void with very high reflectivity. Numerous crack indications lead into this void with one clear leak path leading out.

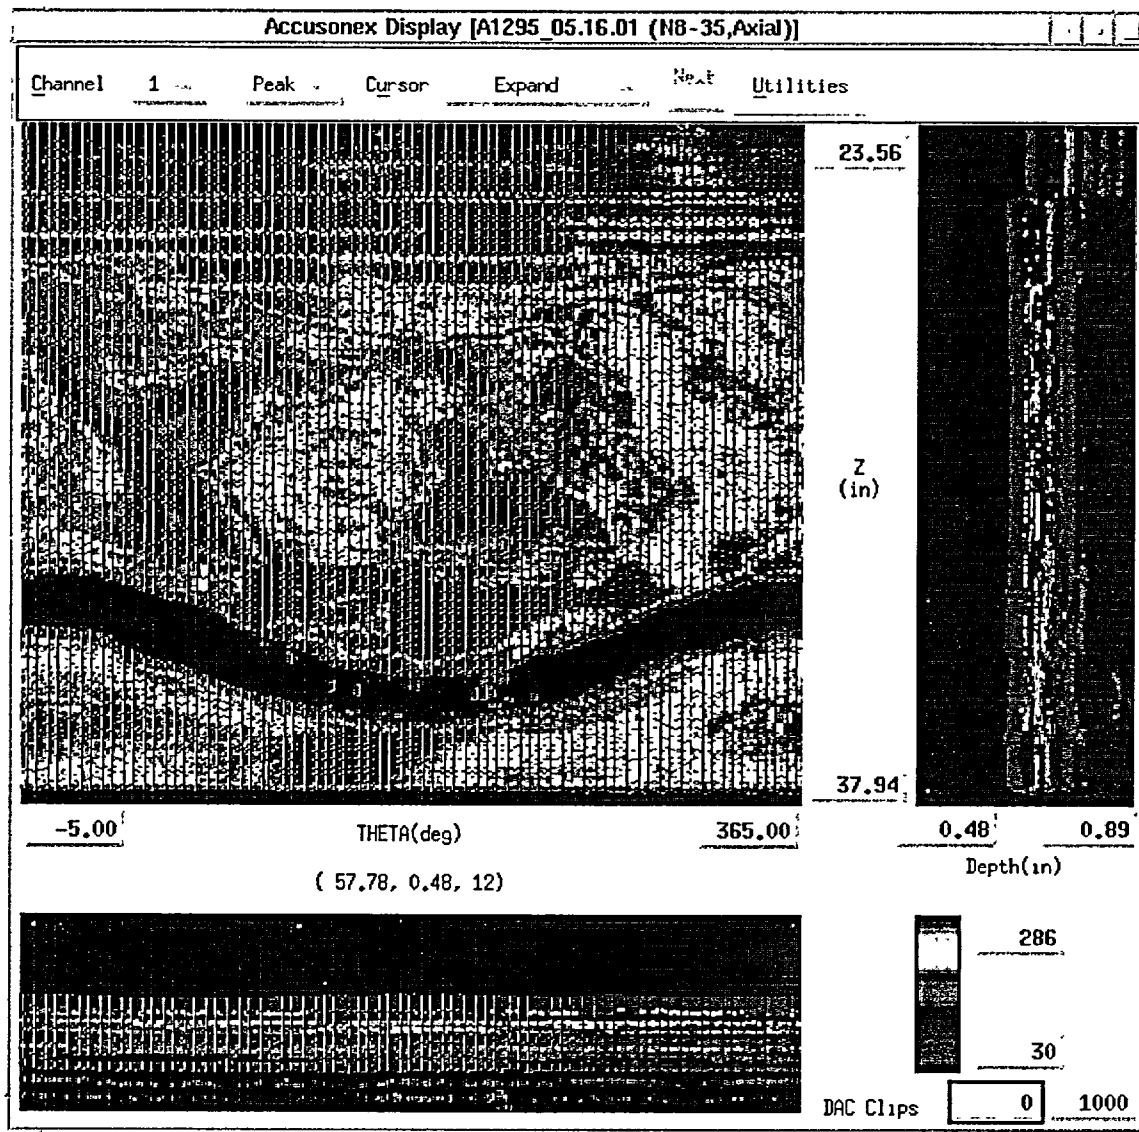
Figure 7 is a printout from a different power station. Again we see an illustration that is less than ideal for a visual study in reflected energy. The color range is 30 to 286 but more importantly, magenta appears between dark blue and black on the color bar code. If the magenta areas that appear in the interference fit and weld portions of the illustration were a color between blue and black it would be more obvious where the areas of energy transmittance are. While an optimal color range selection would provide a better presentation, it is still evident that the area above the low side of the weld and under the interference fit has extremely high reflection. Large areas of high energy reflection are observed passing through the interference fit, denoting a leak. In this particular nozzle, the crack was not detected with ultrasonic flaw detection techniques but a liquid penetrant exam did detect a through wall crack in the weld. This leak would have been detected with an ultrasonic scan of the interference fit.

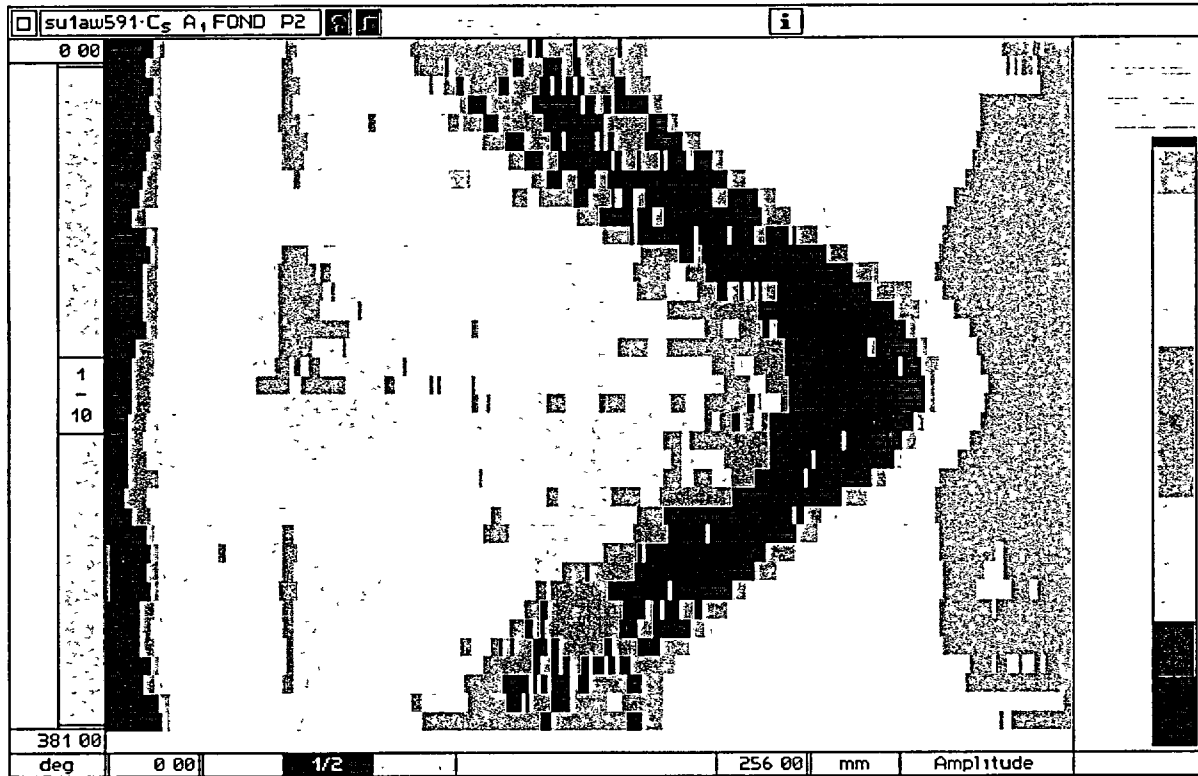
Even though the color scheme in Figure 8 has a light blue shade between the beige and green and also a light blue shade between green and dark blue on the color code bar, it is obvious that there are no leak paths or areas of high energy reflection in the interference fit, (which now appears on the right side of the illustration).

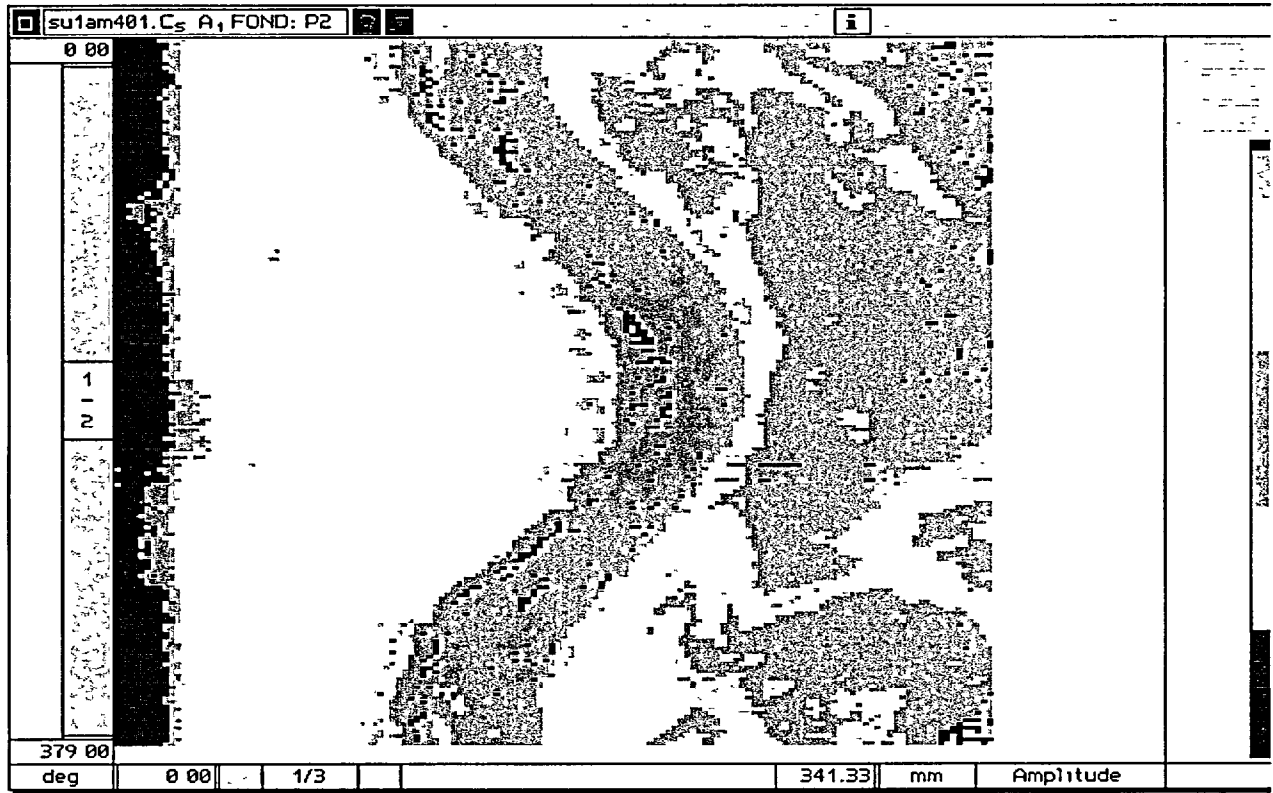
Figure 9

In Figure 9, there is an area above the weld and below the interference fit that displays an area of high energy reflection. The leak path through the interference fit is also visible. Although no cracks were detected with the ultrasonic flaw detection technique, a liquid penetrant test of the weld did produce an indication that turned out to be a through wall leak in the weld.

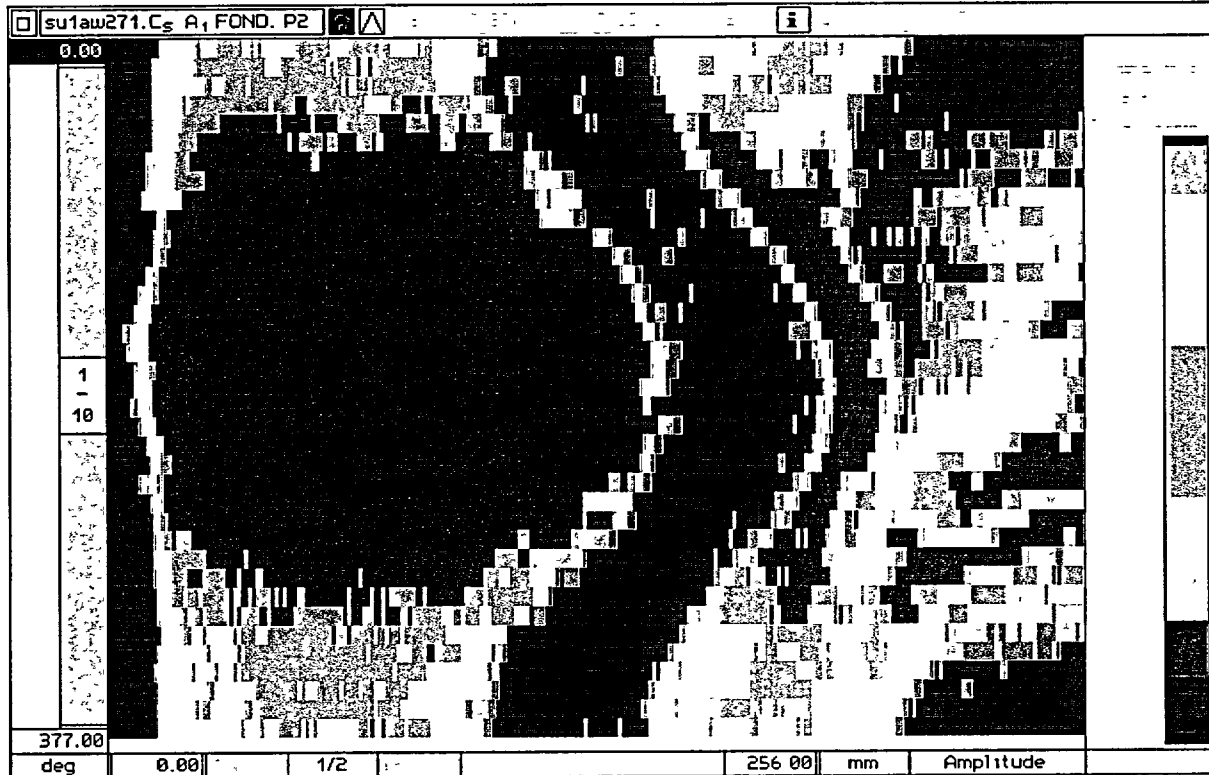
Figure 10 also depicts a leak path through the interference fit on a nozzle that contained a crack in the weld that was not detected with the ultrasonic flaw detection technique.
