Nuclear Management Company, LLC
Prairie Island Nuclear Generating Plant
1717 Wakonade Dr. East • Welch MN 55089

PRAIRIE ISLAND NUCLEAR GENERATING PLANT

Response to NRC Bulletin 2001-01, "Circumferential Cracking of Reactor Pressure Vessel Head Penetration Nozzles

Prairie Island Response to NRC Bulletin 2001-01

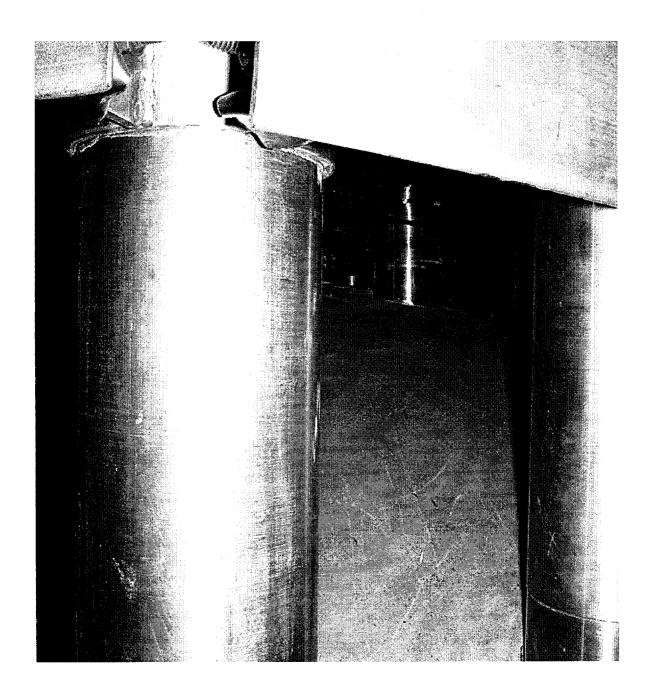
- Description of RPV Head and Nozzle Inspections Within Past Four Years d. As reported in Table 2-1 of MRP-48 [1], a bare metal RV head visual inspection has been performed at least once each cycle for each Prairie Island unit since 1997. The inspections are typically performed by two Reactor Vessel System Engineers working together for safety and ALARA considerations (although some inspections have been performed by only one engineer). The inspections are usually done early in the outage to identify any indications as soon as possible. The inspections can be done with the head on the vessel and the unit in cold shut down, or when the head is on the stand during refueling. There are no limitations or impediments to the inspections as all penetrations can be clearly viewed through two or more of the four view ports. The RV head of each unit is very clean with no residual boric acid or other debris that would mask a leak. There has been no indication of either a crack or leak at the nozzle penetrations on either unit. Following is a summary of inspections with completion date and associated work order number. Attached (Pages 6 and 7) are two photographs taken through the view port of the most recent Unit 1 inspection.

Looking through north insulation door straight in

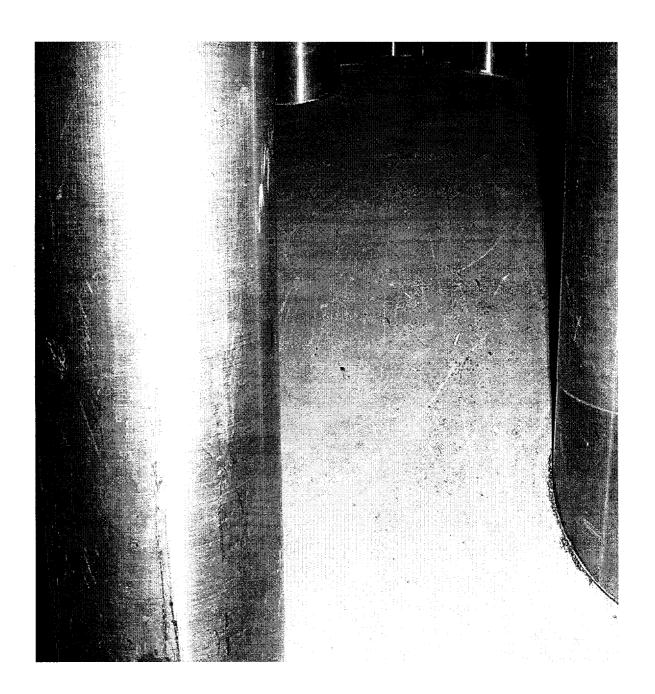
Looking through north insulation door toward the right

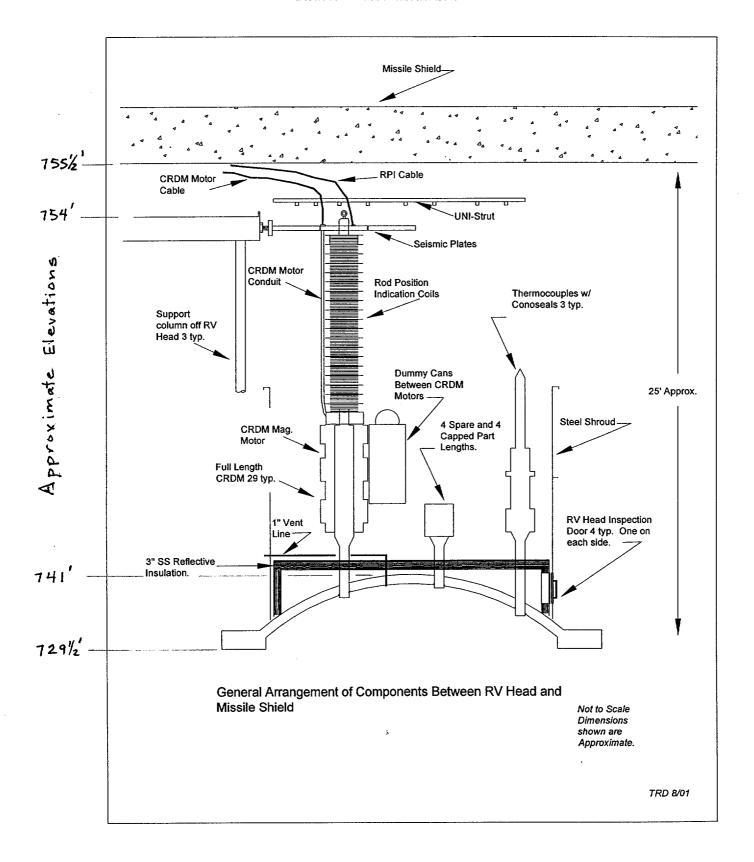
Reactor Vessel Head Sketch

- Description of Equipment and Cables on Top of Vessel Head e. The attached sketch (Page 8) depicts the general arrangement of components and cables between the RV head and the RV missile shield. The control rod drive mechanism (CRDM) housings are supported in the vertical direction by the CRDM nozzles. The CRDM magnetic motors slip over the housings and are supported in the vertical direction by a horizontal ledge on the CRDM housings. The Rod Position Indication (RPI) coils slip over the upper portion of the CRDM housings and are supported in the vertical direction by a horizontal ledge at the elevation of the top of the CRDM motors. "Dummy Cans," which serve as baffles for CRDM cooling air flow, are located between CRDM drive motors. The Dummy Cans adjacent to full length CRDMs hang from the adjacent CRDM. The remaining Dummy Cans are bolted to the tops of the spare and part length nozzle caps. Horizontal movement of the Full length CRDMs and RPI coils is limited by seismic plates. The seismic plates are restrained by trunnions threaded into the RV head platform. The CRDM motor cables exit through a conduit box that fits into the associated seismic plate. The RPI cables exit through a cable connection in the associated seismic plate.
