**UNITED STATES  
NUCLEAR REGULATORY COMMISSION  
REGION IV  
611 RYAN PLAZA DRIVE, SUITE 400  
ARLINGTON, TEXAS 76011-4005**

**SUBJECT: NRC SPECIAL INSPECTION TEAM REVIEW AND NRC STAFF EVALUATION  
OF SOUTH TEXAS PROJECT, UNIT 1, REACTOR PRESSURE VESSEL  
BOTTOM-MOUNTED INSTRUMENTATION PENETRATION LEAKAGE  
INVESTIGATION AND REPAIR ACTIVITIES**

#### Bottom-Mounted Instrumentation Nozzle Leakage Investigation and Repair Activities

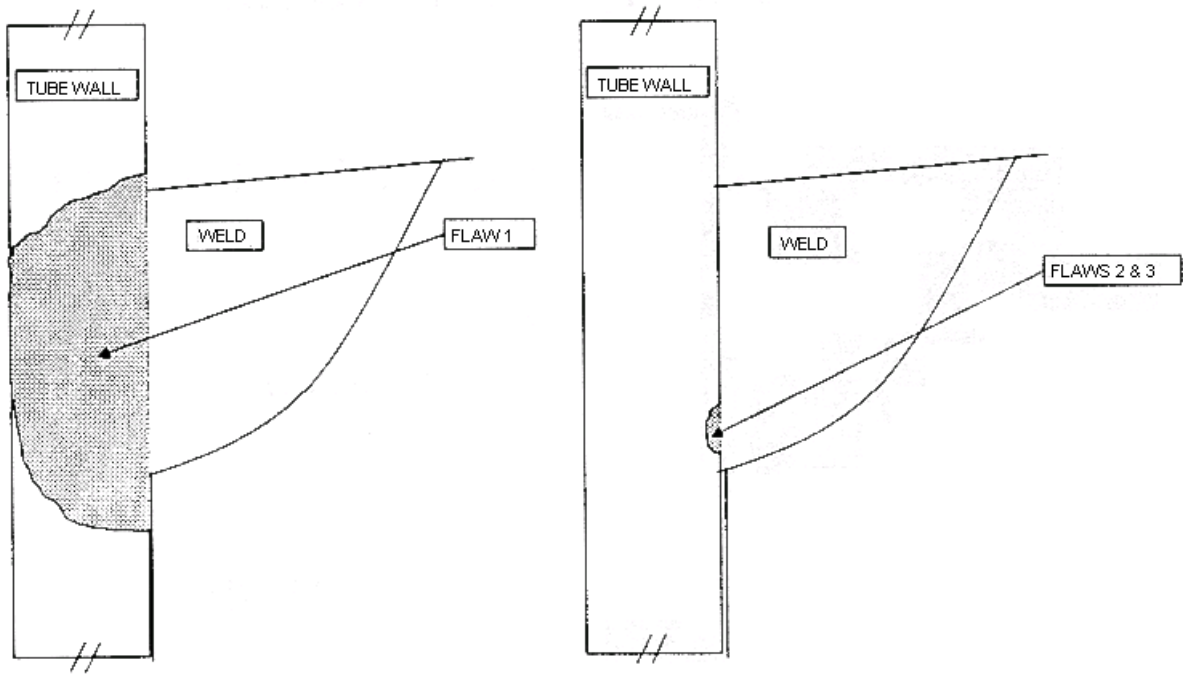
Figure 2

bottom center of the STP, Unit 1, bottom head. The licensee quantified the amount of observed deposits as 150 milligrams around penetration 1 and three milligrams around penetration 46 [Reference 11].

As a result of NDE activities (1) and (3) above, the licensee reported three axially-oriented crack-like indications in the penetration 1 nozzle wall and two axially-oriented crack-like indications in the penetration 46 nozzle wall. As depicted in Figure 2, one of the indications in penetration 1 was characterized as an axial crack with a length of about 1.38 inches, surface breaking on the OD of the nozzle above and below the J-groove weld, as well as surface breaking on the ID of the nozzle. The ID surface breaking nature of this flaw was confirmed by the bobbin coil ETC. The other two indications in penetration 1 were characterized as being small, embedded (i.e., non-surface breaking) cracks near the interface between the nozzle wall and the root pass of the J-groove weld. As depicted in Figure 3, one of the indications in penetration 46 was characterized as an axial crack with a length of about 0.98 inches, surface breaking on the OD of the nozzle above and below the J-groove weld. The other indication in penetration 46 was characterized as an embedded crack having an axial length of 0.95 inches. Figures 2 and 3 were submitted to the NRC as part of the licensee's presentation at a public meeting held at NRC Headquarters on June 5, 2003. However, the UT inspections conducted by the licensee were not demonstrated to be effective for the purpose of examining the subsurface volume of the J-groove weld. Therefore, the licensee's depictions of the indications as shown in Figures 2 and 3 may be incomplete with respect to subsurface cracking of the J-groove weld material. No crack-like indications were identified in any of the other 56 STP, Unit 1, BMI nozzle penetrations [Reference 2].

# Penetration #1

- (4) STP, Unit 1, BMI penetrations 1 and 46 were repaired using a "half-nozzle" repair design that relocated the RCS pressure boundary to the outside surface of the RPV bottom head. The design of these repairs was similar to half-nozzle repairs which have been used to repair RCS pressure boundary penetrations at other facilities. The STP, Unit 1, BMI half-nozzle repairs were designed in accordance with the requirements of the ASME Code, except for those aspects for which STPNOC requested relief, and were designed for the life of the facility. Irrespective of the final root cause determination, the licensee does not believe that there is a potential root cause for the identified cracking which would challenge the effectiveness of the repairs.

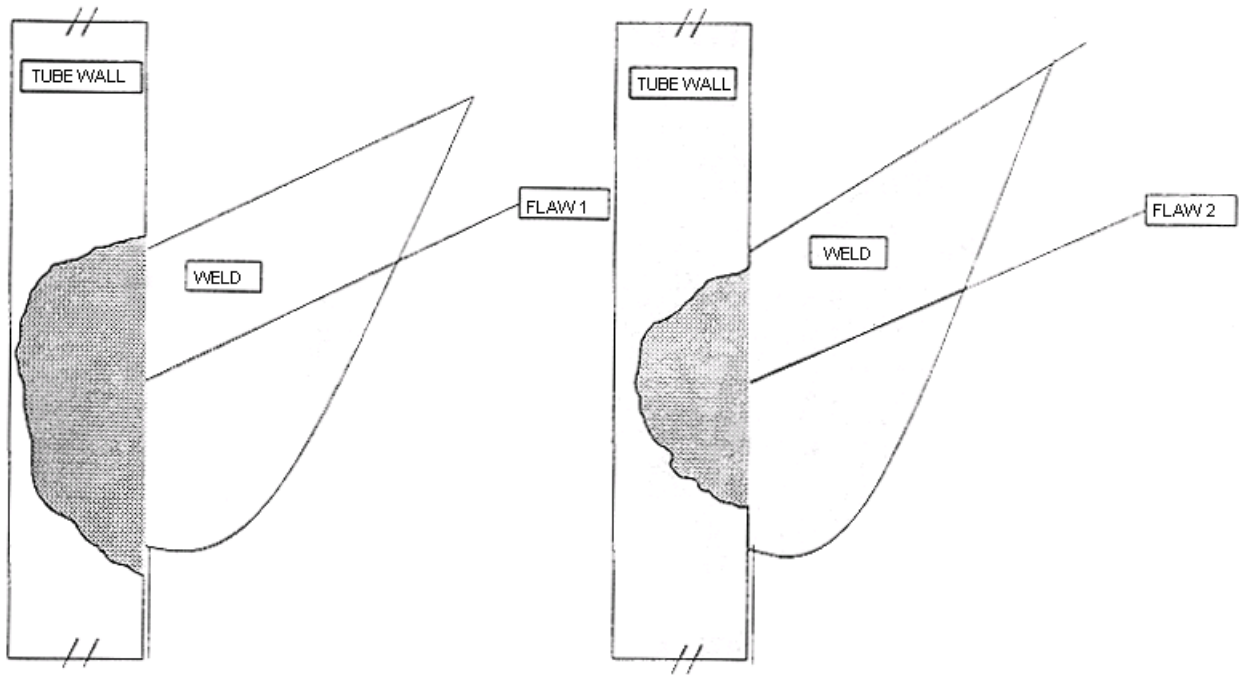
Figure 3

# Penetration #46
