**Second
Five-year Review Report**

**Valley Park TCE Site
Valley Park
St. Louis County, Missouri**

September 2008

**Region 7
United States Environmental Protection Agency
Kansas City, Kansas**

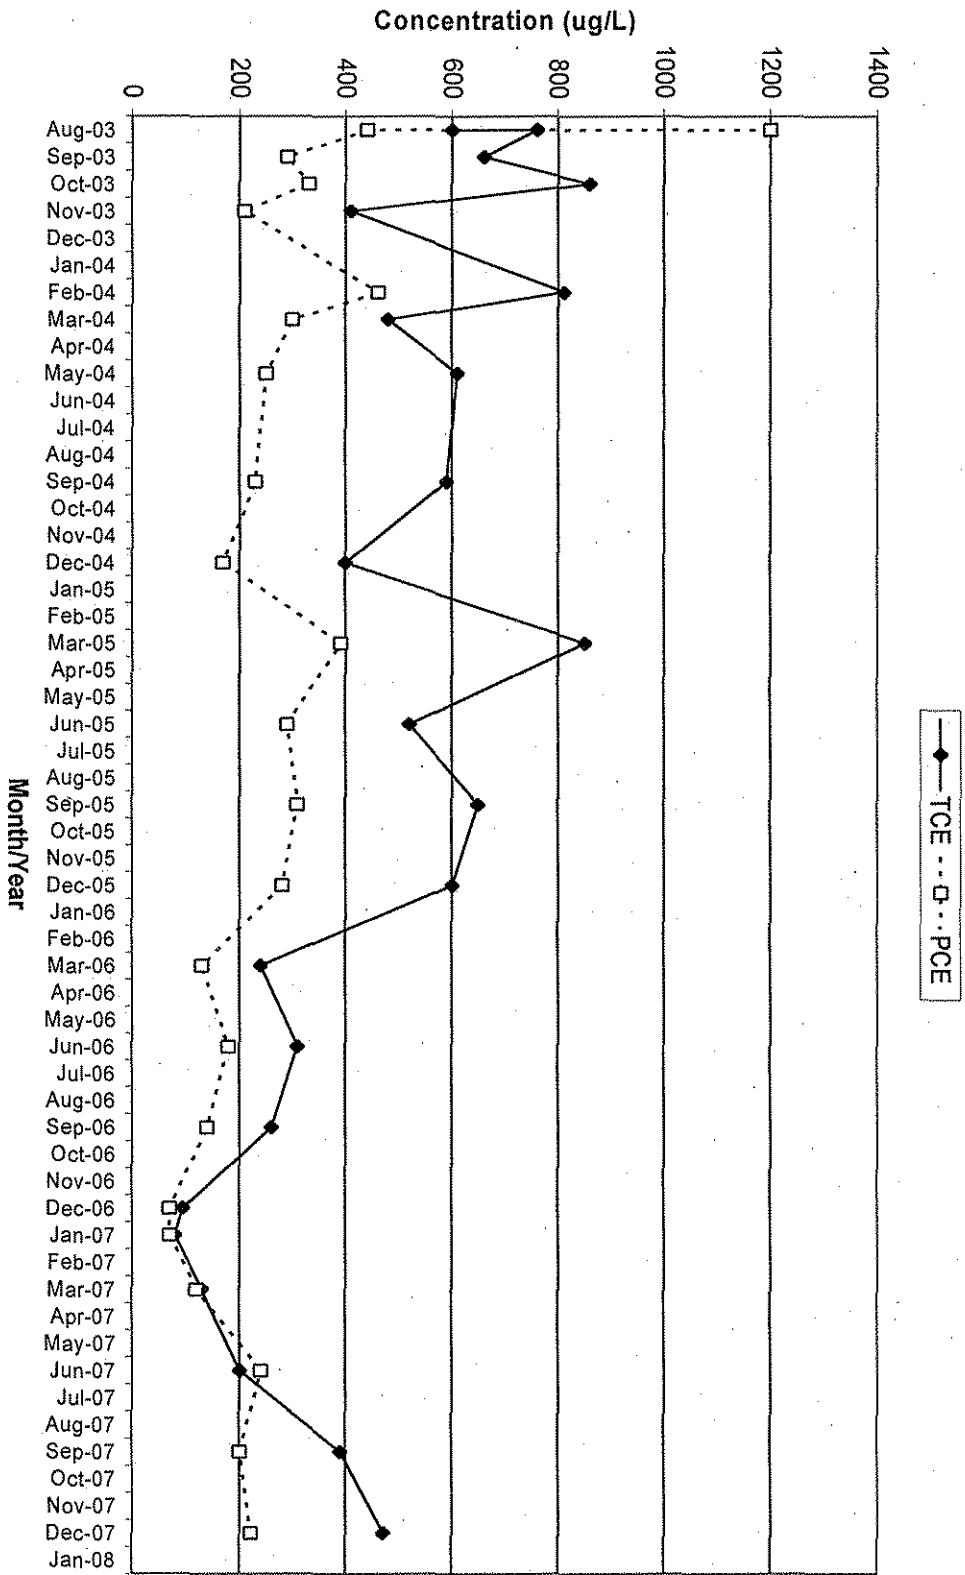
FIGURE 5. CONTAMINANT CONCENTRATION TRENDS IN WOU EXTRACTION WELL

Beginning in February 2006, the pumping rate in the WOU extraction well decreased from approximately 75 gpm to less than 50 gpm by March 2006. A decrease in the pumping rate is a common problem for long-term pumping systems and can result from screen incrustation and/or biological fouling. Corrosion is another cause of a reduction in well output performance that can lead to screen failure, silt formation, and pump damage. To address the cause of the low pumping rate, the following actions were undertaken:

On the basis of quarterly results, Figure 5 was developed depicting the trend in influent groundwater concentration with time. The trend indicates that the influent concentration has decreased since December 2003 but exhibits a very noticeable upward trend beginning in early 2007. Before early 2007, VOC concentration levels suddenly decreased during 2006. The reason for the decrease is being investigated. One possible cause is the reduction in well capacity in the extraction well. The work conducted on the well in late 2006 and early 2007 may have improved the local hydraulic control which resulted in concentrations returning to pre-2006 levels.

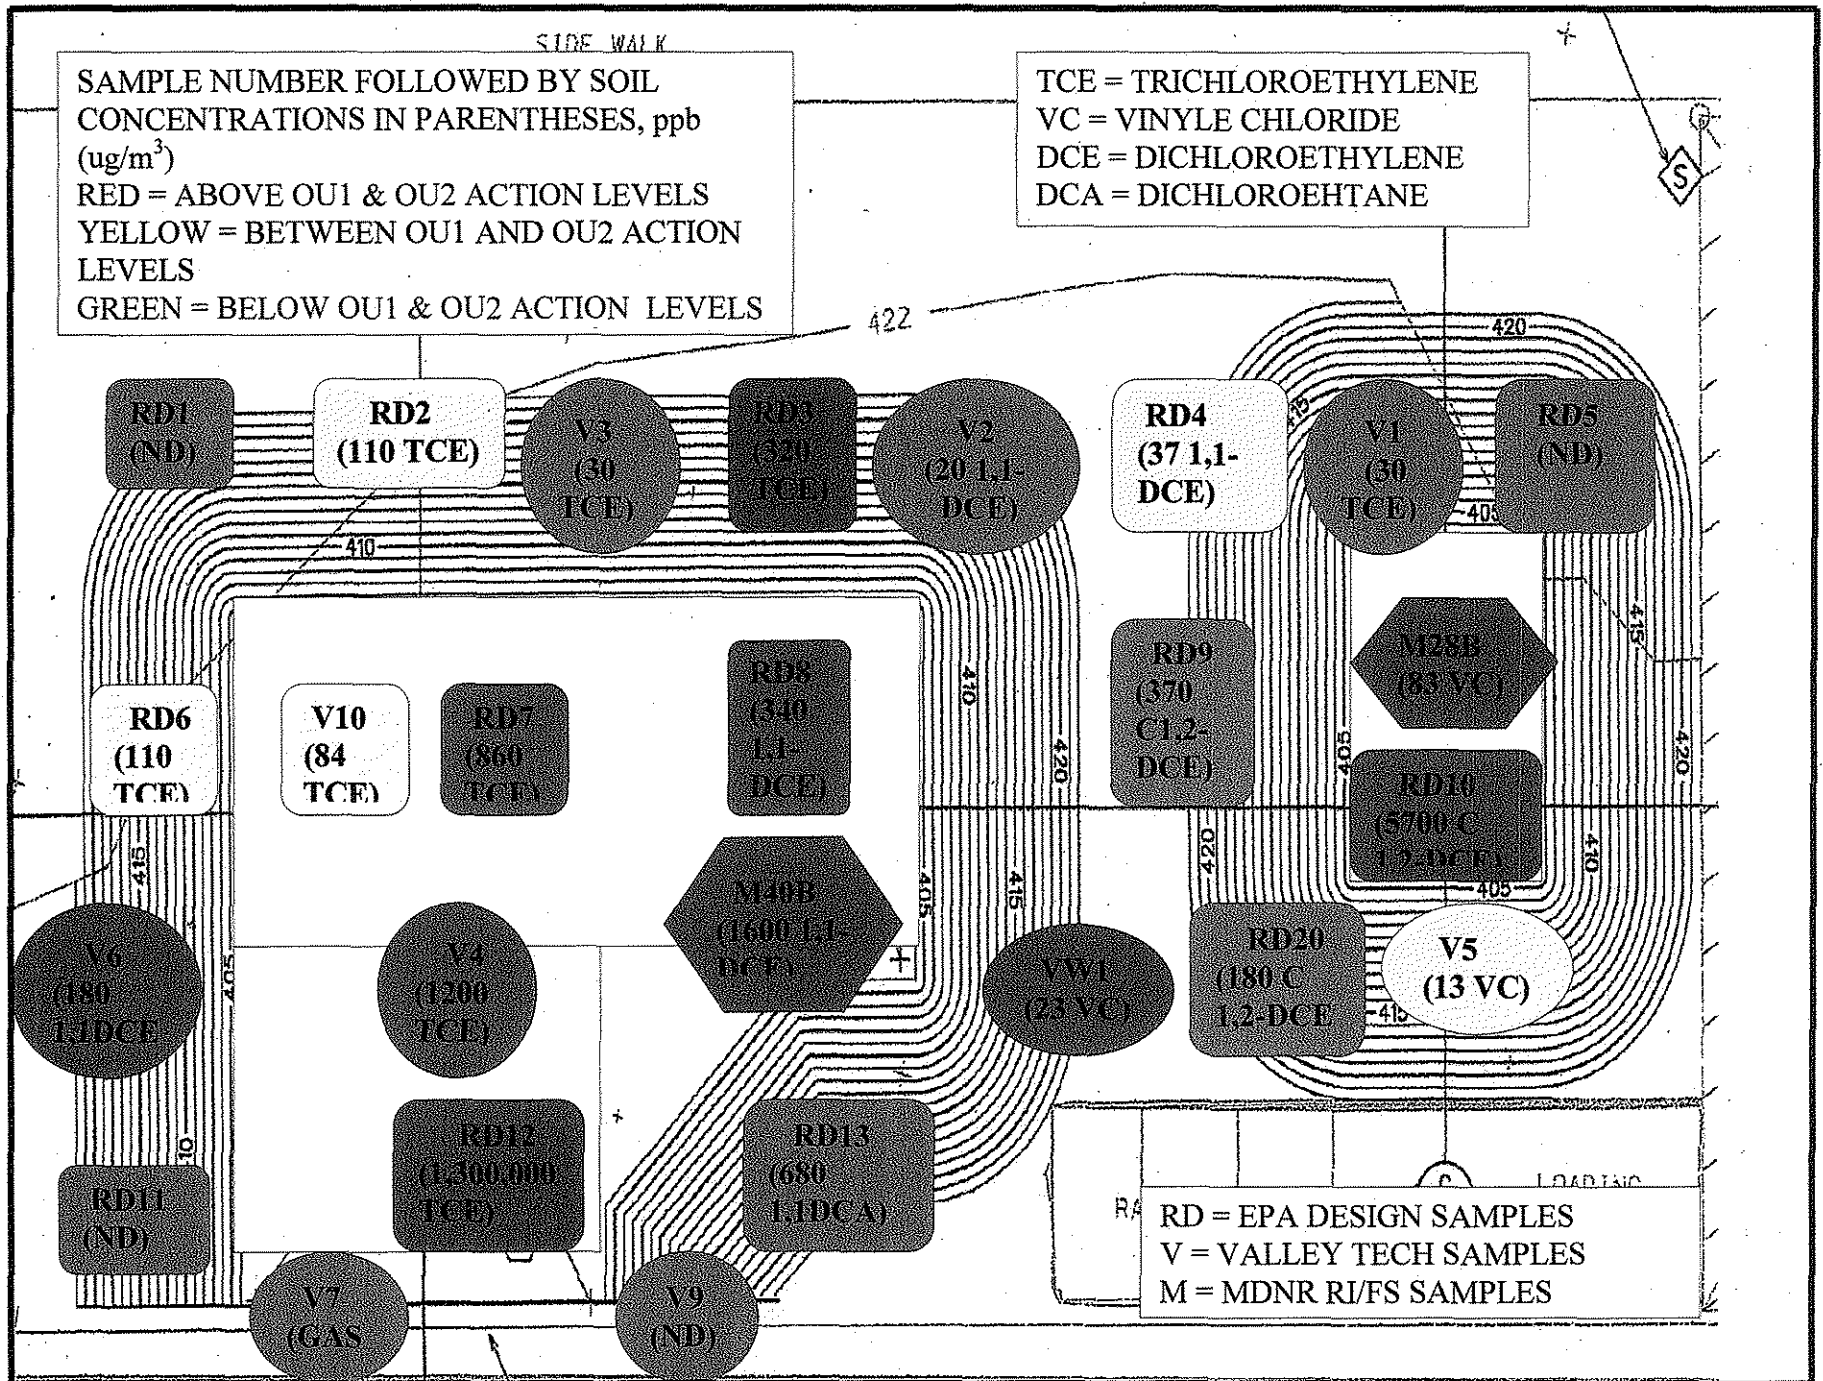
FIGURE 9. MAP OF SOIL CONCENTRATIONS BEFORE THE EXCAVATION AT OU2

Figures 9 and 10 present the soil sampling results before and after the excavation work, respectively. Comparing the two figures clearly shows that the soil excavation was highly effective. For example, the most contaminated location adjacent to the alley was reduced 97 percent in concentration. Essentially, the condition of the soils following excavation is that (1) widespread, low levels (below 250 ppb VOCs) of contamination exist over a large area of the Valley Technologies' parking lot; and (2) the two release/source areas have been found with the one beside the building effectively removed and the one beside the alley significantly reduced in contaminant mass. Although significantly reduced, the contamination levels in the alley source area are still at high levels (up to 38,000 ppb TCE).

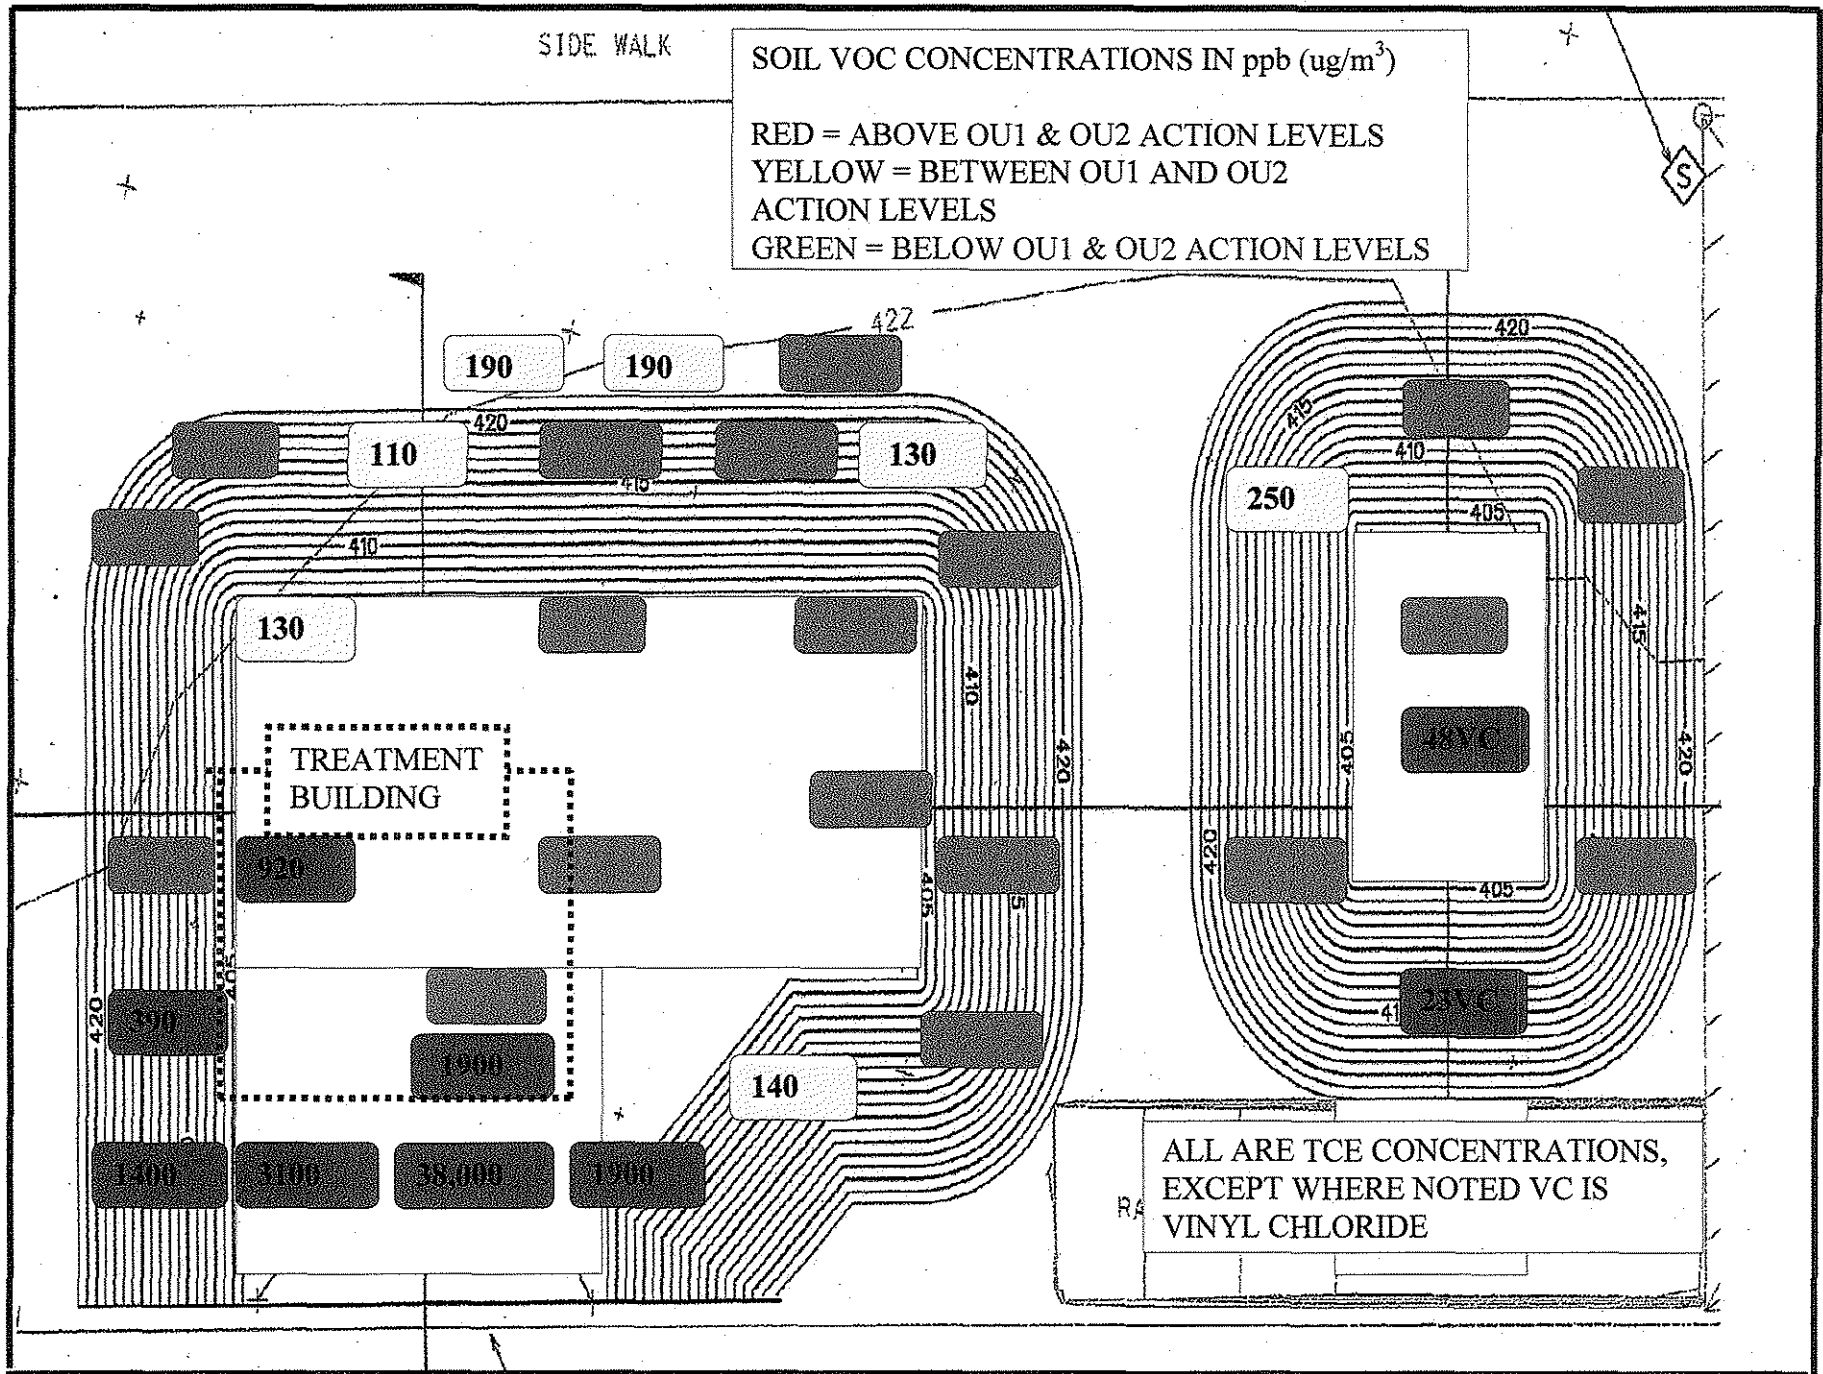
FIGURE 10. MAP OF SOIL CONCENTRATIONS AFTER THE EXCAVATION FOR OU2

In conclusion, the Agencies find that the soil excavation work was very effective for OU2 soil source areas, but additional work is required in the alley source area to achieve the ten-year remediation goal.

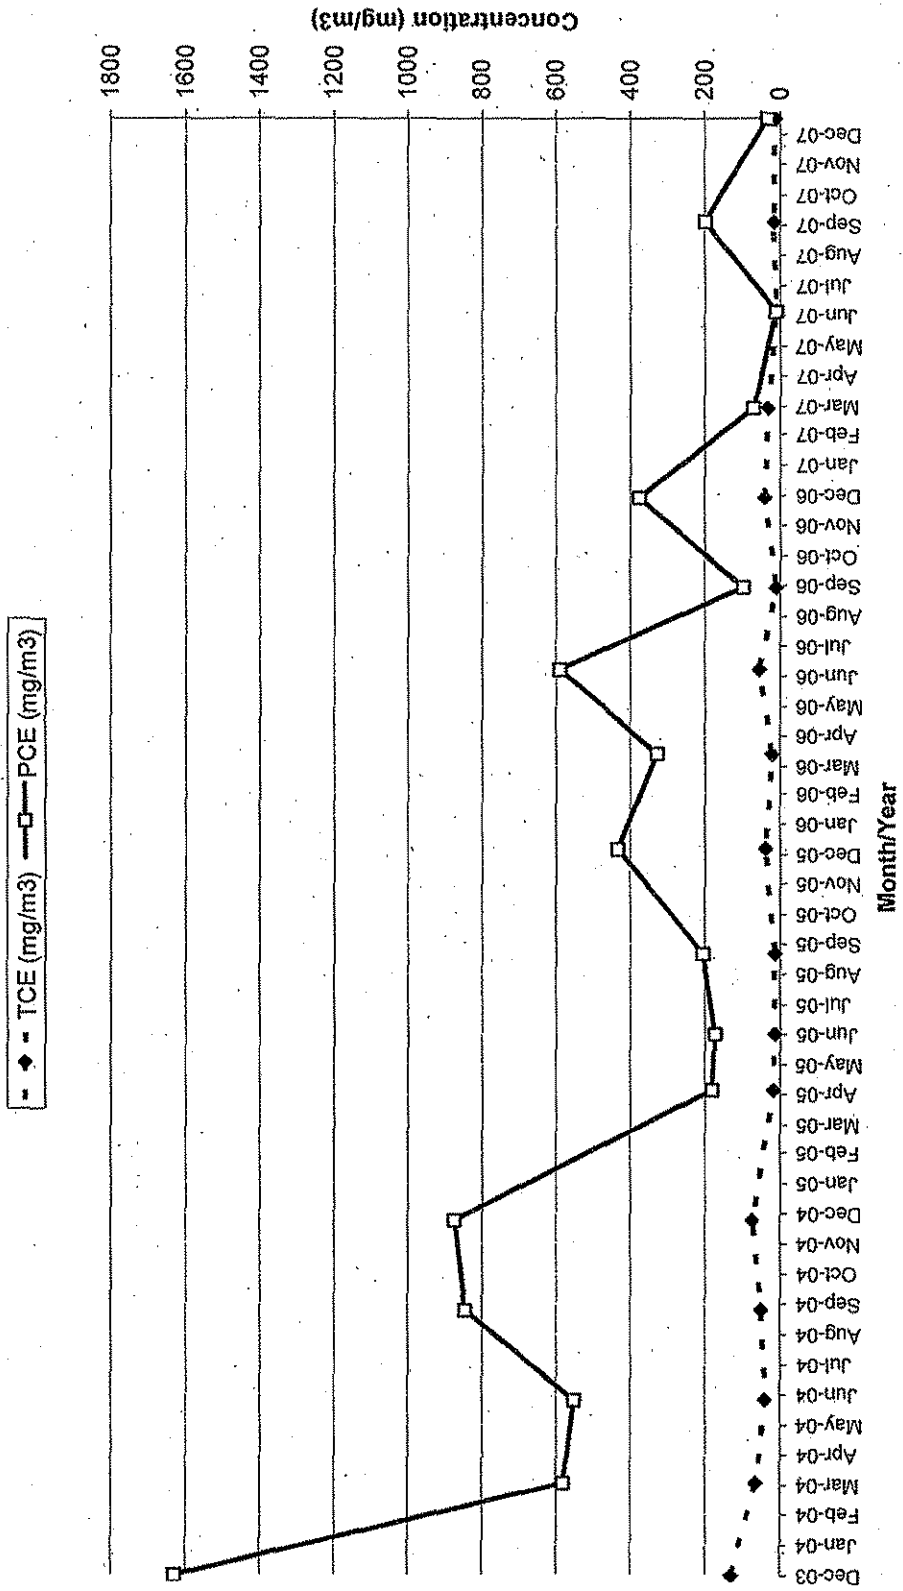
FIGURE 11. CONTAMINANT CONCENTRATION TREND IN OFF-GAS VAPOR FOR WOU SOIL VAPOR EXTRACTION SYSTEM

- SVE vacuum pressures have historically operated at lower values than expected due to excess water (moisture) in the vacuum lines/wells.
- PCE and TCE concentrations measured in the SVE influent stream have shown a variable but steadily decreasing trend in the last five years ranging from 1,500 milligrams per meter cubed (mg/m^3) to 19.84 mg/m^3 for PCE and from 130 mg/m^3 to 12.78 mg/m^3 for TCE (see Figure 11).

- A significant quantity of PCE and TCE has been recovered over the last five years, but the rate of removal has decreased to a point where the trend is exhibiting asymptotic behavior. This behavior may be attributed to but not limited to the following factors (and possible combination): (1) low desorption rates of contaminants in soil due to

diffusion-controlled removal of contaminants within low permeability zones, (2) SVE extraction wells that are not properly located or screened to treat all contaminated areas, (3) an insufficient number of SVE wells, and (4) the presence of an unaddressed source of contaminants preventing cleanup using SVE within the remedial goal.

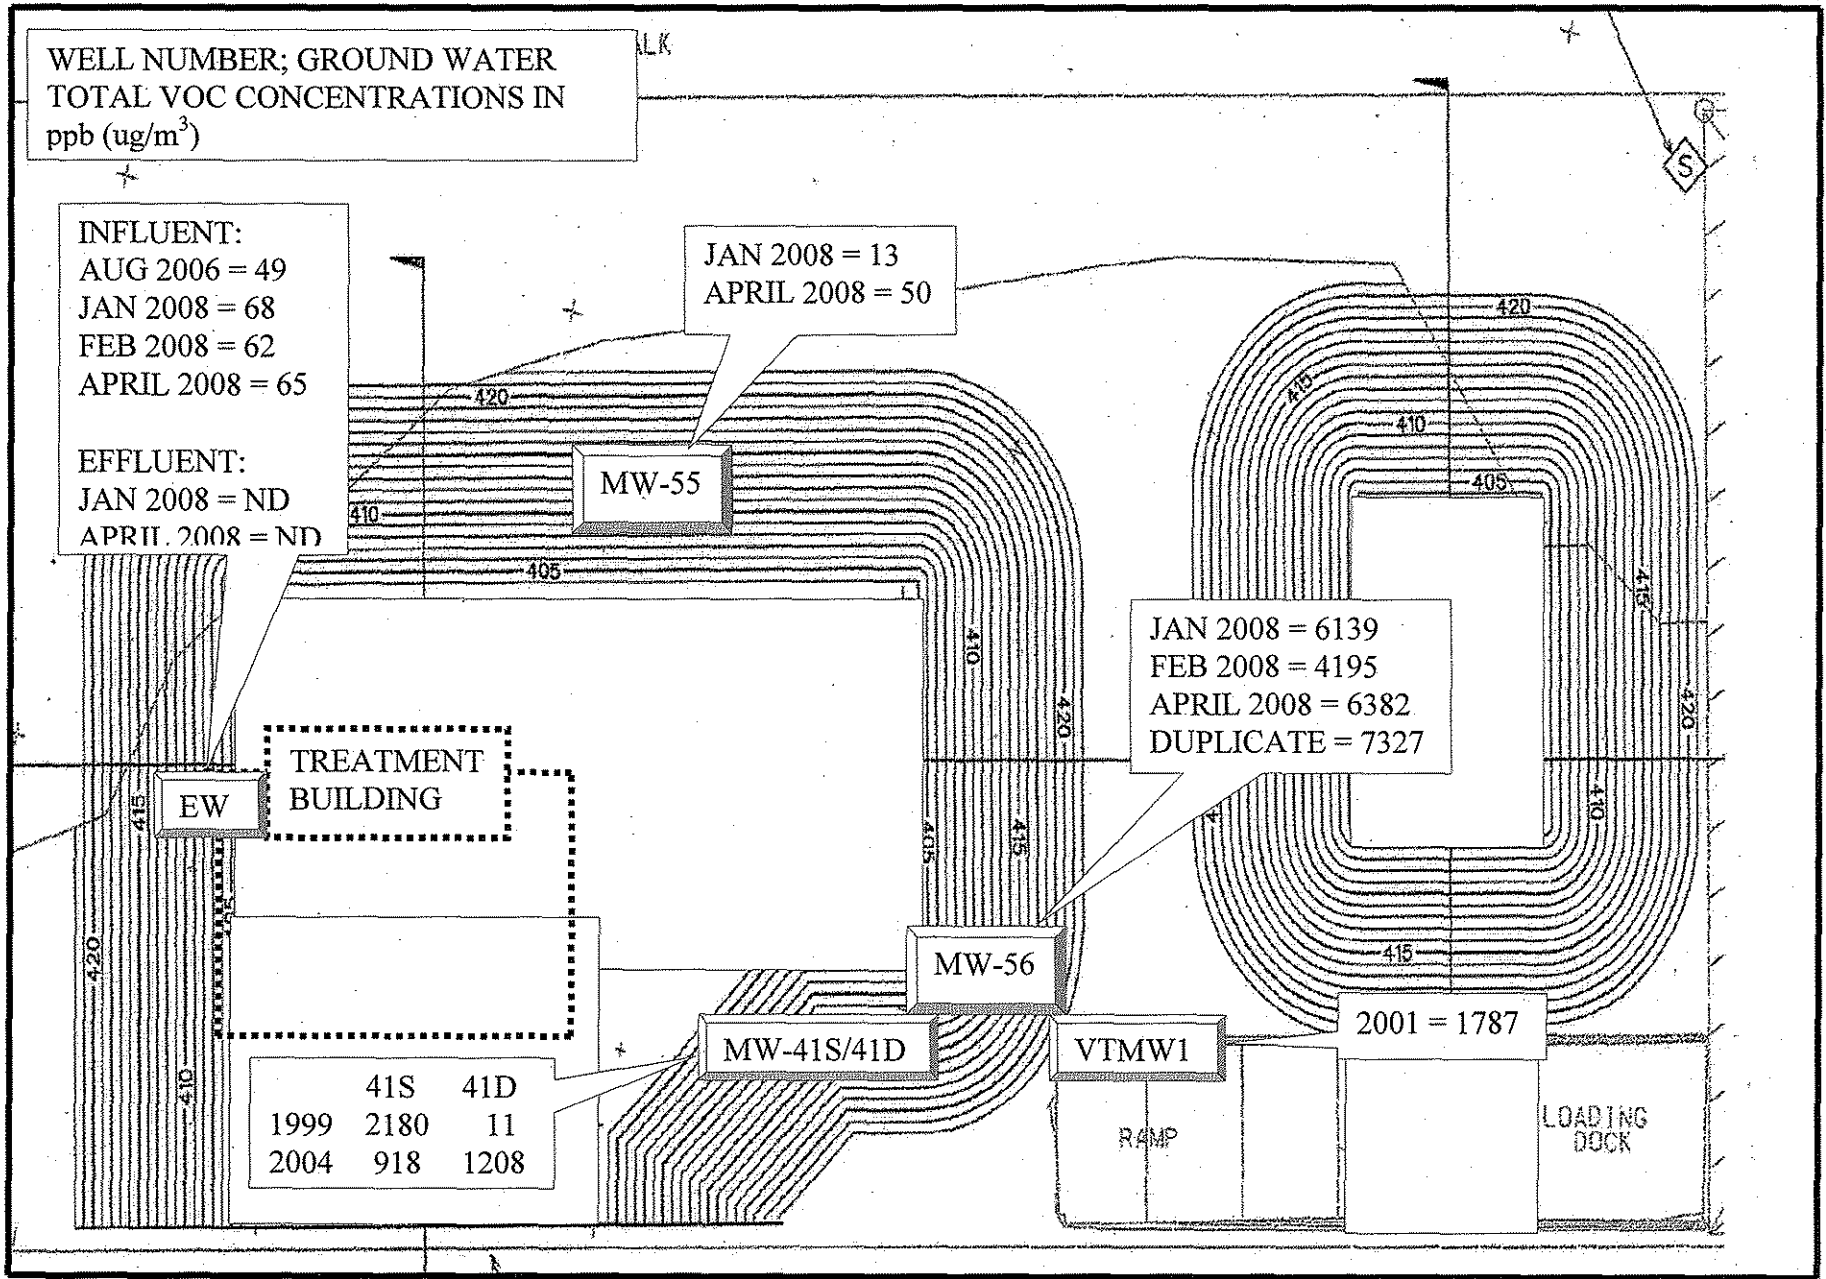
FIGURE 12. MAP OF GROUNDWATER CONTAMINANT CONCENTRATIONS ON

- Figure 12 presents the groundwater data for the monitoring wells located on OU2 source area (MW55 and MW56). In addition, data for three historic wells are presented for comparison purposes. Contaminant concentrations in MW55 are much lower than in MW56. Again, the April 2008 concentrations are higher than the January 2008 concentrations due to the high water conditions. The contaminant concentrations in MW56 are in the 6,000 ppb range, and this level is higher than expected. In comparison, the historic wells and corresponding data averaged 2,000 ppb total for VOCs. The soil excavation data do not indicate a soil source in that section of OU2 which would create the contamination level found in MW56. Thus, one of two explanations is possible: (1) the original plume migrated east and below the Valley Technologies' building, or (2) there is a soil source area below the Valley Technologies' building which was not found previously.

The groundwater contamination levels found in MW56 are higher than anticipated. If this contamination level does not decrease within the next two years, an investigation may be required to determine the source.

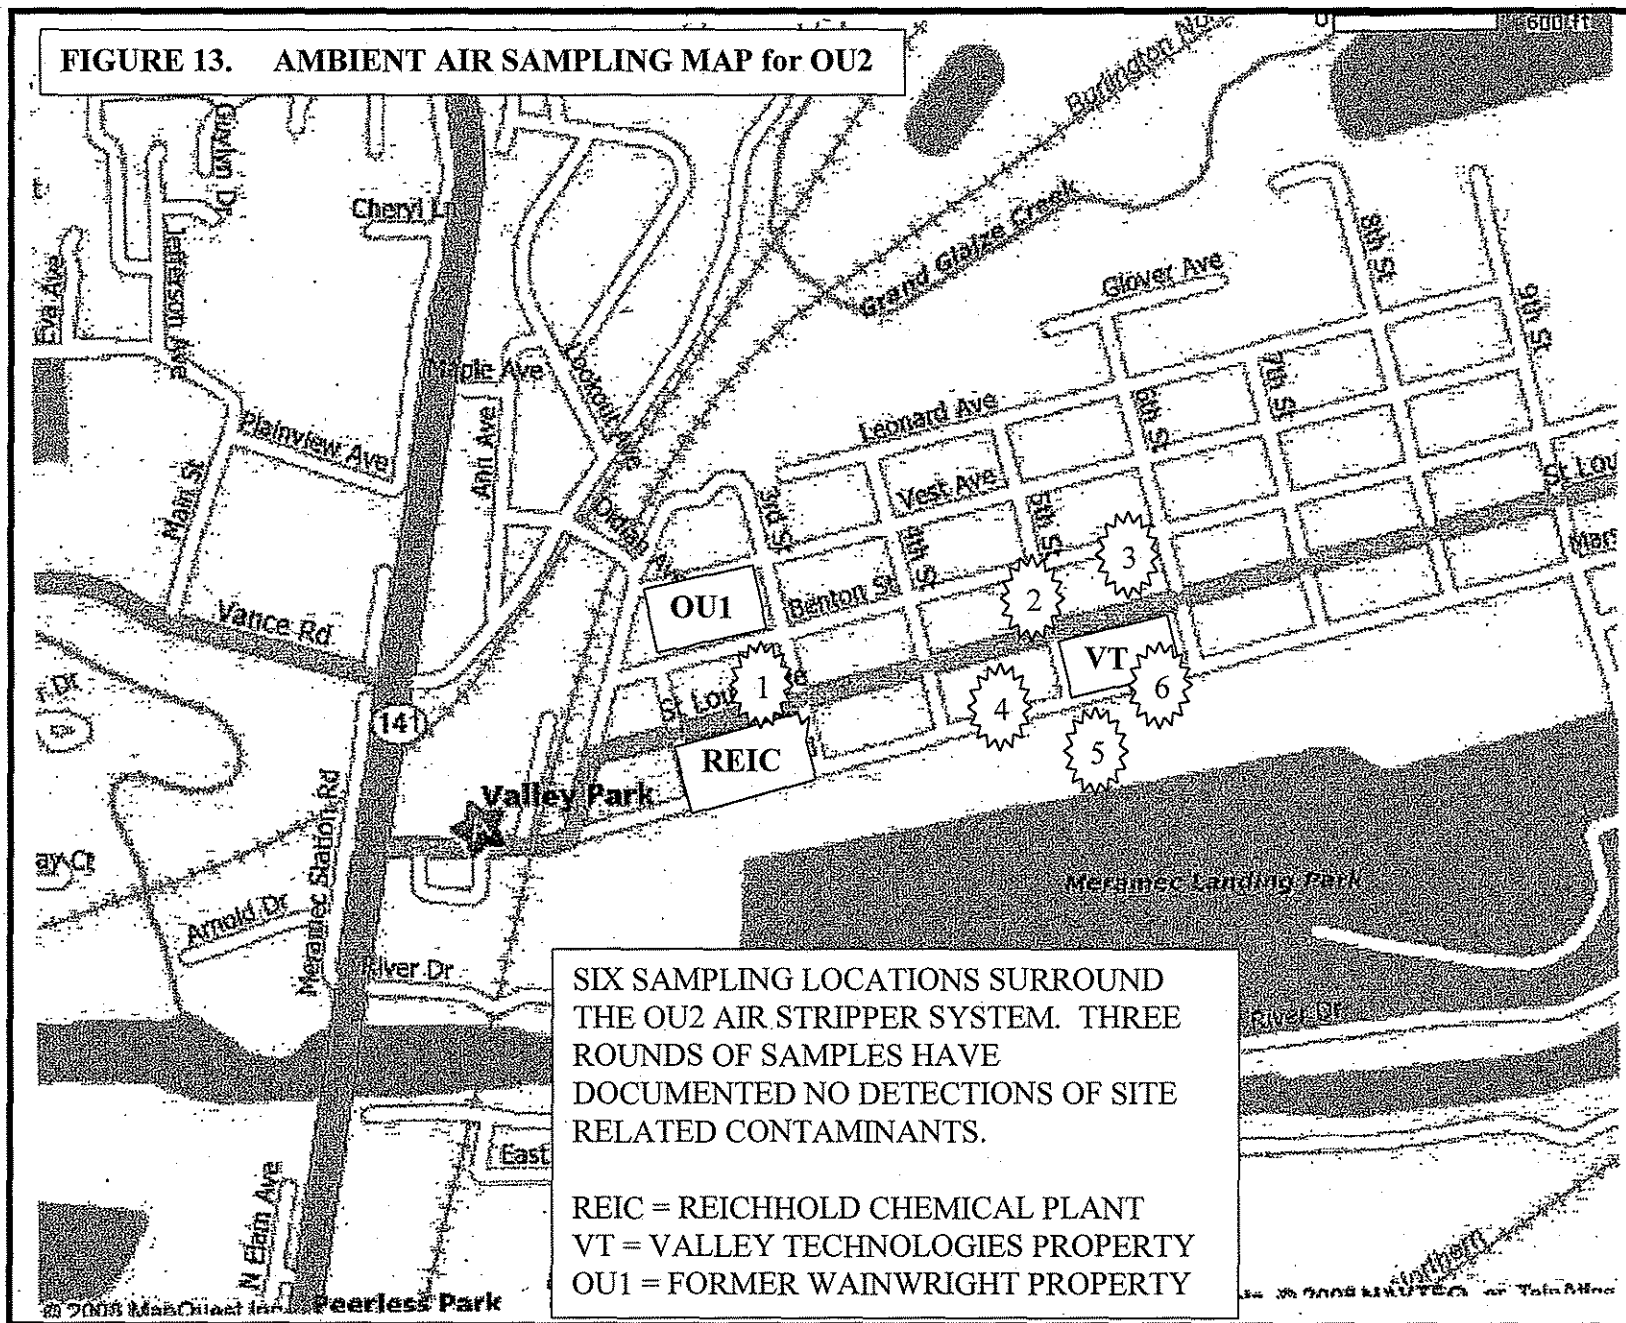
FIGURE 13. AMBIENT AIR SAMPLING MAP for OU2

SIX SAMPLING LOCATIONS SURROUND THE OU2 AIR STRIPPER SYSTEM. THREE ROUNDS OF SAMPLES HAVE DOCUMENTED NO DETECTIONS OF SITE RELATED CONTAMINANTS.

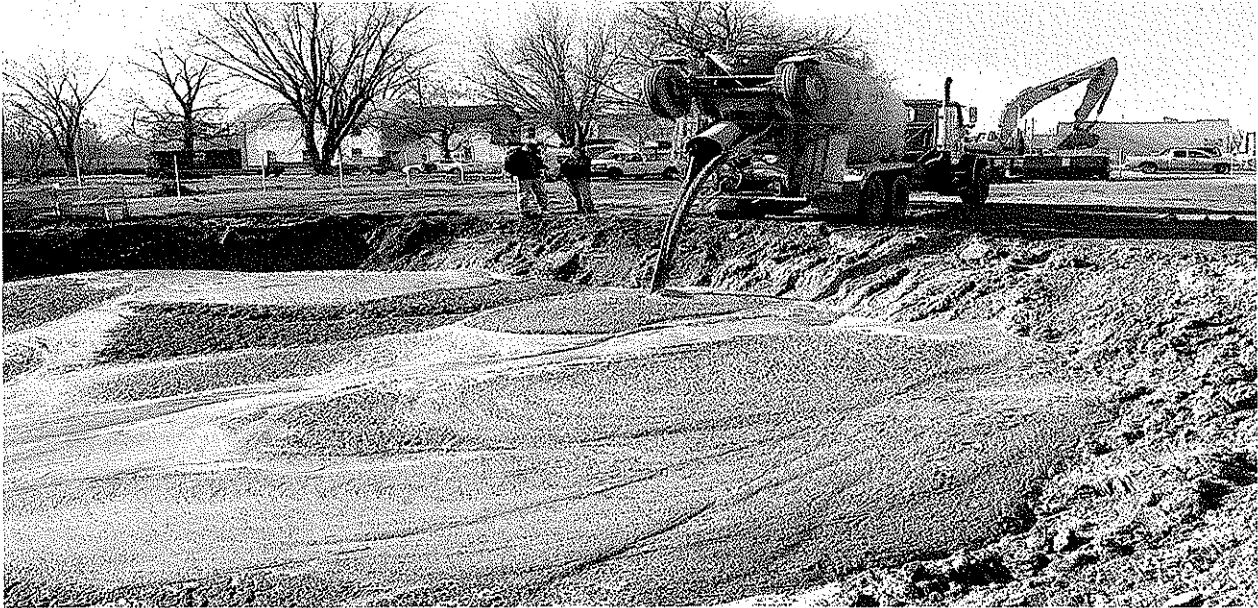
FLOWABLE FILL

EPA believes that the problem with the SVE system is due to the decision to use flowable fill to backfill the excavations. Flowable fill is a combination of sand and a weak concrete mix (see photo in Attachment B). Flowable fill was chosen for the backfill material for several reasons including winter time weather conditions, excellent results in other remedial actions by the design firm, and timely restoration of the parking lot for use by Valley Technologies. Based on these criteria, the use of flowable fill was a success. However, the concrete/bentonite slurry fraction appears to have seeped into the permeable, upper part of the vadose zone where the SVE wells are screened. The result is a significant loss of air permeability. In addition, EPA and the construction contractor noticed several examples of water pooled within the flowable fill and adjacent soils. This observation correlates with the study's finding that water was standing in the SVE wells even though the SVE wells are screened above the groundwater table. Again, the flowable fill appears to have increased the moisture content of the vadose zone which would result in a loss of air permeability.
