FHWA Tunnel Leak Assessment Boston Central Artery *Interim Report*

March 23, 2005

FHWA Tunnel Leak Assessment Team
Peter W. Osborn
Gary Jakovich
Roland Nimis
Matt Greer

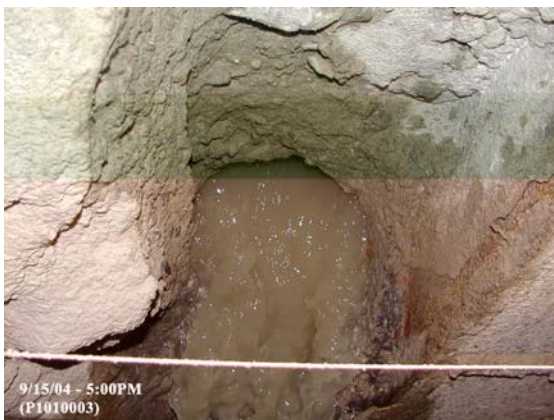
When the leak was discovered on September 15, 2004, a water flow rate equated to the volume of an 8-inch pipe, streamed out of the slurry wall into the back of the architectural wall panel, releasing water underneath and onto the roadway (see Photos 1 and 2). Significant amounts of sand washed in with the water and pooled across two lanes of traffic before flowing to the drains.

Photo 1: Slurry Wall breach

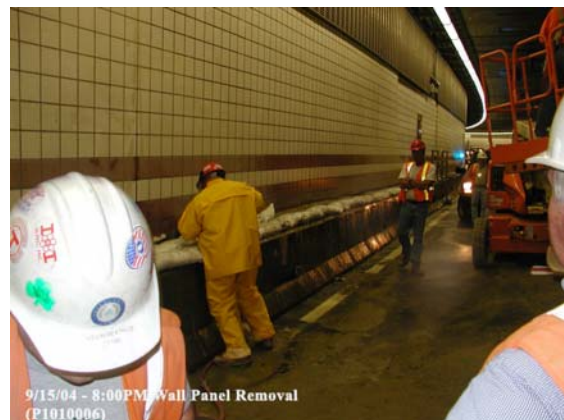
Photo 2: Sand in roadway

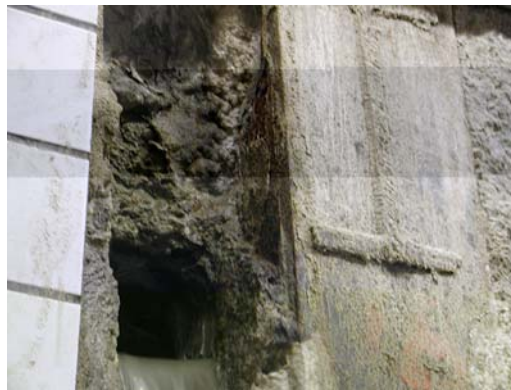
Photo 3: Breach in Slurry Wall Panel

The hole was probed with a rod and was found to extend horizontally three feet back into the wall and vertically down to a depth of 4 feet on about a 60-degree angle away from the front face of the wall. Soft loose material was encountered at the bottom of the void and a soft bentonite paste was observed on each side of the hole; this material was easily removed by hand. A vein of similar material composed of sand, stone and cement/bentonite paste was observed above the hole. An estimated ½ inch thick shotcrete layer was observed both over this vein of soft material to the south of where it was exposed, and on the adjacent concrete surface of the wall.

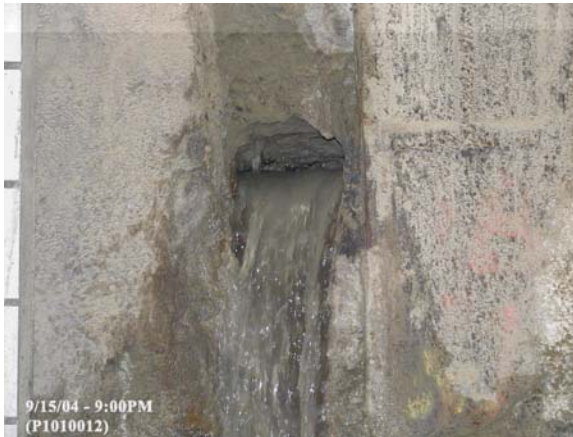
Photo 4: Flow Rate Dissipating

Upon removal of the architectural panel on Wednesday evening, September 15, 2004, (after traffic had lessened), a temporary wood plug was installed to decrease the flow to a trickle (see Photos 4 and 5). The installation of the plug allowed the MTA to restore the tunnel to full operating conditions by 5 a.m. the following day.

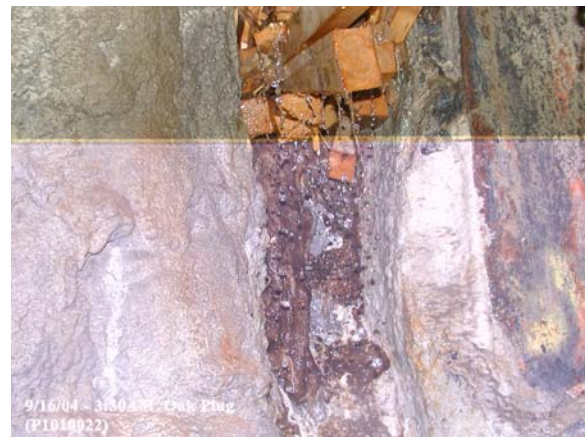
Photo 5: Breach plugged and grouted
