Integrity Assessment for Reactor Vessel Head Penetration Nozzles at B&W-Design Plants

Presented by
S. Fyfitch
Framatome ANP

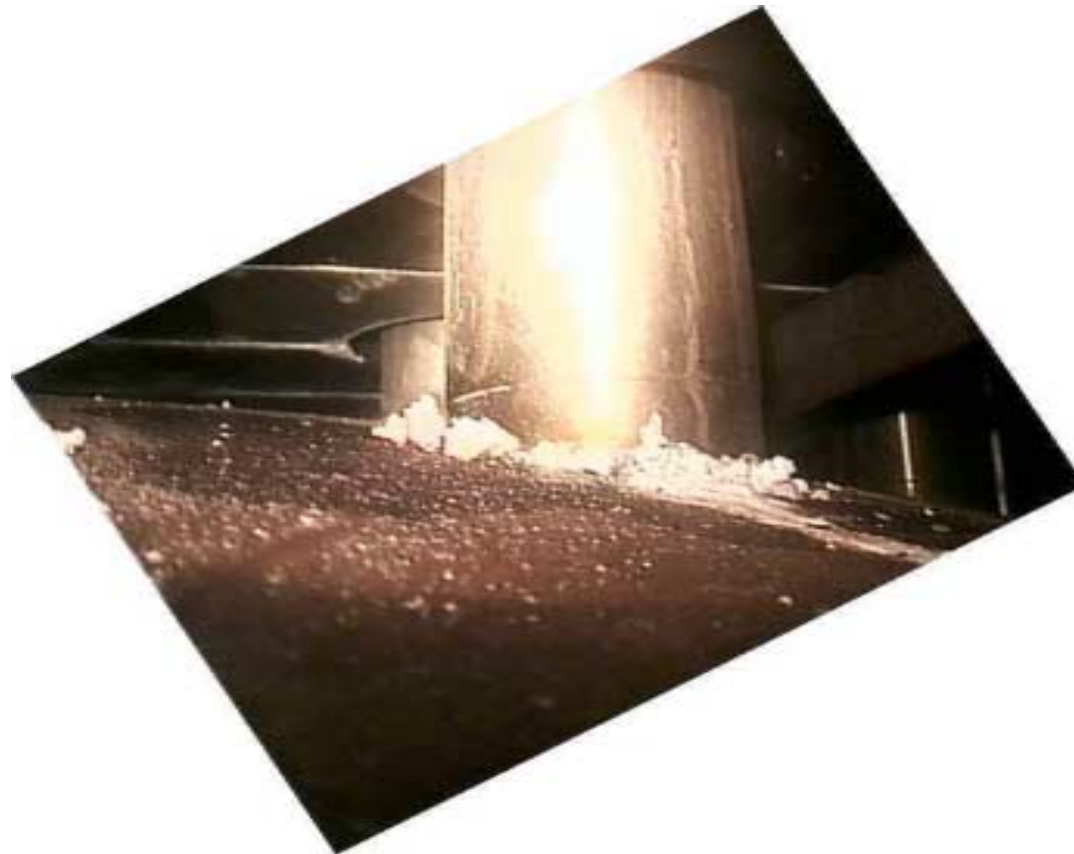
ONS-1 RV Head Showing Boric Acid At CRDM Nozzle 21

- All eight thermocouple nozzles contained flaws predominantly axial in orientation
 - Five nozzles identified as leaking
 - ID cracking observed on all eight nozzles
 - Cracking penetrated into all eight nozzle welds
- CRDM nozzle 21 did not contain ID flaws
 - Flaws in weld material, predominantly axial/radial in orientation, identified as leak source
 - Flaw propagated through the weld area along the nozzle OD
