MRP - Alloy 600 ITG RPV Penetrations

Presentation To ACRS Subcommittees
July 10, 2001

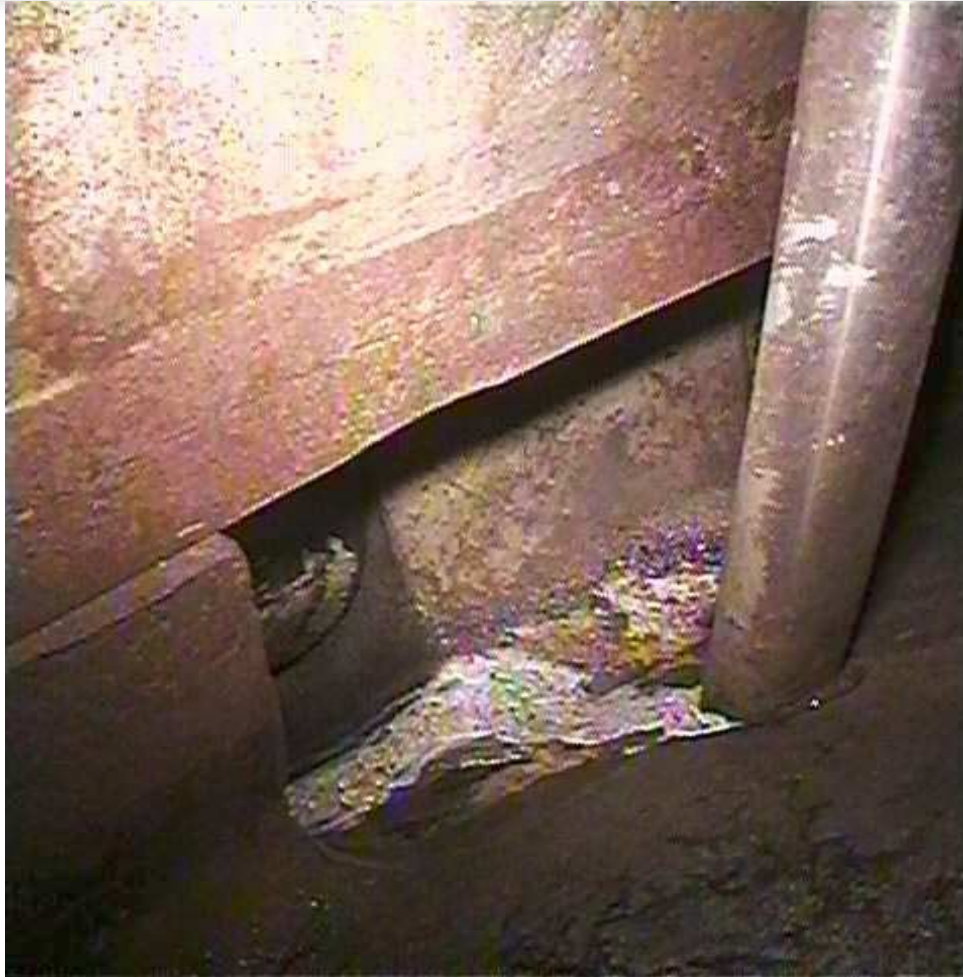
ONS-1 RV Head Showing Boric Acid At Thermocouple Nozzle

- ONS-1:
 - All eight thermocouple nozzles contained flaws predominantly axial in orientation
 - Five nozzles identified as leaking
 - ID cracking observed on all eight nozzles
 - Cracking penetrated into all eight nozzle welds
 - CRDM nozzle 21 did not contain ID flaws
 - Flaws in weld material, predominantly axial/radial in orientation, identified as leak source
 - Flaw propagated through the weld and nozzle base material

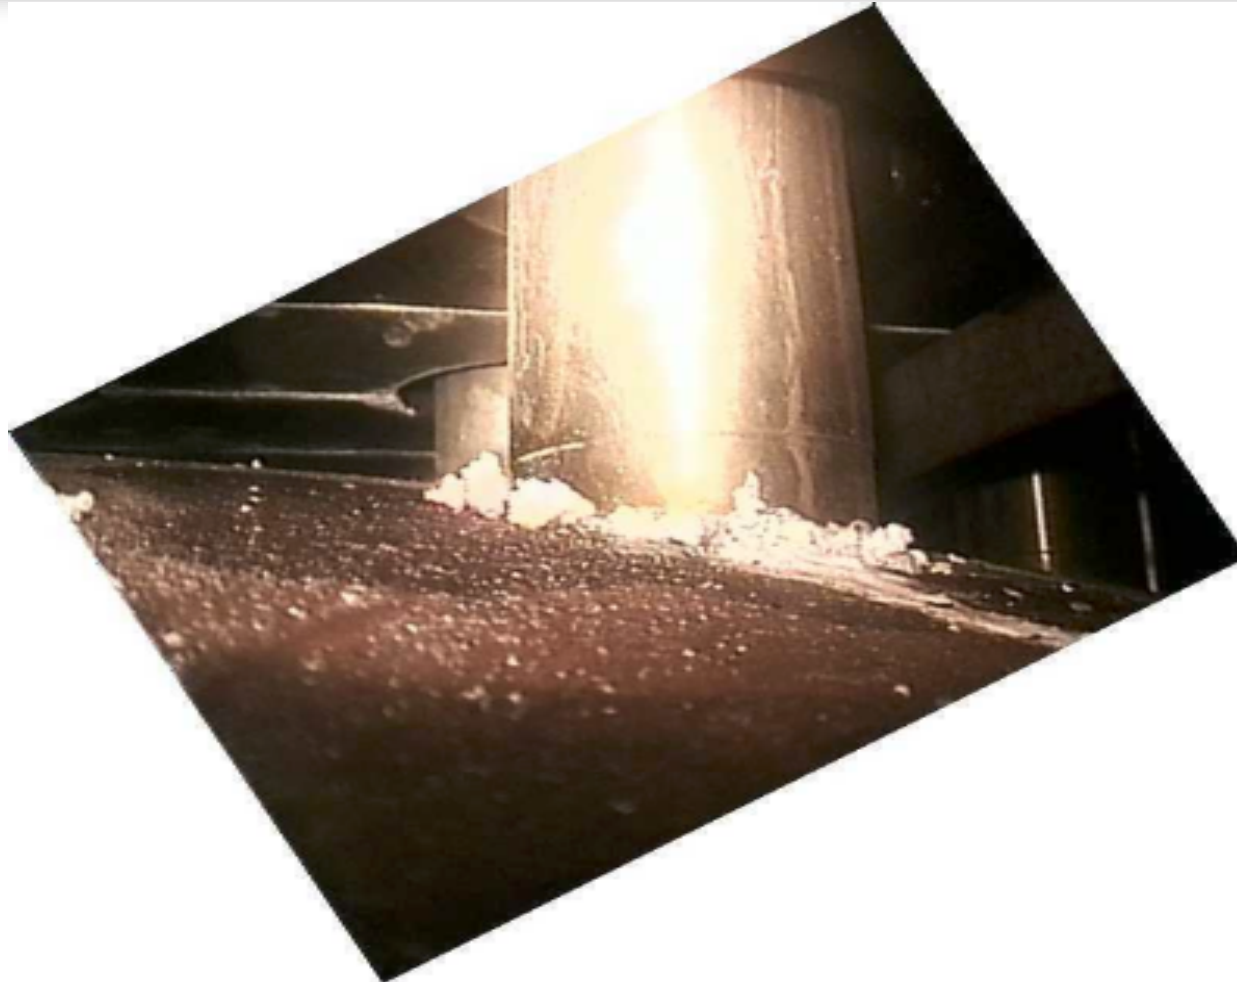
ONS-1 RV Head Showing Boric Acid At CRDM Nozzle 21

- CRDM Nozzle 21:
 - Crack in weld was completely interdendritic
 - No conclusive evidence of manufacturing defects in the original weld
 - Crack in weld was connected to a branched intergranular crack in the nozzle wall
 - Qualitative comparison of boat sample to a 182 weld pad confirmed alloy type material, as expected
 - PWSCC was the primary mechanism for crack propagation in the CRDM weld and housing

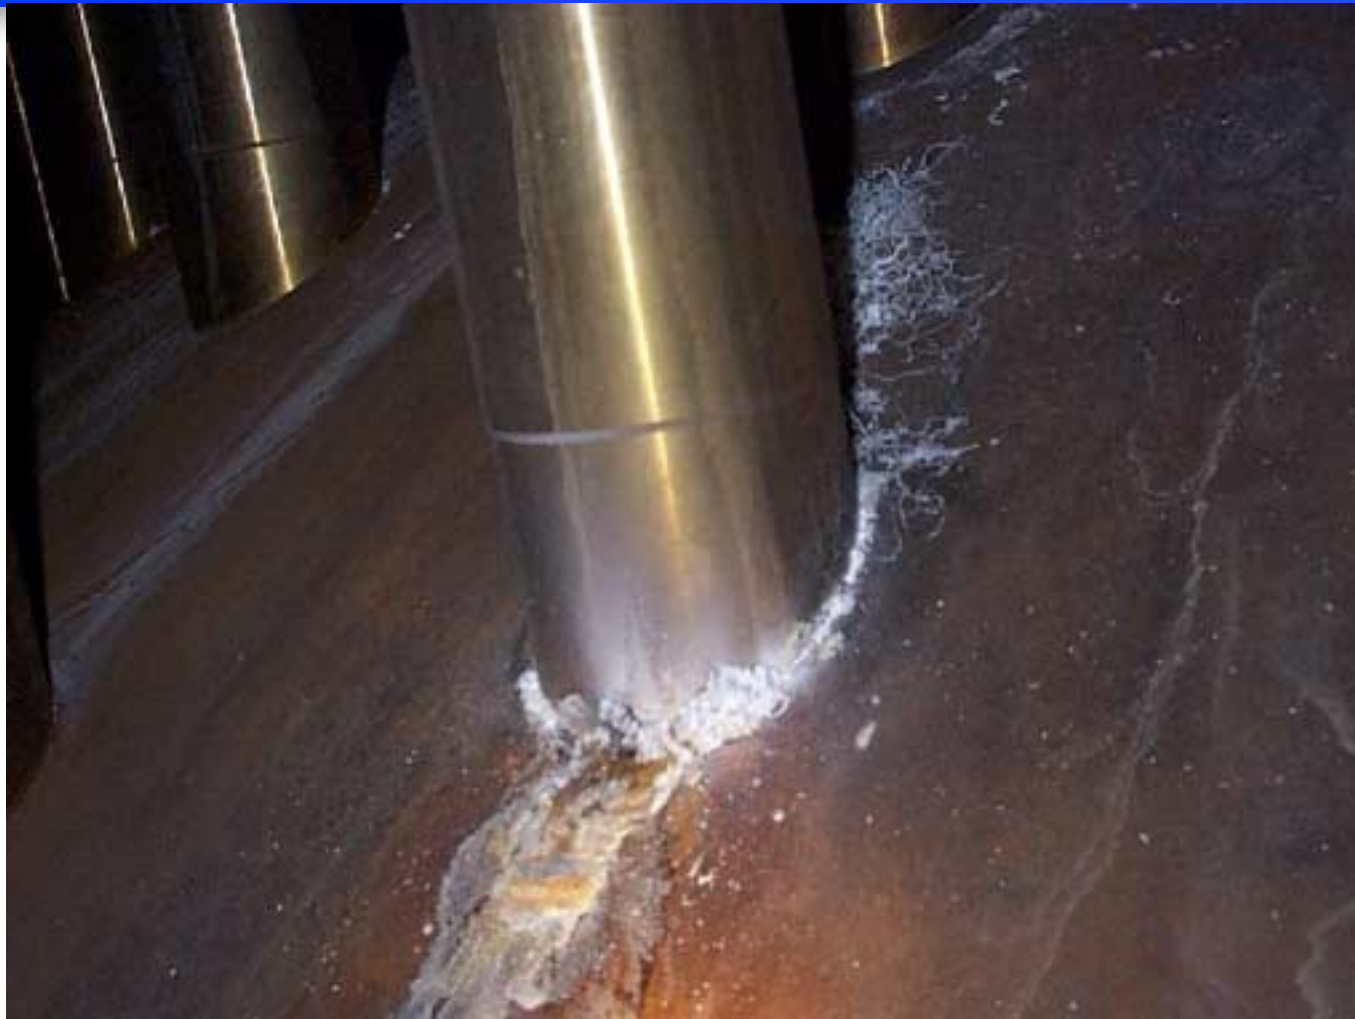
CRDM Nozzle #56

- ONS-3:
 - Nine CRDM nozzles found leaking
 - Numerous axially oriented flaws identified
 - OD-initiated circumferential flaws (relatively deep and below the weld) identified on four nozzles
 - OD-initiated circumferential flaws (above the weld and up to through-wall) identified on two nozzles
 - Some weld cracking also identified

- CRDM 56 Boat Sample (Circ Crack):
 - Boat sample in the area of circ crack that was found above the weld after the weld repairs were completed
 - Boat sample contained a face of the circ crack along with 3 small axial cracks that intersect the circ crack
 - Section through the axial crack confirms crack is totally intergranular with small intergranular branches
 - Scanning electron microscopy of the circ crack face revealed only intergranular morphology.
 - There are no tears or other indications of the origin of the circ crack
 - Circ crack is indicative of PWSCC

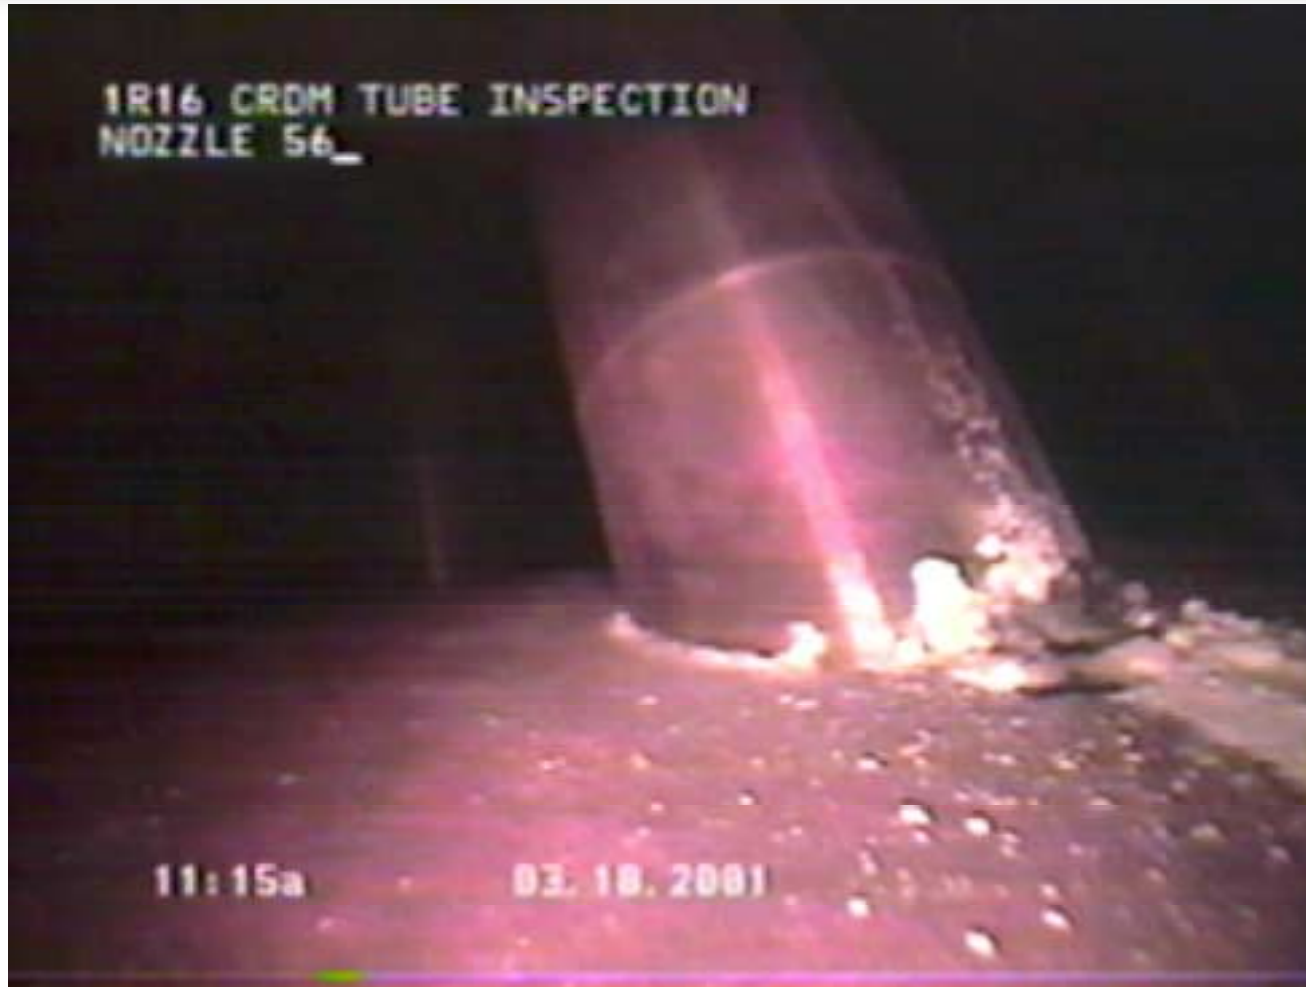
Visual Inspection ANO 1

- ANO 1 CRDM nozzle 56 found leaking
 - No ID axially oriented flaws identified
 - One OD-initiated circumferential flaw below the weld that turned axial identified
 - Flaw propagated through the weld area along the nozzle OD

- Embedded Flaw Repair
 - OD axial flaw removed down to the butter
 - Weld repaired, isolating remaining flaw above the weld from the environment
 - Peened repair area
- Post-repair UT to confirm remaining flaw did not grow during repair process

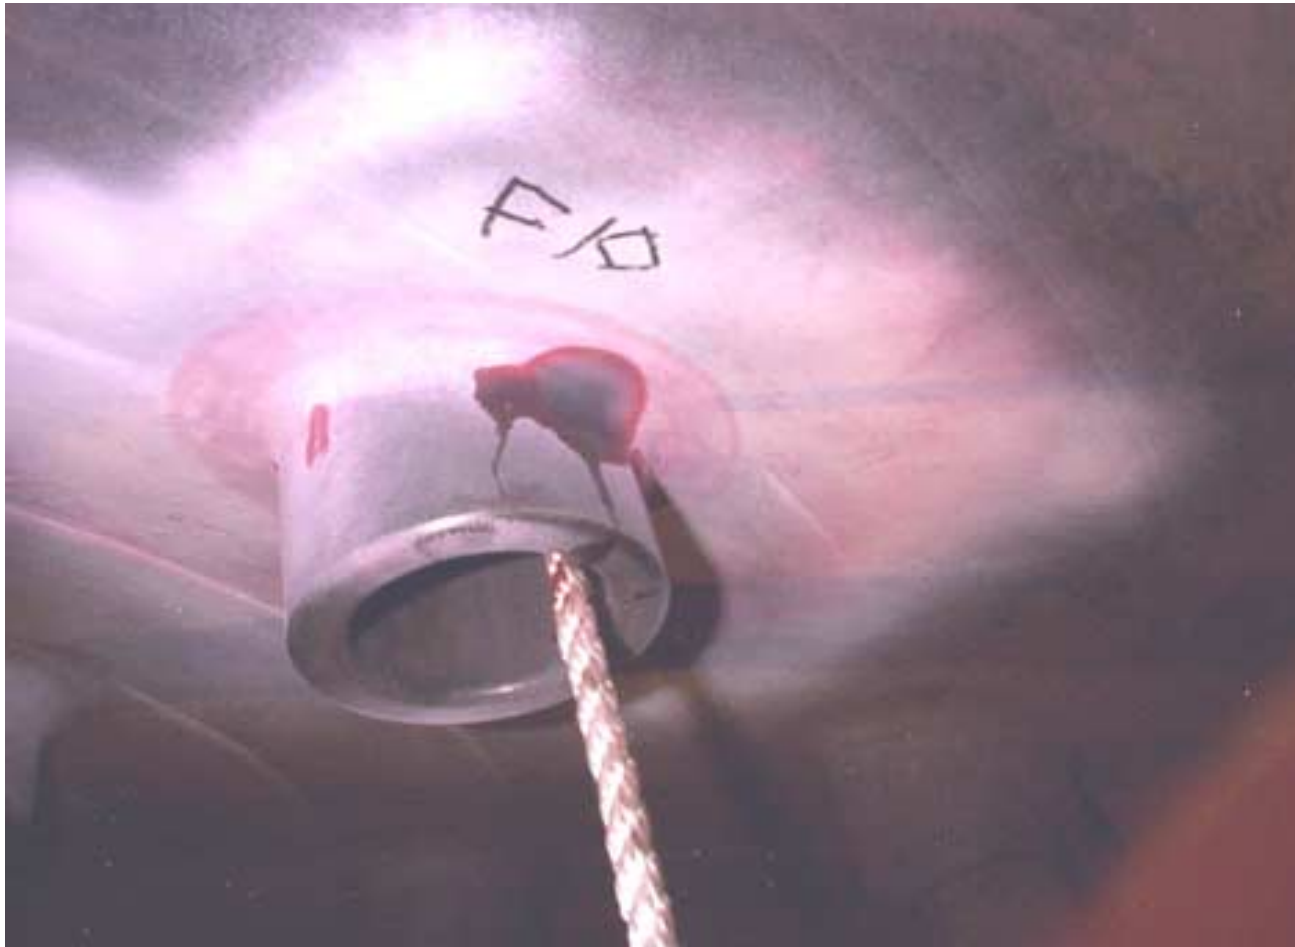
CRDM Nozzle #11

- Total of 48 indications in the nine leaking CRDMs
 - 39 are axial and located beneath the weld at the uphill and downhill
 - 16 indications thru wall (39%), all are axial, and occur on 6 of 9 nozzles
- Confirmed two (2) above the weld circumferential cracks
 - Nozzle 56 crack was thru wall
 - Nozzle 50 except for pin hole indications on ID was not thru wall
 - Inspection and metallurgical results indicate the circumferential cracks were O.D. initiated.
- Unit 3 CRDMs extent of condition inspections (9 additional nozzles):
 - Cluster indications above and/or below the J groove weld.

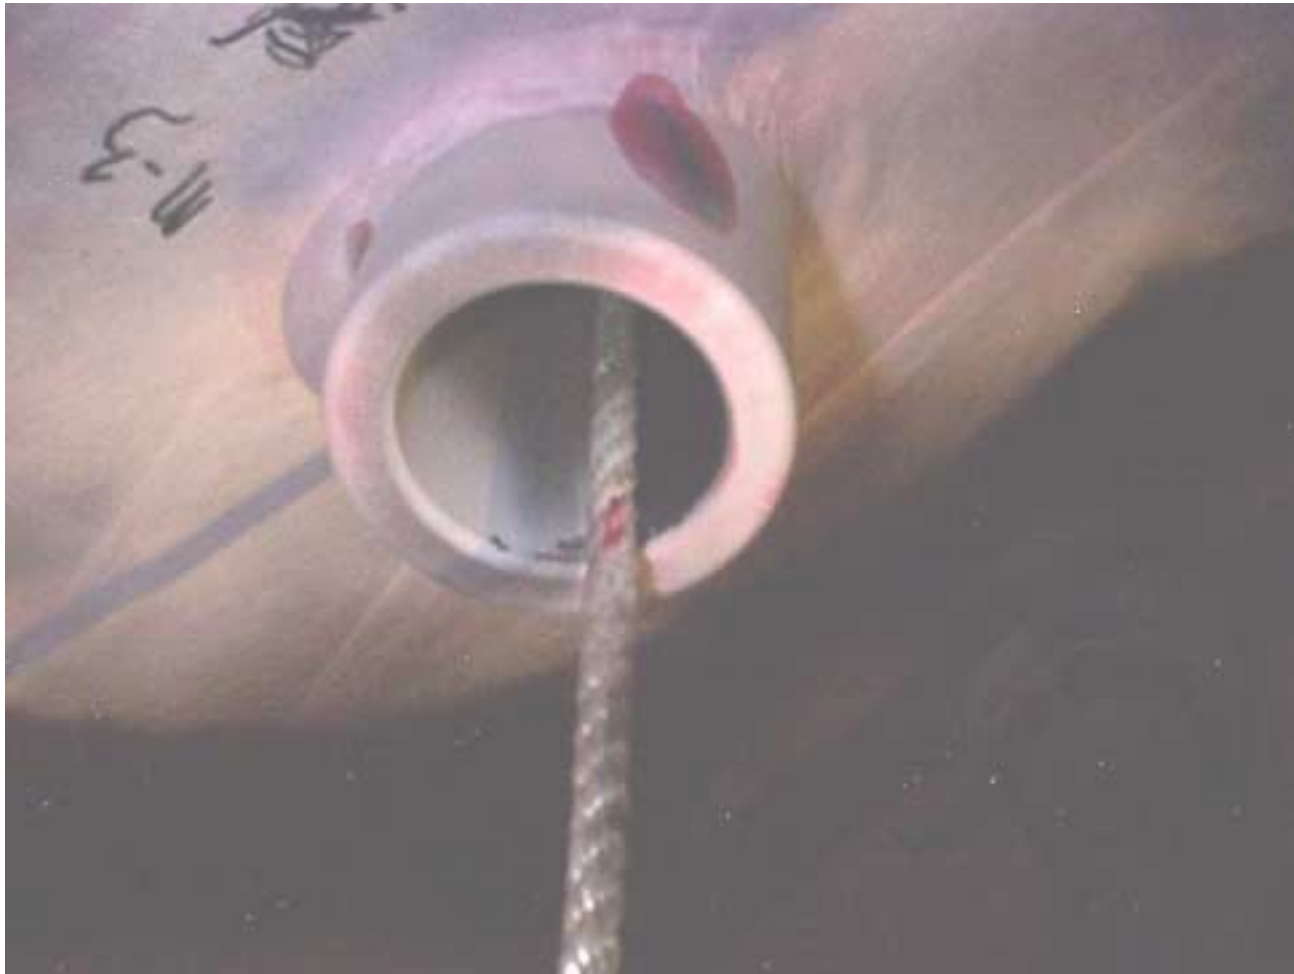
CRDM Nozzle #56

- Discovered during post weld repair NDE of Nozzles 50 & 56
- Circumferential cracks followed the weld profile contour and were O.D. initiated.
- Both ECT and UT inspections identified indications in these areas but were dispositioned as crazed cracks with unusual characteristics
- The original NDE characterization for nozzles 50 and 56 subsequently changed.
- This change in interpretation of the NDE signals is related to the flaw orientation with respect to the sound beam of the UT search units.
- Actions taken as a result of this discovery were:
 - All Unit 1 and 3 ECT and UT data re-reviewed applying the LLs
 - EPRI NDEC led an independent review of ONS 1 & 3 data to confirm results and findings

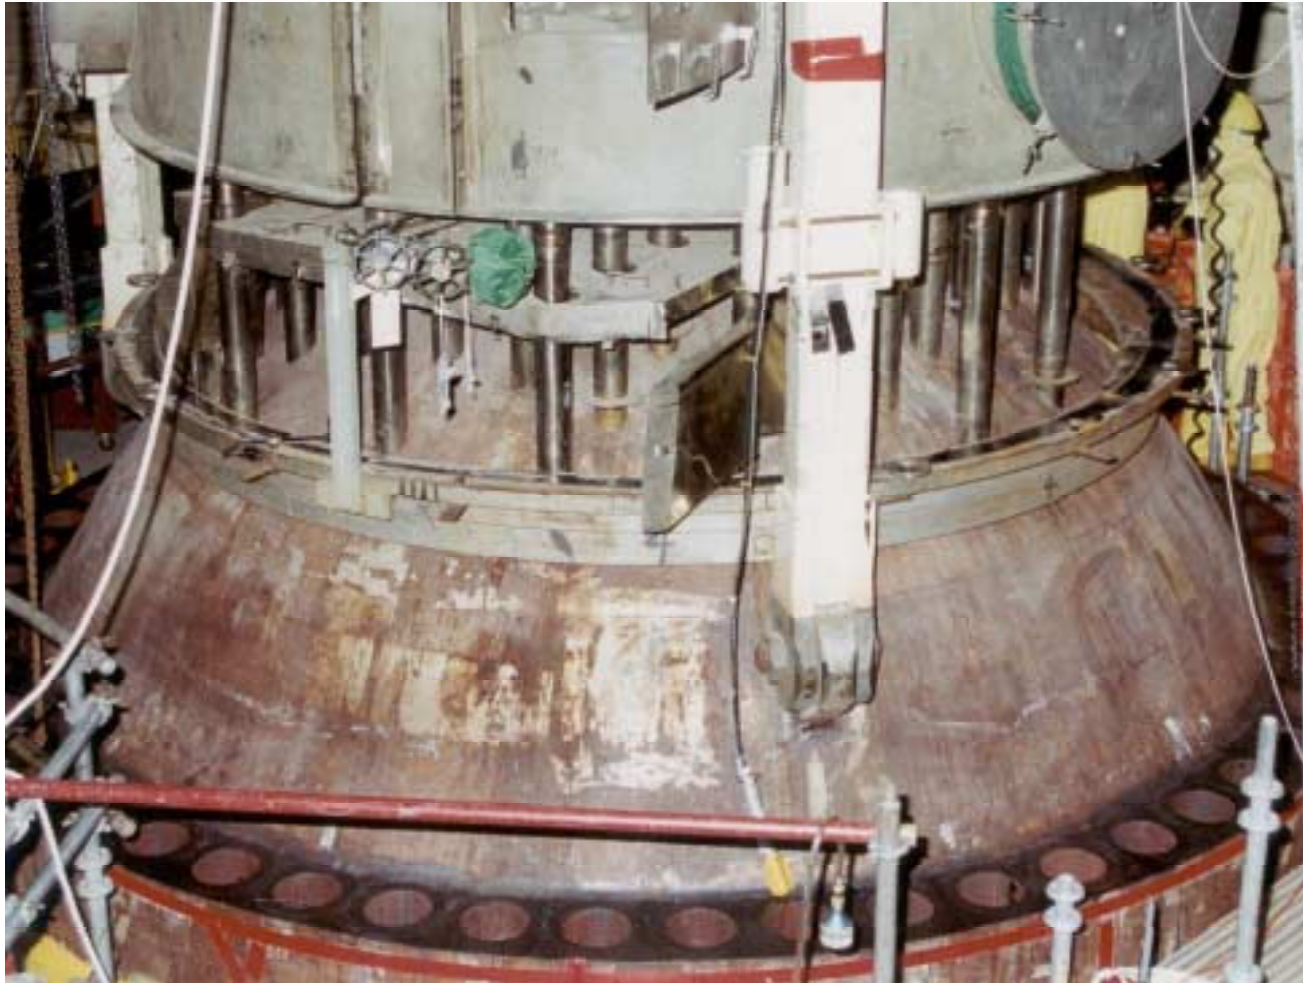
- Several other plants performed visual inspections during Spring outages
 - Robinson 2
 - Salem 1
 - Farley 2
 - Prairie Island 1
 - McGuire 1 (partial)
 - SONGS 3 (partial)
- Heads reasonably free of masking boric acid deposits
- No evidence of leakage found

Visual Inspection Salem 1
