Davis-Besse Nuclear Power Station

Reactor Vessel Incore Nozzles

Incore Nozzles Configuration

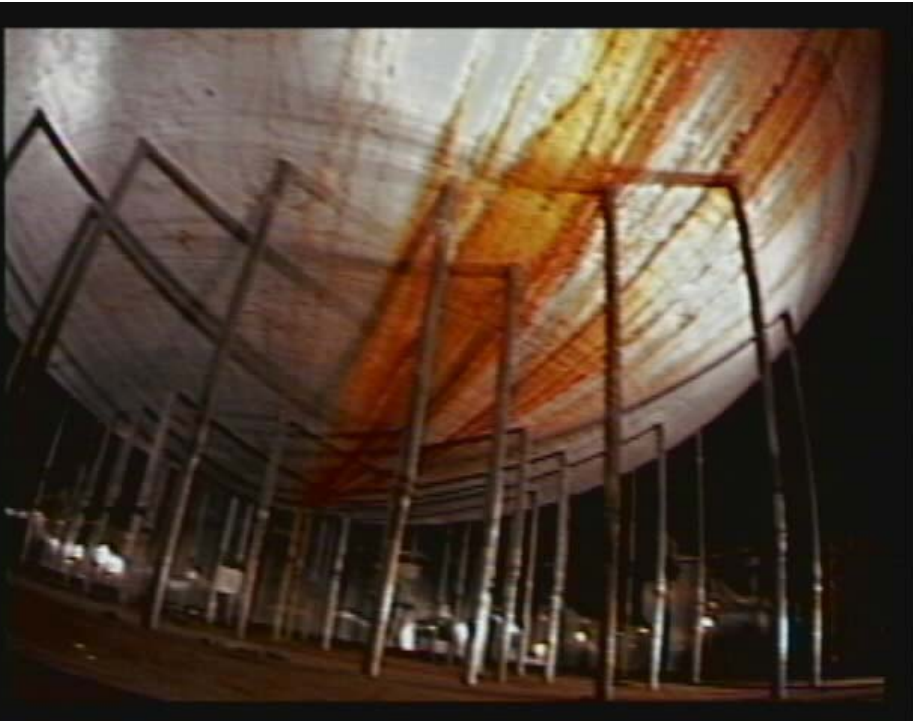
Bottom of Reactor Vessel

- Boron and rust deposit trails were observed on the sides and bottom of the reactor vessel
- Similar deposits observed on several incore nozzles
- Tape remnants and residue observed on incore nozzles
- No build-up of boric acid or corrosion products on top of insulation
- No evidence of wastage on bottom of reactor vessel

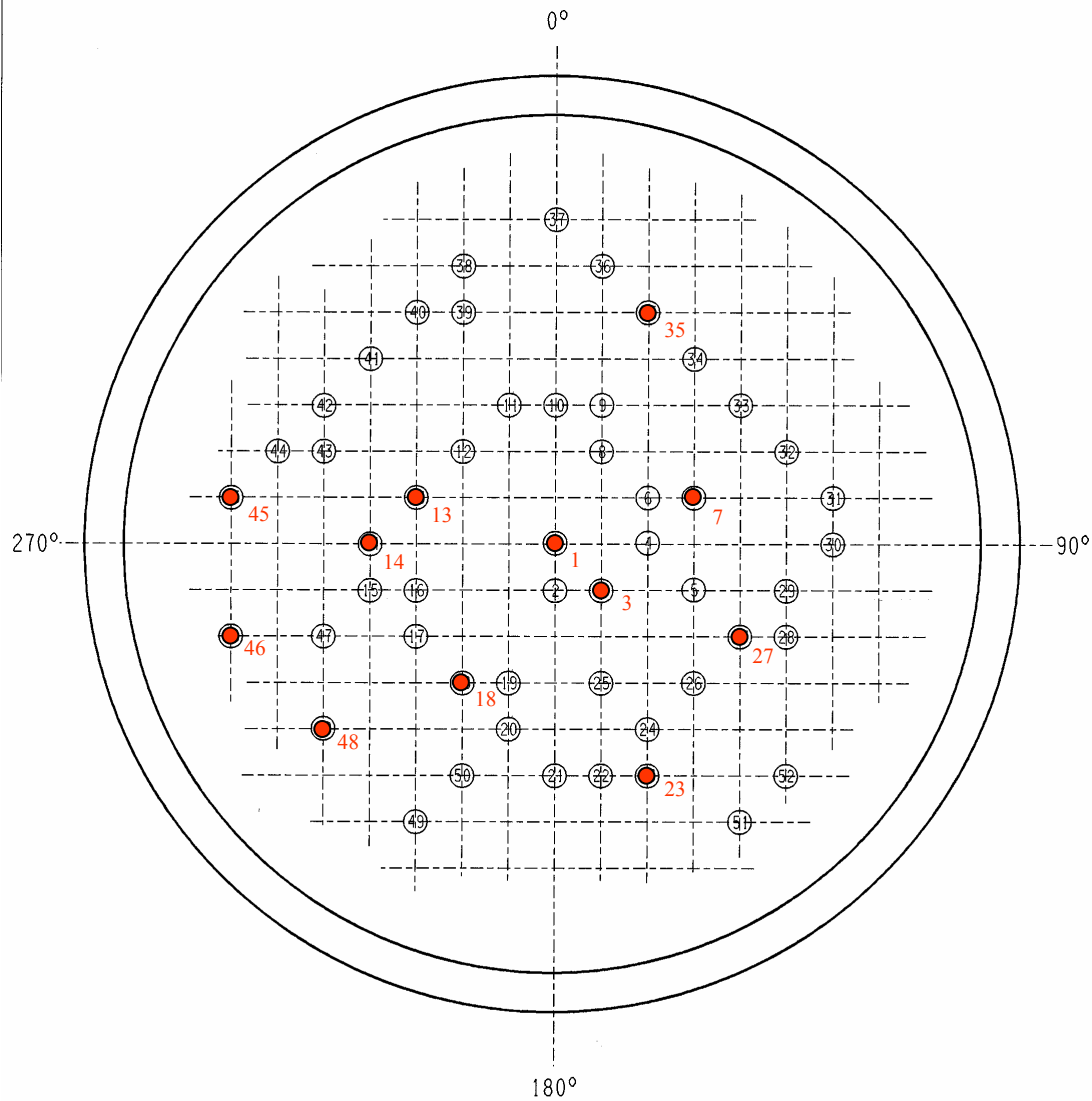
INCORE INSTRUMENT CORE LOCATION MAP
BOTTOM HEAD INSIDE VIEW

- Sample locations (●) chosen were nozzles
