**Cleveland Mill Superfund Site, Grant County, New Mexico
Removal Action, September 1997 - September 1998**

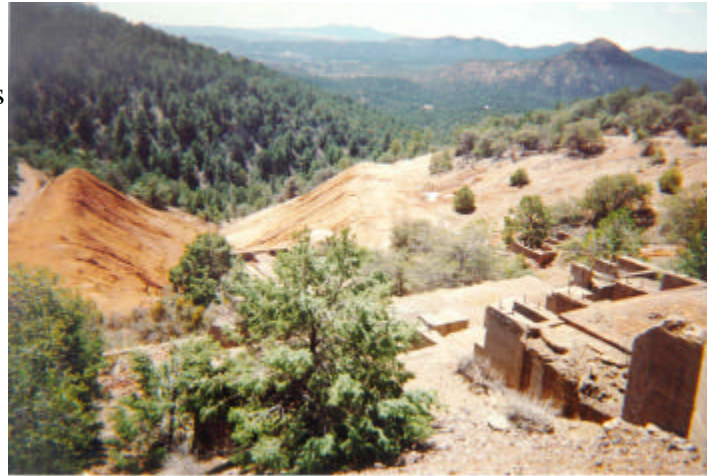
Photo #1: This photo shows the tailings which were disposed of at the headwaters of Little Walnut Creek during milling operations. (Mill foundation shown lower right.) The orange tailings contain metals which leach into the creek and which could travel to the ground water.

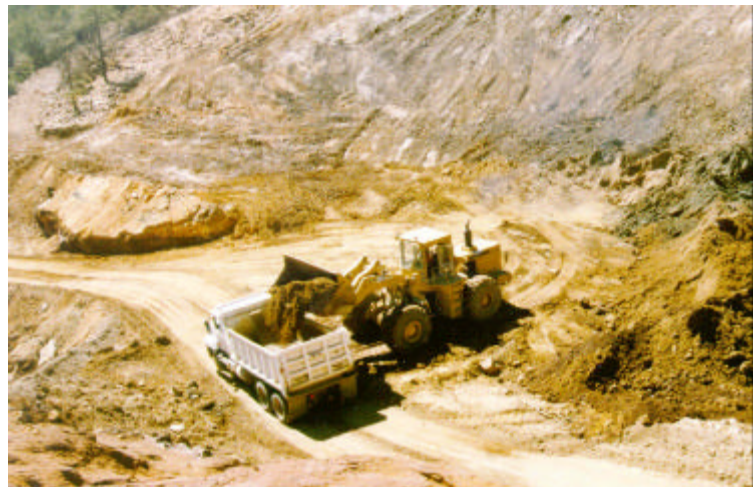
Photo #2: Approximately 165,000 cubic yards of tailings were excavated from the mill and mine areas and from Little Walnut Creek.

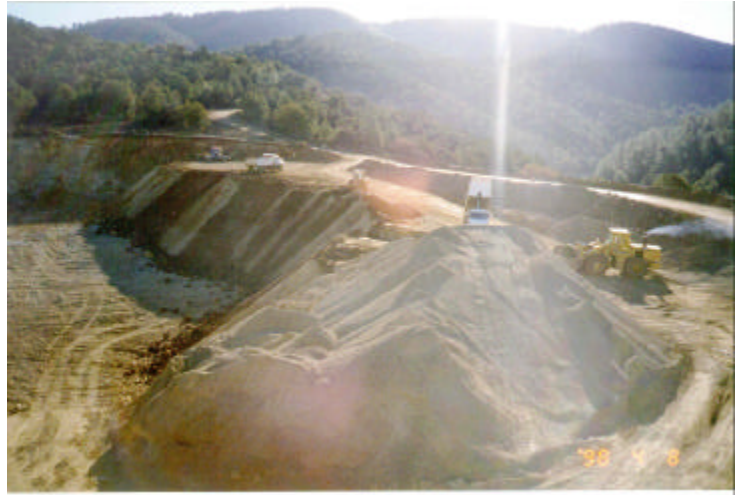
Photo #3: The tailings were taken to an on-site disposal cell where they were amended with limestone (seen in foreground) before being placed into the cell. The cell will be covered with a multi-layer cap.

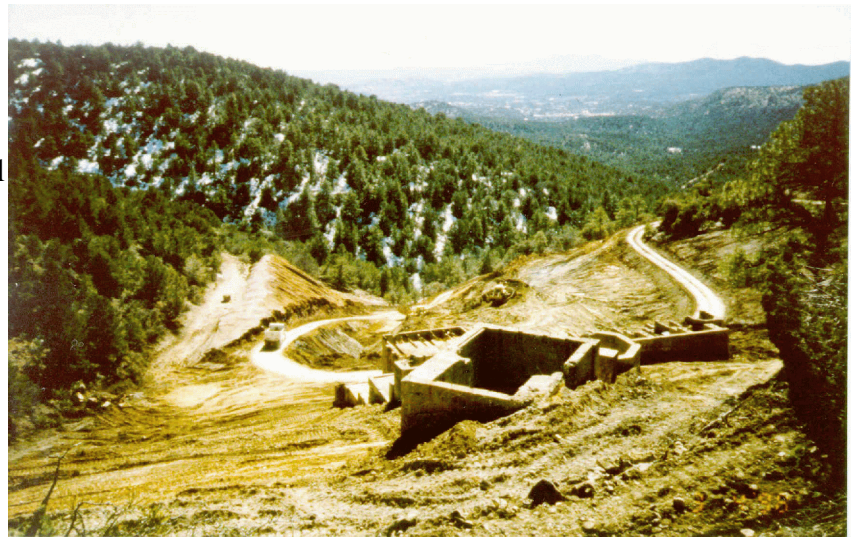
Photo #4: A view of the mill area after the tailings were removed.
