3 General Assessment and Characterization of Damage

3.1 PROPERTY PROTECTION

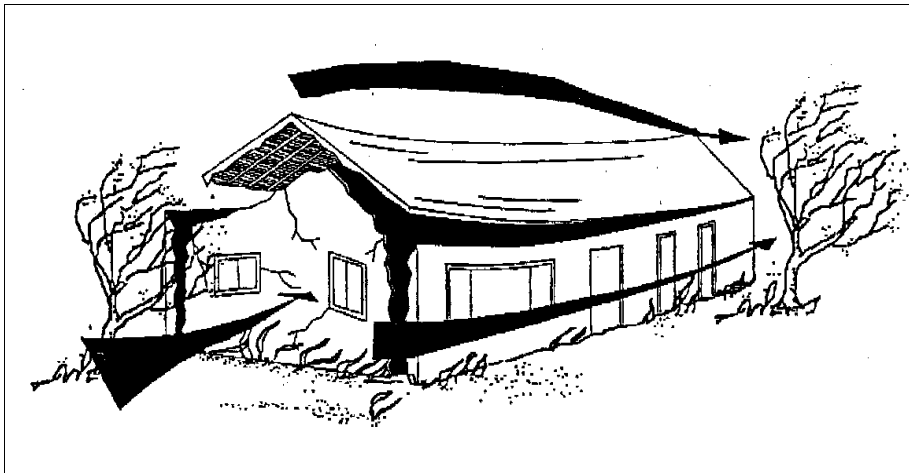
FIGURE 3-2: This building failure is the result of inward wind forces and uplift wind forces acting on a building or structure during a high wind event.

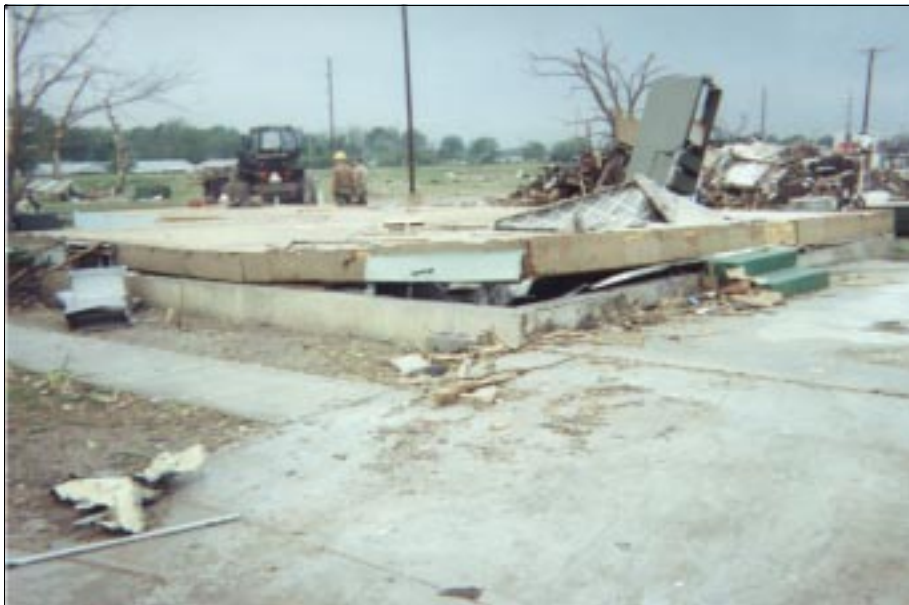
A primary effect of high winds flowing around and over a structure is the wind loads that act on the structure. Uplift is the force caused by the wind accelerating around and over buildings and other structures (Figure 3-2). An example of uplift strong enough to move a house off its foundation is presented in Figure 3-3. This house was separated from its foundation when it experienced winds associated severe tornado that passed through this neighborhood in the city of Haysville, Kansas. Although anchor bolts extended from the concrete foundation into the wood floor framing, nuts were not attached to the bolts to provide a continuous load path at this connection point that would have resisted the uplift forces. This deficiency was observed at more than just this one house.

FIGURE 3-3: Wind uplift acting on this house in Haysville, Kansas, resulted in this corner of the building being lifted off its foundation.

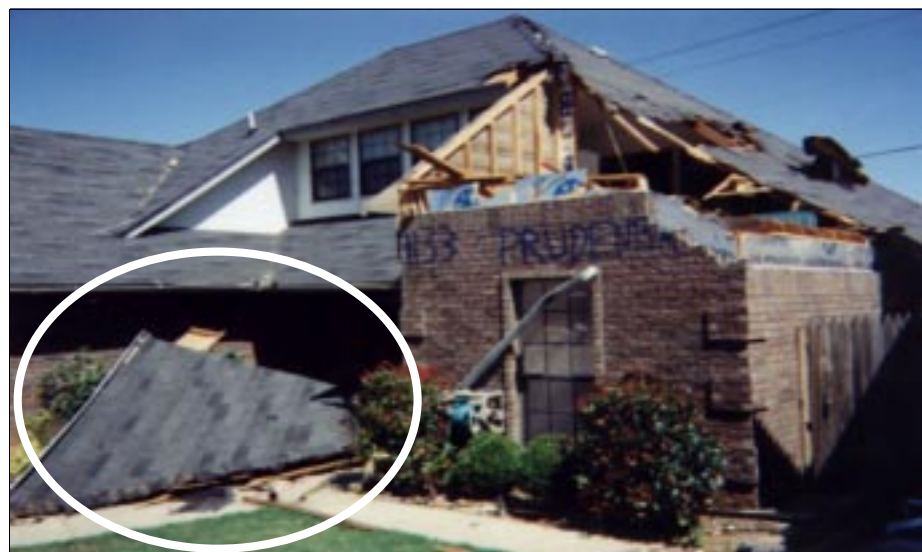
FIGURE 3-5: Failure of hip roof due to internal pressures and leeward wind forces acting together. This house, which was exposed to inflow winds of a violent tornado, was located in a suburb of Oklahoma City, Oklahoma.

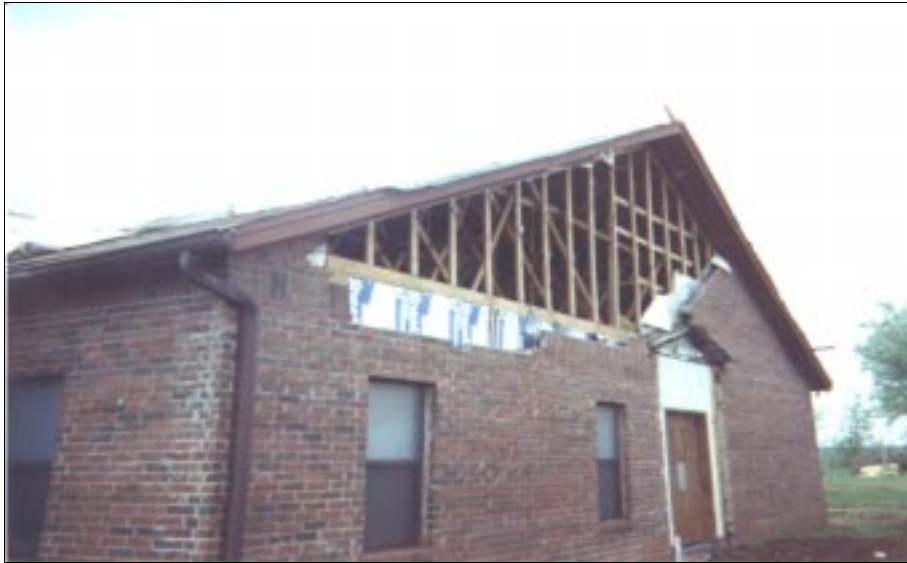
FIGURE 3-6: Failure of this gable wall section was due to wind suction forces of the leeward wall. This house was on the outer edge of a violent tornado path.

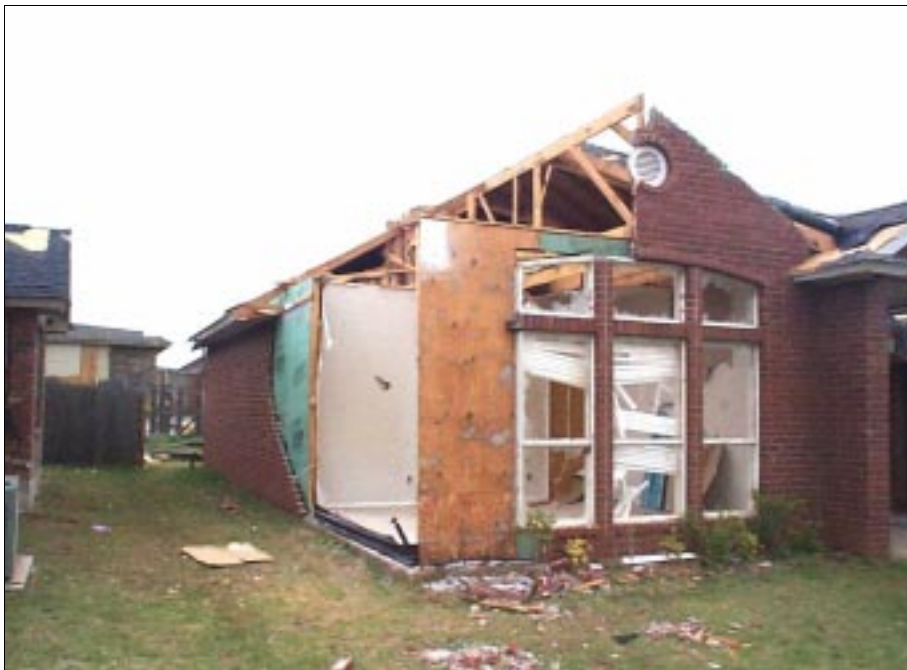
FIGURE 3-7 Failure of this exterior wall and roof section in Moore, Oklahoma, occurred when the windows broke and the front room saw an increase in internal pressure. Most of the debris from the roof and exterior wall had been cleaned up prior to this photograph. This home in Moore, Oklahoma, was located on the periphery of a violent tornado track.

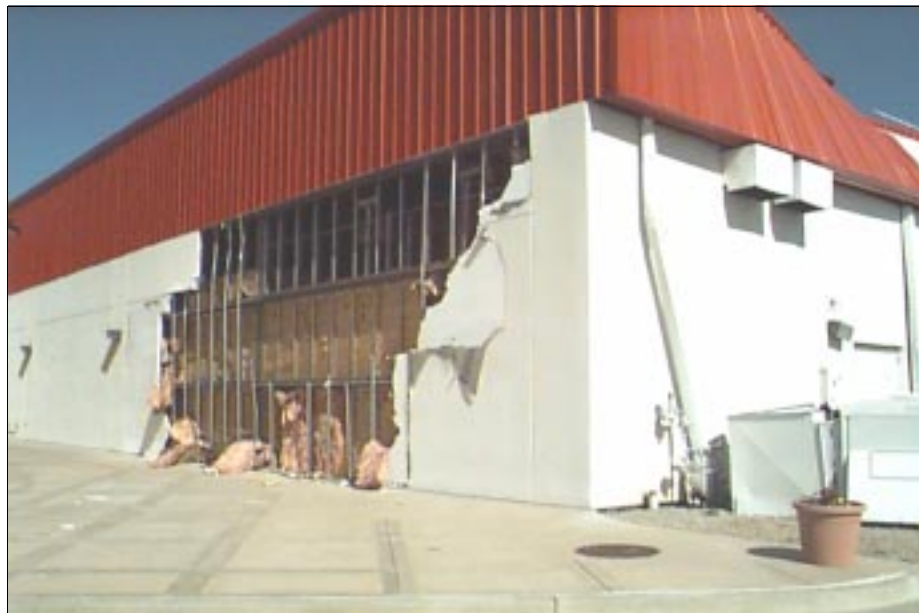
A number of non-residential buildings, such as schools, factories, warehouses, and commercial buildings were in the direct path of the moderate tornado vortexes or in the inflow of severe and violent tornadoes and received varying degrees of damage. In a few cases, damage could be considered non-structural because architectural and decorative materials on the exterior and roofing were the only damage to the buildings. Engineering standards such as ASCE 7, identify these elements as components and cladding, and provide design guidance for designing to specified regional wind speeds. The failure of an exterior insulating finishing system (EIFS) exterior wall covering and architectural roof parapet is shown in Figure 3-8 at the Regional Mall at Stroud, Oklahoma. This was the only damage experienced by this particular store; however, other significant damage was experienced at the mall that was struck by a moderate tornado and is discussed later in this report.

Figure 3-8: EIFS and metal component damage at the regional outlet mall in Stroud, Oklahoma.

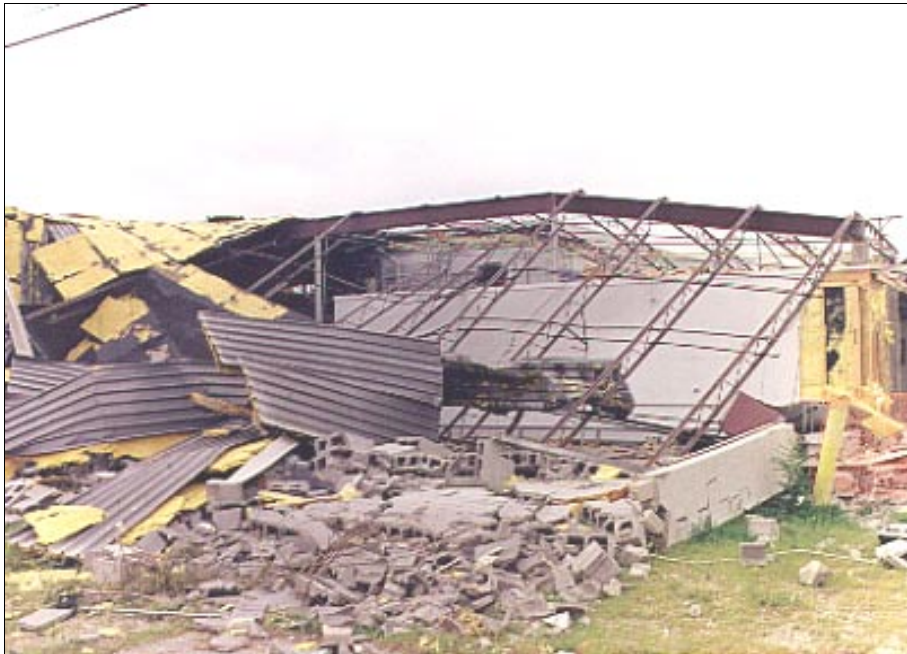
Figure 3-9: This URM wall failed when inflow winds from a severe tornado acted on this building in Wichita, Kansas.

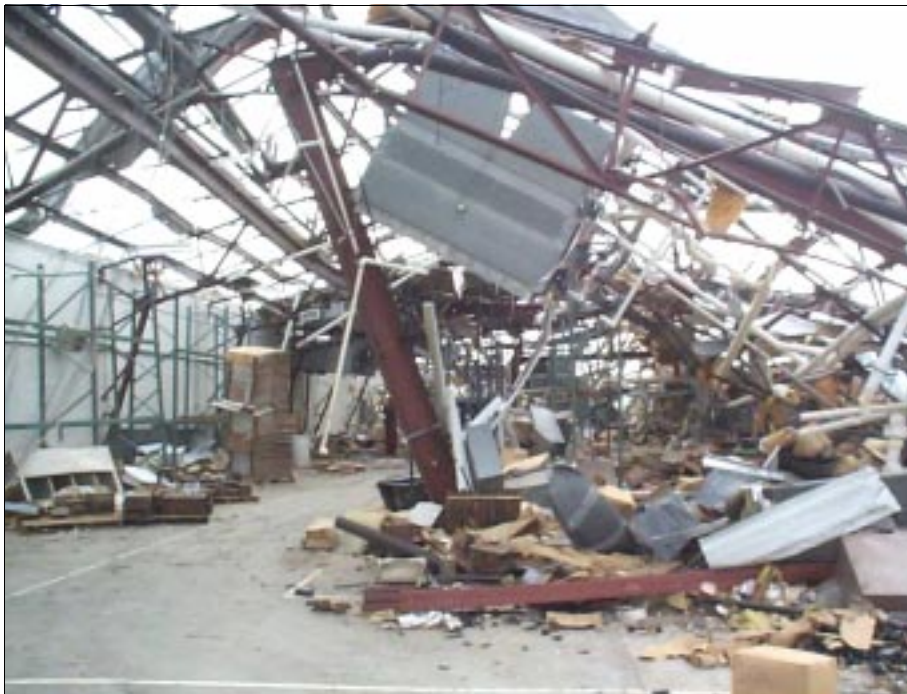
Figure 3-10: The vortex of a violent tornado passed within 100 yards of this plastics manufacturing plant in the City of Haysville, Kansas. The wind forces caused the failure of its primary structural system: a steel frame with masonry infill walls.

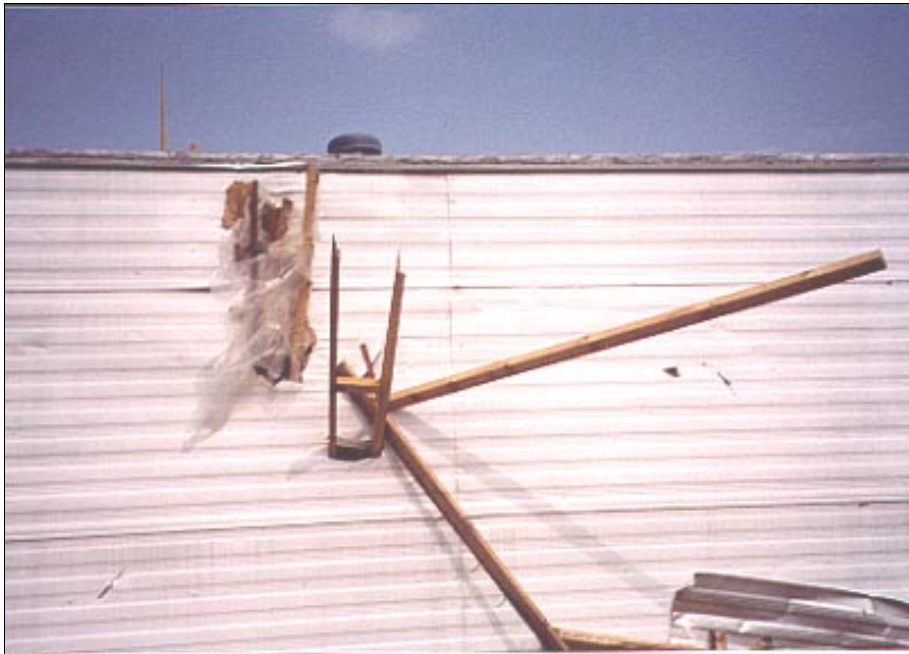
FIGURE 3-12 *These medium sized missiles struck and remained embedded within this manufactured home in Wichita, Kansas.*

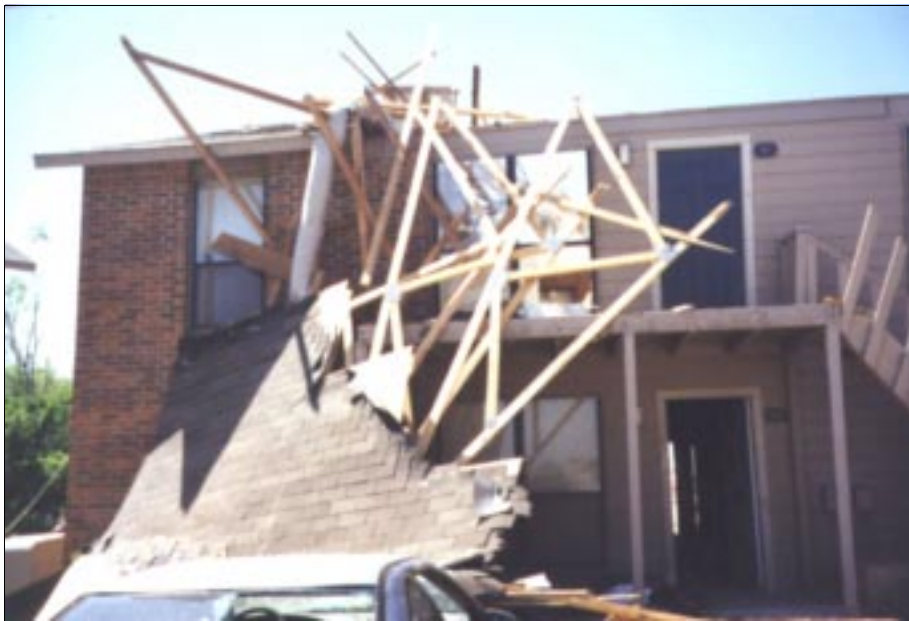
FIGURE 3-13: *These trusses and roof covering (still attached to the roof sheathing) was displaced by the winds of a violent tornado and are capable of becoming large, windborne missiles.*

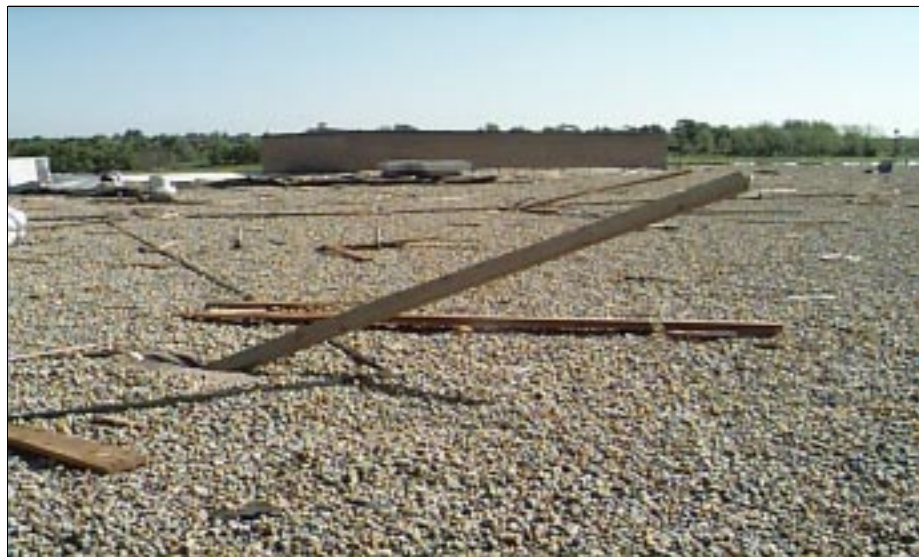
FIGURE 3-14: *In the foreground, a medium sized missile, a double 2-in by 6-in, 13 feet long board can be observed sticking out of Westmoore High School's roof, Moore, Oklahoma. A larger missile, double 2-in by 10-in, 16 feet long board is lying in the background.*

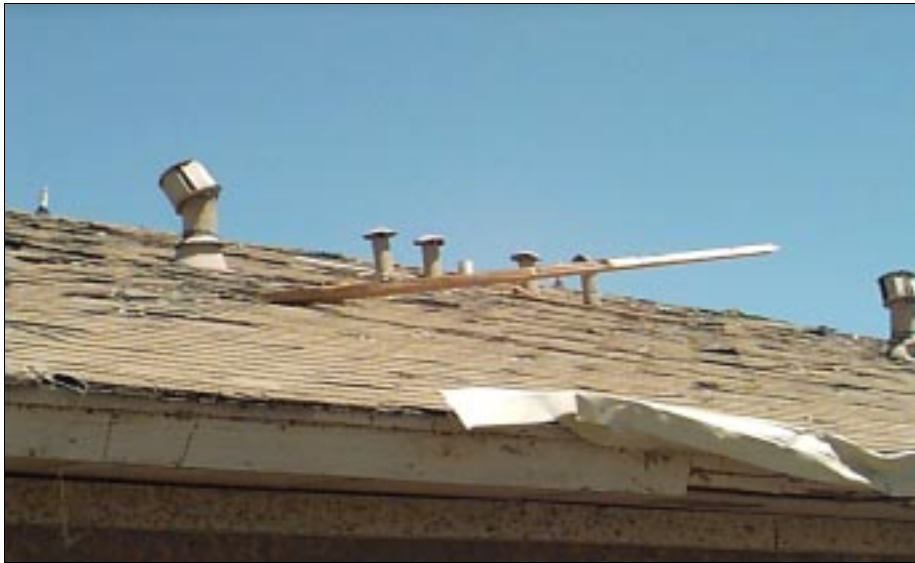
FIGURE 3-15: Windborne missile striking a house located in Moore, Oklahoma.

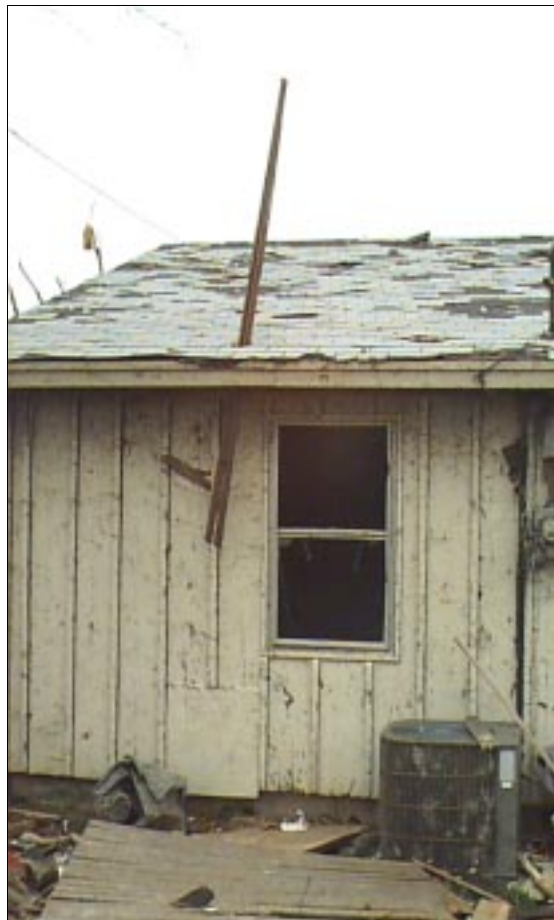
FIGURE 3-16: A missile vertically striking the roof of a home in Mid West City, Oklahoma. It fell nearly vertical illustrating the importance of a strong cover over the top of a tornado shelter to protect against free-falling debris.

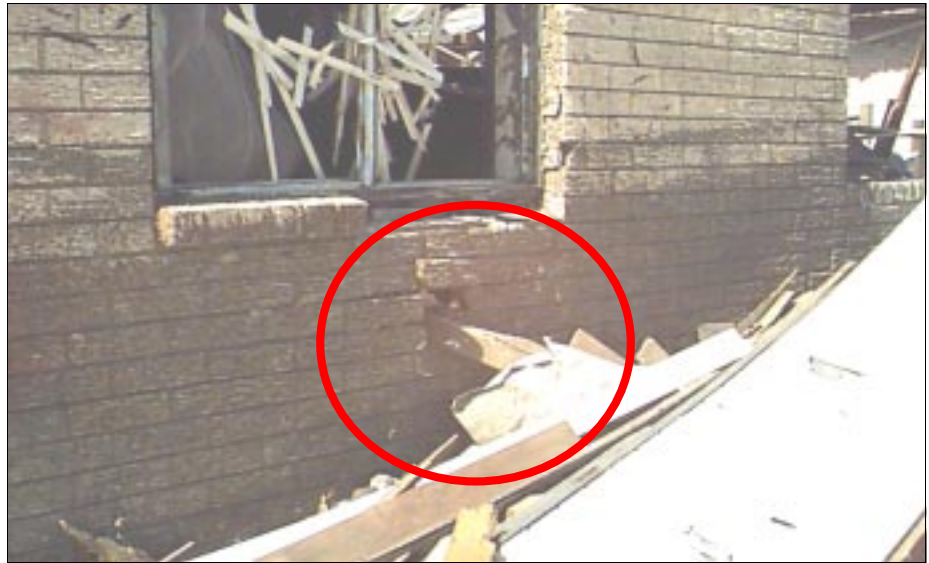
FIGURE 3-17: A 2-in by 6-in can be seen completely penetrating the brick veneer of a home in Moore, Oklahoma.

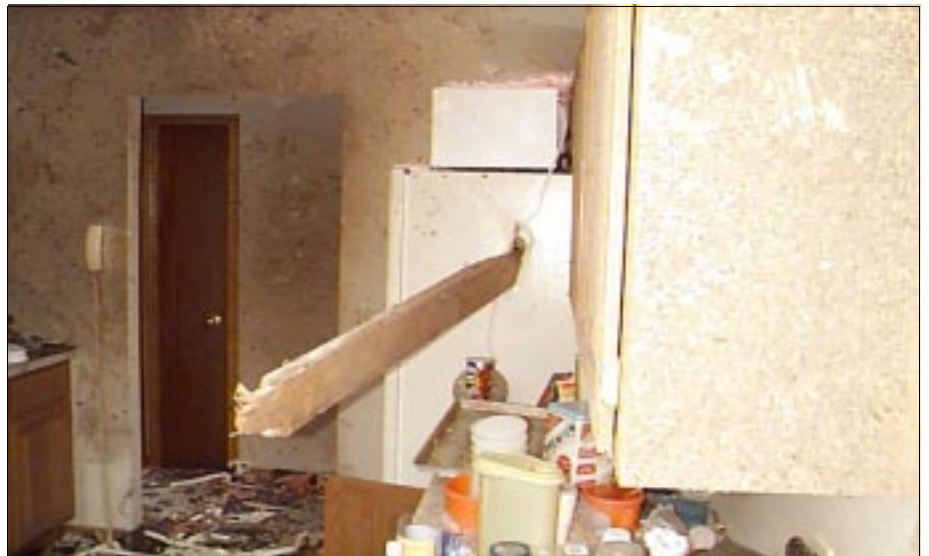
FIGURE 3-18: A 2-in by 6-in board missile penetrating a refrigerator located inside a home in Country Place subdivision outside Oklahoma City, Oklahoma.

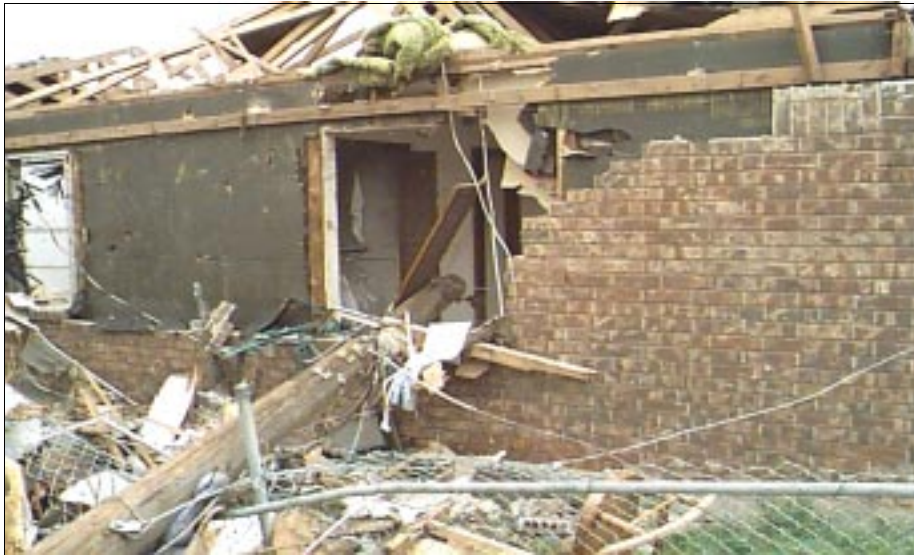
FIGURE 3-19: This power pole penetrated a window and extended several feet into the house after traveling approximately 40 feet from its original location. This home was located in Moore, Oklahoma, along the track of a violent tornado.

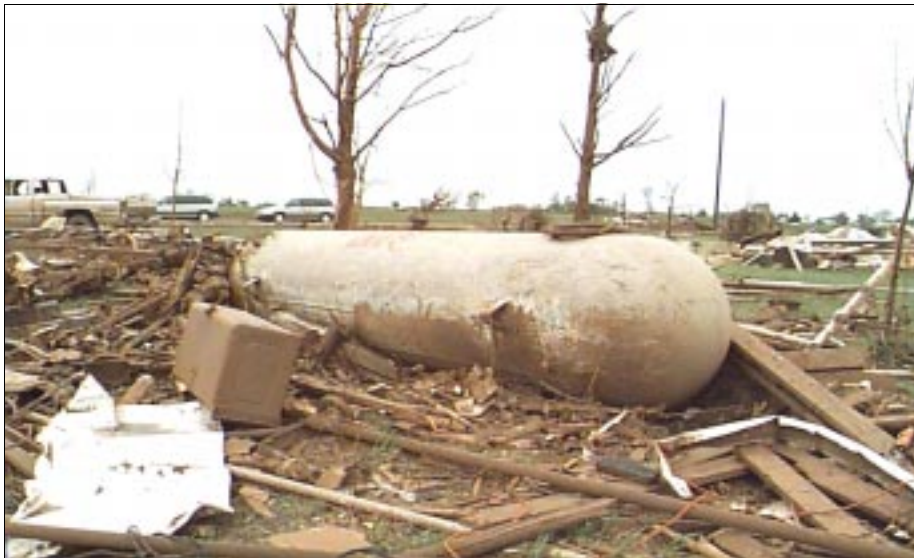
FIGURE 3-20: Wind displaced this very large propane tank in Bridge Creek, Oklahoma; its original location could not be determined. This area was hit by the vortex of a violent tornado.

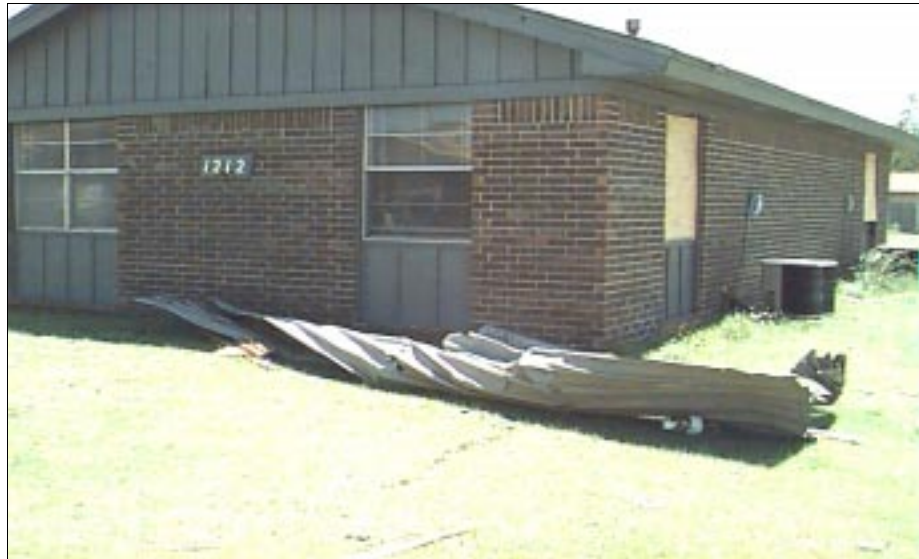
FIGURE 3-21: *This piece of steel deck landed at the periphery of a violent tornado damage area in Moore, Oklahoma. The building it likely came off of was a few hundred feet away.*

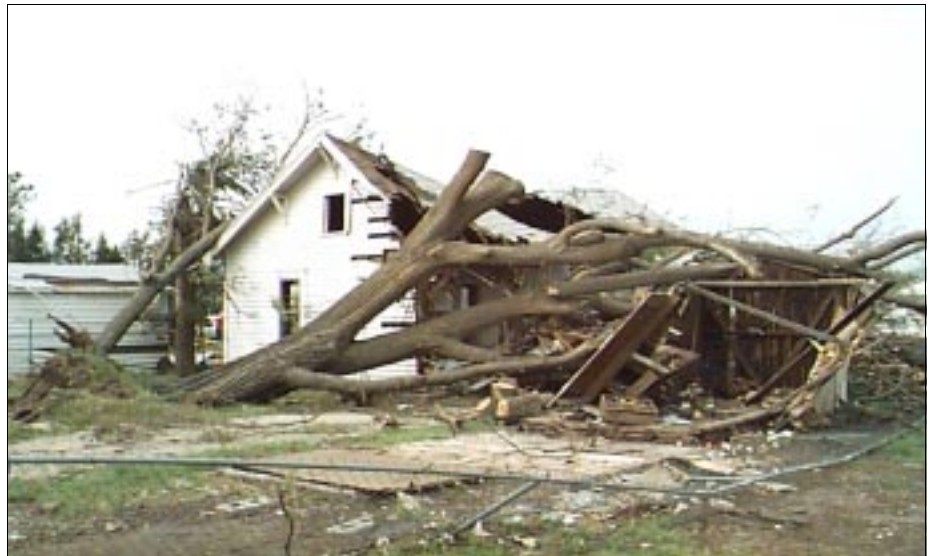
FIGURE 3-22: *This building was on the periphery of a violent tornado damage area in Haysville, Kansas. One large tree fell near the corner of the house and collapsed a large portion of the roof and the corner walls. A smaller tree caused minor damage on the other corner of the house.*

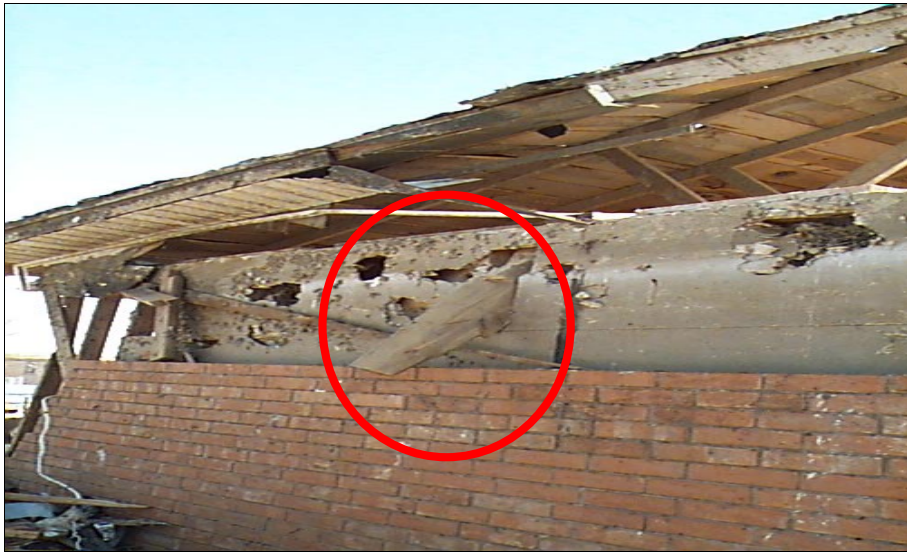
FIGURE 3-27: Several missiles struck the wall of this house in Del City, Oklahoma, including a medium sized piece of debris in the center of the picture. For scale, the square metal fastener plates near the board corners are 3-in by 3-in.

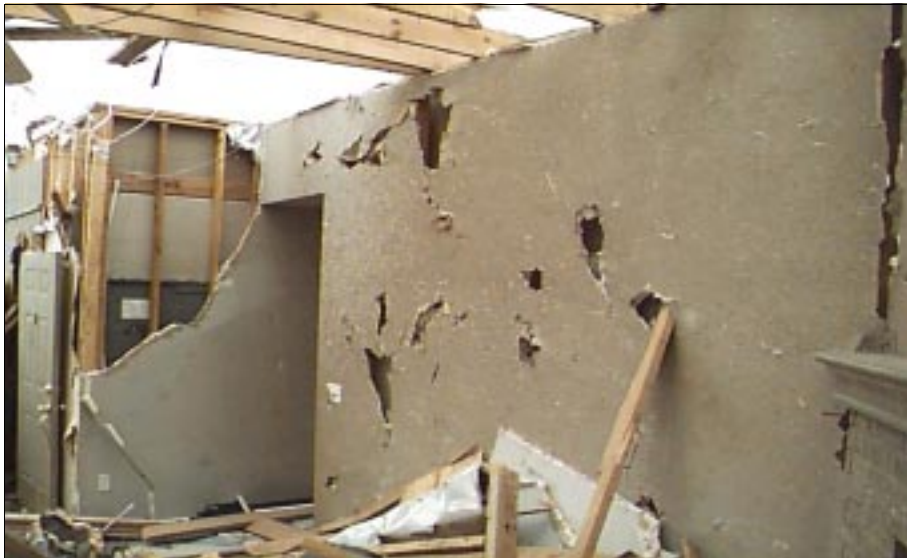
FIGURE 3-28: Several missiles struck and perforated the interior wall of this house in Moore, Oklahoma.
