4 Observations on Residential Property Protection

4.1 SINGLE FAMILY CONVENTIONAL CONSTRUCTION

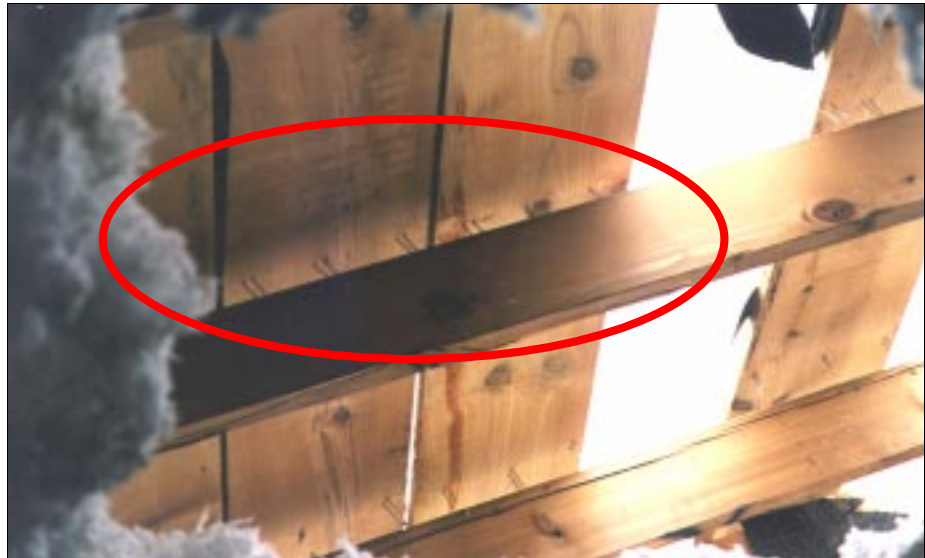
FIGURE 4-3: Failed stapling of boards to rafters viewed from home in Moore, Oklahoma.

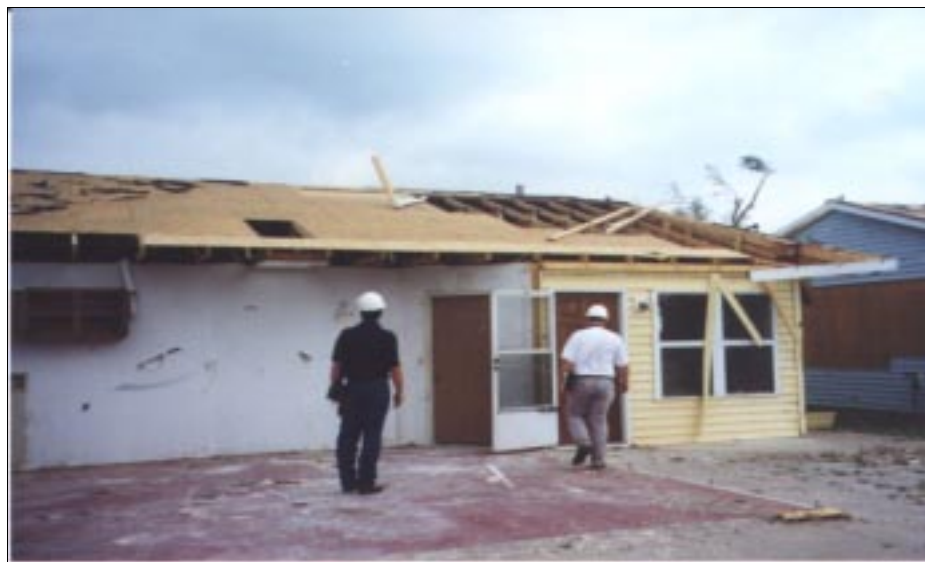
FIGURE 4-4: Although roof sheathing was lost at this Wichita, Kansas, home code requirements of staggering joints in sheathing applications was observed. This house experienced inflow winds from a severe tornado.

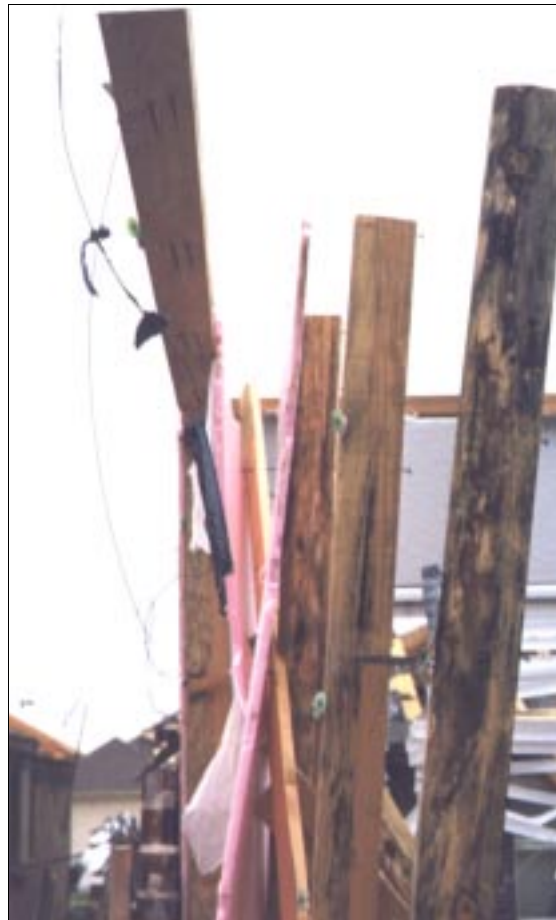
FIGURE 4-9: Failures of the connection of the double-top-plate to the supporting studs below by home located in Moore, Oklahoma. This home was located along the periphery of a violent tornado.

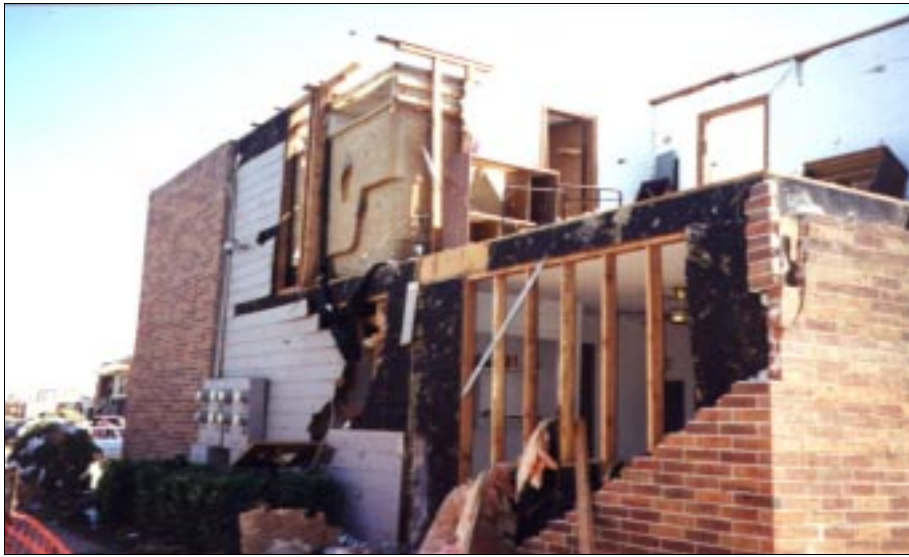
FIGURE 4-11: Stud-wall and sole-plate-to-floor failure on a second story wall. This multi-family residence in Wichita, Kansas, was located approximately a few hundred feet from the vortex of a violent tornado and was exposed to inflow winds.

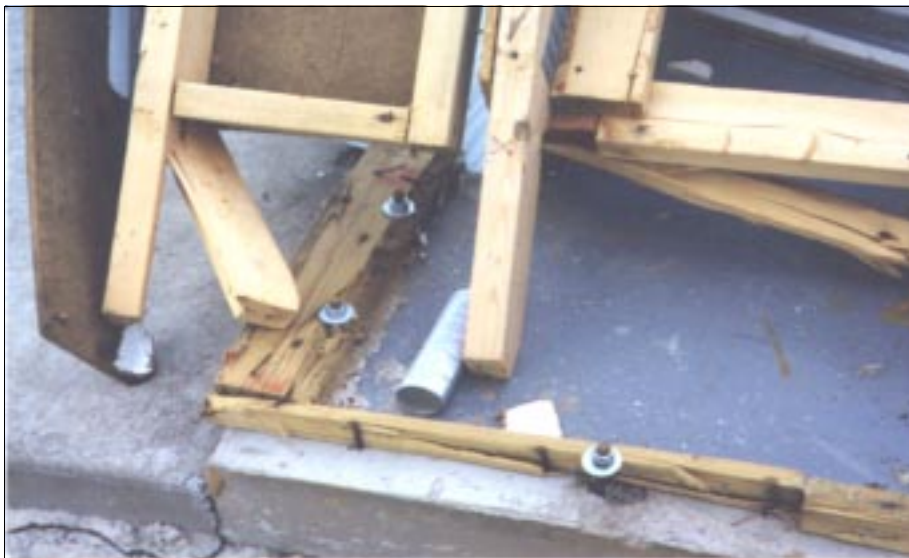
FIGURE 4-12: Failure at base of wall between wall studs and sill-plate. The sill-plate, which was connected to the foundation slab with anchor bolts and nails, has splintered.

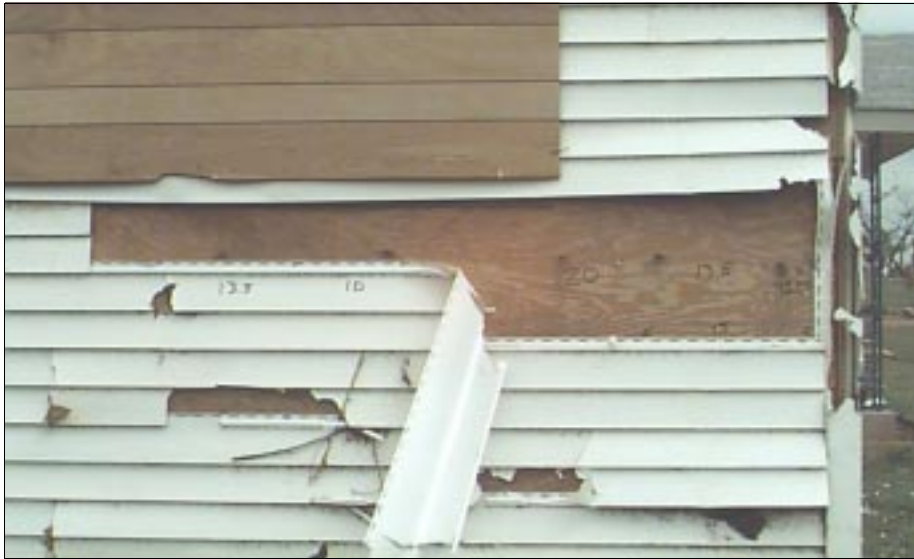
FIGURE 4-17: *Some pieces of vinyl siding were blown off and in other areas the siding was torn away by missiles. The home was located along the periphery of a violent tornado in Mullhall, Oklahoma.*

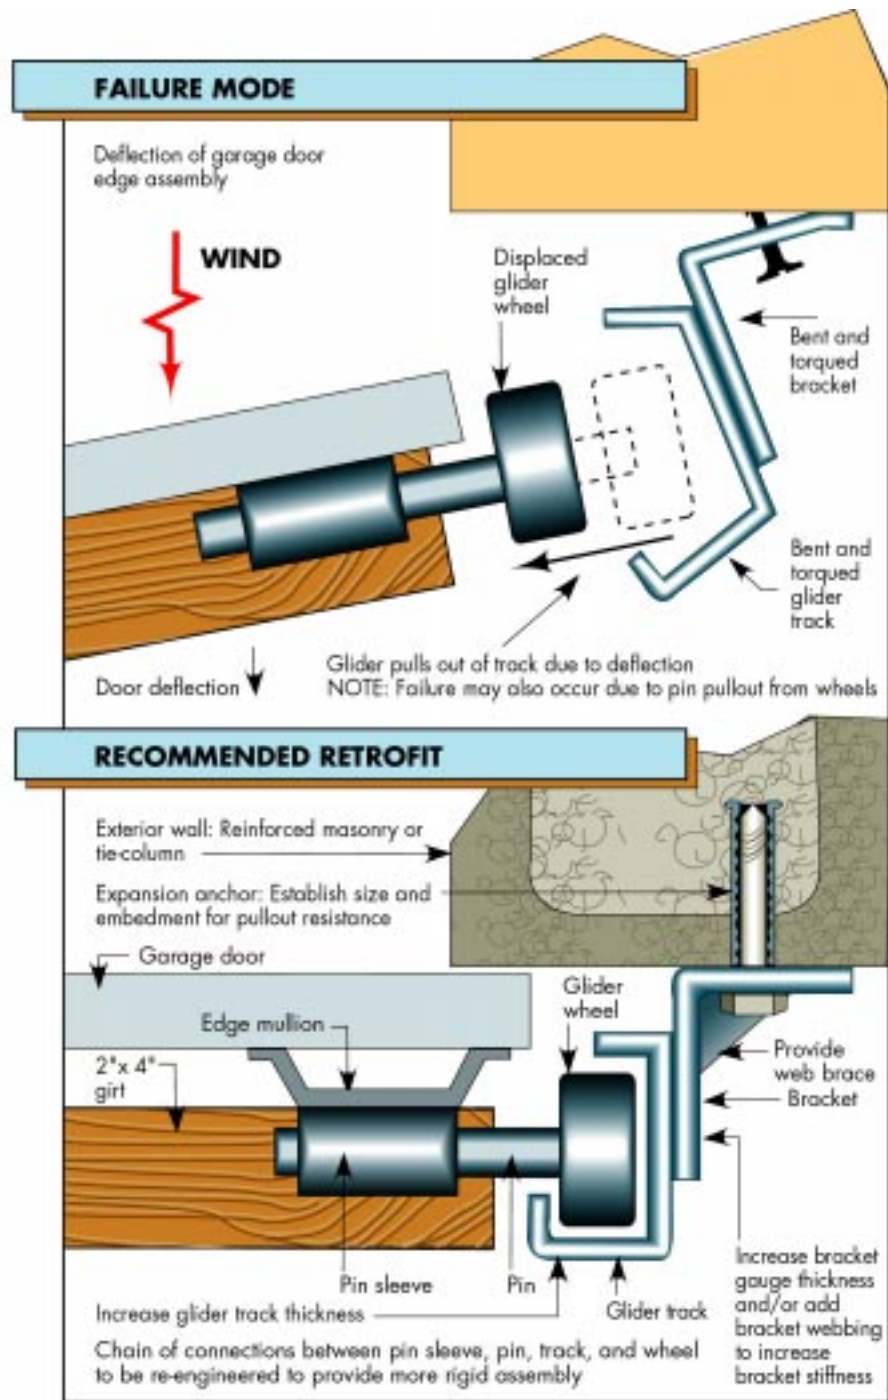
Detail B from Figures 18 e door failure at track and recommend assembly improvements.

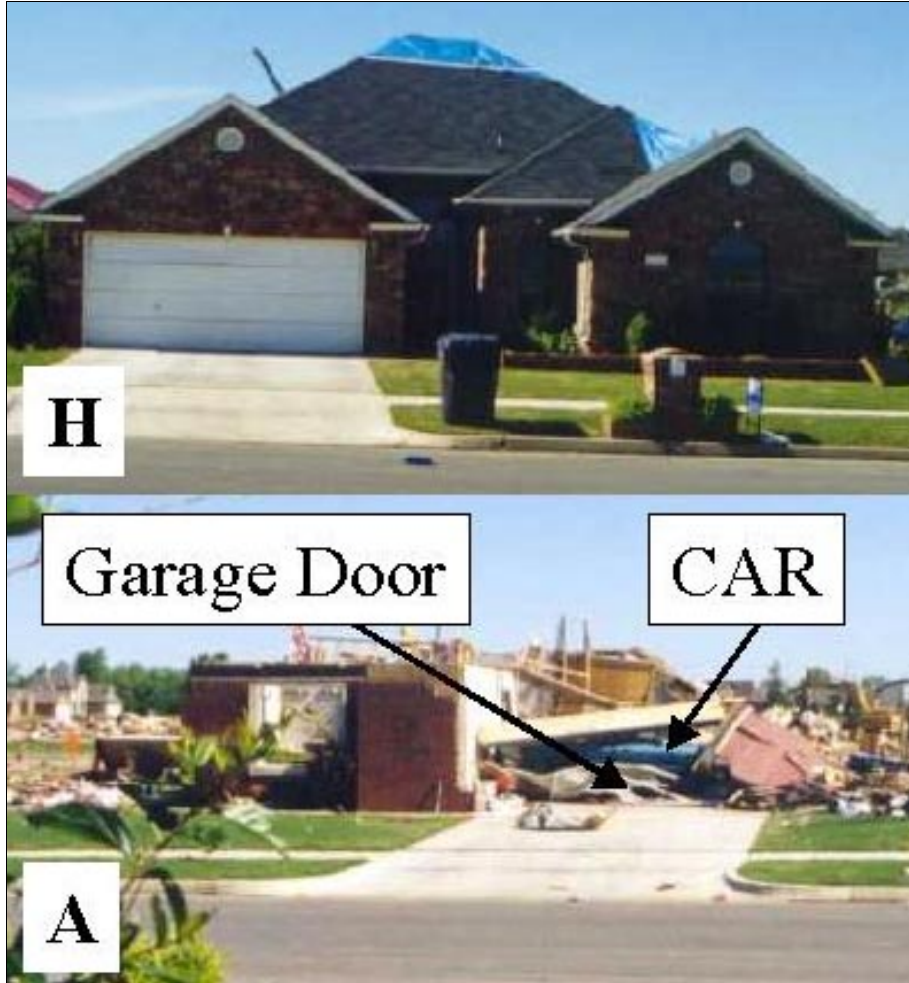
Homes located at H and A are shown in Figure 4-20. The damage states of the two homes are significantly different even though they are located directly across the street from one another, approximately 95 feet, and may have experienced relatively similar wind conditions based on the approximate track location (Figure 4-19). The home located at H had seven broken windows, primarily at the back of the home as a result of debris generated from a failed wooden fence. It also had one breached glass entry door, and lost approximately 60% of its roof covering. The home located at A lost its entire roof and several exterior walls. For the remaining structures, similar “across-the-street” damage gradients were observed between the homes, A through G and H through N, with the exceptions of the home at location F, which did not lose its entire roof, and the home at location G, which did not lose any roof, but did sustain severe roof framing damage due to uplift. Table 4-1 (**not included at this time**) lists observed damage states for all homes shown in Figure 4-19, illustrating the expected decreasing damage gradient as the distance between home and storm track increases.

FIGURE 4-20: Home in Moore, Oklahoma, with partial roof loss (H) vs. home with total roof loss due to garage door failure (A) under positive pressure.

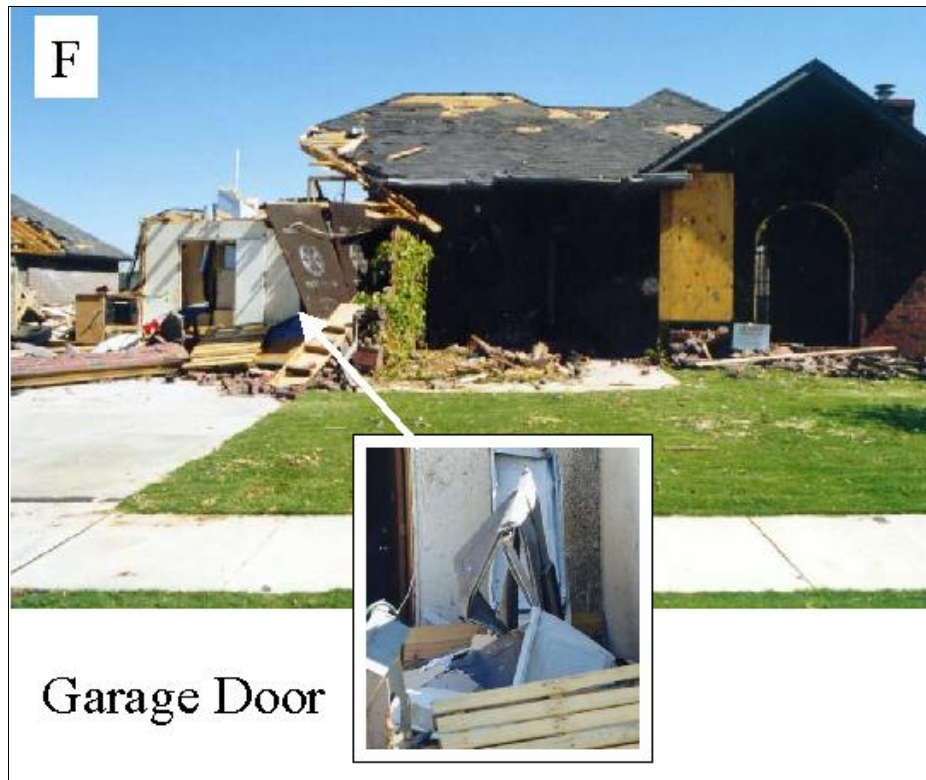
FIGURE 4-22: Garage door failure possibly resulting in the localized partial roof failure on the left side of this home located in Moore, Oklahoma.

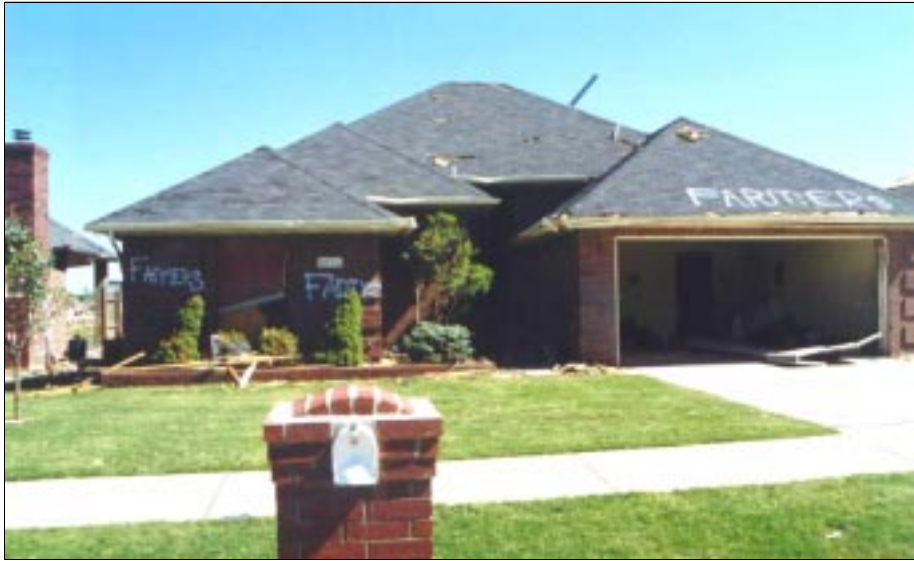
A final example of observed internal pressurization and roof uplift is shown in Figures 4-23 and 4-24 for the house located at G. The garage door failed by positive pressure and was found inside the garage. Figure 4-24 shows strong evidence of the early stages of roof uplift between the garage roof and exterior wall. The ceiling was observed to have pulled away from the exterior wall perimeter, indicating that the whole roof frame was lifted up. The space shown in Figure 4-24 was apparent along most of the perimeter of the garage ceiling. Figure 4-21 shows an exterior view of the roof and wall interface where the initiation of roof uplift was observed. Tension cracks in the brick

FIGURE 4-23: A view of home G with a garage door that failed due to positive or inward acting wind loads.

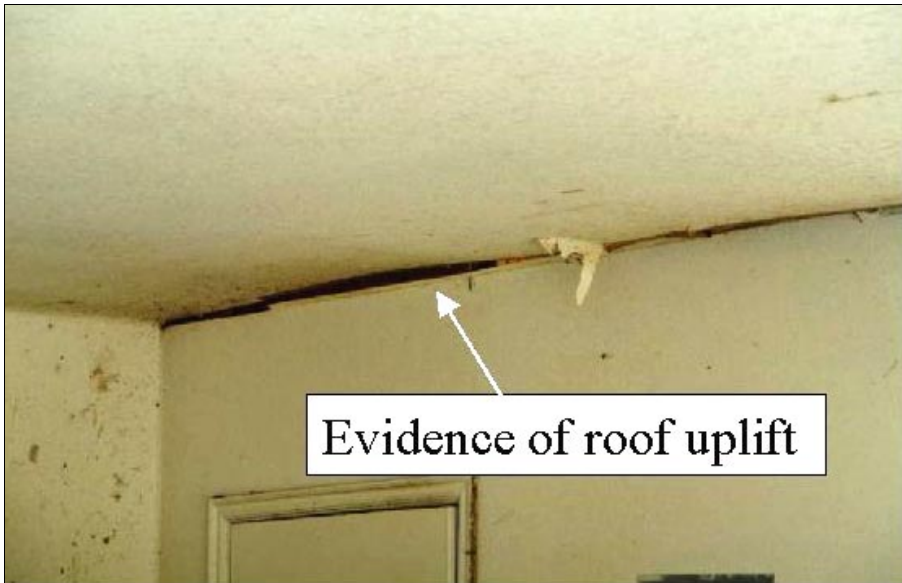
vener and a large gap along the length of the right exterior wall between the roof and top plate were also observed.

FIGURE 4-24: Roof uplift between garage roof and exterior wall at home G.

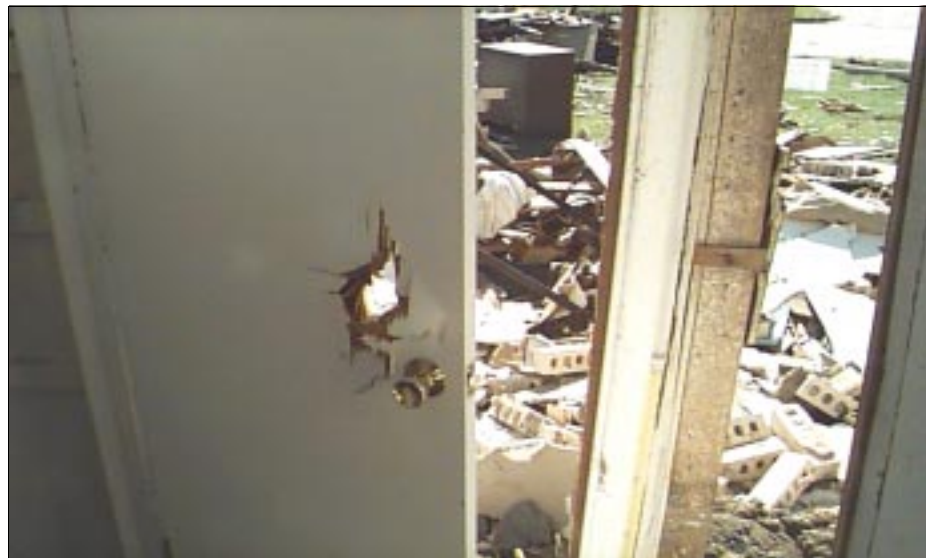
FIGURE 4-25: A missile penetrated this exterior door in Del City, Oklahoma. Interior hollow-core doors typically offer even less missile protection than common exterior doors.

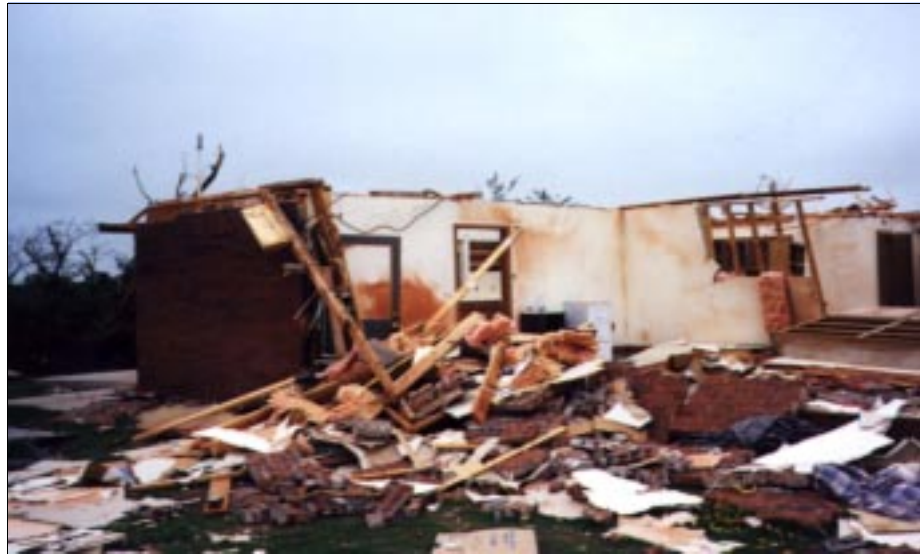
FIGURE 4-30: Failure of brick masonry veneer construction. The vortex of the severe tornado that caused the winds at this site passed approximately 30 feet from this building in Bridge Creek, Oklahoma.

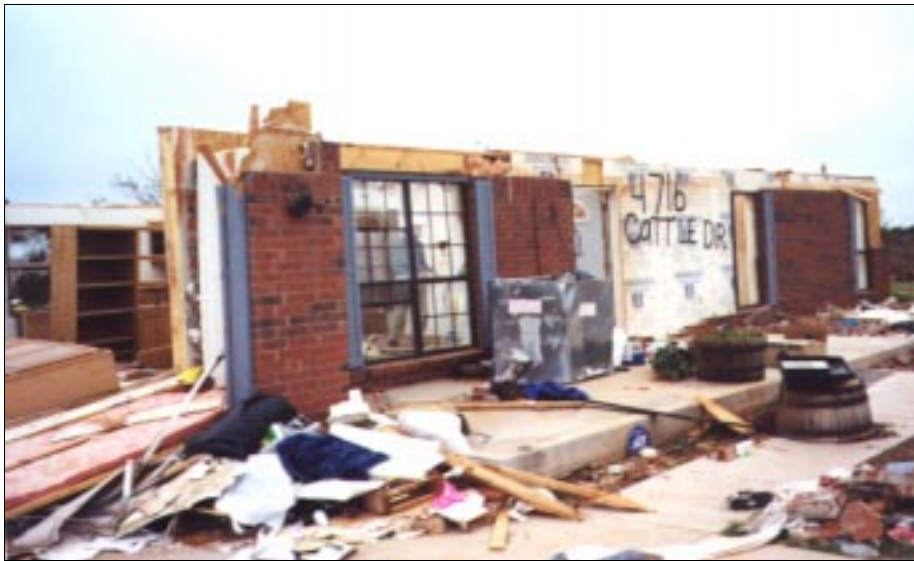
FIGURE 4-31: Brick veneer failure at the house shown in Figure 4-30.

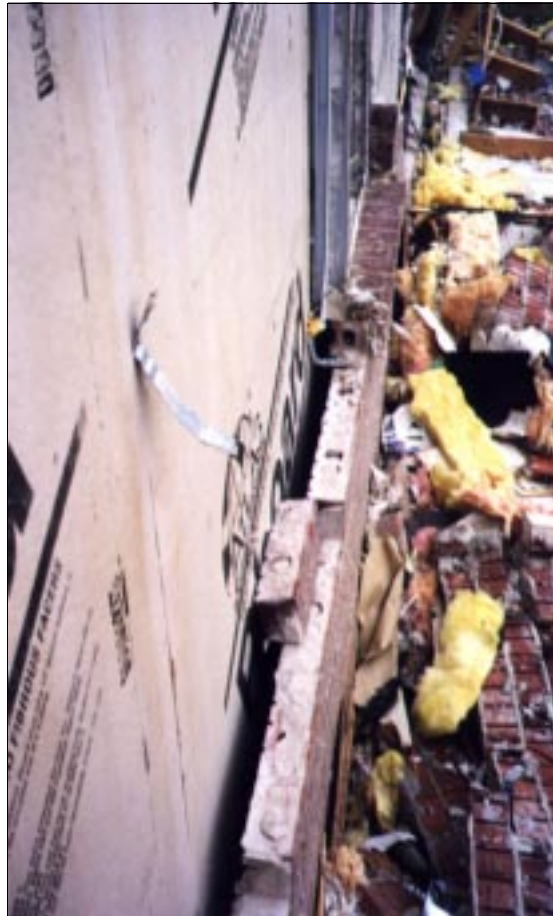
FIGURE 4-35: Inadequate bonding of mortar to galvanized brick ties, Bridge Creek, Oklahoma.

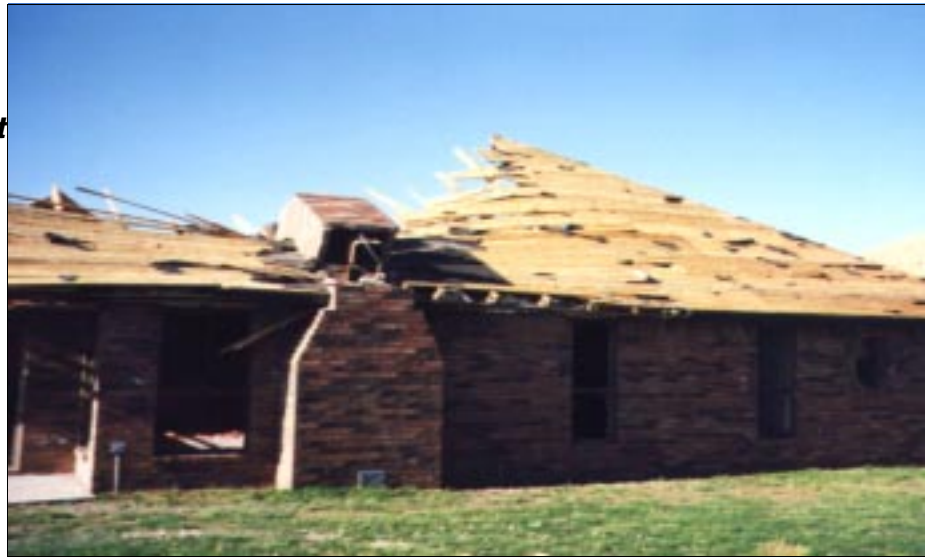
FIGURE 4-40: Failure of brick chimney onto roof of home located along the periphery of a violent tornado, Moore, Oklahoma.

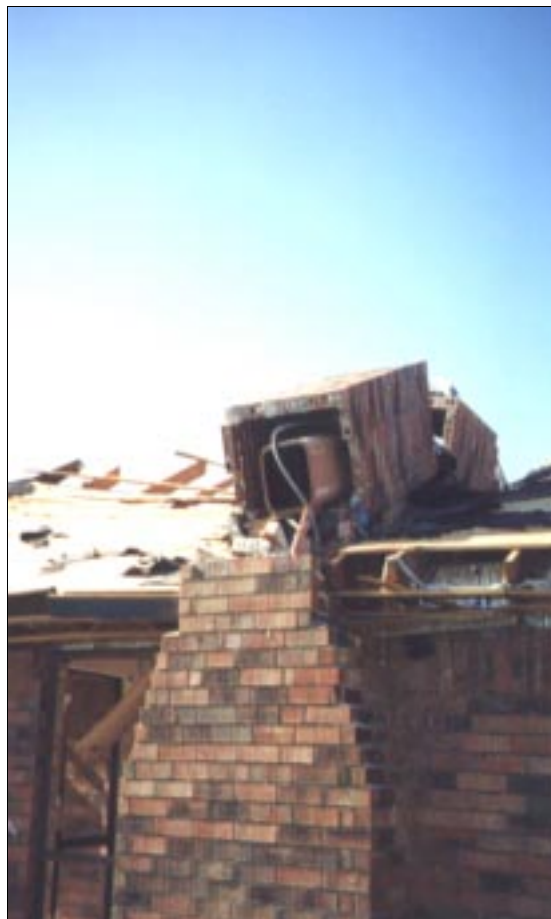
FIGURE 4-41: Close-up view brick chimney failure in Figure 4-40.

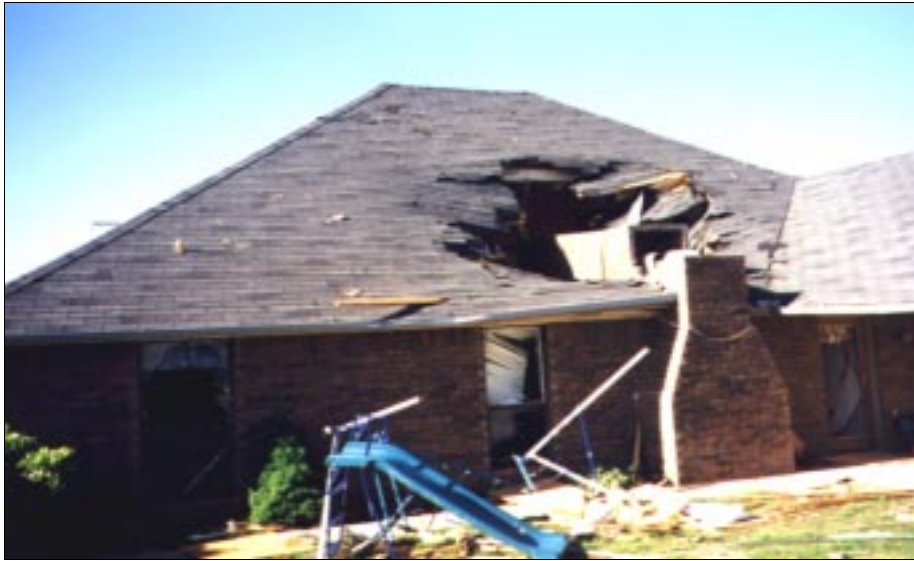
FIGURE 4-42: Failure of brick chimney onto top of home located along the periphery of a violent tornado, Moore, Oklahoma.

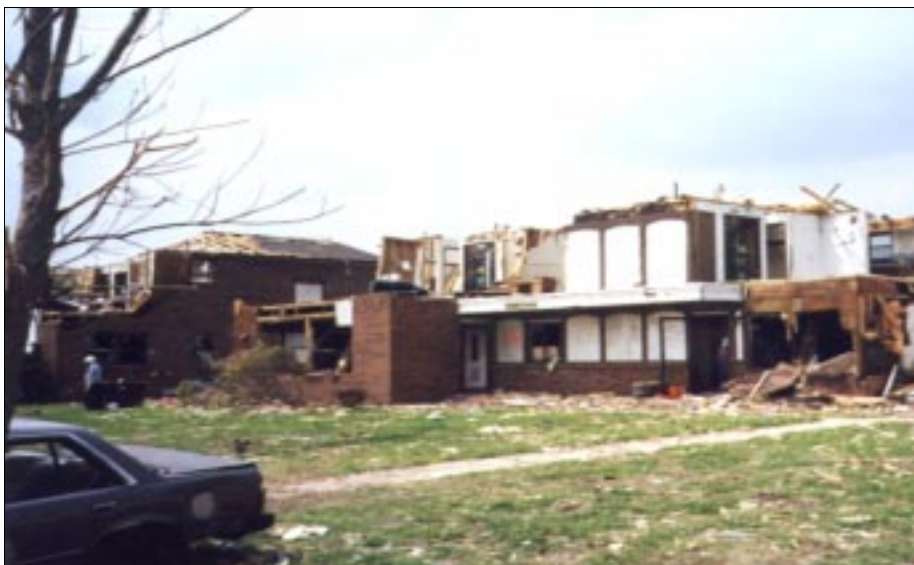
FIGURE 4-43: Failure of masonry veneer.

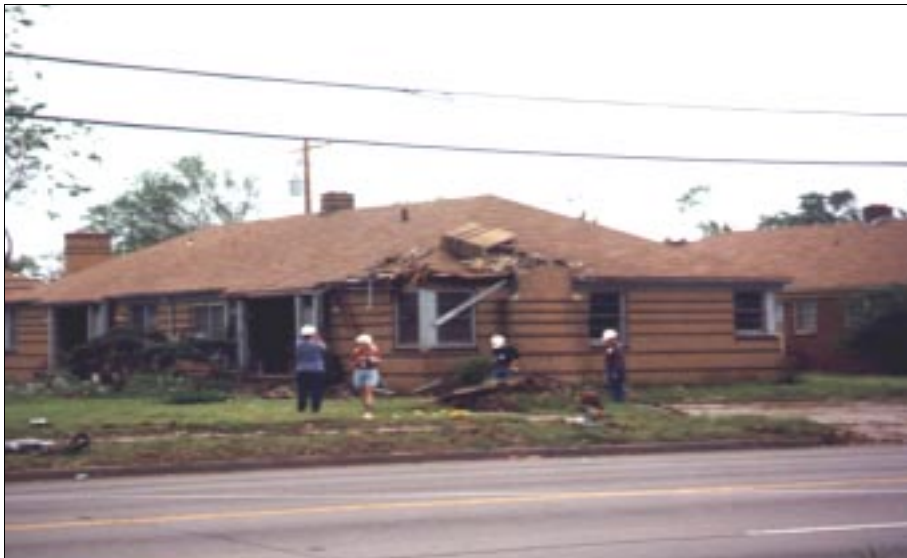
FIGURE 4-46: Chimney failure onto roof of single family attached housing, Wichita, Kansas. This building was located along the periphery of a severe tornado.

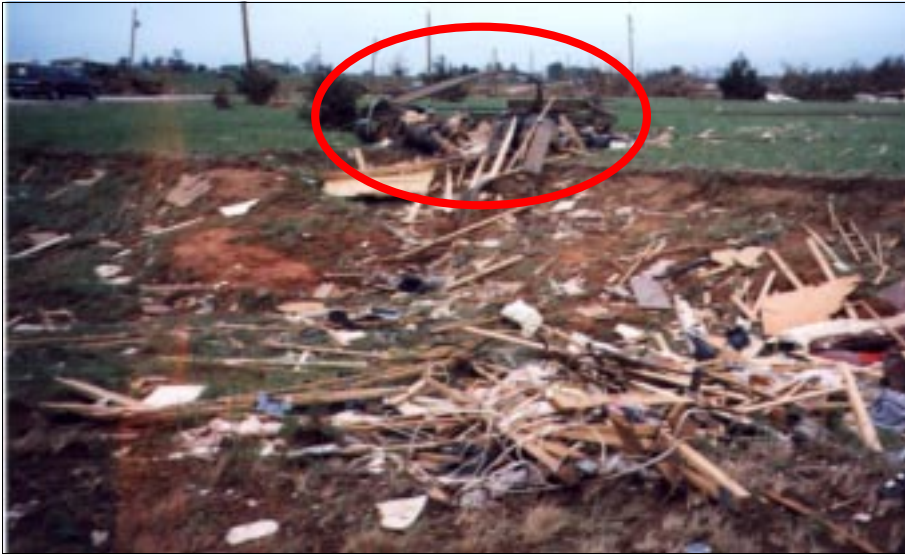
FIGURE 4-48: This 14-ft x 60-ft manufactured home chassis in the background of this picture moved about 200 yards from its original anchoring site in Figure 4-49, Bridge Creek, Oklahoma.

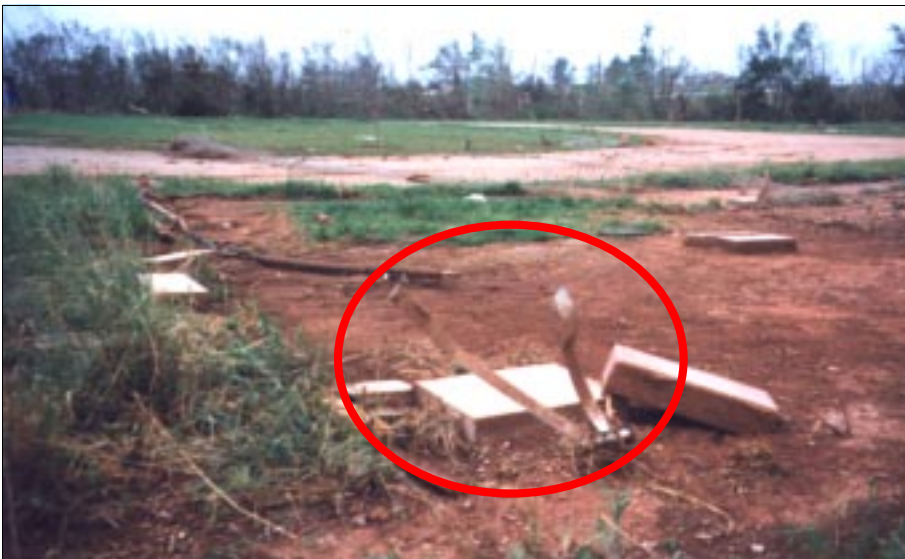
FIGURE 4-49: Failed straps at the anchorage of a manufactured home in Bridge Creek, Oklahoma. This site was 300-400 feet from a violent tornado vortex.

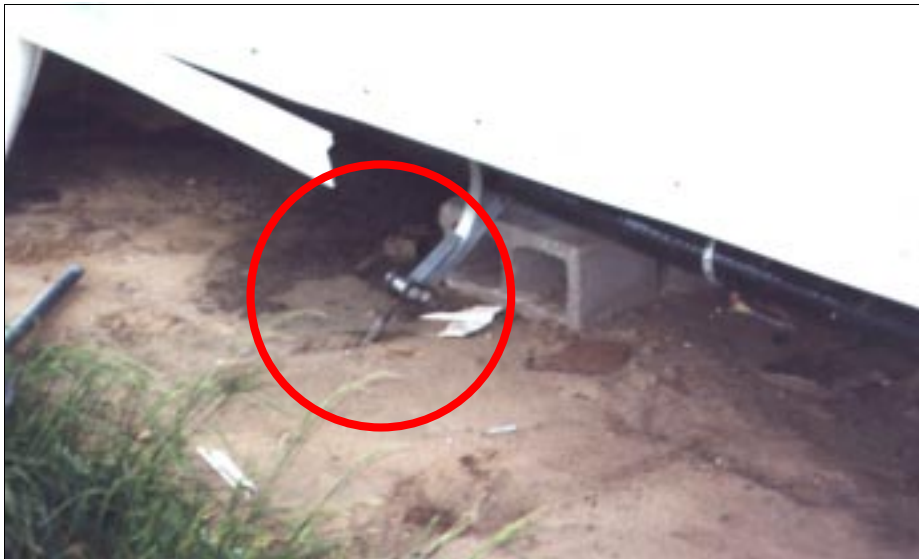
Figure 4-52: Anchor of manufactured home bent and pulled up from soil. This home in Wichita, Kansas, was located within the inflow area of a severe tornado.
