Building Performance Assessment Report

Hurricane Georges...

In The Gulf Coast

**Observations,
Recommendations,
and Technical Guidance**

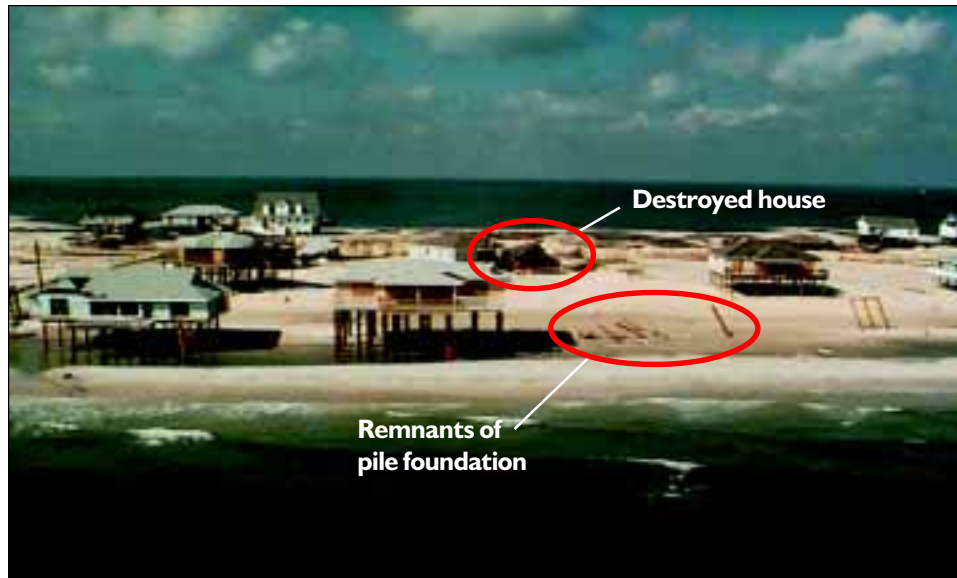
FIGURE 3-4 Front-row house separated from its foundation and destroyed by the storm on Dauphin Island, Alabama. Note the properly elevated and set back house on the right fared very well.

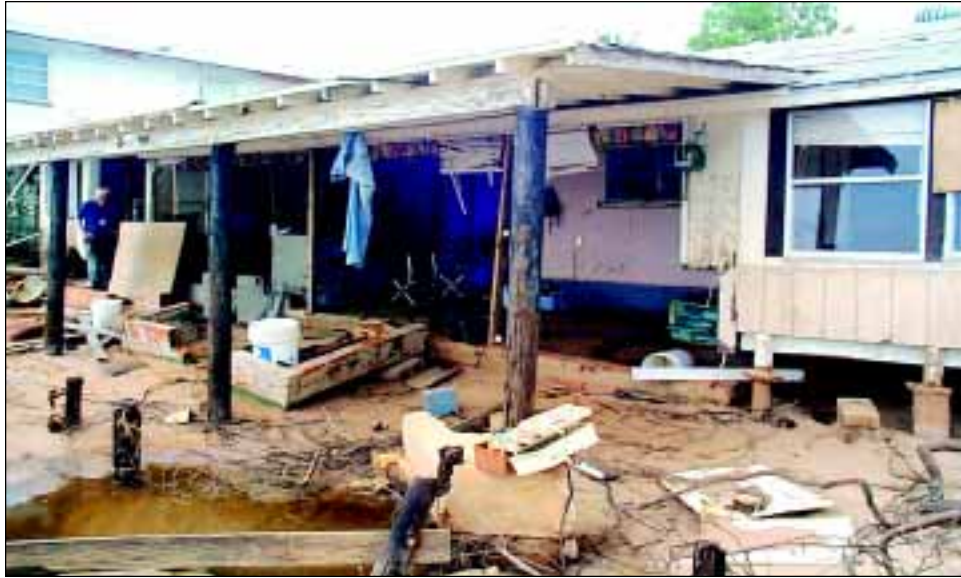
FIGURE 3-8 In some cases, scour behind bulkheads resulted in structural damage along Mobile Bay, Alabama.

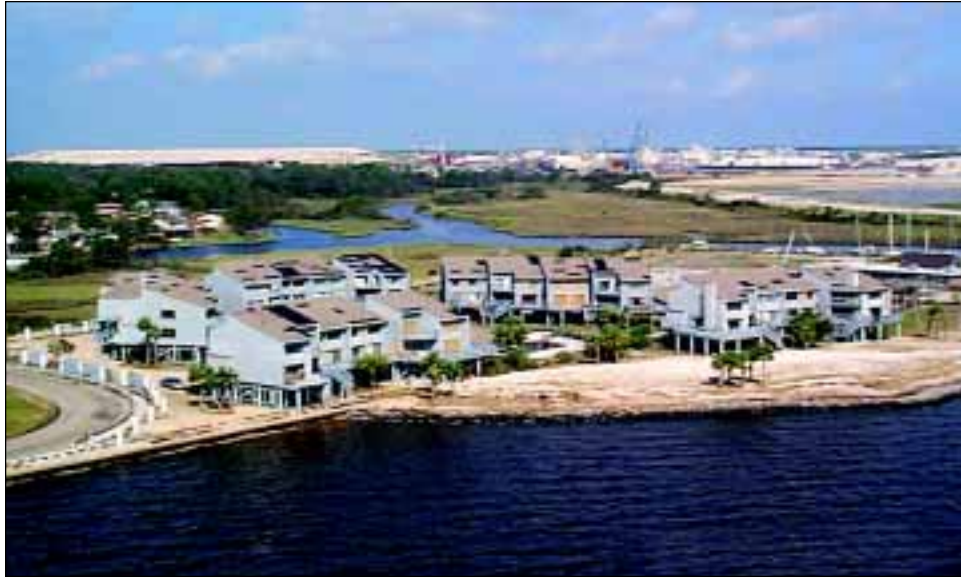
FIGURE 3-11 These condominiums near Pascagoula, Mississippi suffered wind damage to roofing shingles and siding.

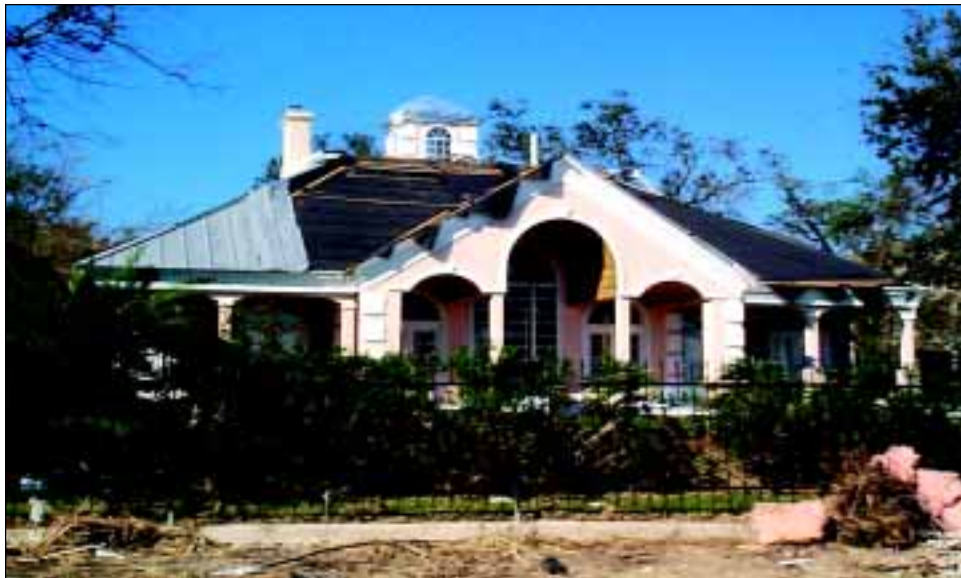
FIGURE 3-12 Wind damage to roofs and trees in Pascagoula, Mississippi.

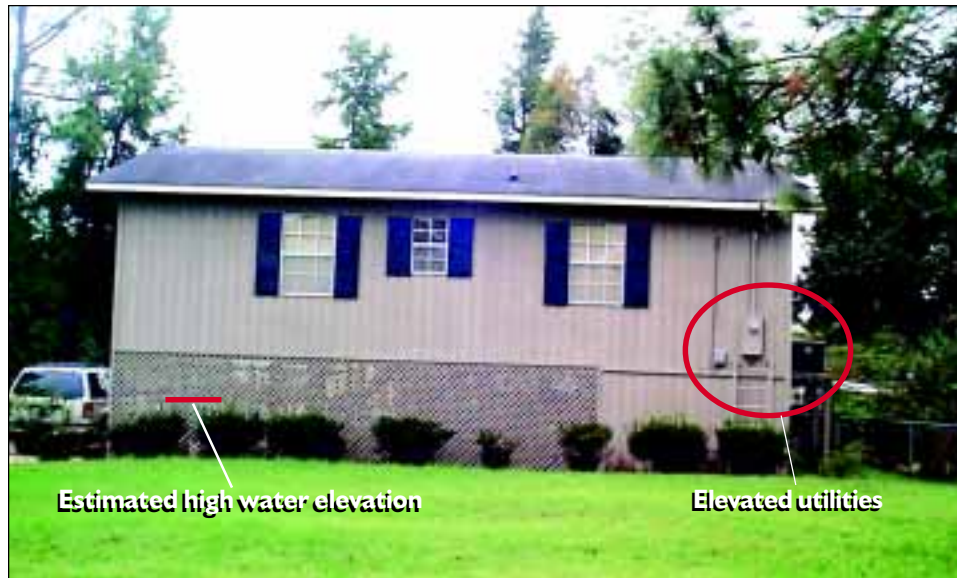
Elevated structures still have some degree of residual flood risk. The house pictured in Figure 4-6 was previously elevated by the homeowner and subsequently was flooded approximately 1 inch to 2 inches above the first floor by Hurricane Danny. Fortunately, flood levels in this area during Hurricane Georges were less than those experienced during Hurricane Danny. The only damage to this home during Hurricane Georges was to the contents stored below the first floor.

FIGURE 4-6 Previously elevated house along the Fish River suffered damage to contents below the first floor. Note that the homeowner also elevated utilities on the right side of house, preventing loss or damage.

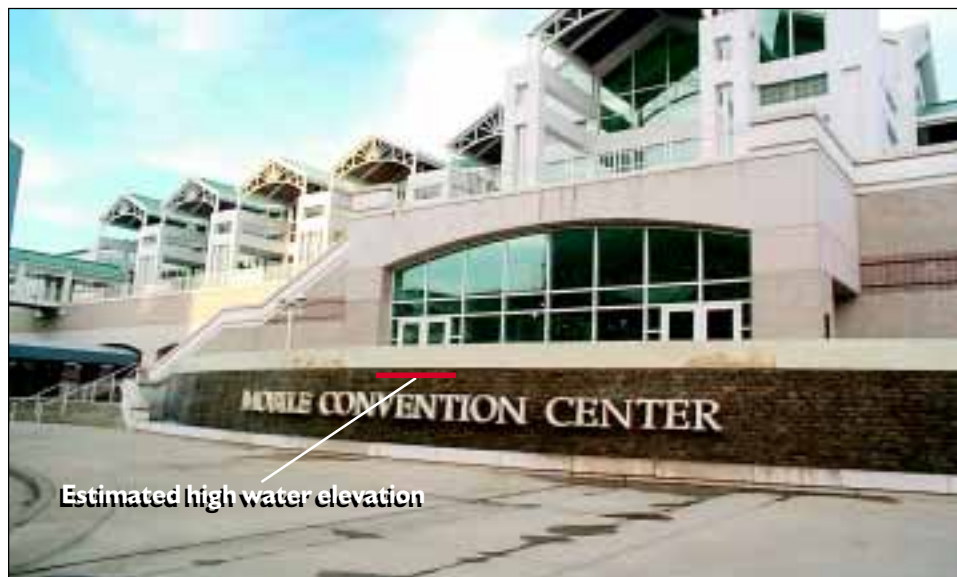
Located in Upper Mobile Bay, the Mobile Convention Center, which was constructed in 1993, is the centerpiece of downtown Mobile's revitalization efforts (Figure 4-7). Elevated above the BFE, the Convention Center received only minor damage from Hurricane Georges. Total damage — including flood fighting and cleanup costs — has been \$156,000 to date with approximately \$350,000 estimated for additional repairs. Most of the damage incurred was due to wind-driven rain that entered around windows and doors. Since the Convention Center was properly elevated, it was able to resume operations within three days after Hurricane Georges. In addition, the center received additional bookings from other

FIGURE 4-7 Despite approximately 7 feet of flooding in this area, the Mobile Convention Center suffered only minor damage and was operational when the floodwaters receded.

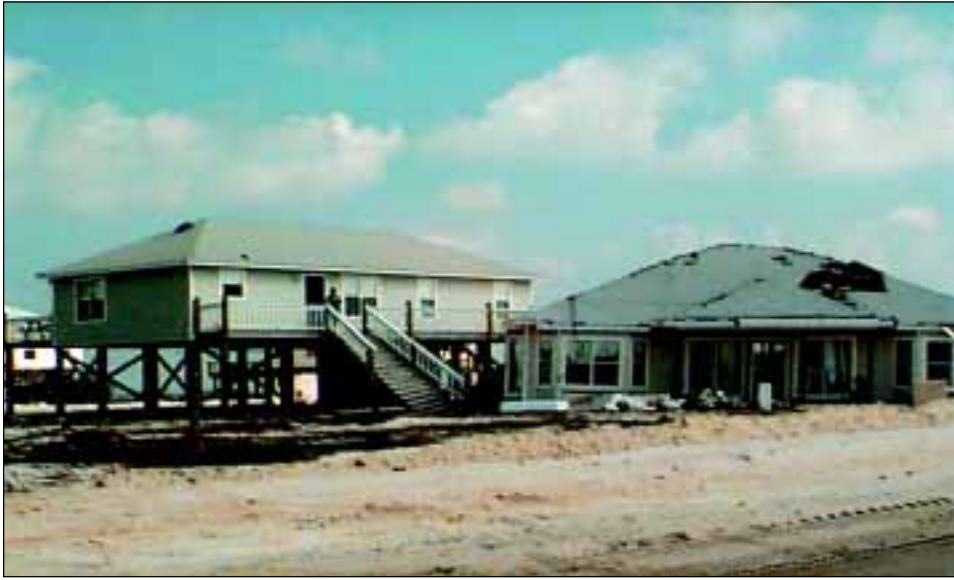
A combination of inadequate pile embedment with erosion and scour resulted in the failure of several homes on pile foundations on the windward/southern side of Dauphin Island (Figure 4-10). While some structures did not suffer complete losses, they did suffer severe damage due to the surge. Damage included loss of piles, movement and/or settlement of piles, leaning or partial collapse of the structure, washout and scour around piles and around and under grade level concrete slabs, loss of exterior access stairways, and loss of lower level enclosures.

FIGURE 4-10 The structure on the right lost its pile foundation system and was washed into the structure on the left.

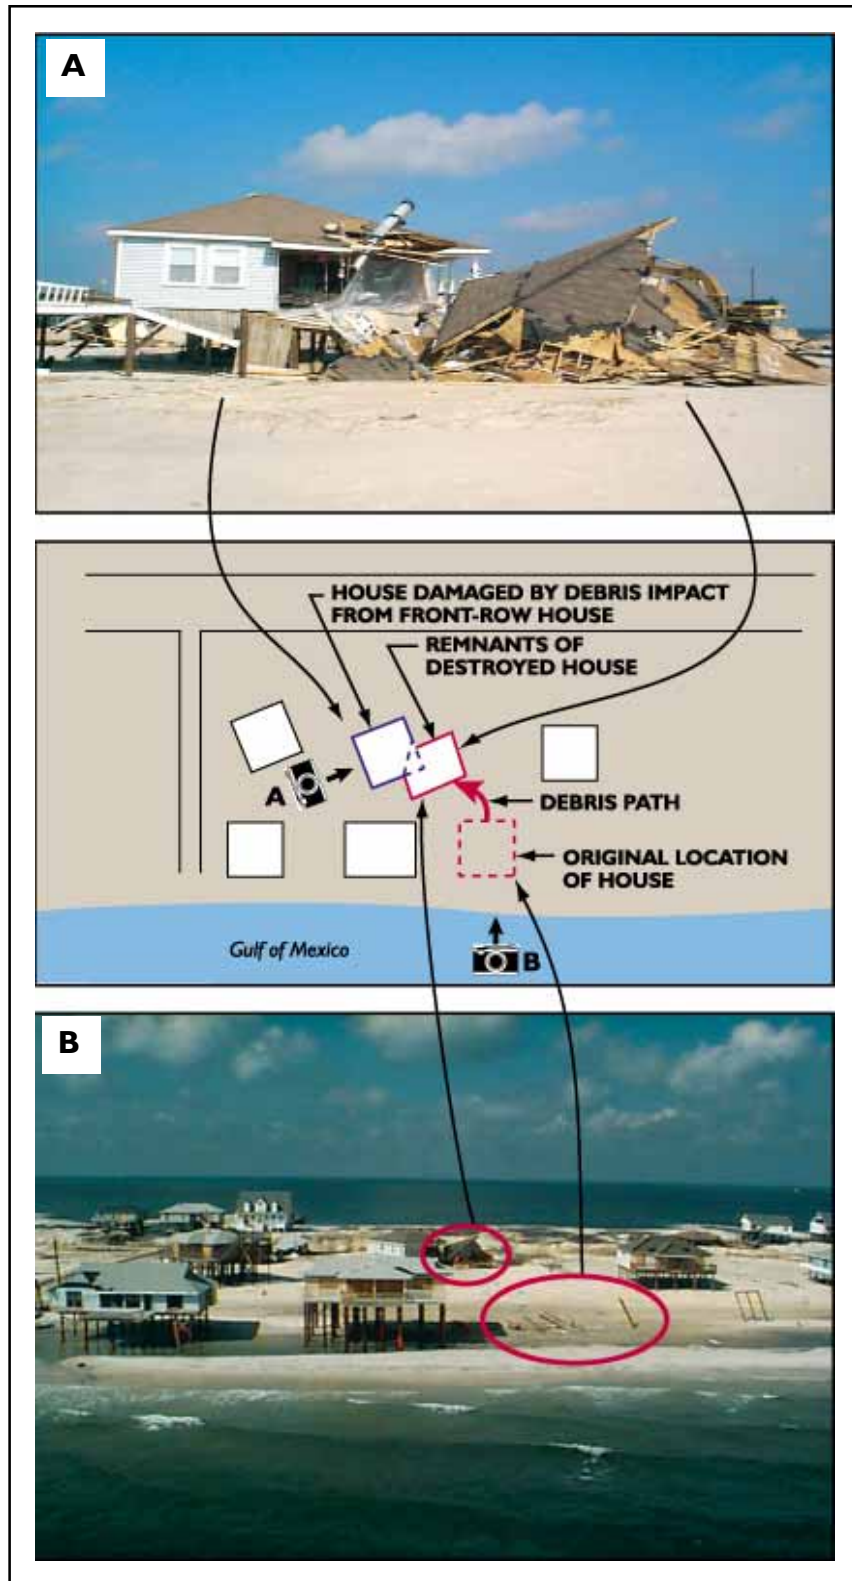
FIGURE 4-15 Significant debris impact created by destruction of a front-row house.

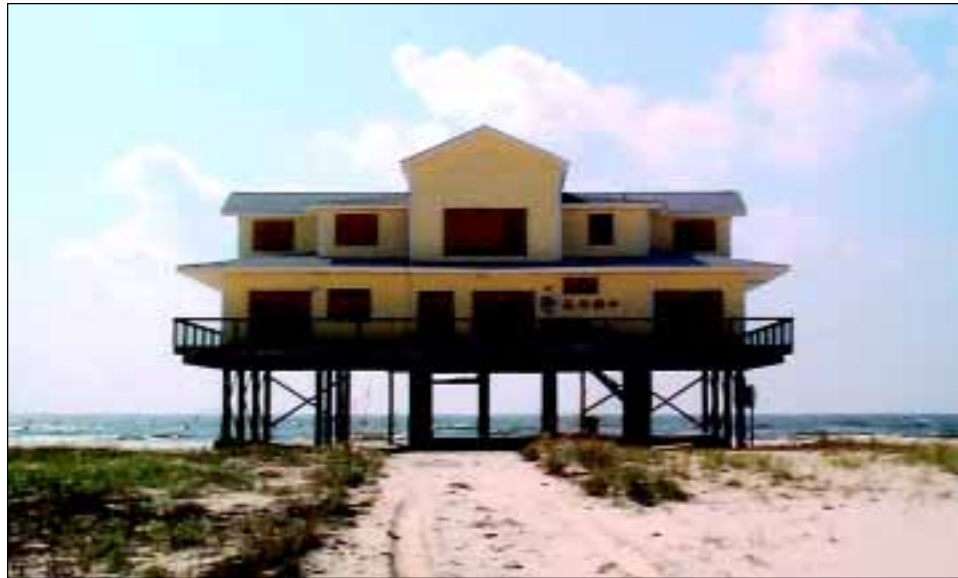
FIGURE 4-18 This house sustained no damage with the exception of loss of stairs and items stored below the first-floor elevation.

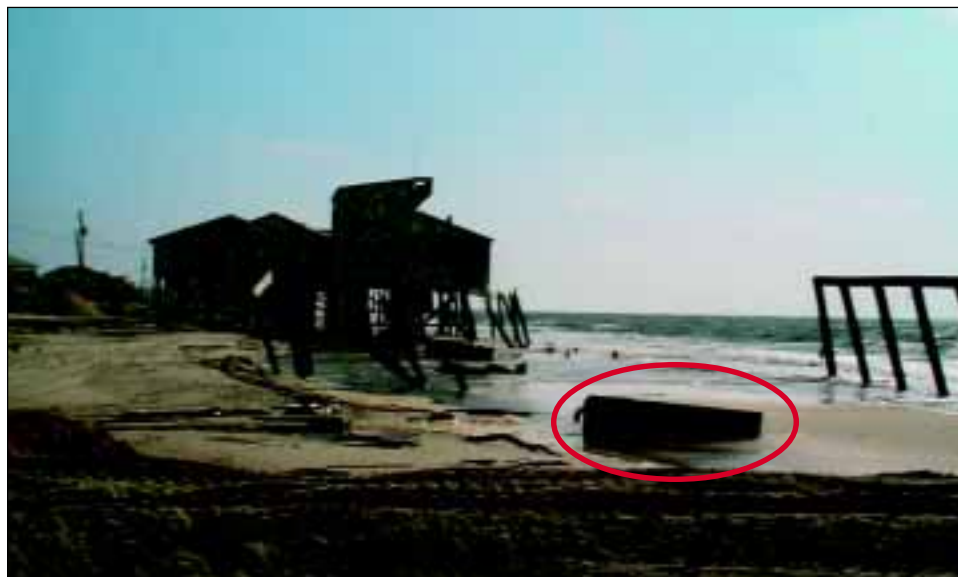
FIGURE 4-19 Old concrete septic tanks (circled) and drain fields have been superseded by the new municipal sanitary sewer system. The old systems still create a hazard as waterborne debris.

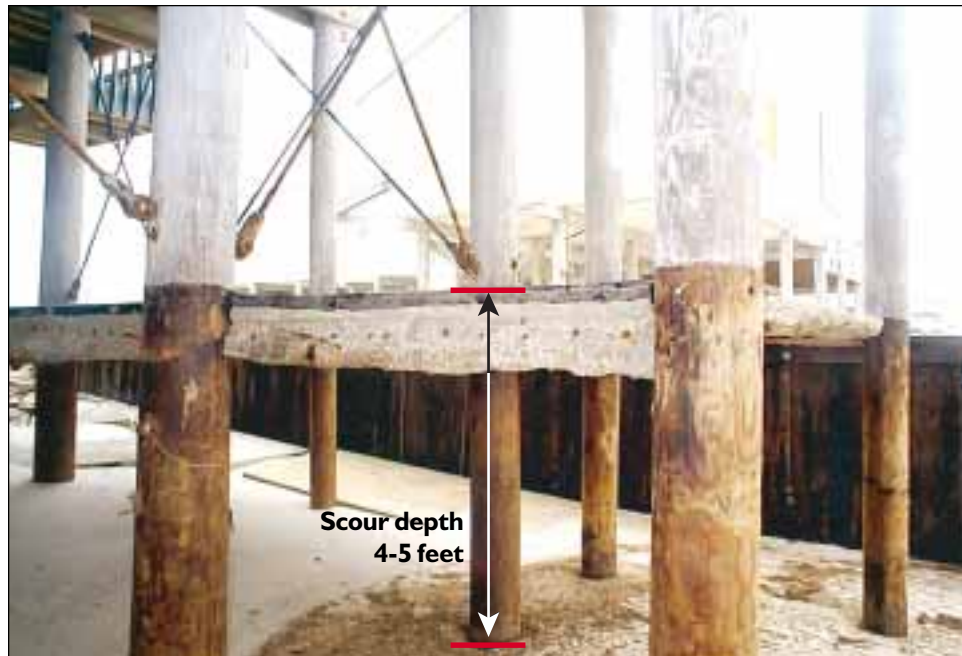
FIGURE 4-21 Erosion/scour behind bulkhead and below the concrete slab caused by storm surge. Note the concrete slab did not completely detach from the piles.

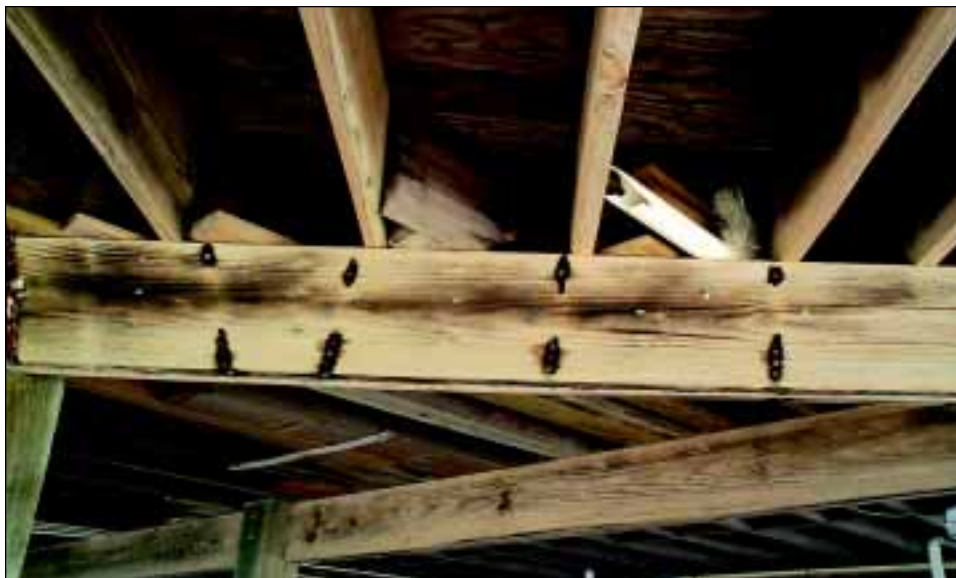
FIGURE 4-24 Only remnants of corroded hurricane straps remain.

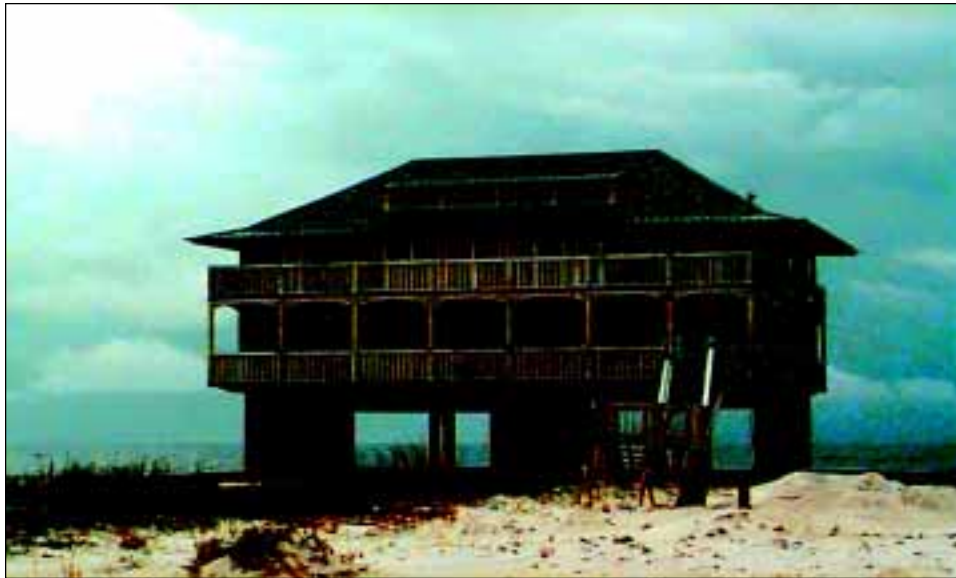
FIGURE 4-27 This properly elevated structure in Gulf Shores suffered no damage other than the loss of breakaway walls and slight damage to its stairs.

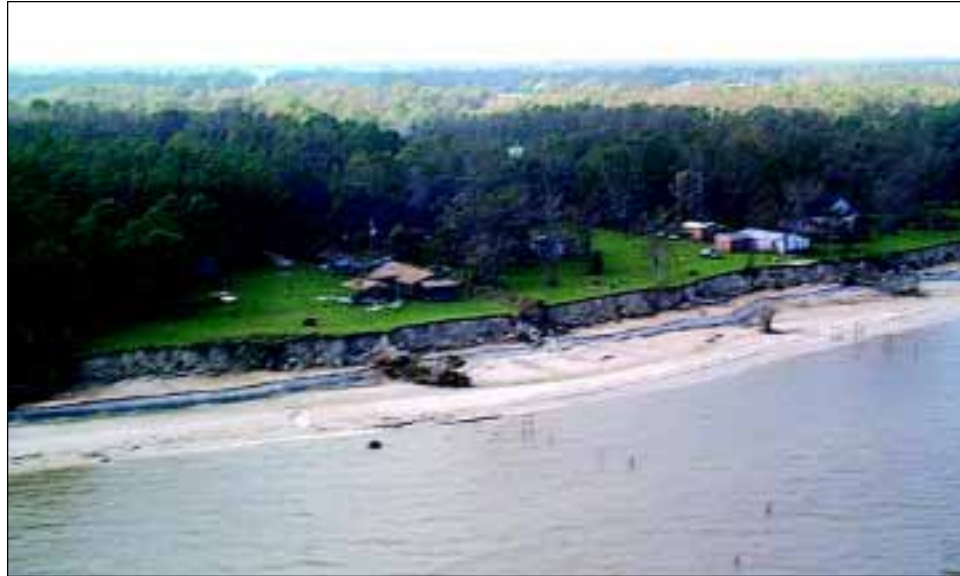
FIGURE 4-29 Typical erosion along bluffed shoreline areas of Mobile Bay (western side).

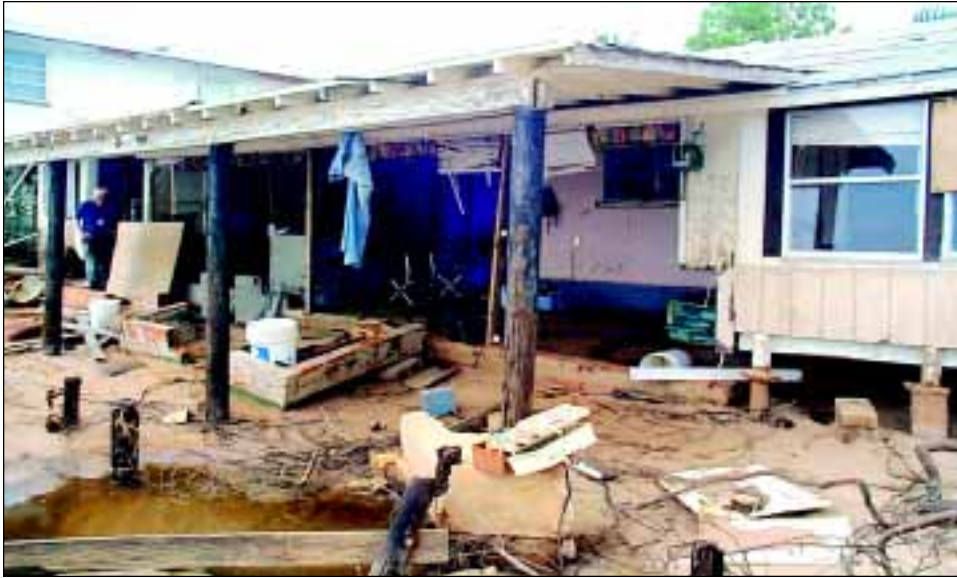
FIGURE 4-31 Non-elevated pre-FIRM structure severely damaged by coastal storm surge.

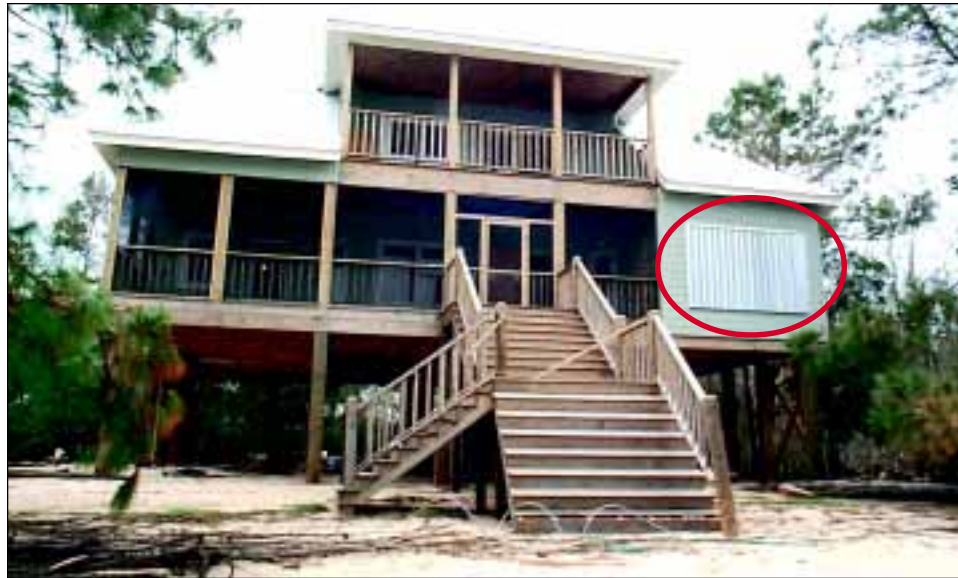
FIGURE 4-33 A properly elevated post-FIRM front-row coastal house that suffered only minor damage to stairs. Note the storm shutter on the front window.

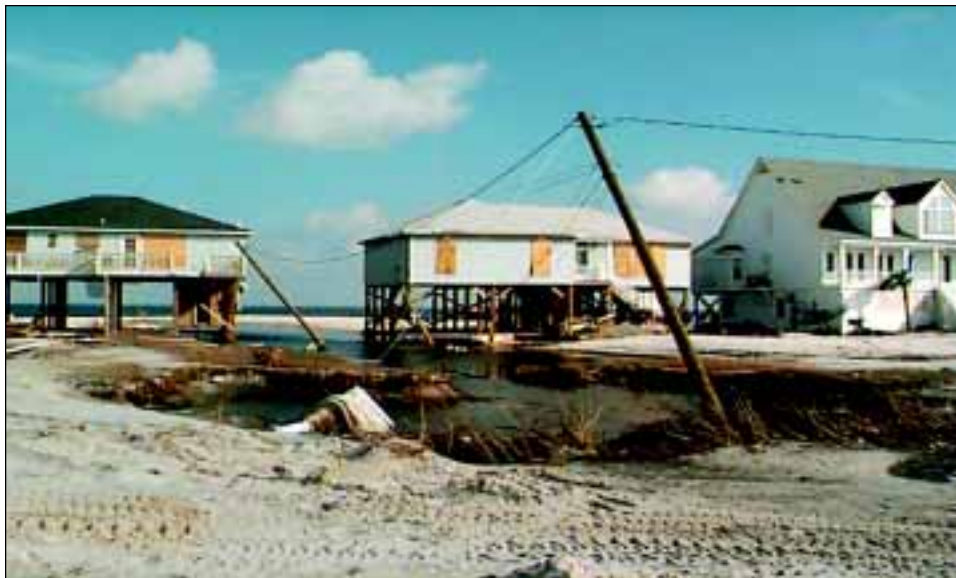
FIGURE 4-35 Utility poles damaged by wind, coastal surge, and erosion.

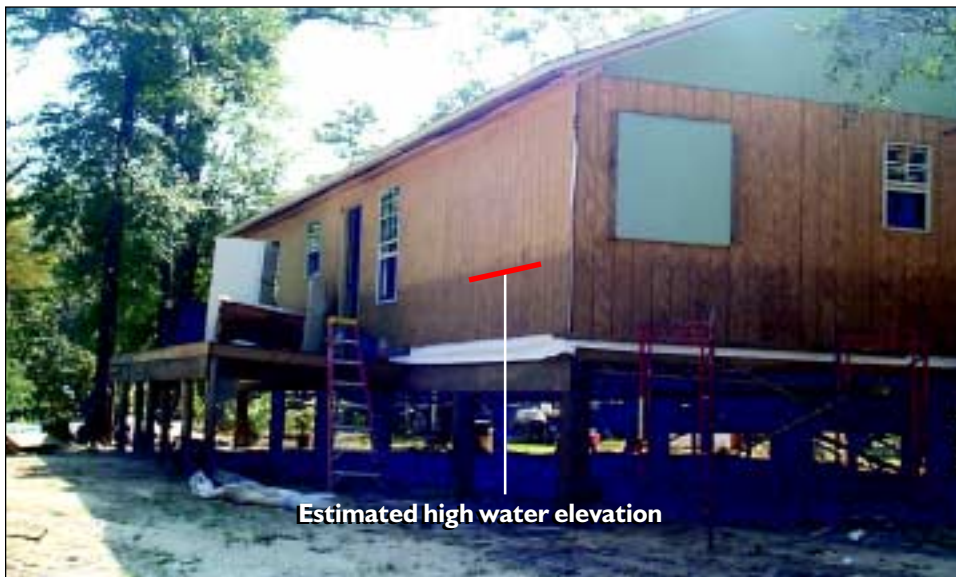
FIGURE 5-2 A high water mark is visible approximately 3 feet above the first floor elevation. The house, located along the Shoal River in Okaloosa County, suffered little damage because insulation and wallboard had not yet been installed.

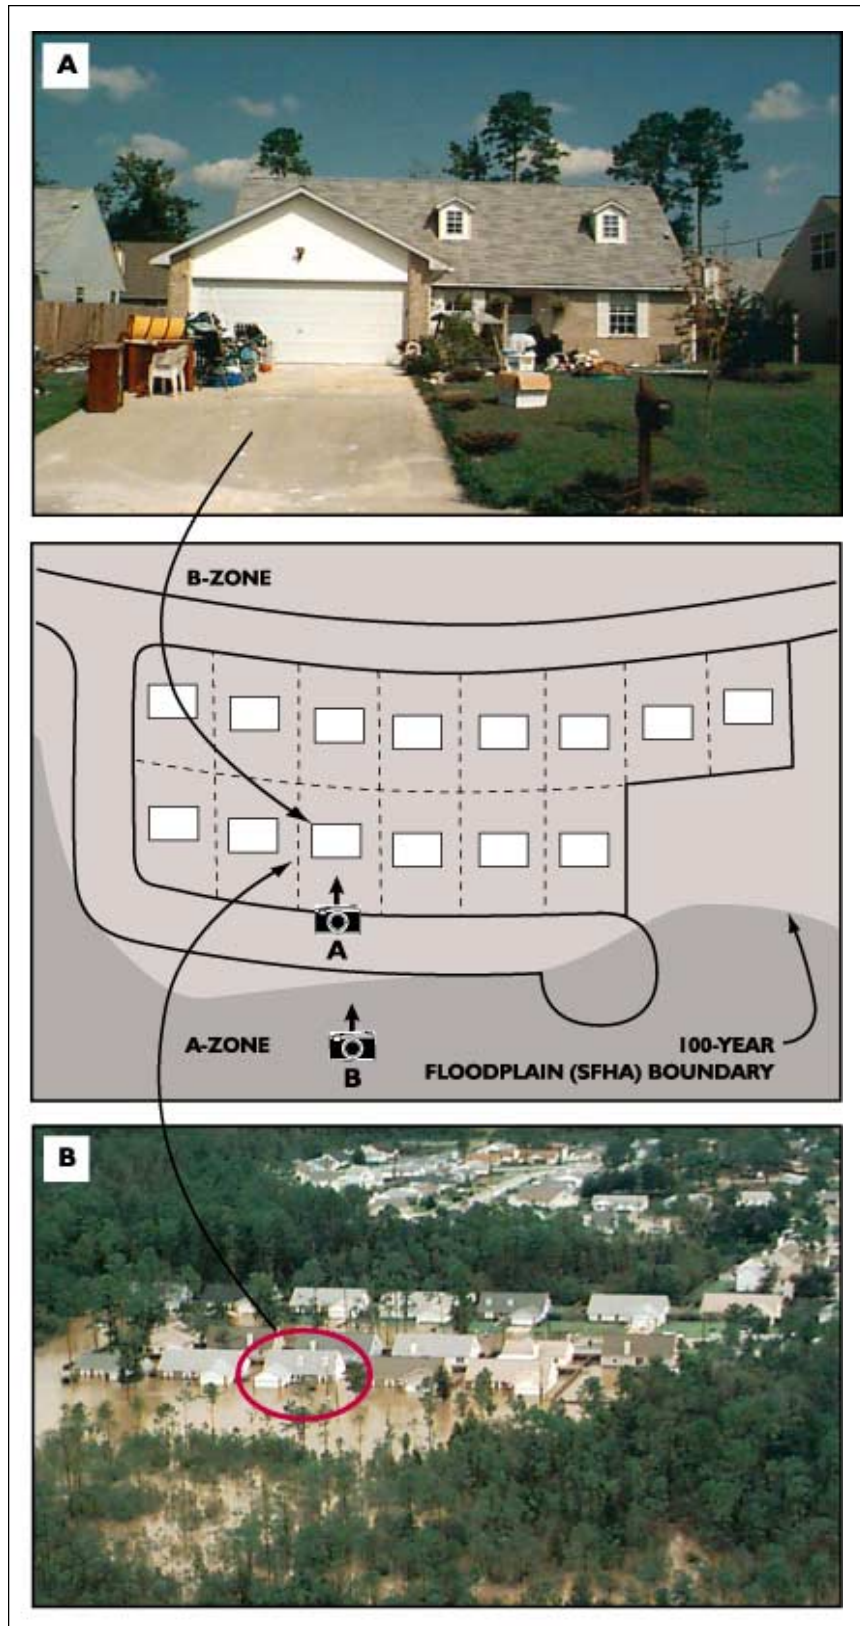
FIGURE 5-3 The home pictured above is one of approximately 10 homes in this subdivision which experienced flood depths of 2 to 3 feet when the water levels exceeded the BFE and extended beyond the limits of the SFHA.

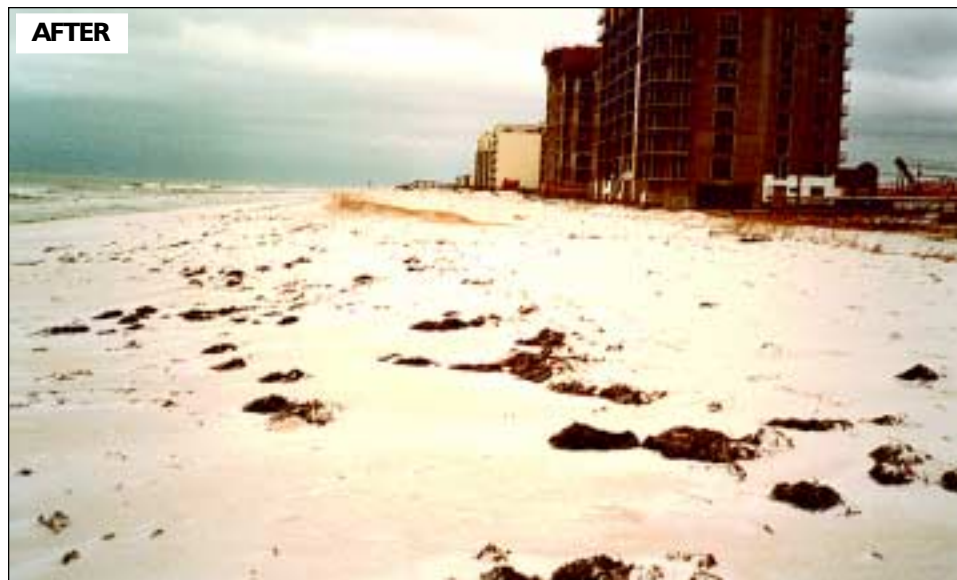
FIGURE 5-8 Navarre Beach after Hurricane Georges. Note the loss of revegetated dune.

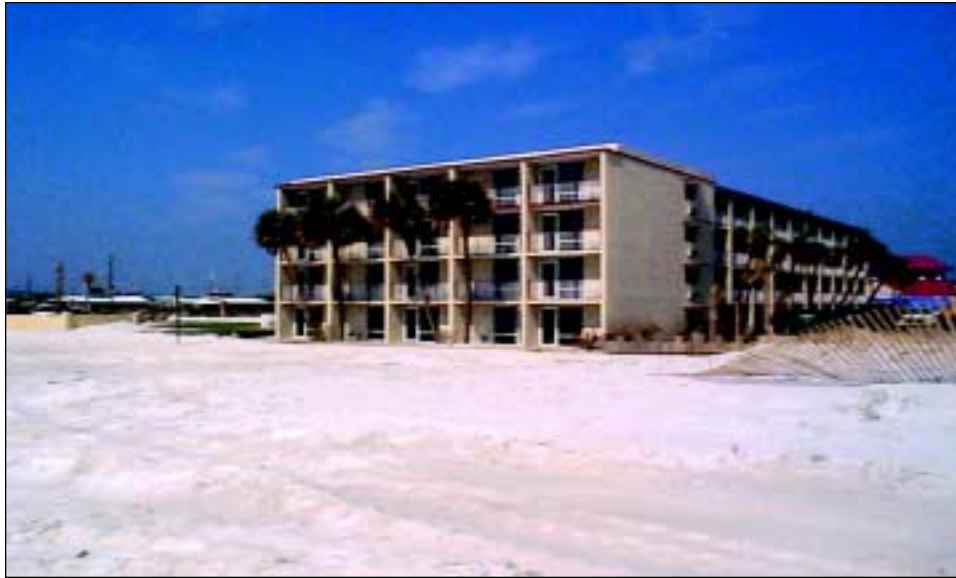
FIGURE 5-11 An older hotel that suffered significant damage to the interior due to storm surge and roof leakage.

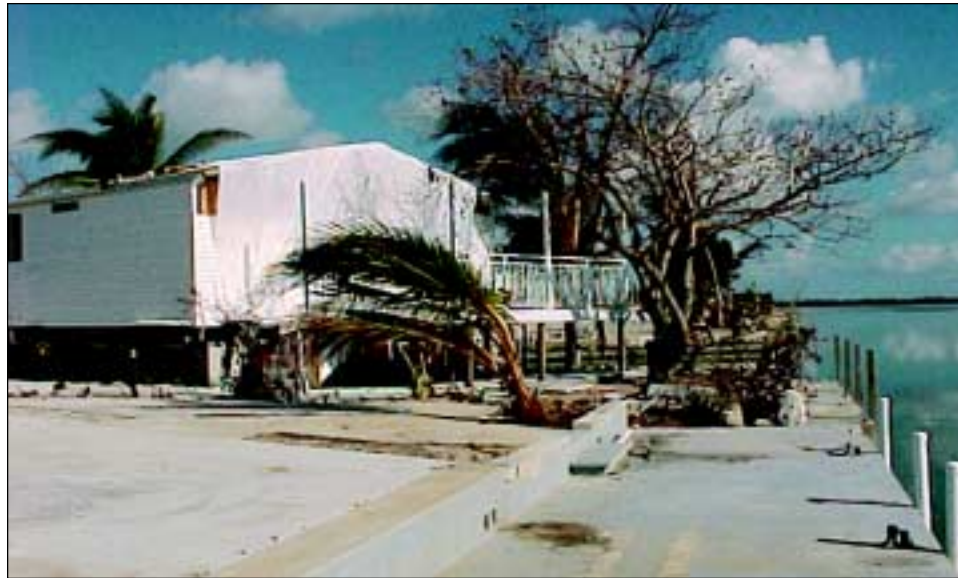
FIGURE 5-17 This home suffered damage when its awning blew off. The lot next door contained an older manufactured home that was completely destroyed by high winds and coastal surge.

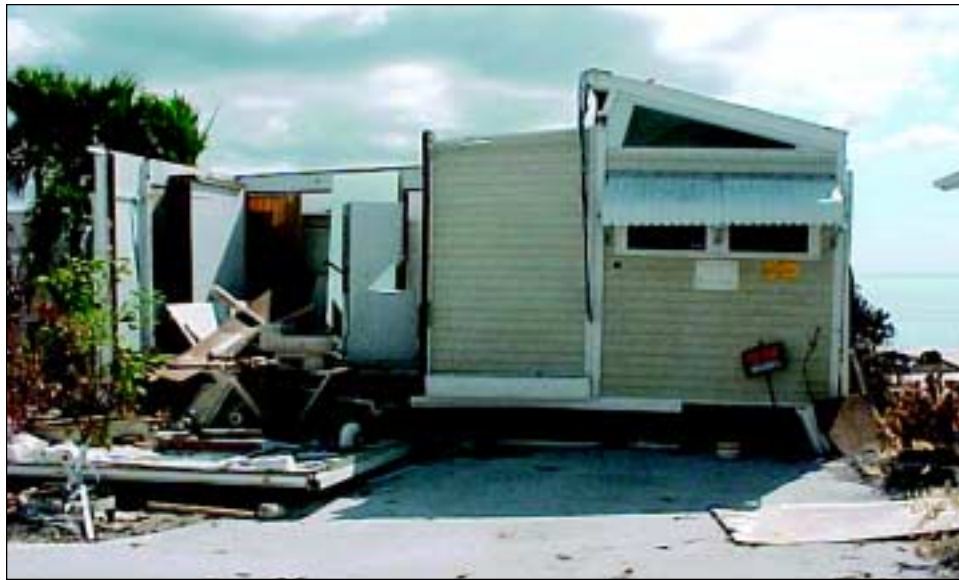
FIGURE 5-20 Older, non-elevated manufactured home with an addition that sustained substantial damage.

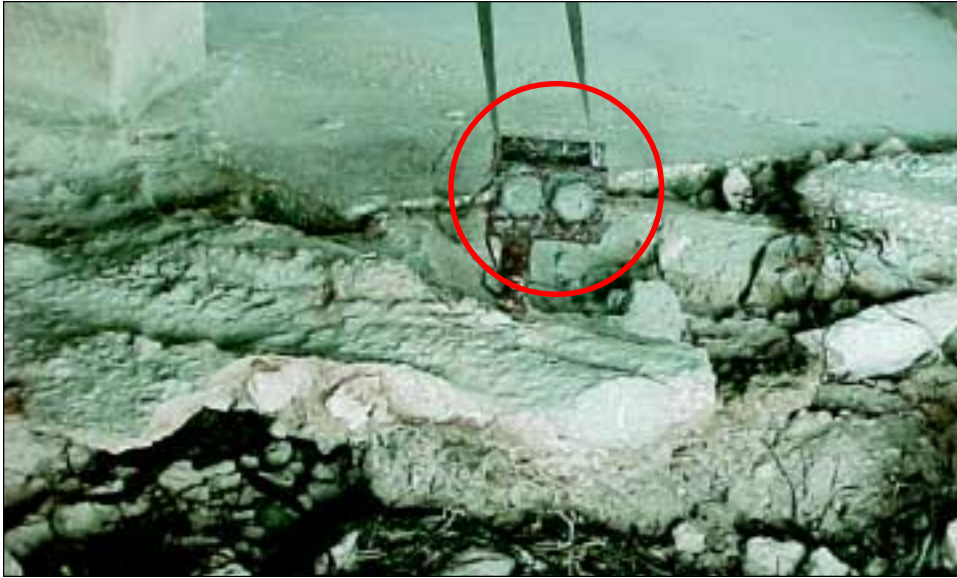
FIGURE 5-21 This anchor is only encased on the edge of the concrete fill pad and could easily be dislodged when the home is subjected to more severe wind or flood loads.

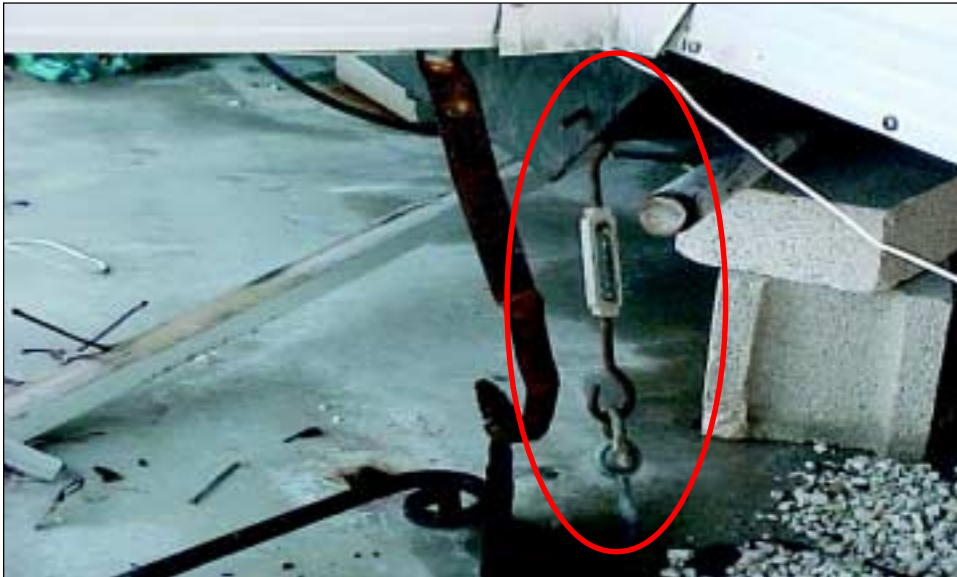
FIGURE 5-22 Inadequate turnbuckle anchor installed by homeowner on this older manufactured home. The home was severely damaged due to the lack of elevation, an unreinforced foundation system, and poor anchoring.

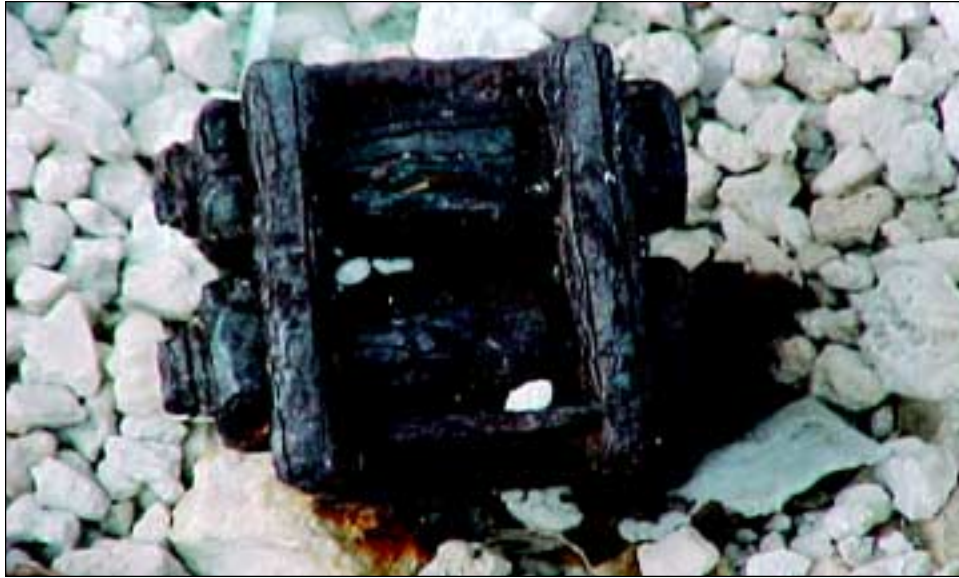
FIGURE 5-23 Rusted anchor under an older manufactured home. The State of Florida mandated galvanized anchors after January 1, 1999.

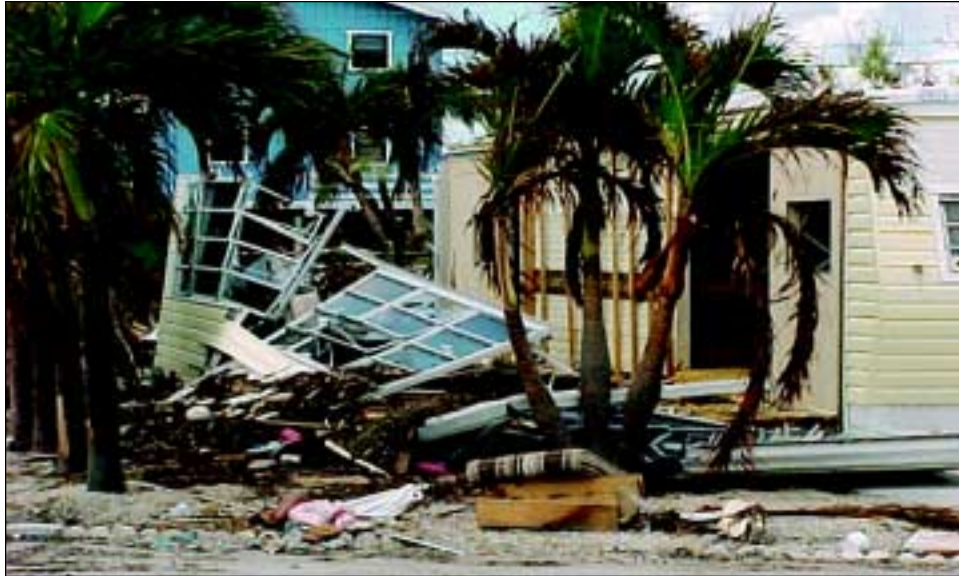
FIGURE 5-26 The addition to this manufactured home was destroyed, causing considerable damage to the rest of the home.

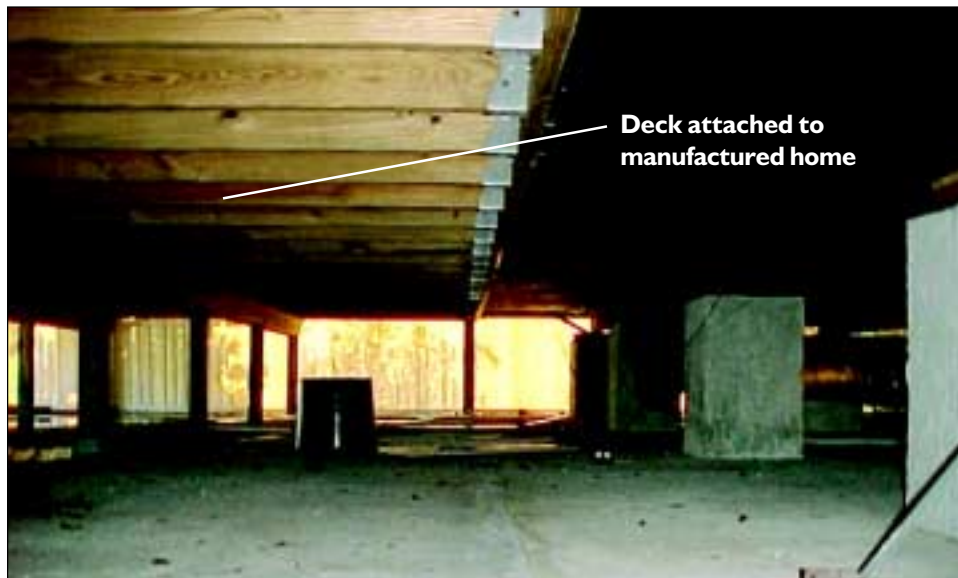
FIGURE 5-27 The underside of a deck that has been attached to the sidewall of a new manufactured home. The deck is not anchored as well as the home.

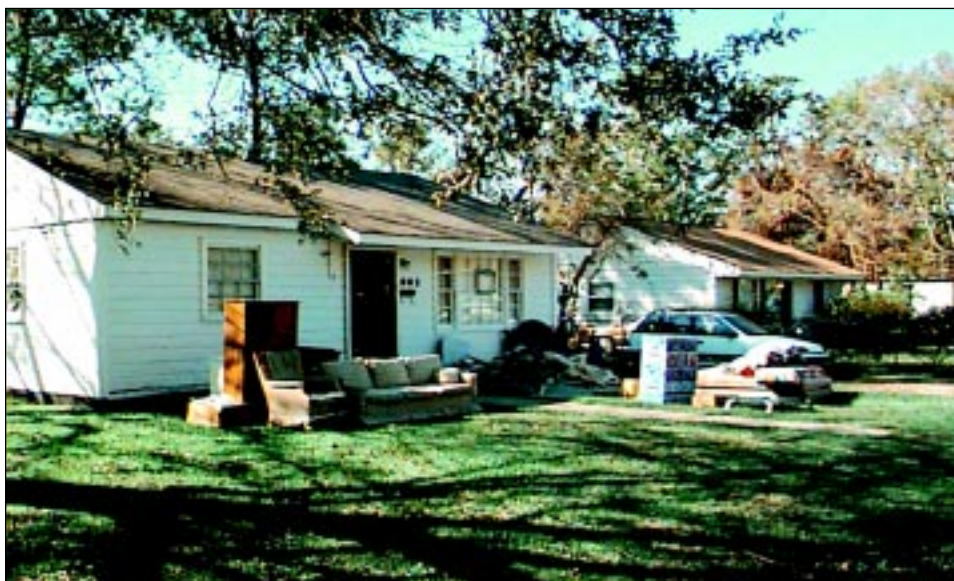
FIGURE 6-2 Typical pre-FIRM at-grade house flooded several feet in Pascagoula.

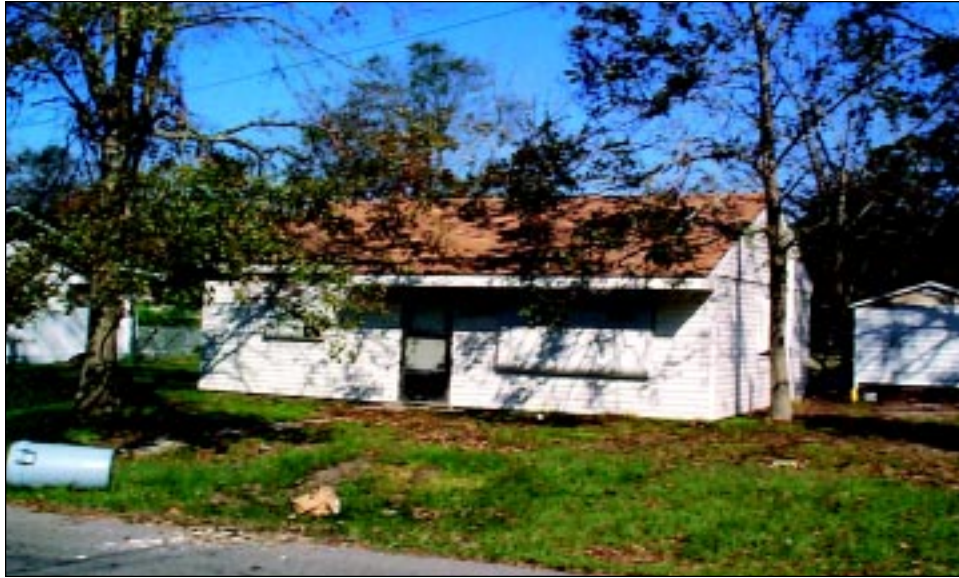
FIGURE 6-3 This home has suffered flood damage on numerous occasions. During Hurricane Georges it flooded several feet.

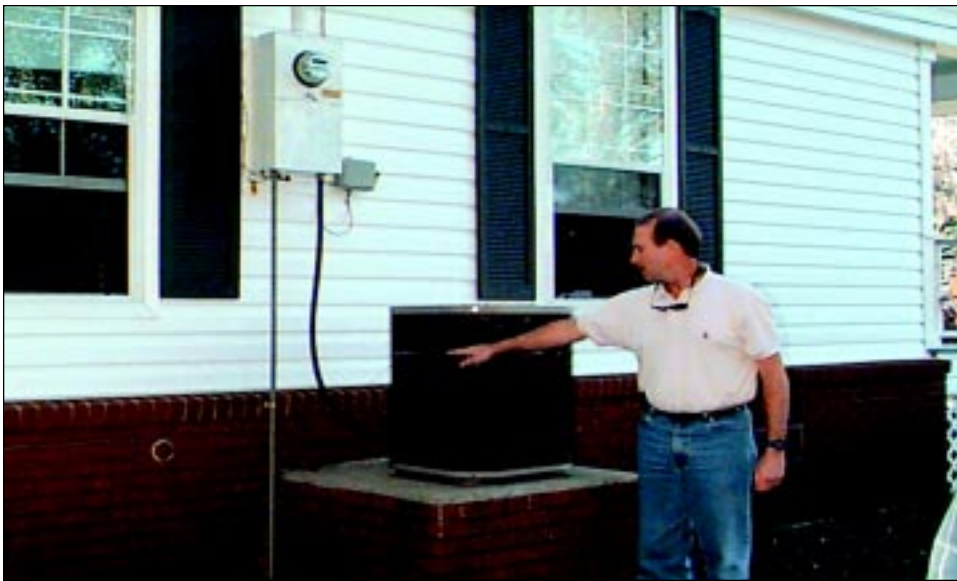
FIGURE 6-5 The high water mark on the air conditioner compressor indicates that the flood level was approximately 3 inches above the lowest floor.

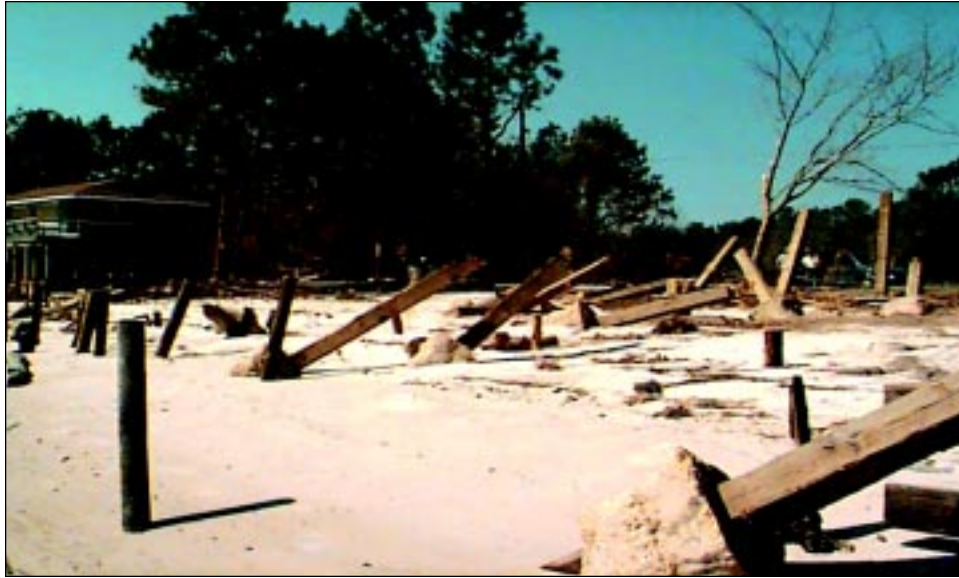
FIGURE 6-14 The houses in this area were destroyed. Piles were embedded in concrete to a depth of only 2 feet. Storm-induced erosion of 2 to 3 feet resulted in complete failure of the foundation systems.

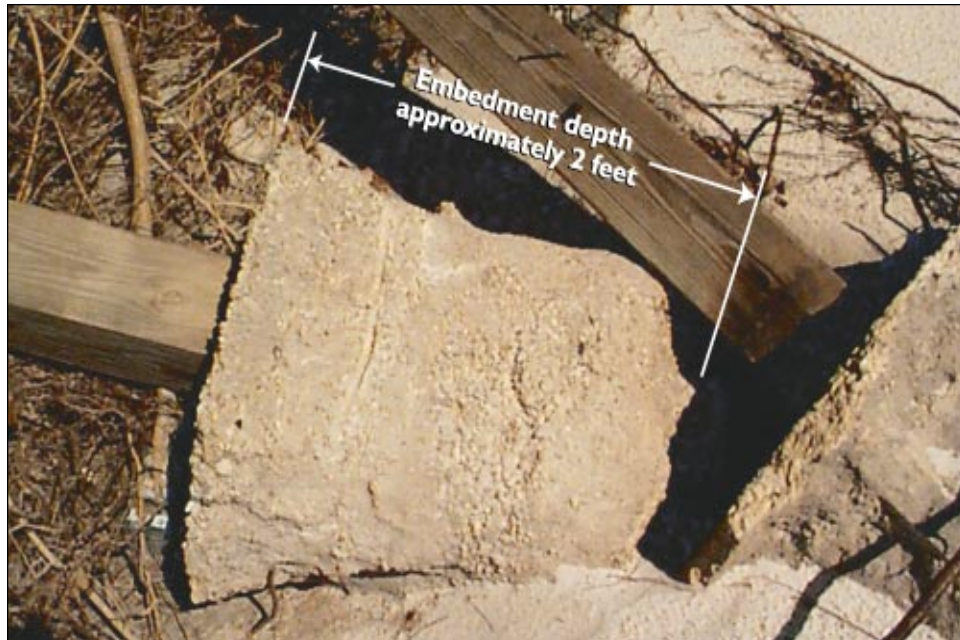
FIGURE 6-15 Inadequate embedment of piles from a destroyed home.

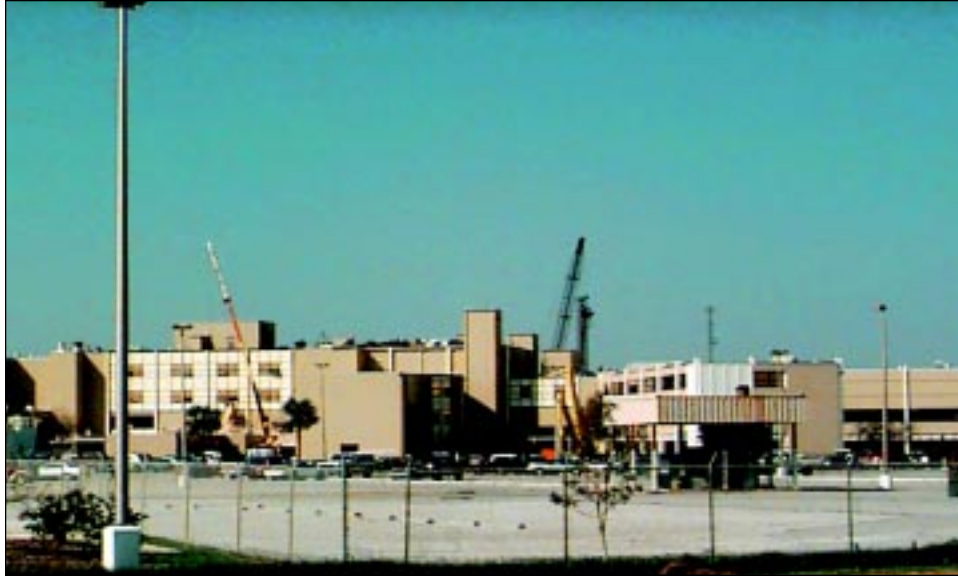
FIGURE 6-18 Singing River Hospital, where emergency roof repairs are underway.

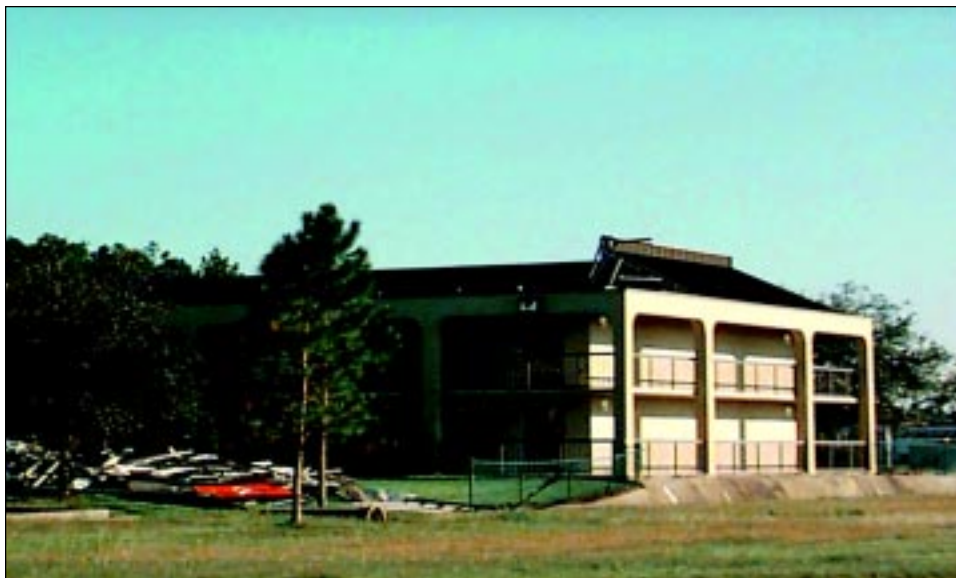
FIGURE 6-20 Roof damage to a hotel in Pascagoula.
