Building Performance Assessment Report

Hurricane Georges...

In The Gulf Coast

**Observations,
Recommendations,
and Technical Guidance**

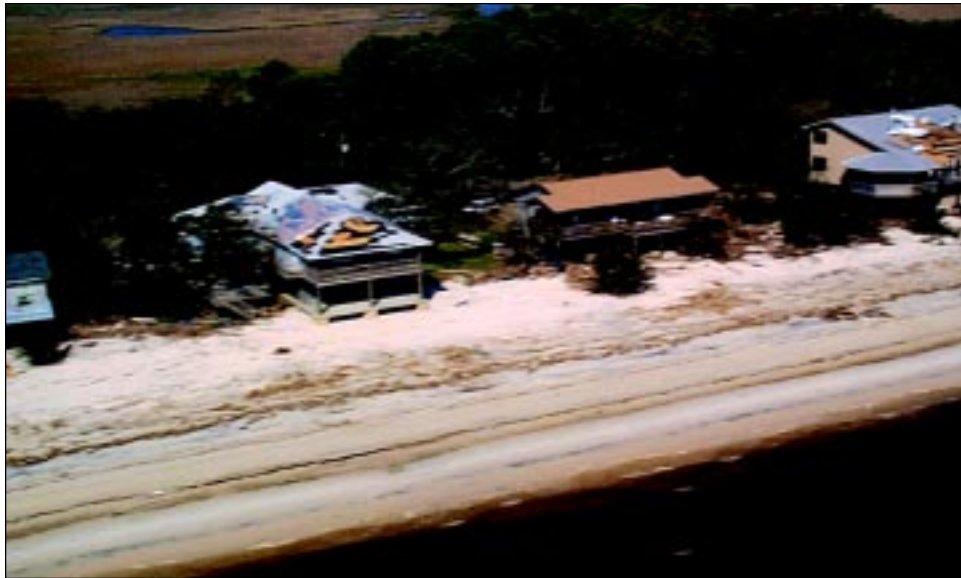
FIGURE 6-21 Shingle roof damage to homes along the open Mississippi coast.

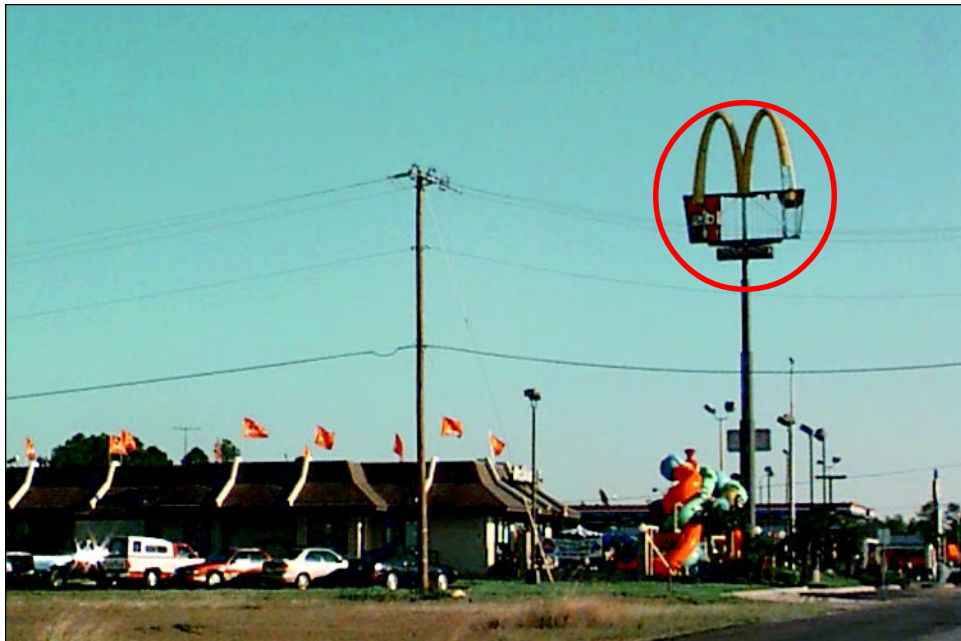
FIGURE 6-22 Sign damage in Pascagoula.

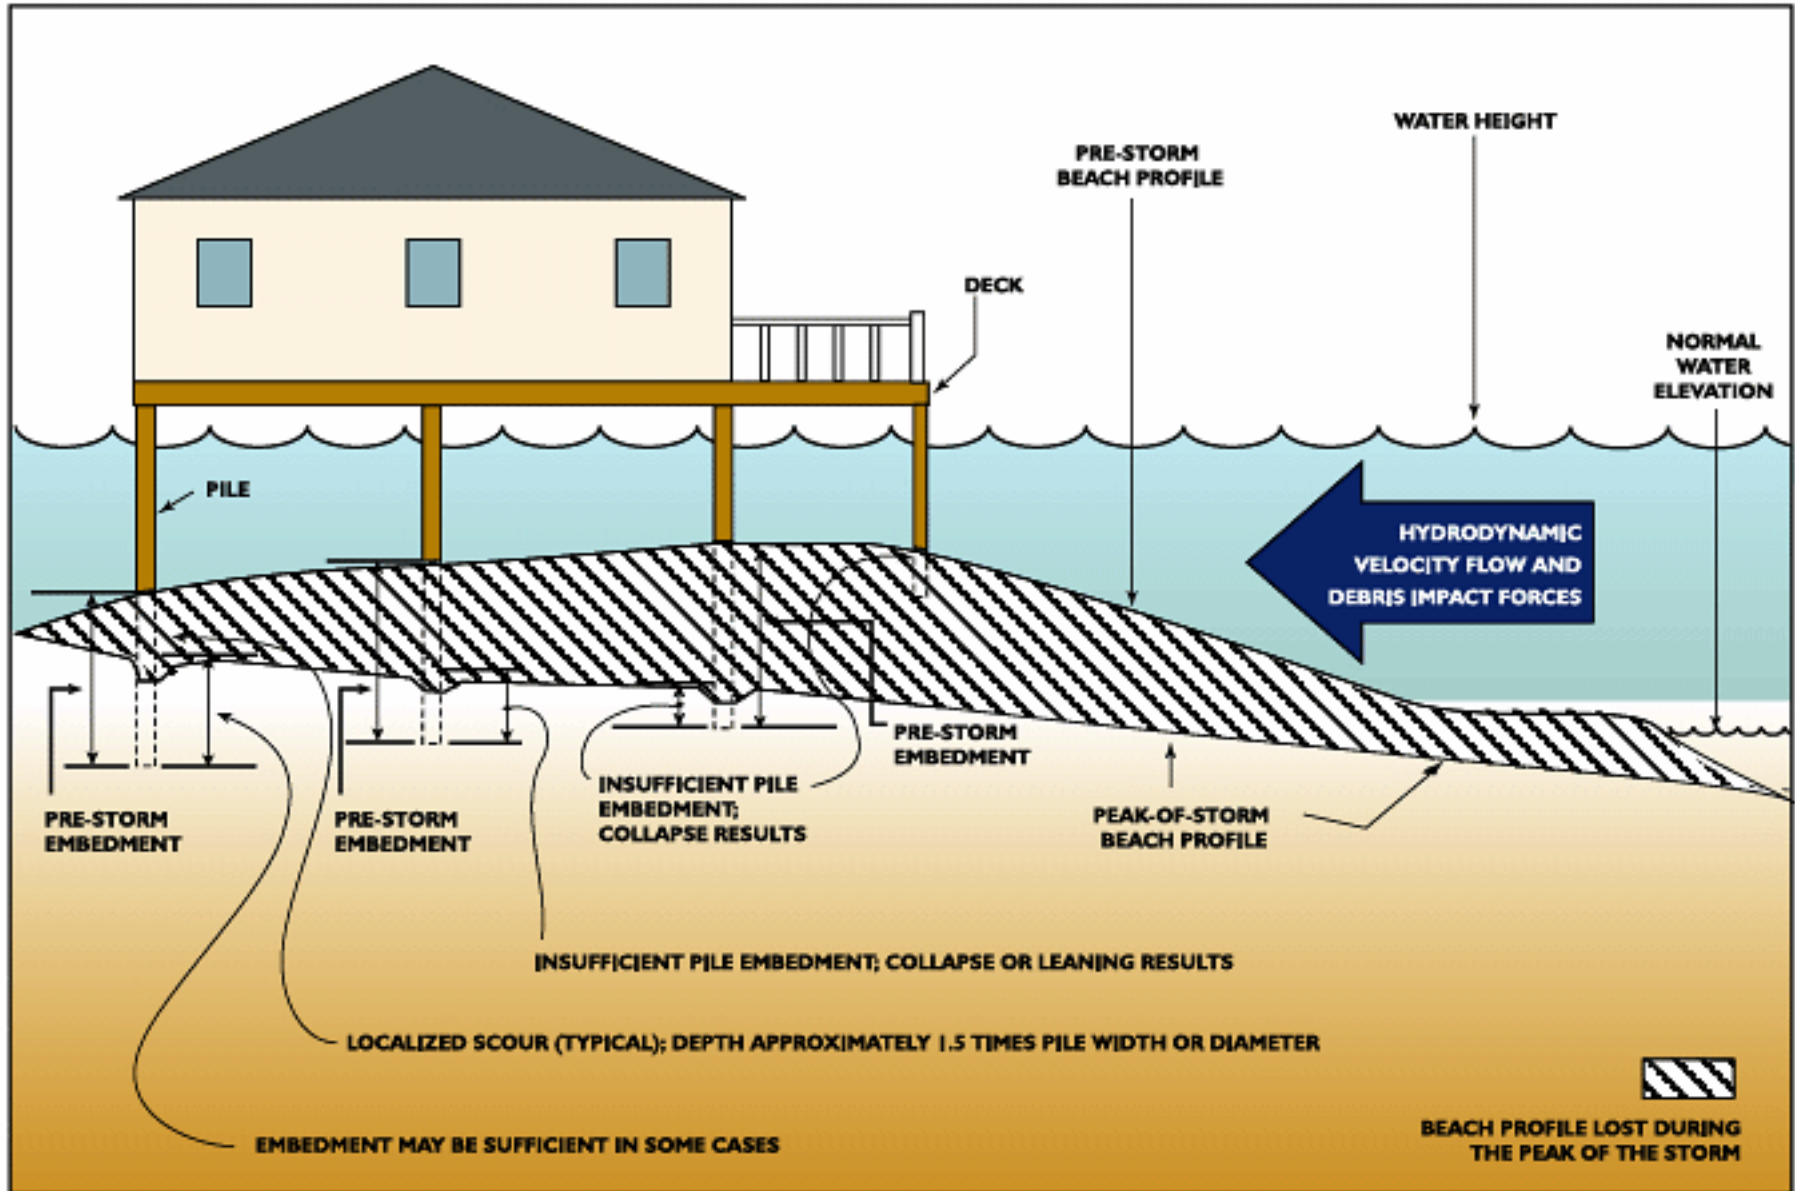
FIGURE 7-2 Typical collapse mechanism of post-FIRM buildings due to storm-induced erosion and scour.
