# Longshoring and Marine Terminals:

## Hazard and Abatement Summaries

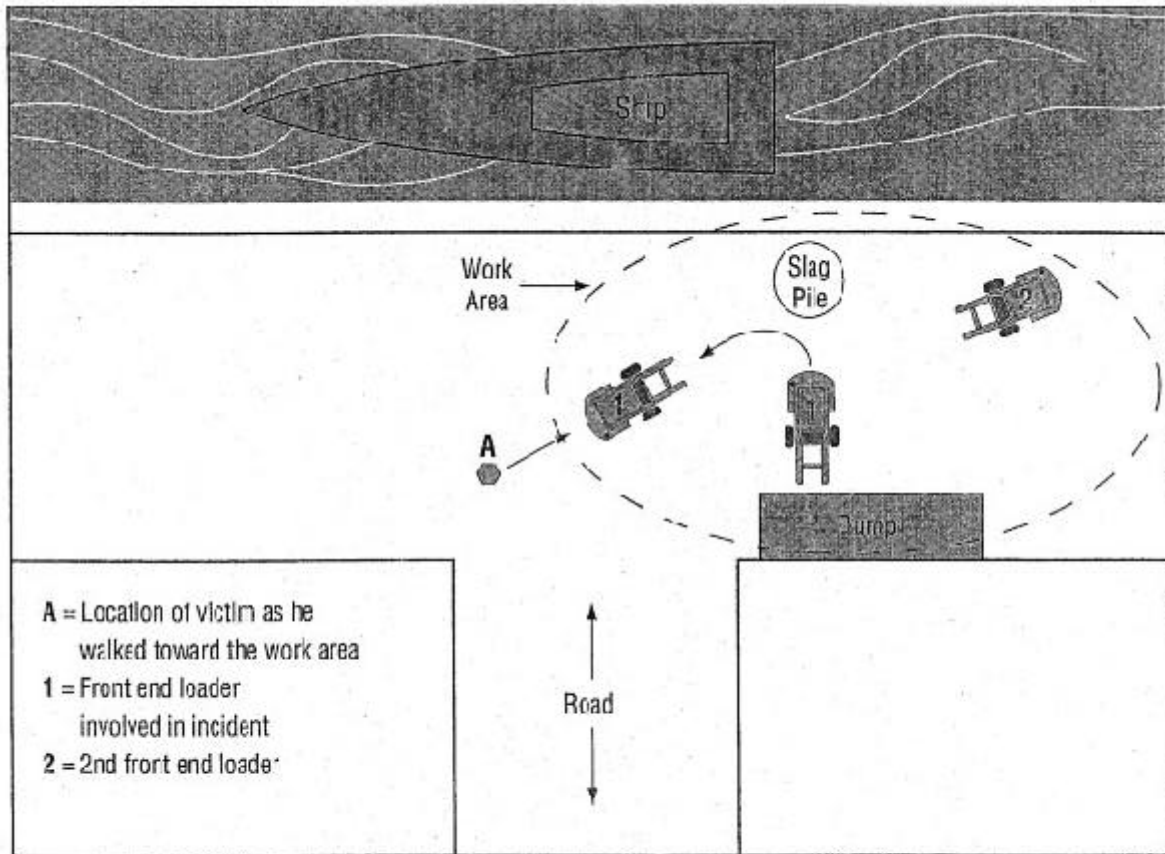
### Vehicle Accidents Summary No.2

At the time of the incident, the front-end loader was operating with broken front and rear lights. Employees were not trained to avoid entering the work area where the loaders were operating.

**Incident Description:** Front-end loader #1 struck victim (A) while backing up.

- Operating the front-end loader with properly working front and rear lights and rear view mirrors;
- Maintaining the front-end loaders in safe operating condition and taking them out of service if defects make them unsafe to operate;
- Using a reverse signal alarm that is distinguishable from the surrounding noise level. If it is not equipped with a reverse signal alarm, an employee should be stationed at the operation to signal when it is safe to back up whenever the operator has an obstructed view to the rear. (Good work practice);
- Prohibiting workers from passing through an area where there is danger of being hit by a front-end loader; and
- Providing adequate illumination (at least 5 foot-candles) during equipment operations, pursuant to 29 CFR 1917.123(a).

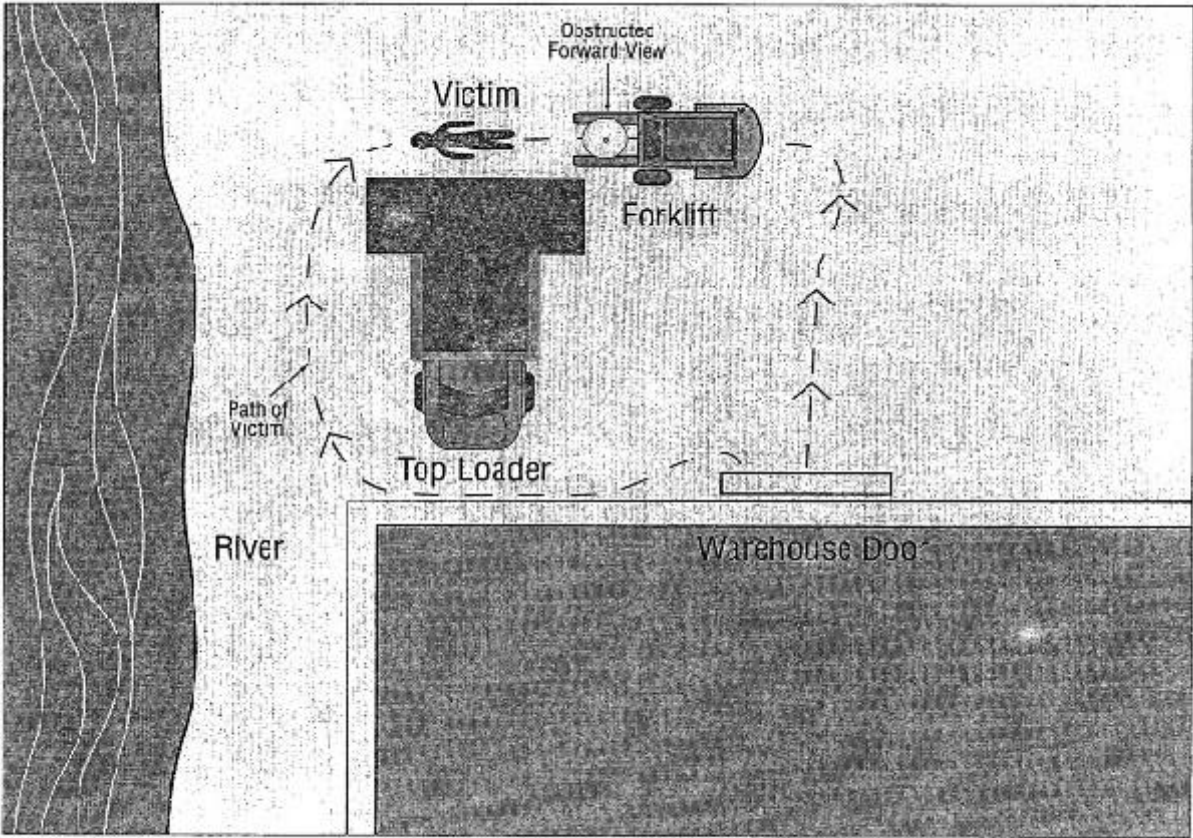
**Vehicle Accidents Summary No.8**

Forklift operators failed to use their horns when approaching locations where visibility was obstructed.

This hazard might have been prevented if the employer had ensured that the forklift operator had a clear forward view, used a spotter when entering the container, and sounded the horn whenever visibility was obstructed.

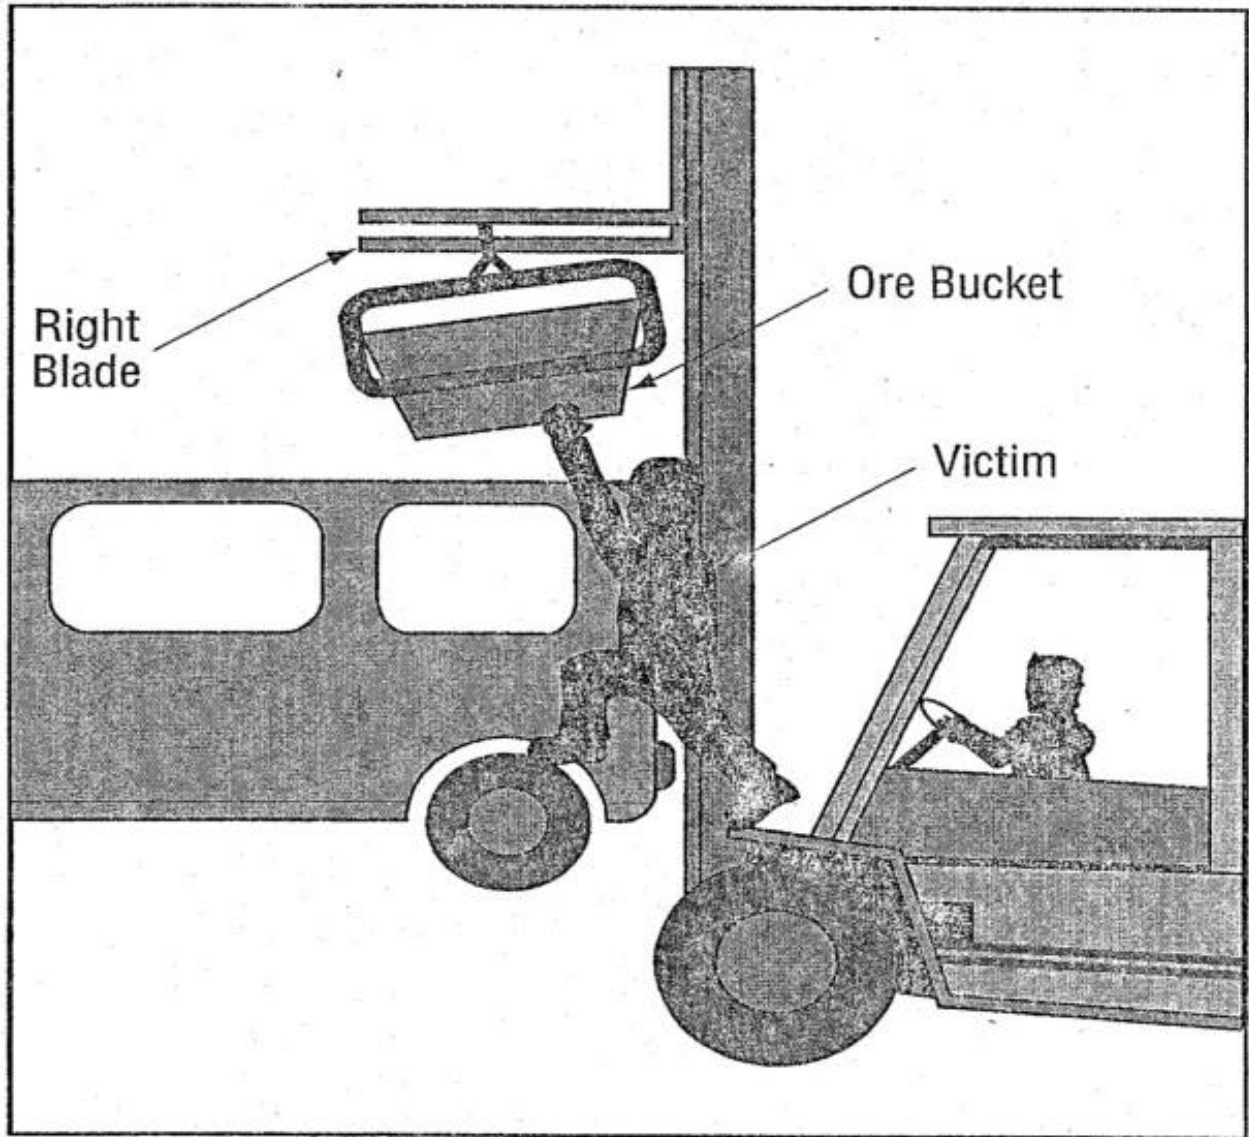
The fork truck blade became disengaged from the carriage and fell off when the bucket was jostled up and down. Additionally, the forklift truck had two major deficiencies that may have contributed to the incident. The end stops, which prevent the blades from sliding off the end of the carriage, were broken off and the spring-loaded latch, which keeps the blade secured between the notches of the carriage, was missing. An inspection of forklifts in the shop revealed that all of the forklifts had broken end stops.

This hazard might have been prevented if the forklift had been properly maintained and inspected prior to its use and taken out of service until repairs were completed. Specifically, the end stops and spring loaded latches should have been repaired to prevent the forks from becoming dislodged. The blade stops were removed from a fork lift allowing the fork lift blade to be accidentally disengaged.

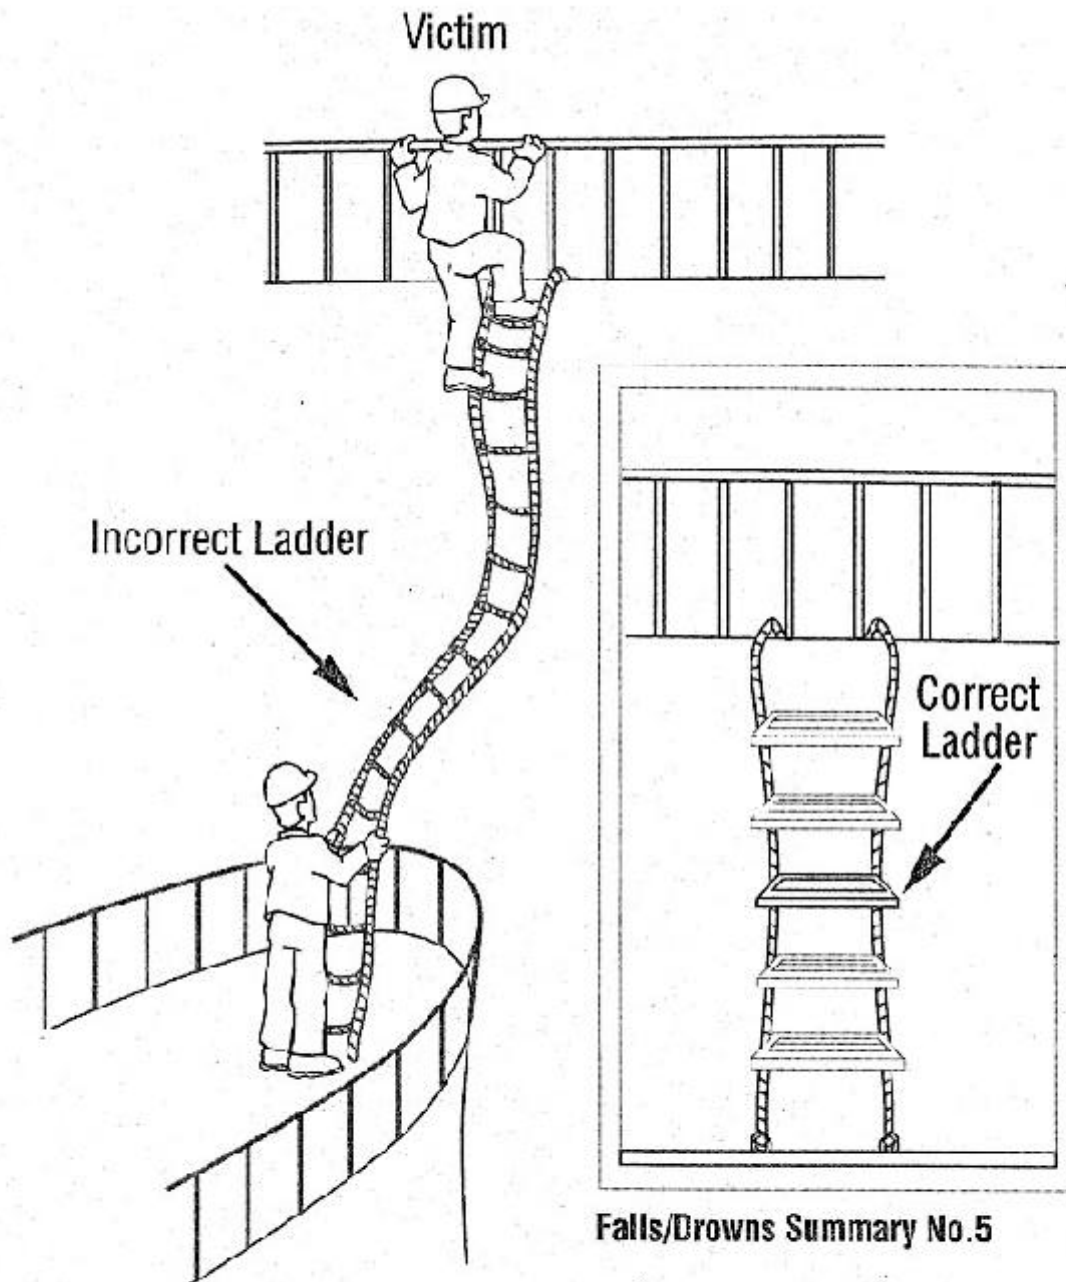
**Incident Description:** Victim fell off rope rung ladder while attempting to descend.

New employees should receive training on shipboard safety, including hands-on training in the use of properly designed Jacob's ladders, before working aboard vessels.

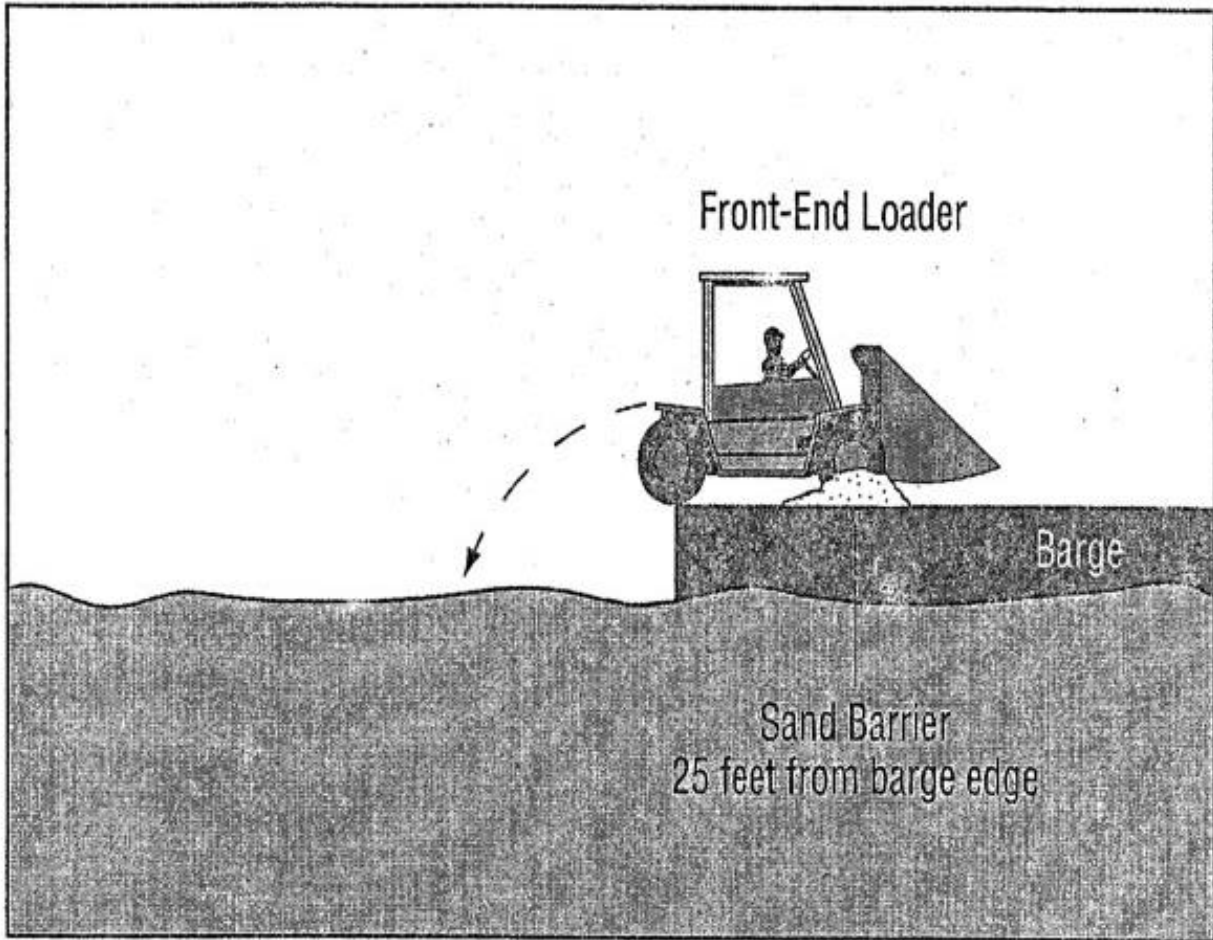
## Falls/Drowns Summary No.6

**Incident Description:** The front-end loader operator accidentally backed off the barge and drowned. The barge edge had been improperly guarded with a sand barrier.

- Operators of machinery such as front-end loaders must be properly trained regarding the hazards and safe work practices for operating the machinery on an open barge in accordance with 29 CFR 1918.98(a)(1).

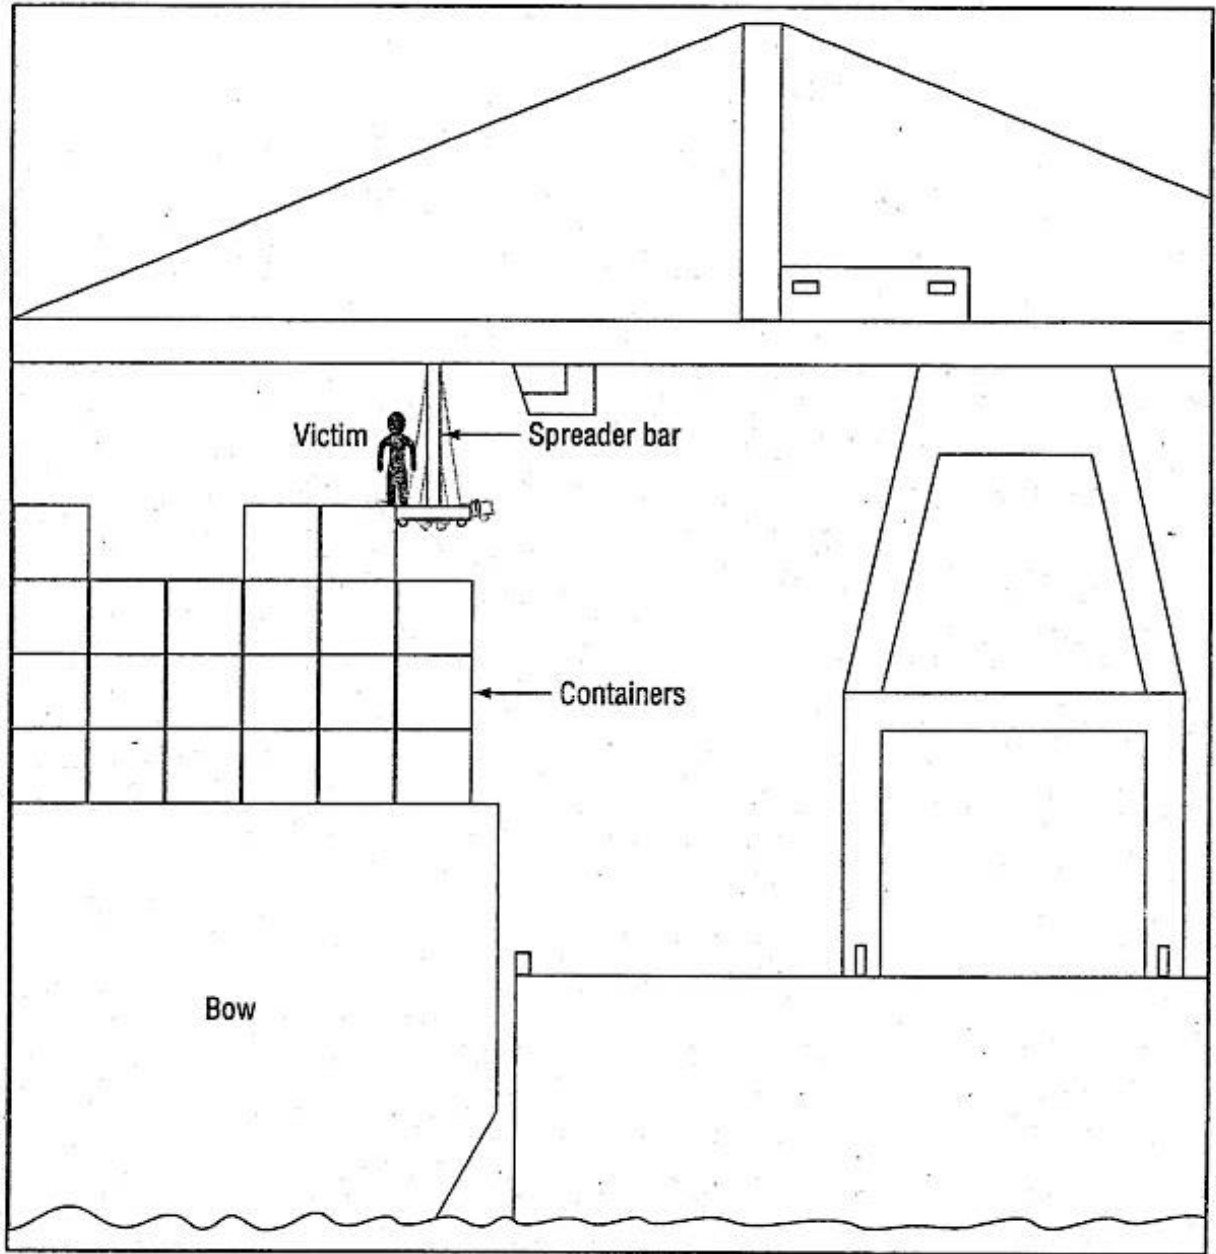
### Falls/Drowns Summary No.11

**Incident Description:** Crane operator pulled spreader bar away as worker attempted to step on it

Clearly delineate lines of authority to prohibit the crane operator from acting on his own. The crane operator should communicate with the gangwayman before performing any operations, by using, for example, a walkie-talkie or radio.

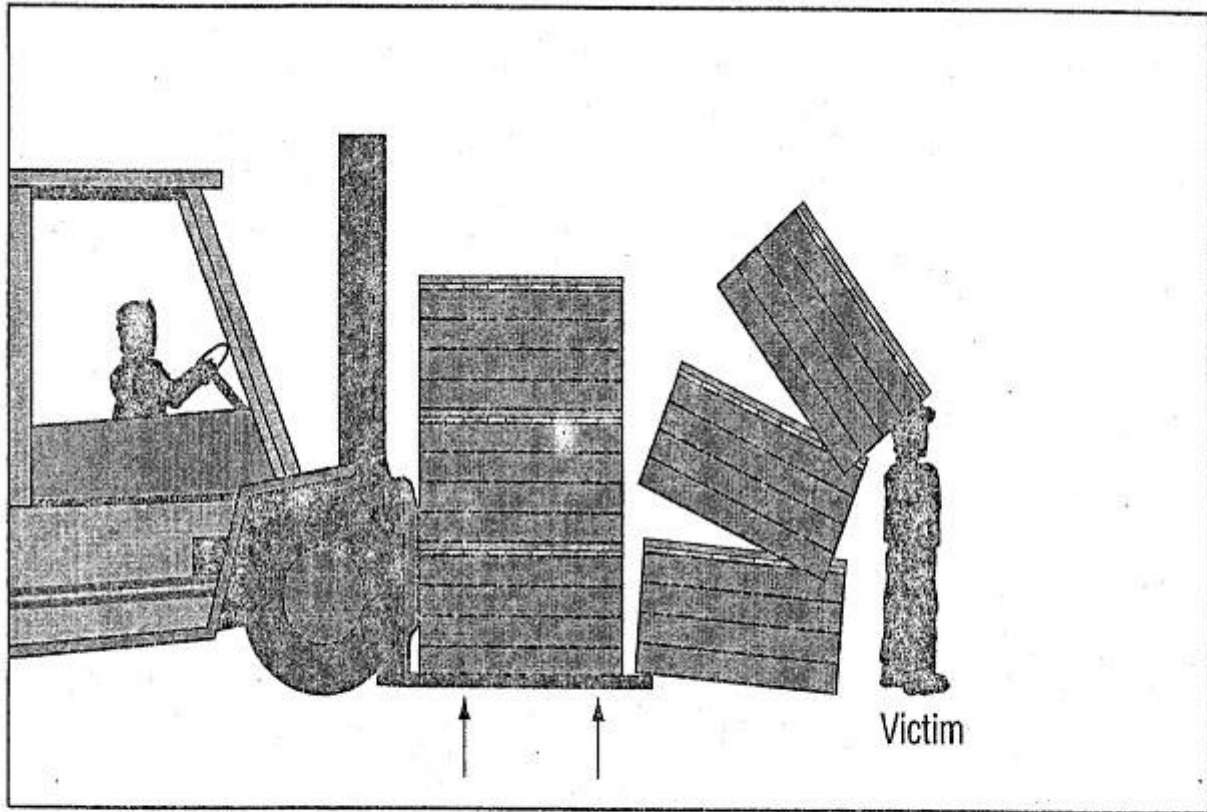
### **Material Handling Accidents Summary No.7**

**Incident Description:** Victim was struck by toppling crates that became dislodged by forklift blades

Train the operator, through initial and periodic refresher training, to observe all safe operating procedures.
