U.S. CHEMICAL SAFETY AND HAZARD INVESTIGATION BOARD

# INVESTIGATION REPORT

## DUST EXPLOSION

**WEST PHARMACEUTICAL  
SERVICES, INC.**

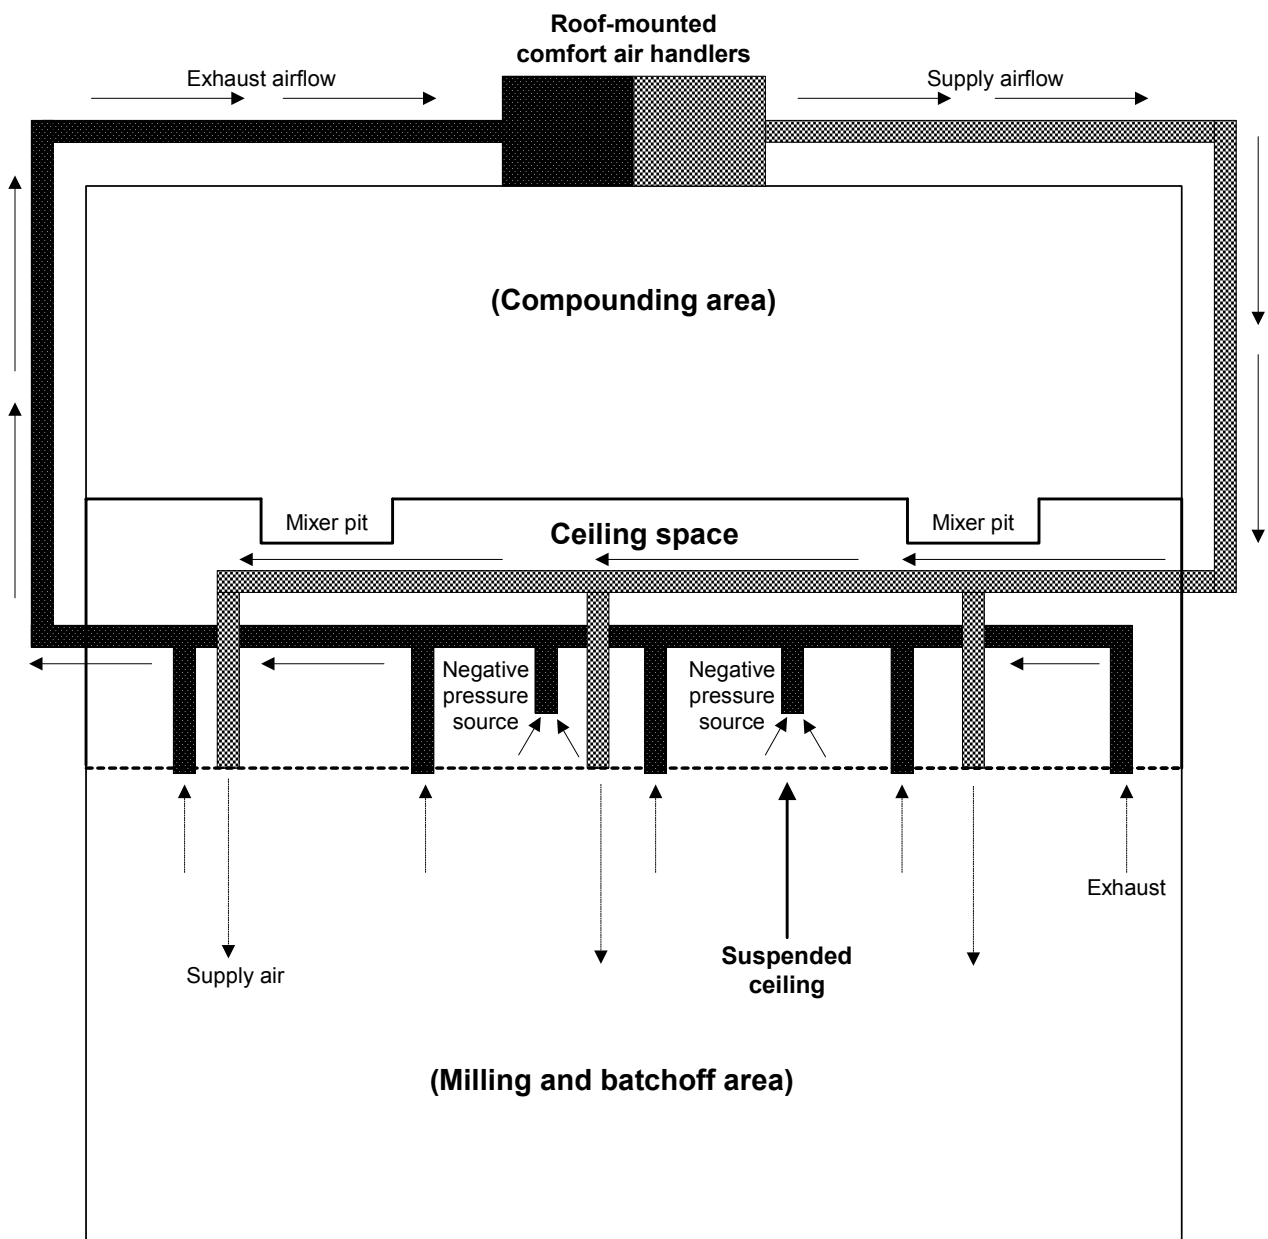
Air handlers located on the building roof provided comfort air for the milling and batchoff area (Figure 5). They drew air from the room, filtered and heated or cooled it (mixing it with some fresh air), and then returned it. Air from the room generally flowed to the air handlers through ducts (equipped with diffusers) connected directly to the suspended ceiling; however, some ducts

were not so connected and instead drew air from the area above the ceiling. Because the zone above the suspended ceiling had a slightly lower pressure than the room it covered, a portion of the room air was drafted through the ceiling into the open space above.

**Figure 5. Comfort air system for milling and batchoff area.**

The comfort air system created a slight negative pressure above the suspended ceiling, and room air was pulled into this zone, where conditions were favorable for the settling of dust. West changed out large areas of ceiling tiles from time to time—primarily for aesthetic reasons because they tended to discolor. However, the frequency of replacement was insufficient to address dust accumulation. There was no organized cleaning program for surfaces of beams, conduits, and other features above the ceiling.

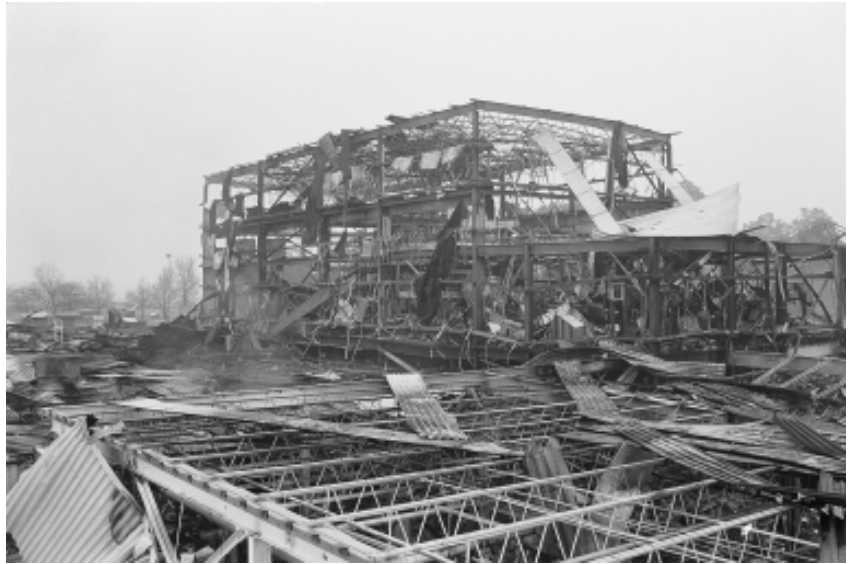
The explosion and ensuing fire heavily damaged the compounding section of the Kinston facility. Photographs below and in the remaining sections of this report show the extent of damage. All exterior sheathing on the compounding structure was destroyed. Masonry block walls were knocked down, the warehouse collapsed, and the building was rendered mostly unusable (Figures 6 and 7).

**Figure 6. Roof of facility, with two-story compounding section in background.**

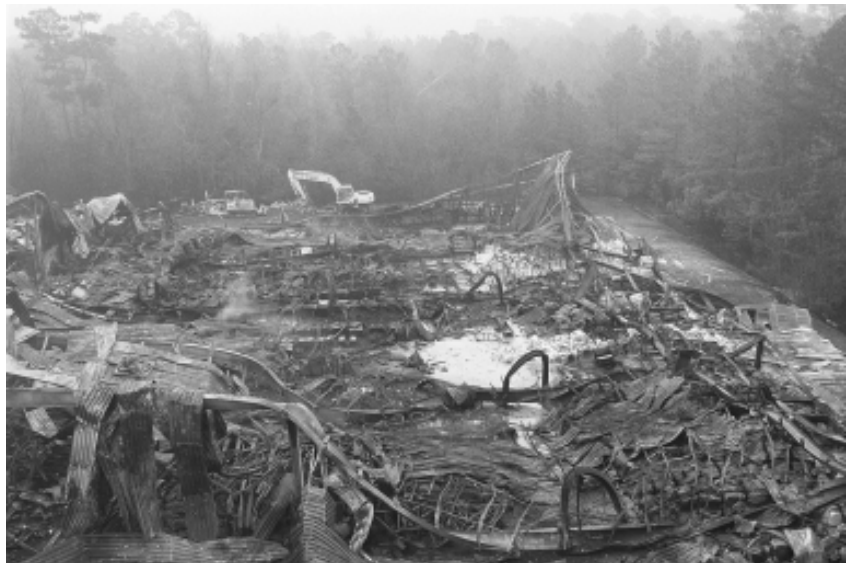
**Figure 7. Remains of ACS warehouse viewed from compounding area.**

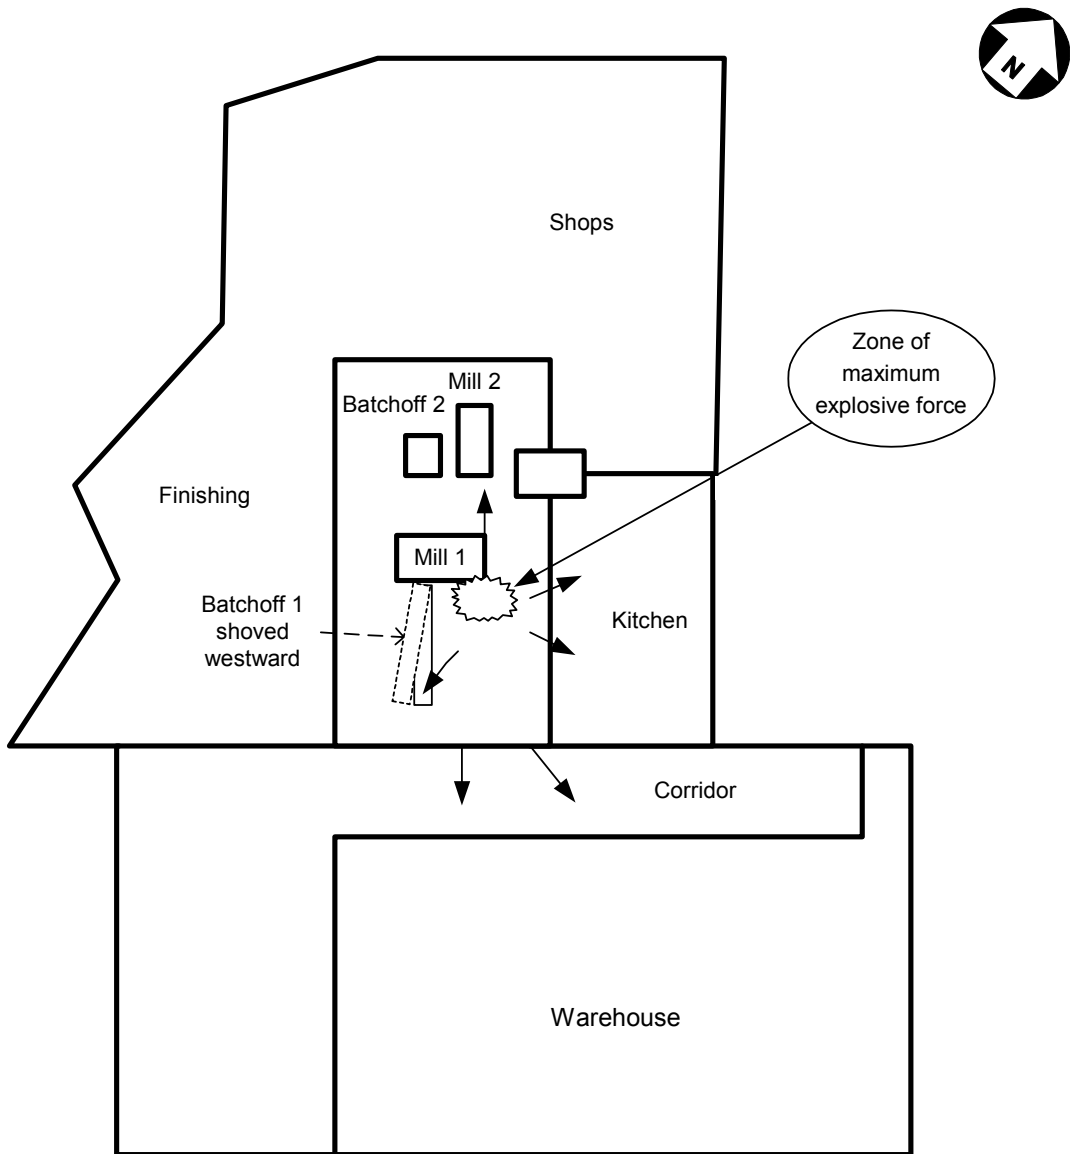
mill #1 (Figure 9). Force vectors derived from observed damage to the building and surrounding equipment indicate that the largest pressure developed in the compounding section and emanated spherically outward (Figure 10). Appendix B describes the damage patterns CSB used to estimate the directions and magnitude of explosive force.

- Nearly all of the tiles appeared to be burnt and splattered on the top—but not on the bottom, which had faced the room below.
- Some of the fluorescent light fixture pans recovered from the mill #1 area were flattened from above, as if they had been forcefully driven downward to the concrete floor.

**Figure 9. Estimated zone of maximum explosive force.**

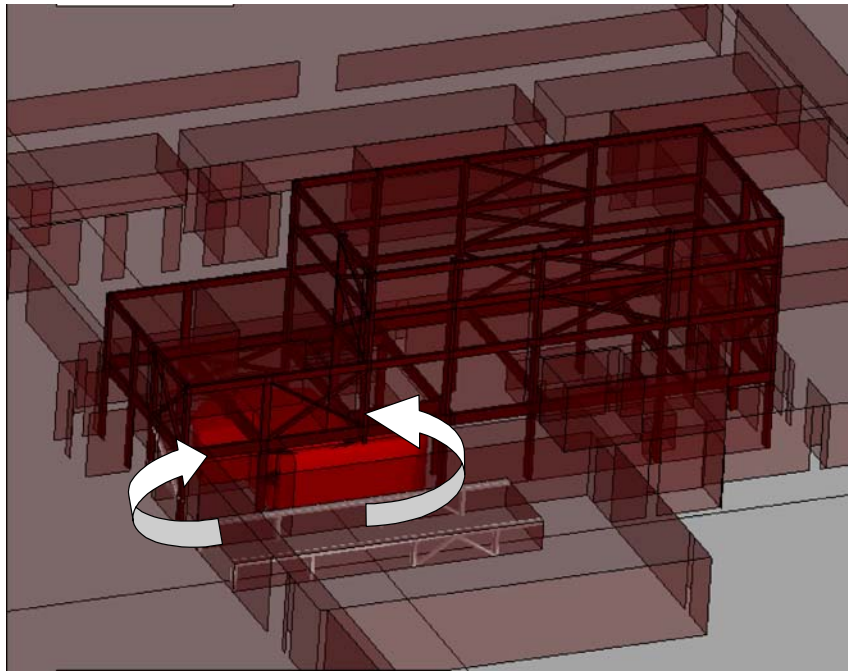
**Figure 10. Location of maximum explosive force.**

- The explosion occurred on the first floor of the rubber compounding area.
- The explosion pressure from this area was the source of blast damage throughout the facility.

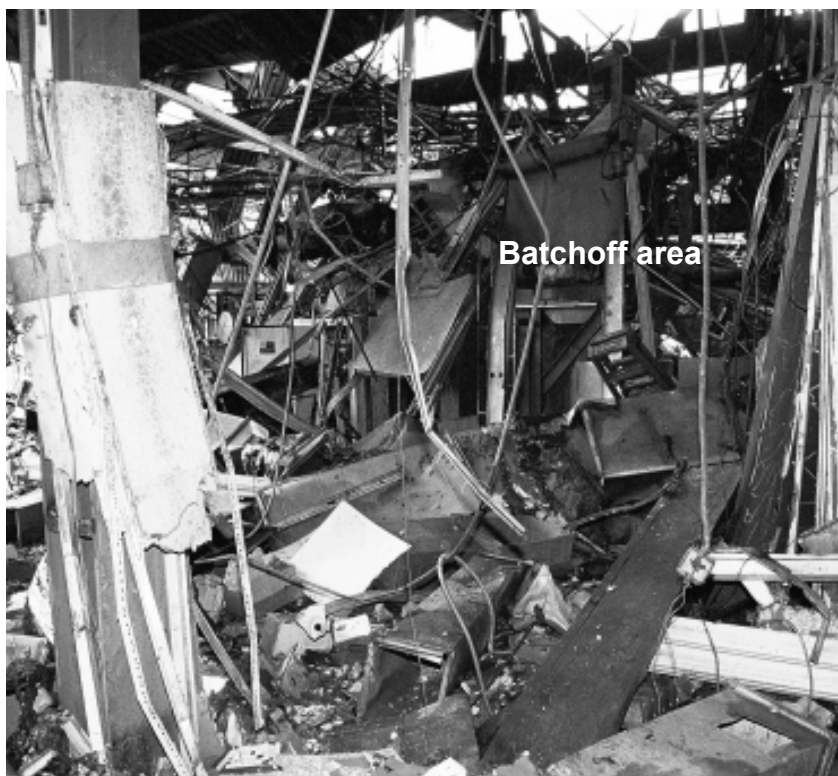
The extent of damage to the Kinston facility made it extremely difficult to definitively determine the event that dispersed the dust or what ignited it (Figure 11). Investigators focused on the most pertinent hazard—the accumulation of combustible dust—and considered the initiating event as a matter of secondary

- Overheating of a batch of rubber and subsequent ignition of the vapors produced by thermal decomposition.
- Ignition of the dust layer by an overheated electrical ballast or light fixture.
- Ignition of the dust layer by an electrical spark from an unidentified electrical fault.
- Unsettling of dust in a cooling air duct for an electric motor and subsequent ignition of the dust by the motor.

**Figure 11. Extensive damage and debris near mill and batchoff machine #1.**

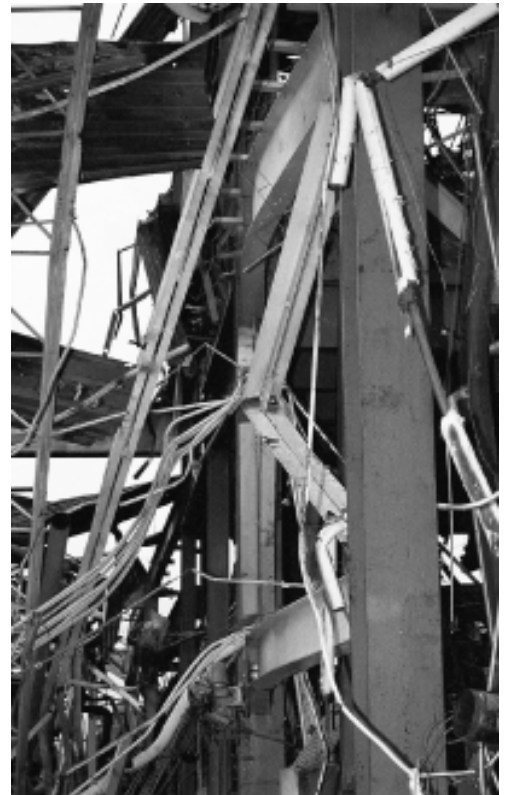
In examining the damage to structural steel and masonry block walls, CSB determined that the most severe forces—which emanated with a blast pattern of 360°—were on the first level of the plant in the area southeast of mill #1.

**Figure B-1. Beam and cross bracing deflected southeastward toward warehouse.**

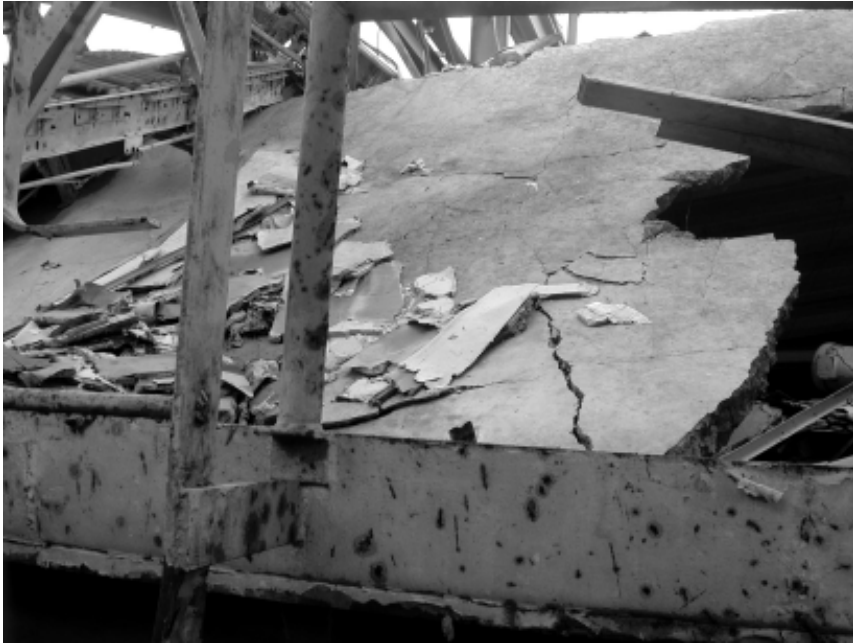
**Figure B-2. Uplifted concrete floor in mixer area.**

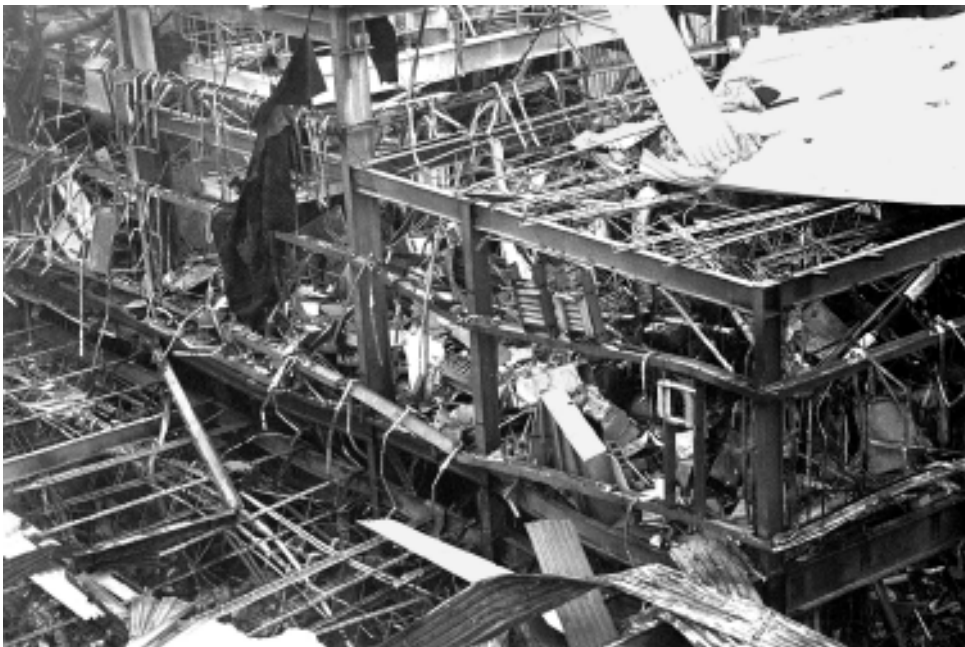
- The force of the blast displaced batchoff #1—a machine that weighs several tons—several feet to the southwest.
- To the immediate east of this area, the two masonry walls of a hallway used to conduct tours of the facility were blown northeastward into the kitchen. Structural steel in this area was deflected in the same direction.
- To the southeast, masonry walls for an elevator shaft and stairwell were blown southeastward toward the warehouse. Structural steel and cross bracing were deflected in the same direction (Figure B-1).
- The upper-level concrete slab flooring directly over the mill #1 and batchoff #1 areas was heaved upward. The floor to the northwest between the two mixers was also heaved (Figure B-2).
- Structural steel for the wall adjacent to batchoff #1 was deflected to the southwest (Figure B-3).

**Figure B-3. Southwest wall of compounding area deflected outward.**
