I-70 Overpass Beam Failure Lakeview Drive Bridge

Washington County, PA

NHI Real Solutions Seminar *July 2008*

**Field Inspection and Forensic Investigation
of the
SR 1014 Lake View Drive Bridge
over
Interstate 70**

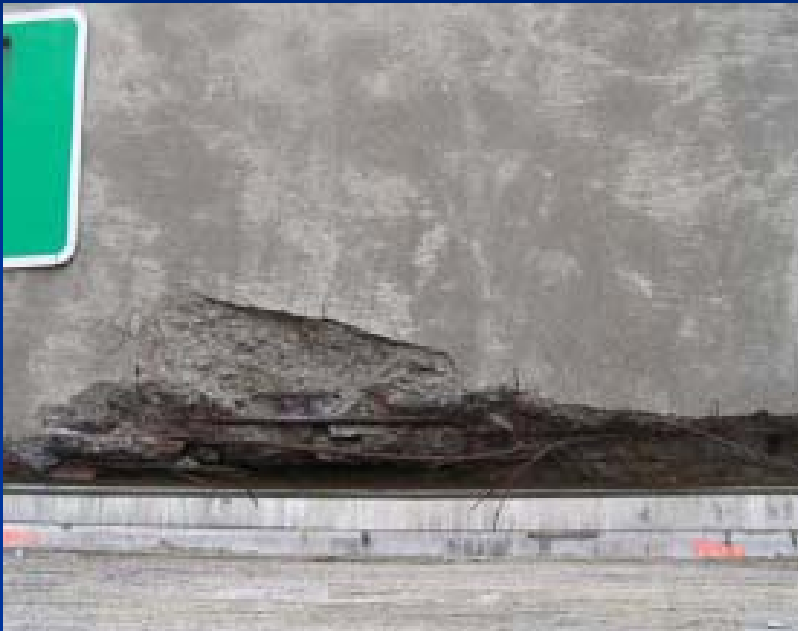
**Collision
Damage**

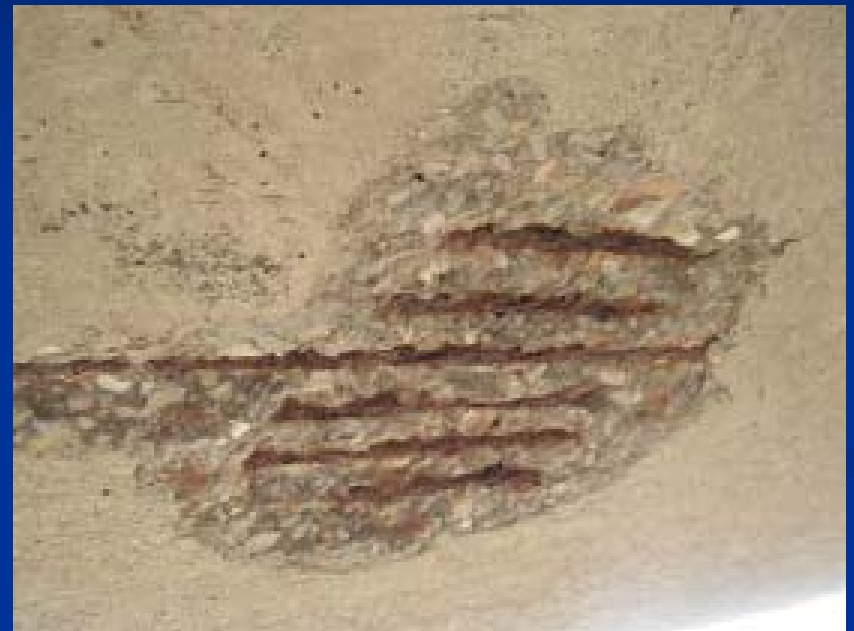
**Corrosion
Damage**

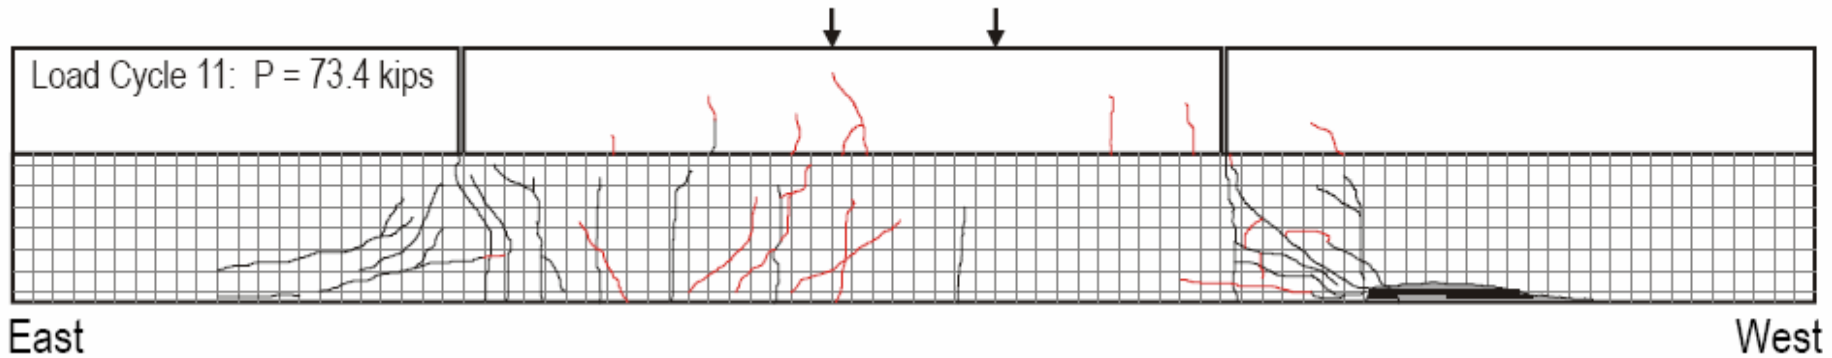
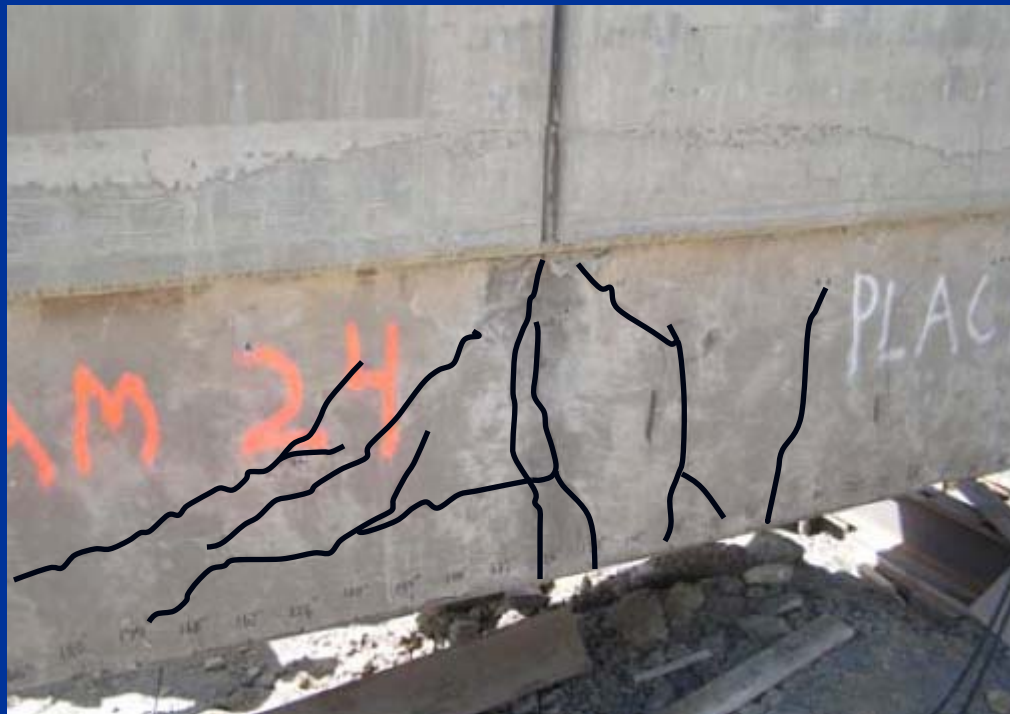
Cracking Near Barrier Joints

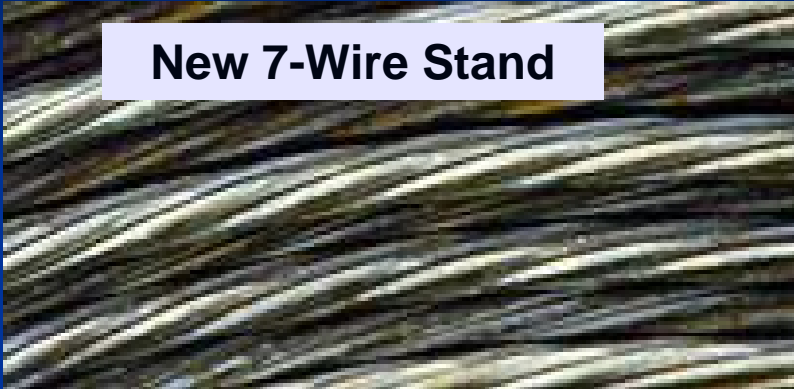
New 7-Wire Stand

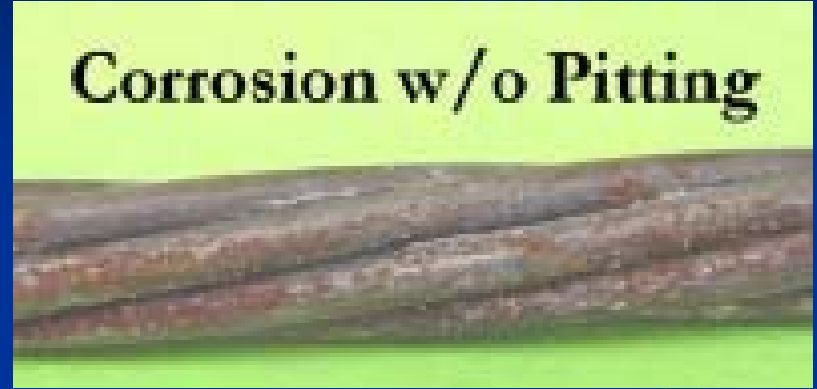
Corrosion w/o Pitting

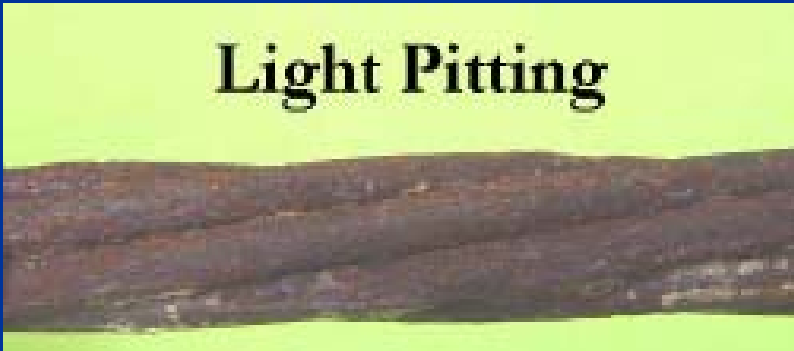
Light Pitting

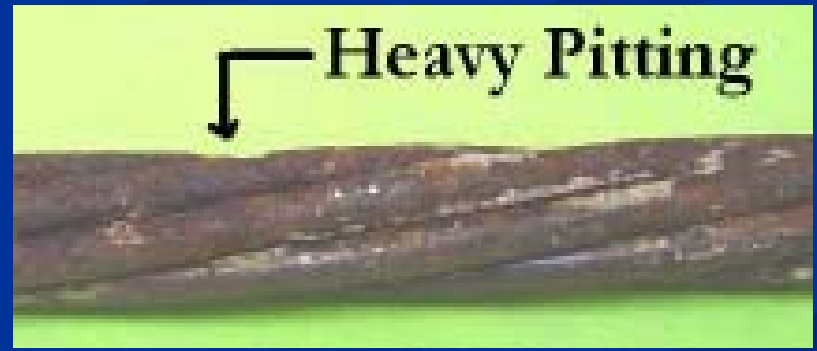
Heavy Pitting

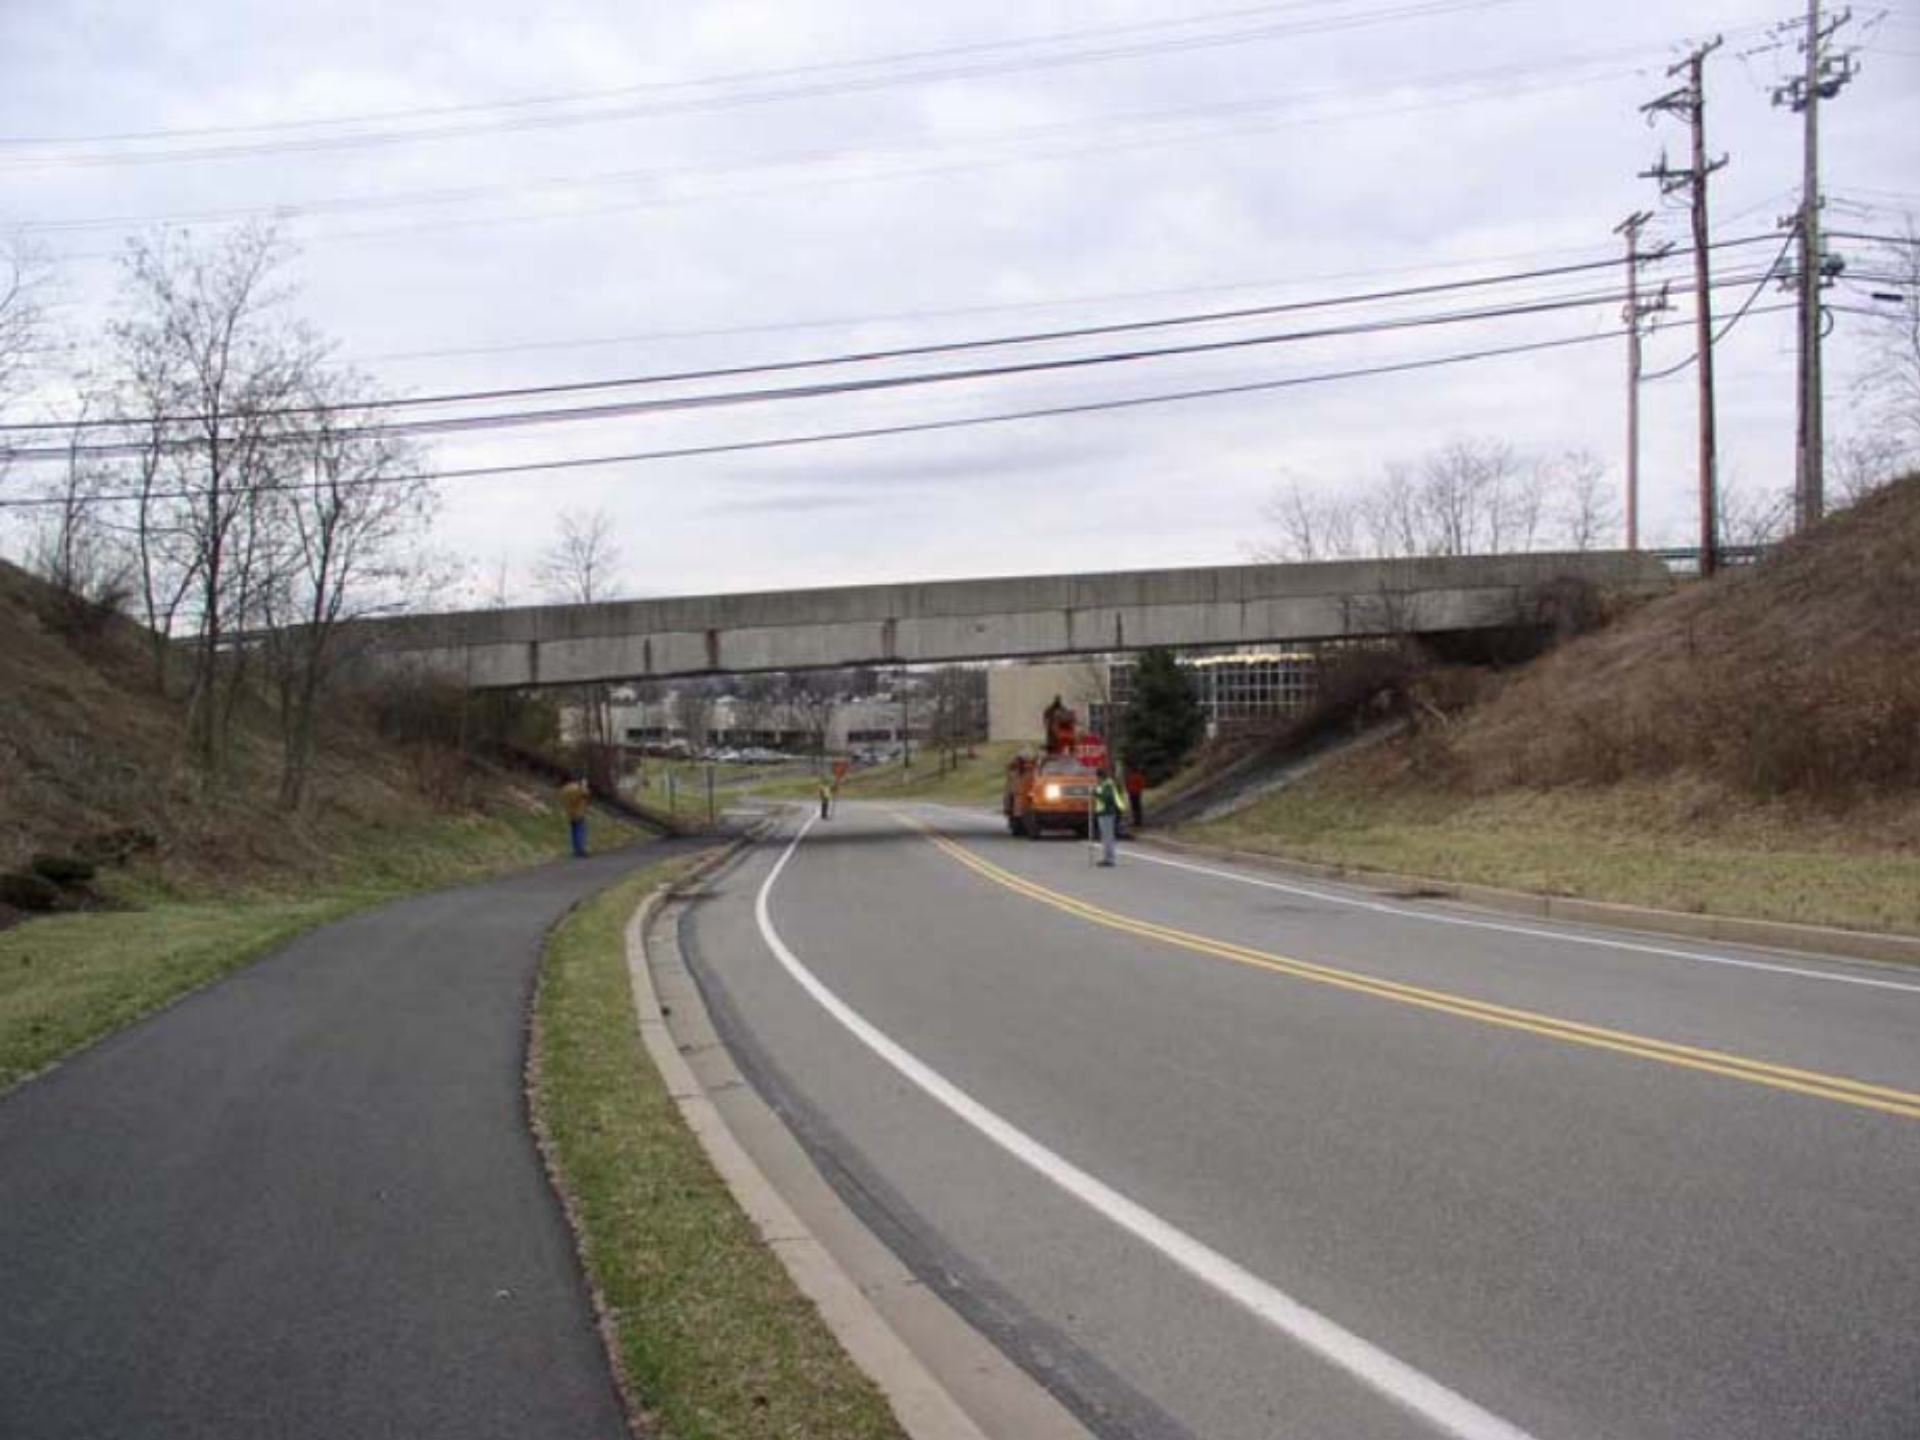
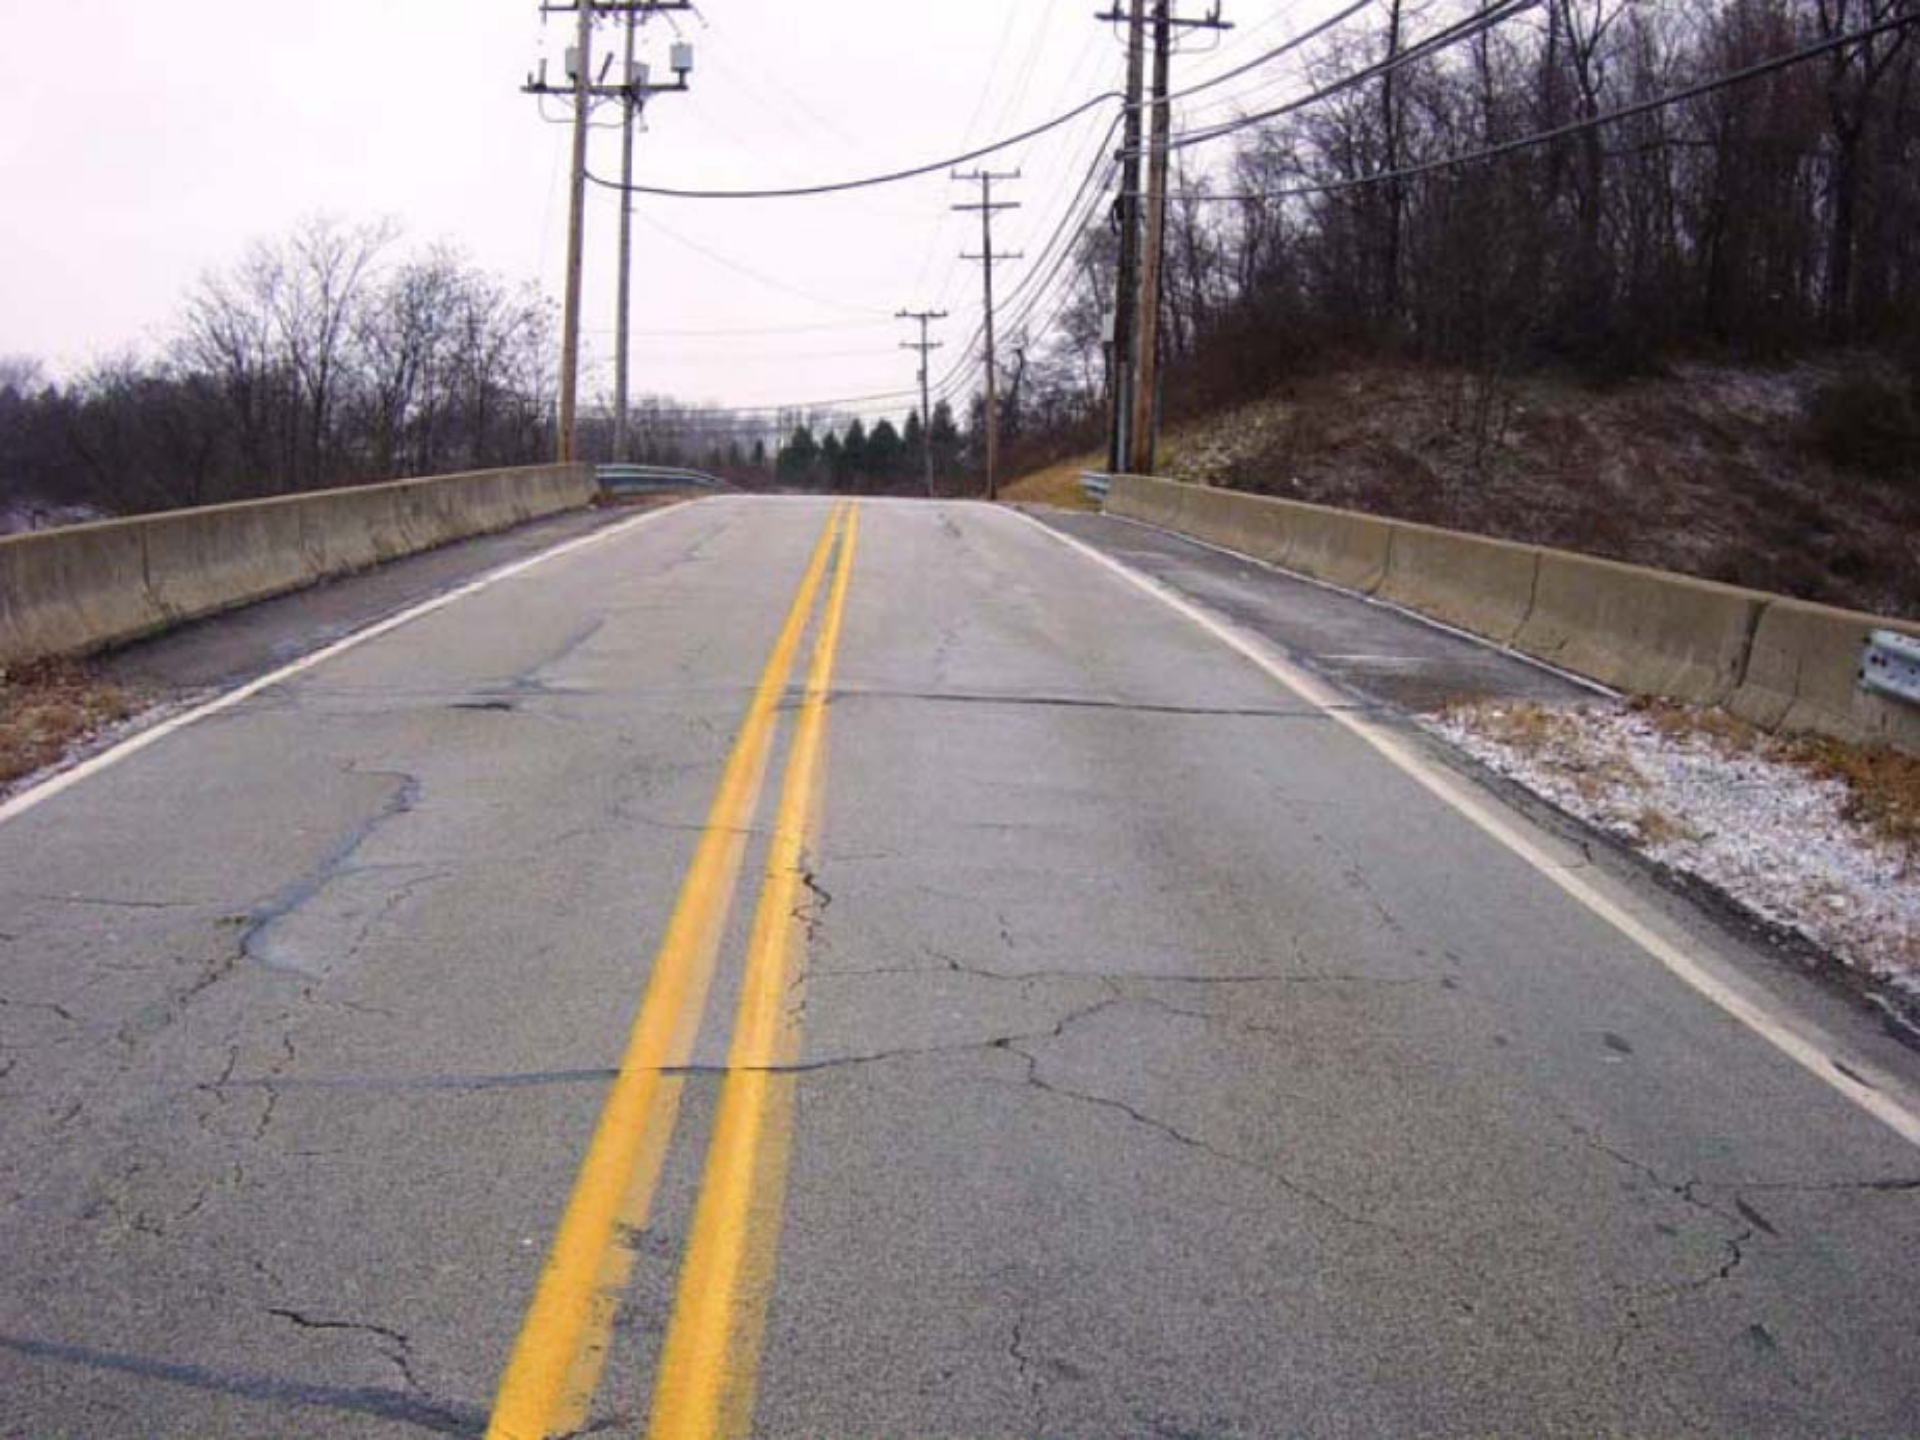
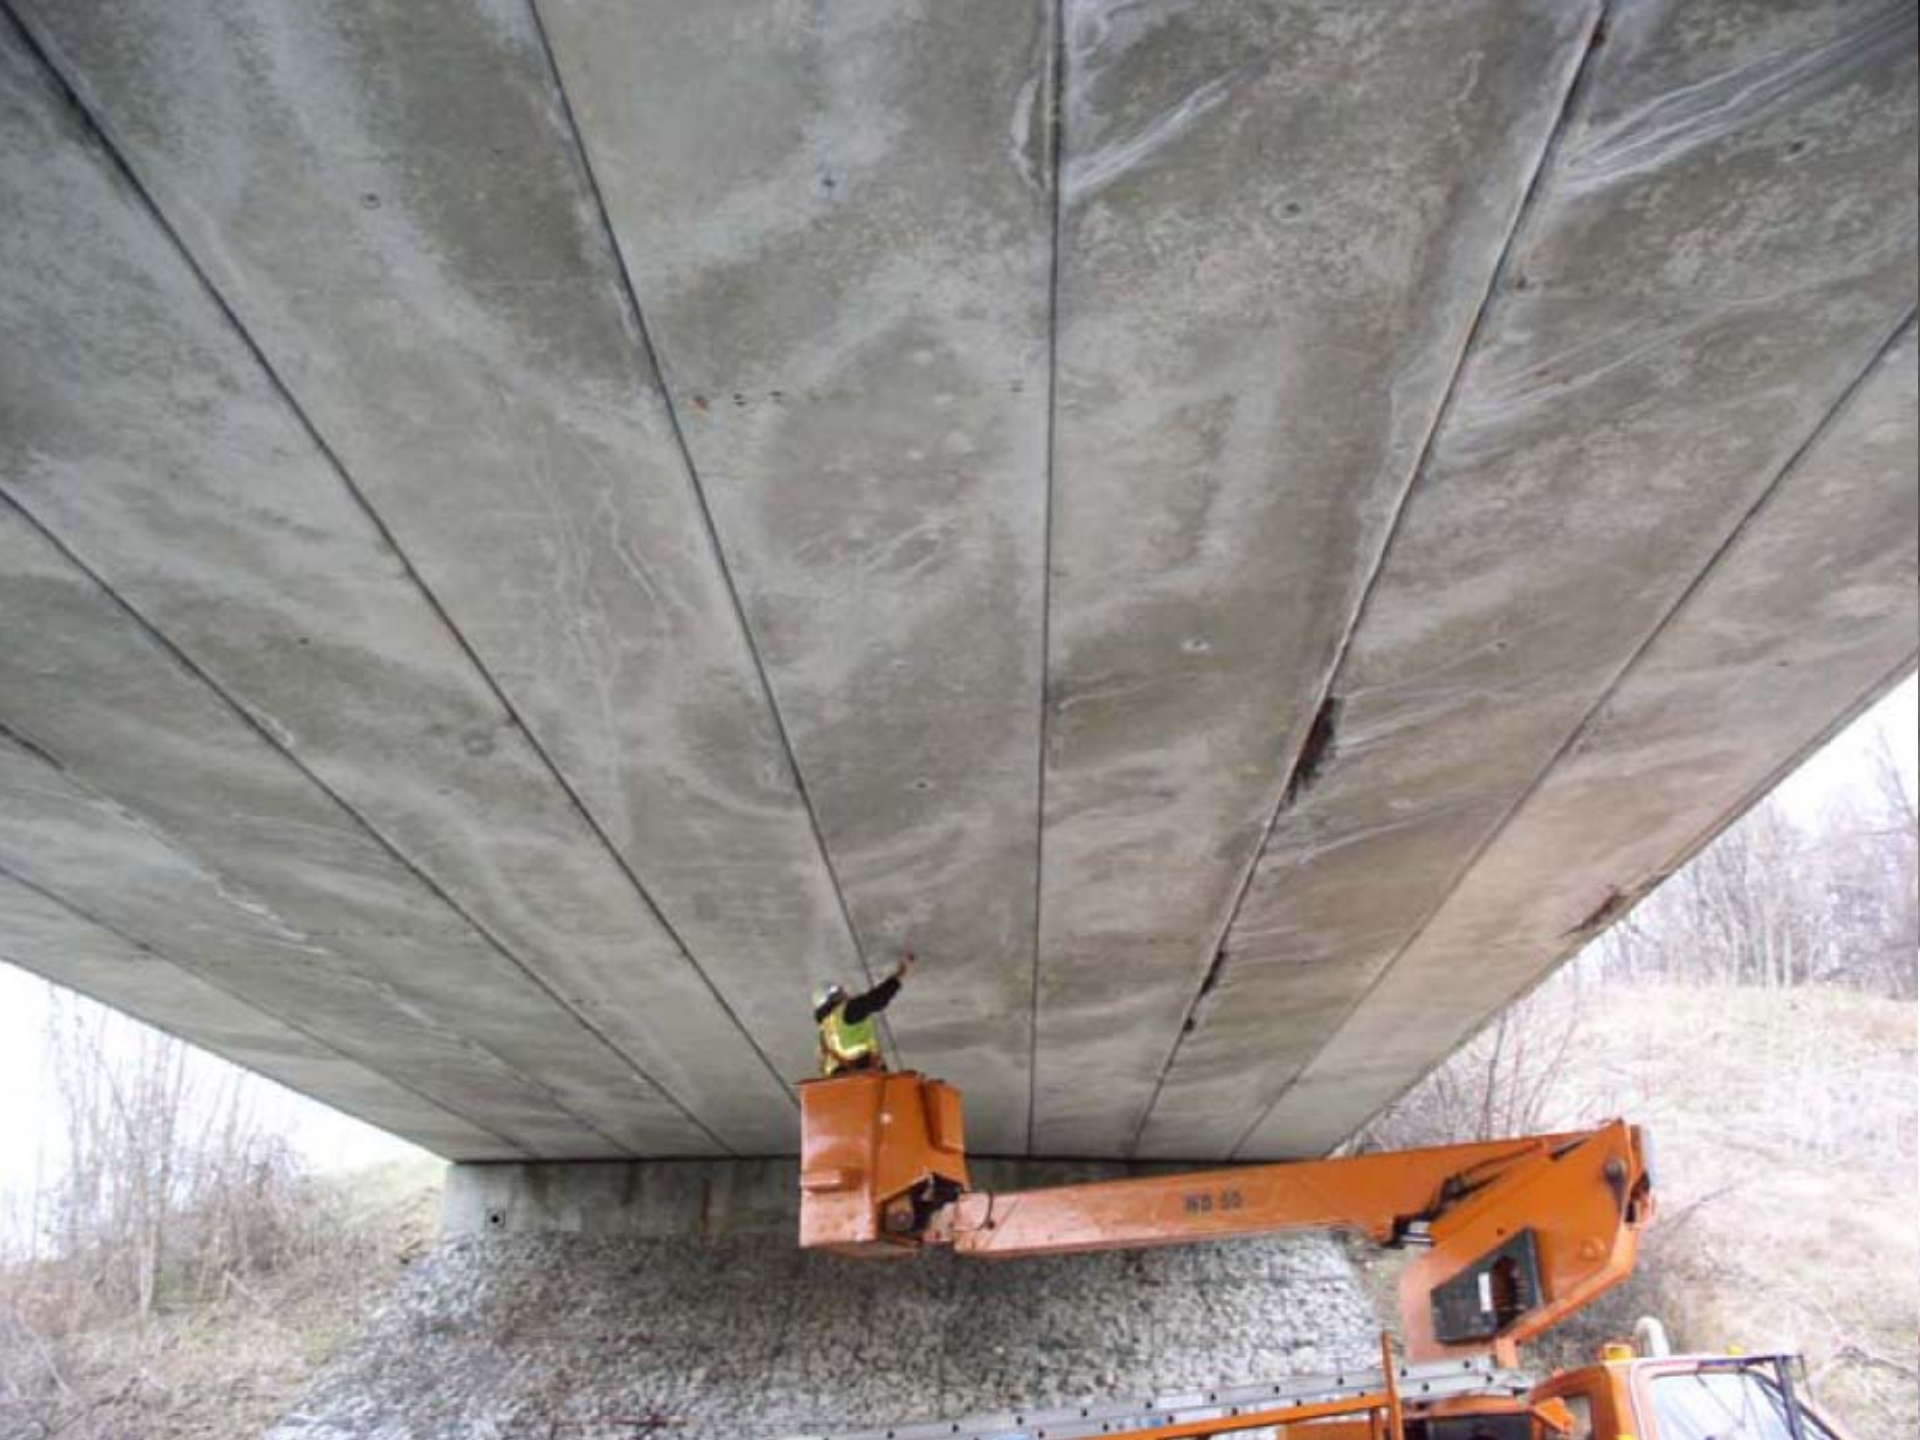
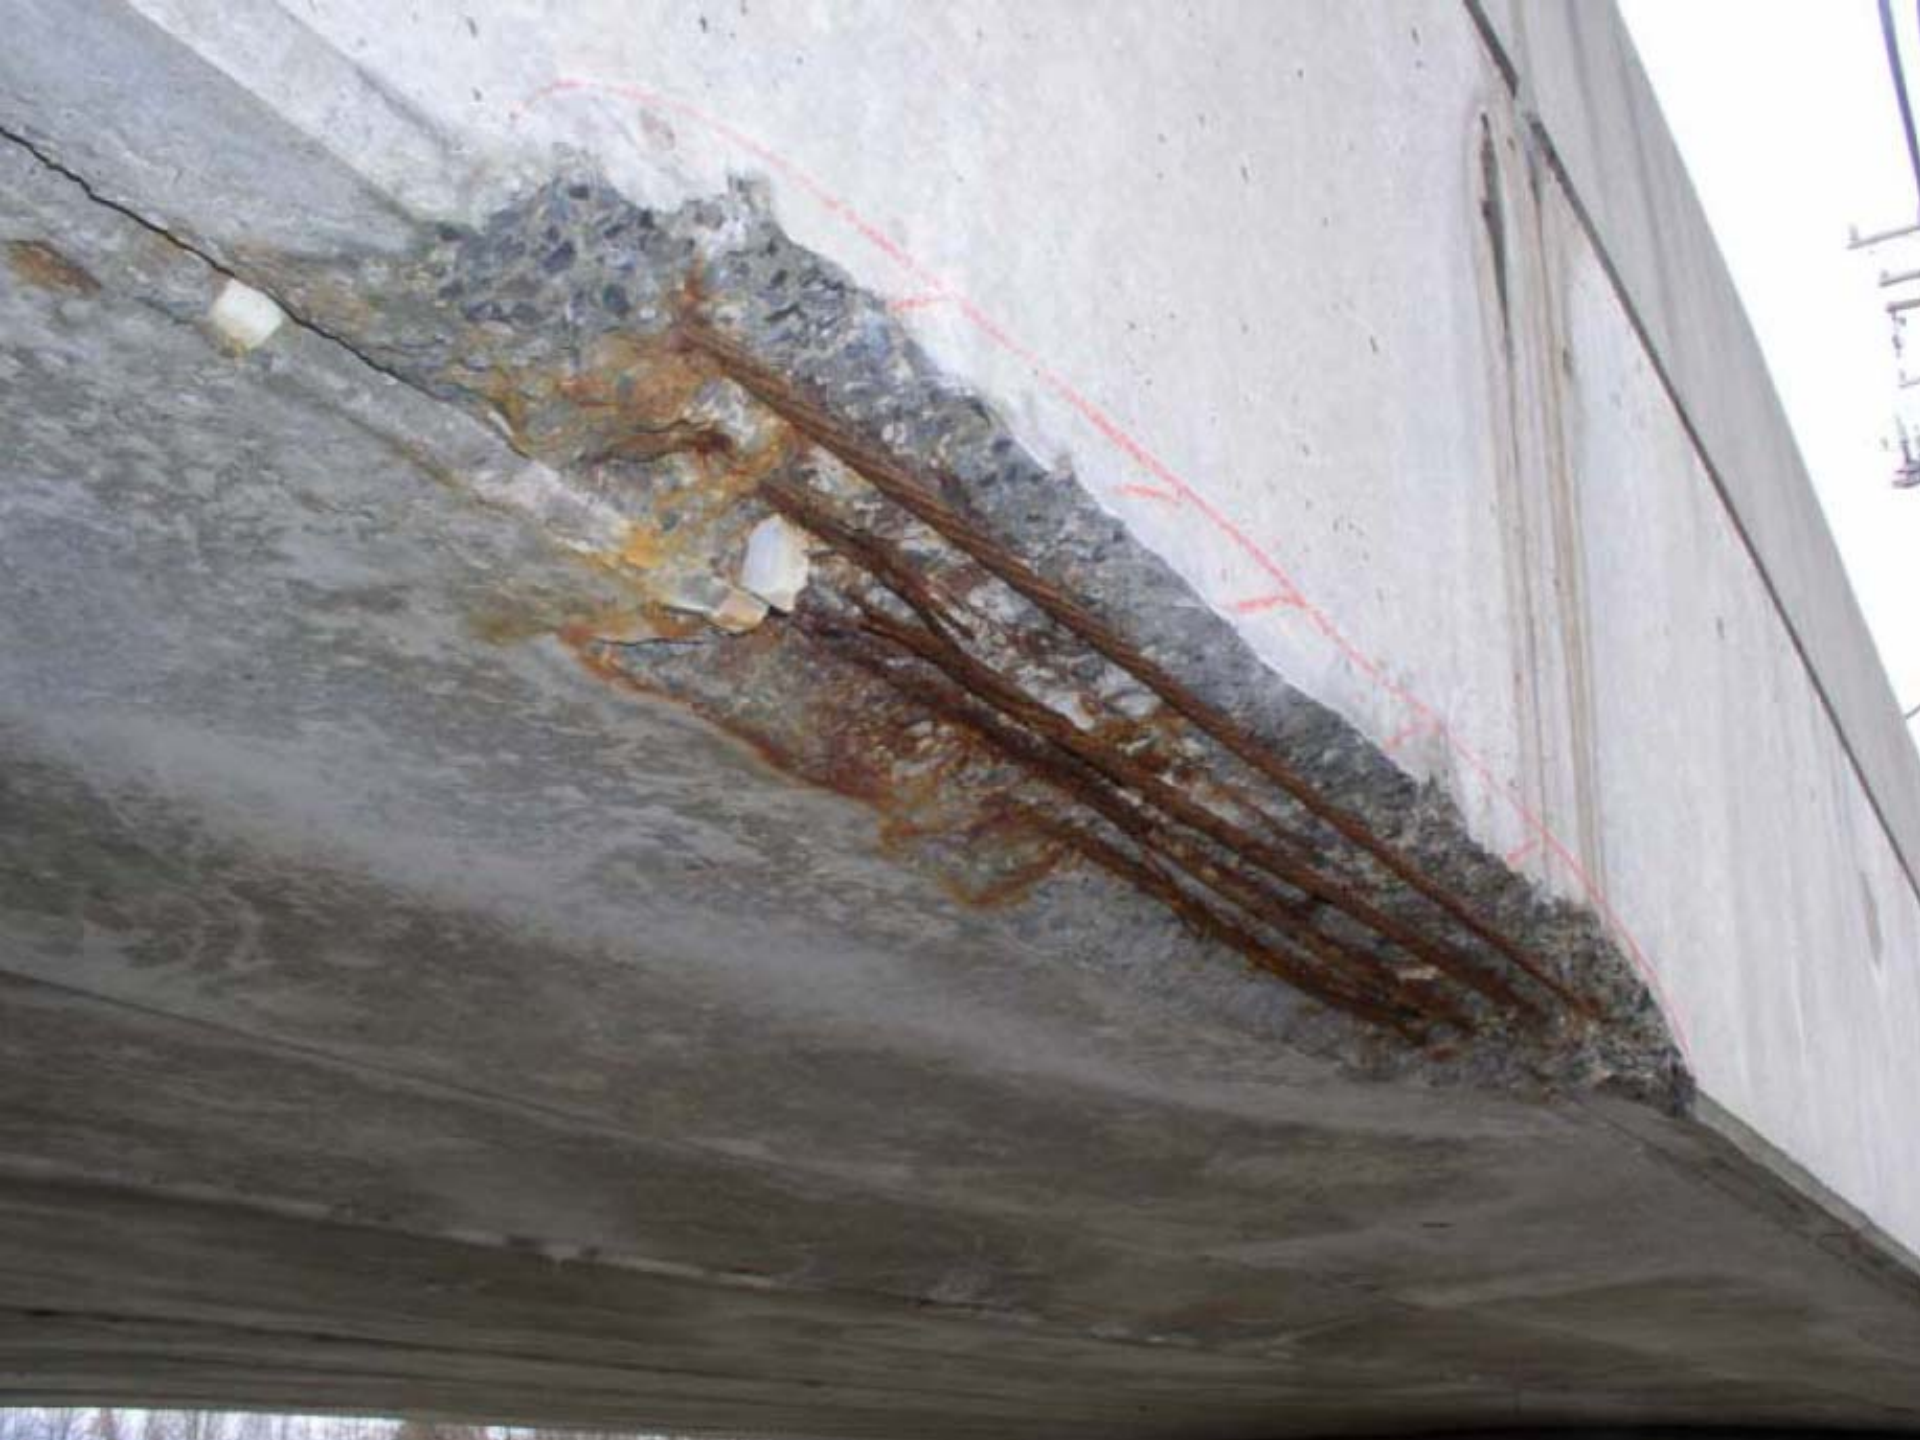
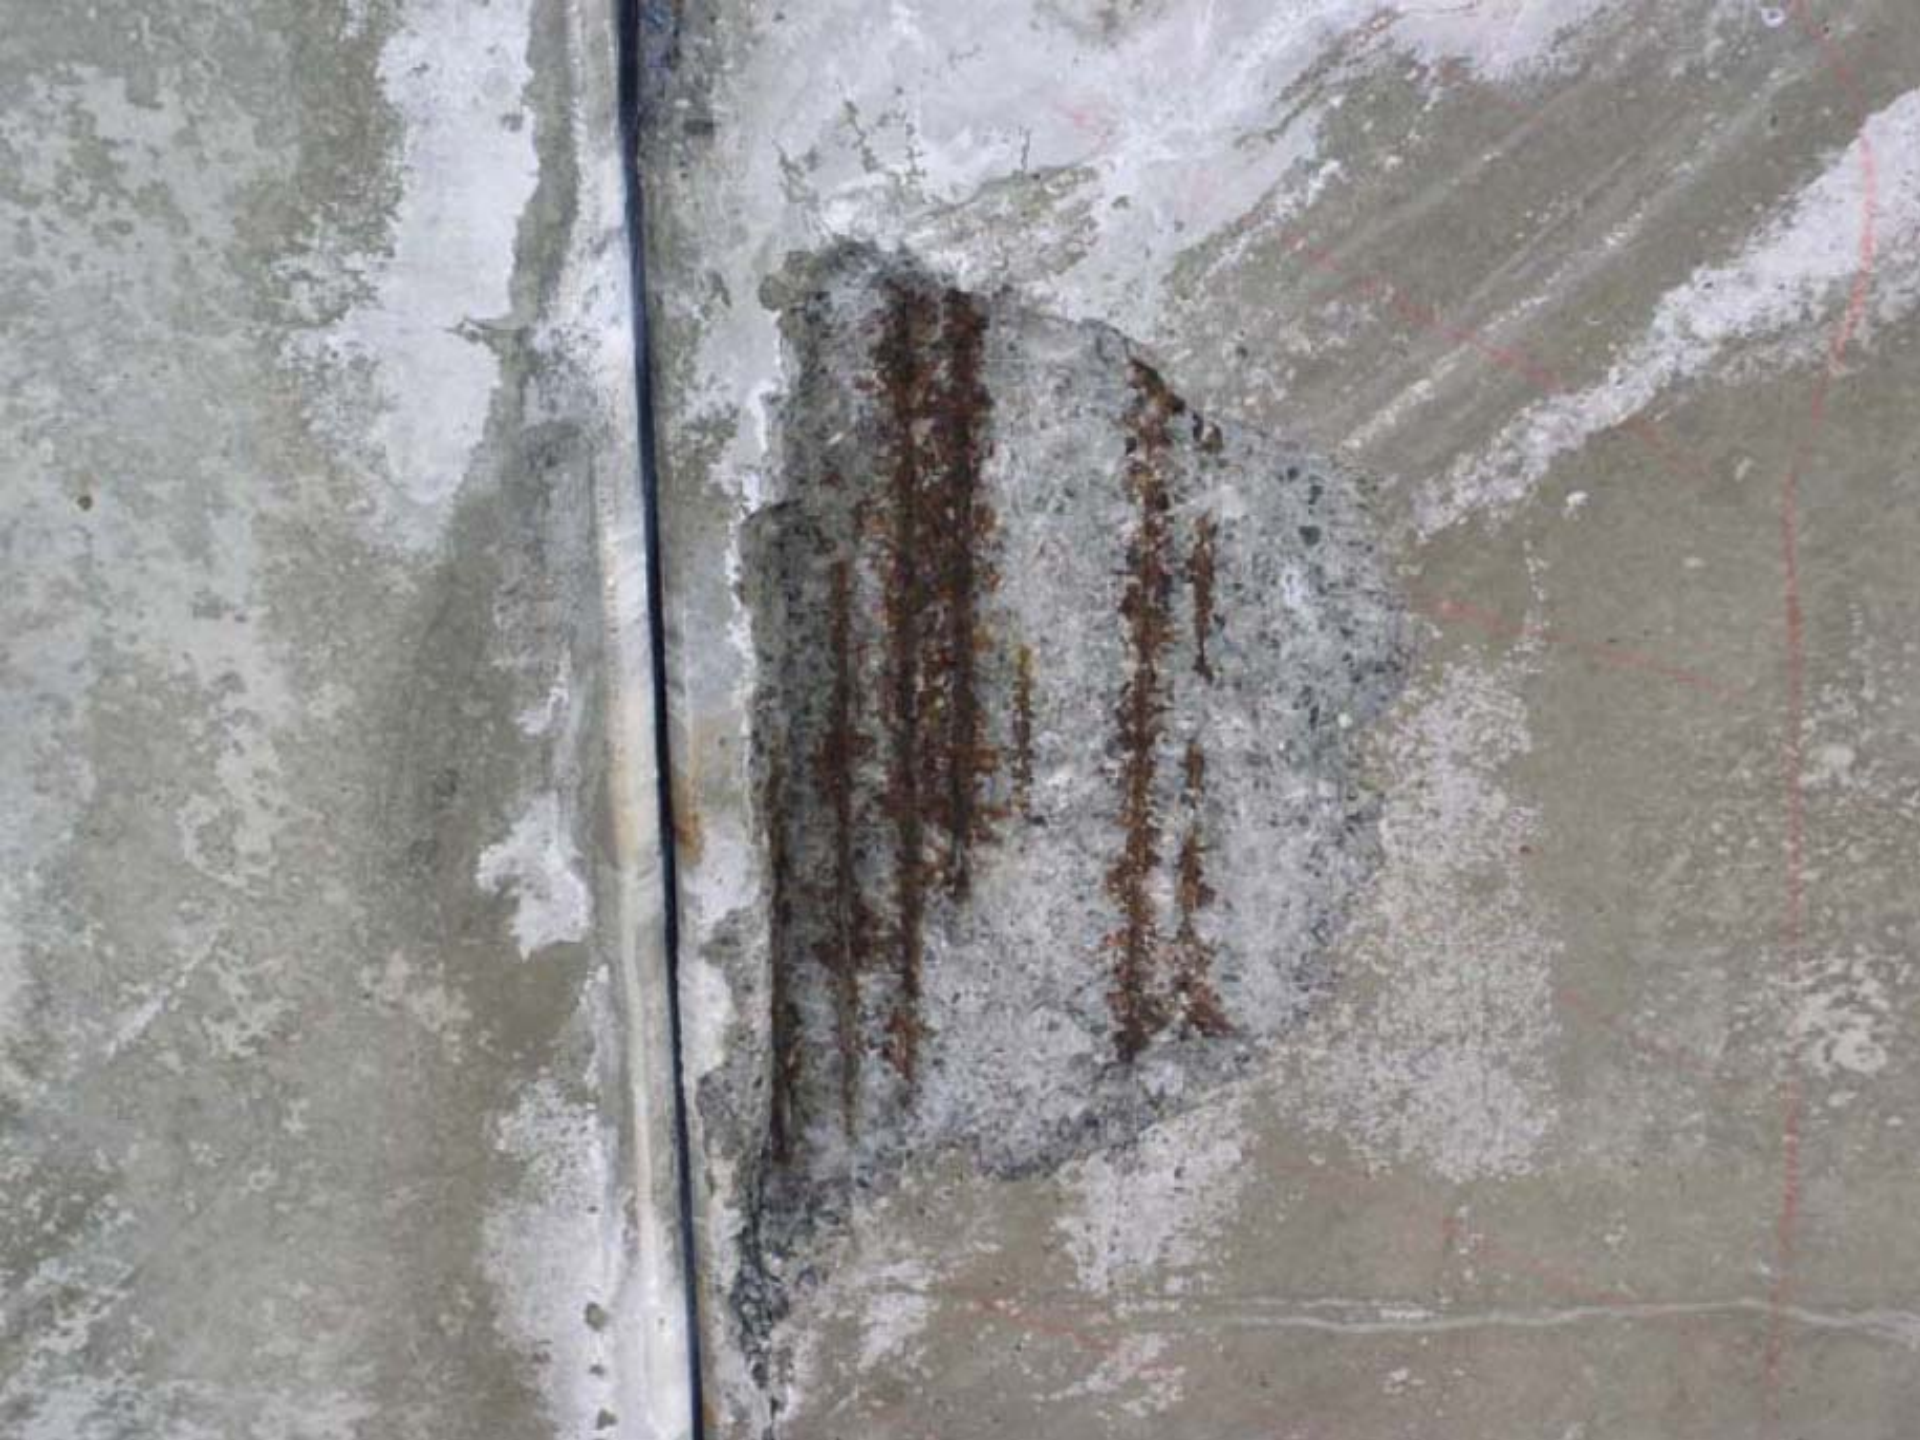
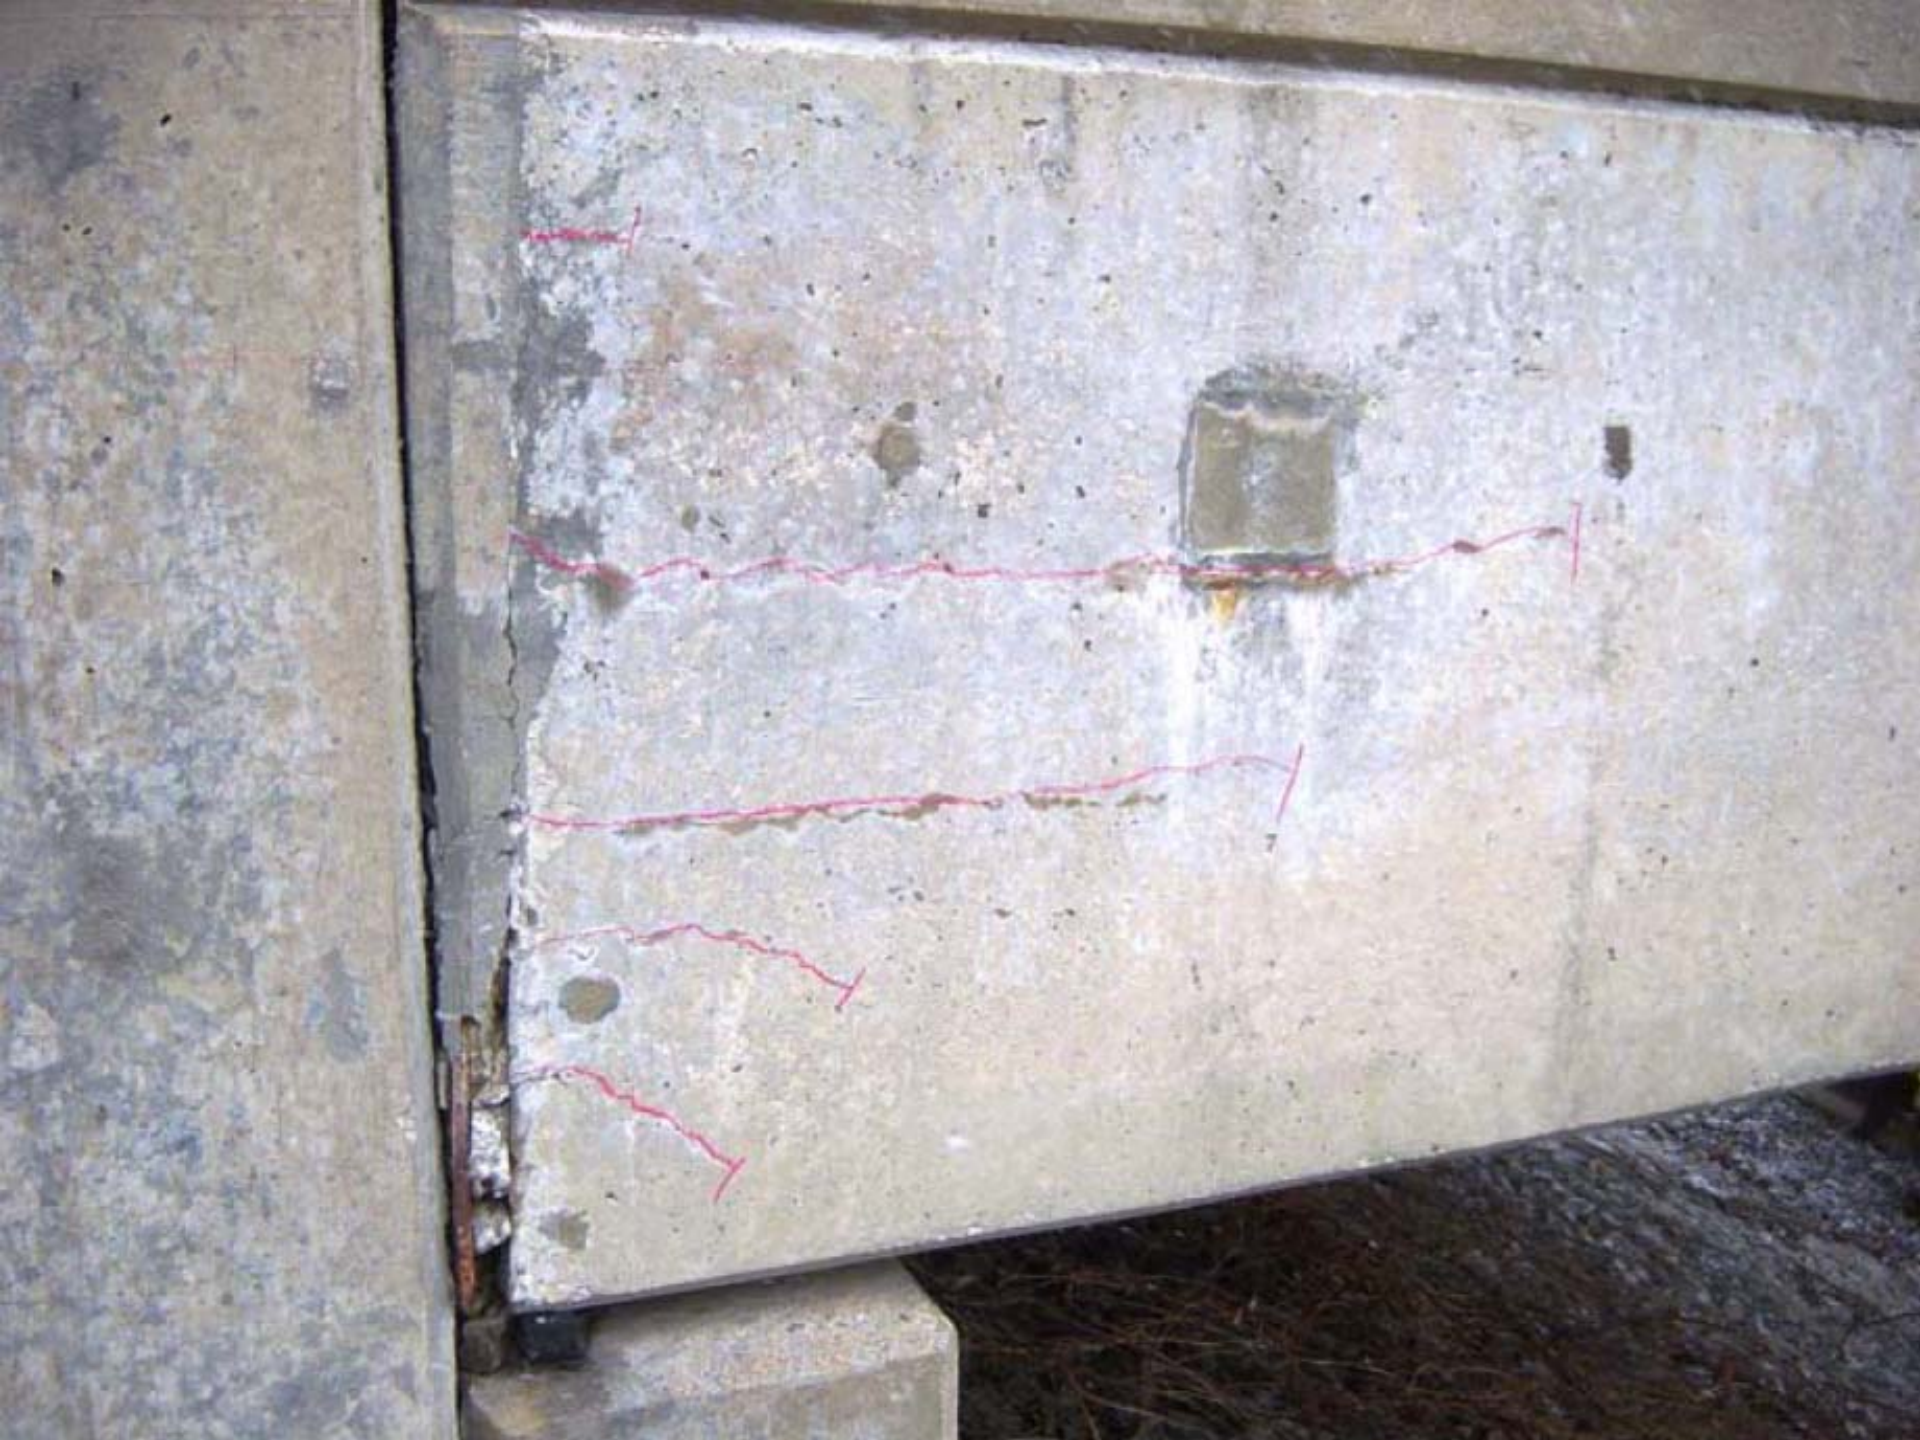
- There are delaminations and spalls throughout and several longitudinal cracks up to 1/8" wide. Beam 2 has 30% of its area spalled or delaminated and 7 out of 54 (13%) strands exposed.

Rating = 3, Serious

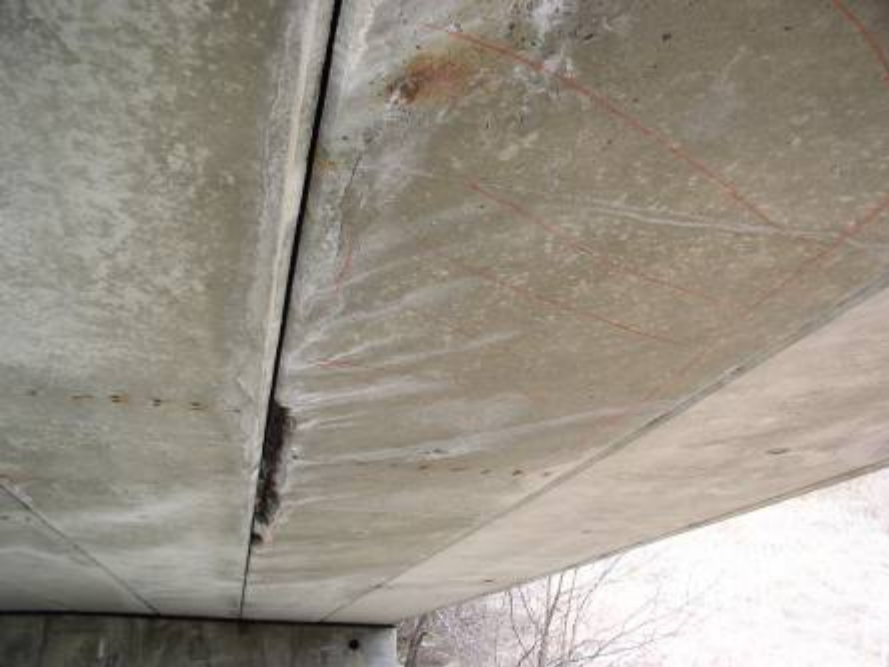
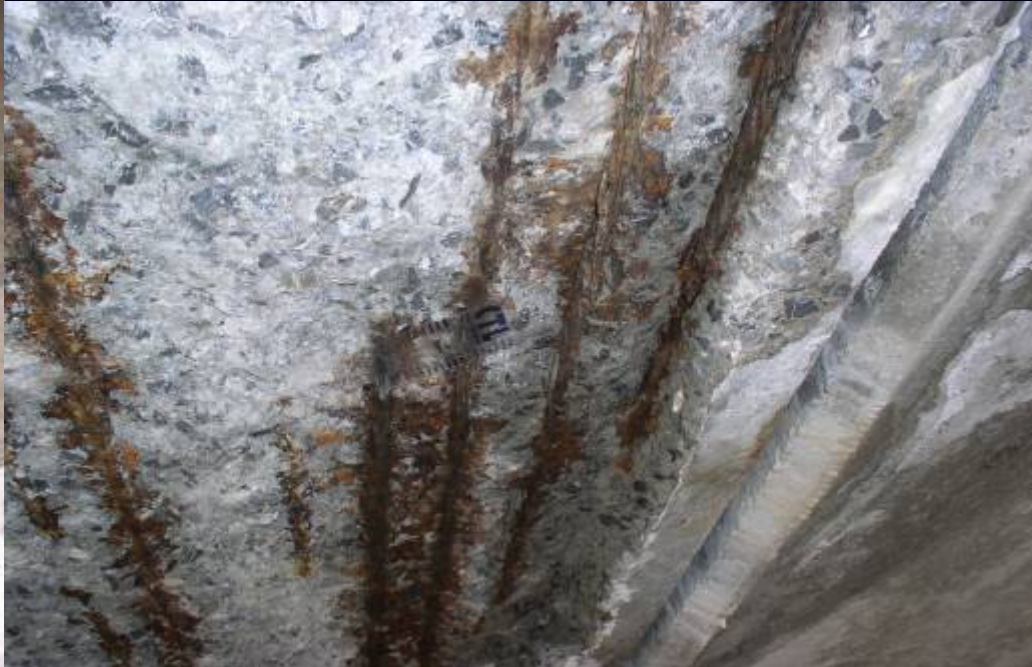
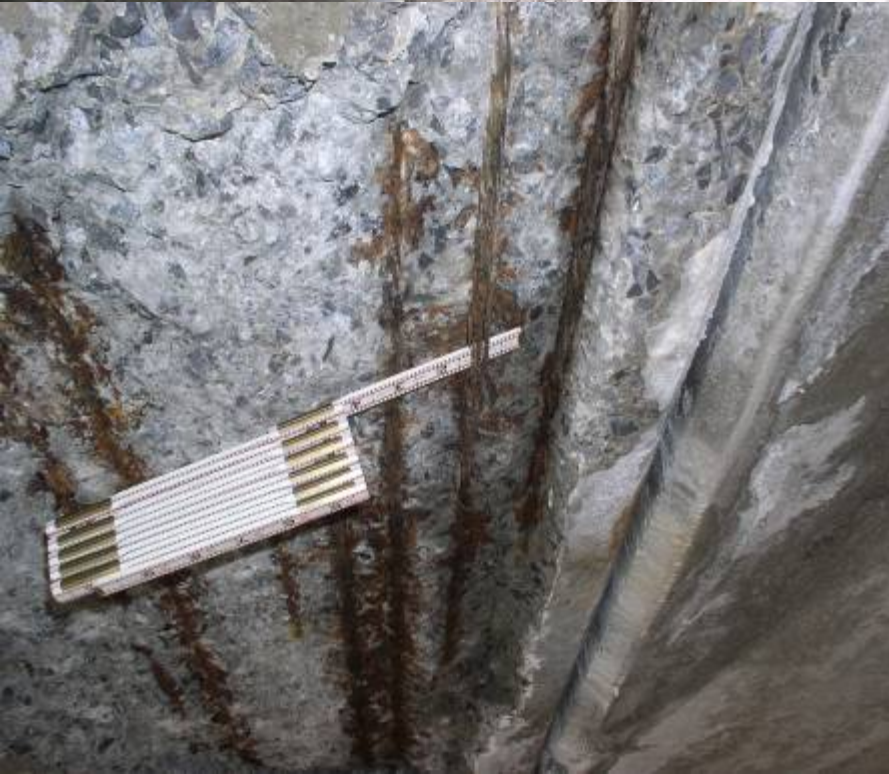
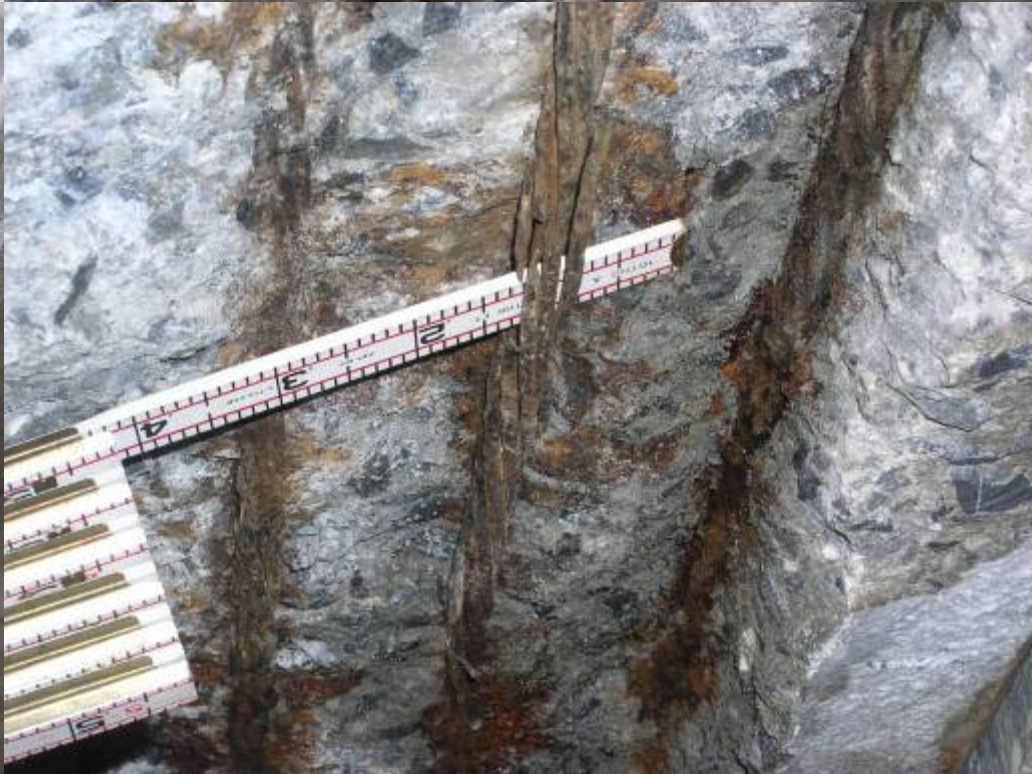
Rating: 4

6-15%

**Strands Exposed
(single beam)**

Rating: 3

**Spalls/Delaminations
>25%**
