Inspection Advisory

Dyna-Lock[®] Self-Retracting Lanyard – 20ft. Models

August 6, 2008

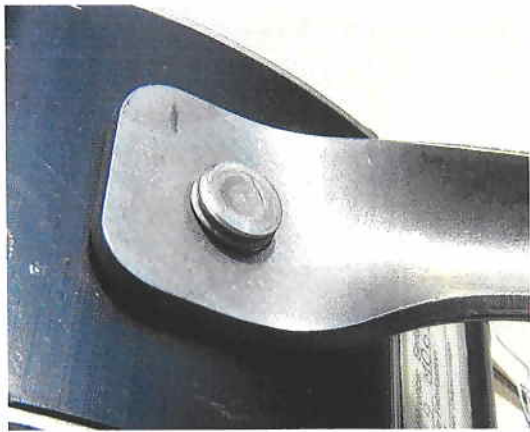
When inspecting 20ft. Dyna-Lock handle screws, compare them with the photos below. These photos illustrate the ends of a swaged (flattened) screw and an unswaged screw. Note that the swaged screw appears flattened; whereas, the unswaged screw has a cup shape appearance with a raised edge:

Good – Swaged (flattened) Screw

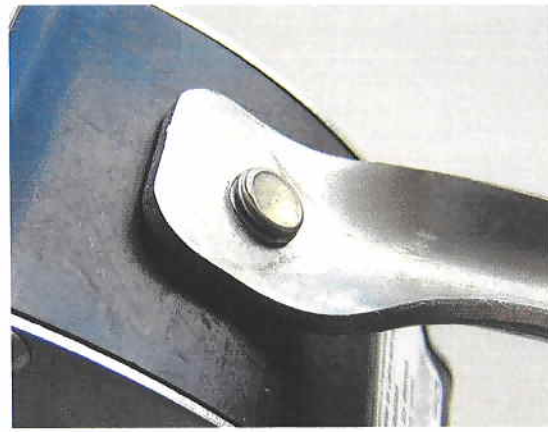
Bad – Unswaged (cup shaped) Screw

Upon inspection, if any units are found to have unswaged screws (one or both), immediately remove the unit from service. Complete the attached shipping form and return the unit and the shipping form to MSA at the address provided below:

When receiving a unit with the above described condition, MSA will replace the housing/handle assembly and also perform a general inspection and cleaning of the unit (minimum service) free of charge. Returned units will be repaired and express shipped back to the customer within approximately three business days of receipt.
