U.S. Department
of Transportation
**Federal Railroad
Administration**

Documentation of Deformation from Passenger Rail Two-Car Impact Test

DOT/FRA/ORD-03/08

Final Report
November 2003

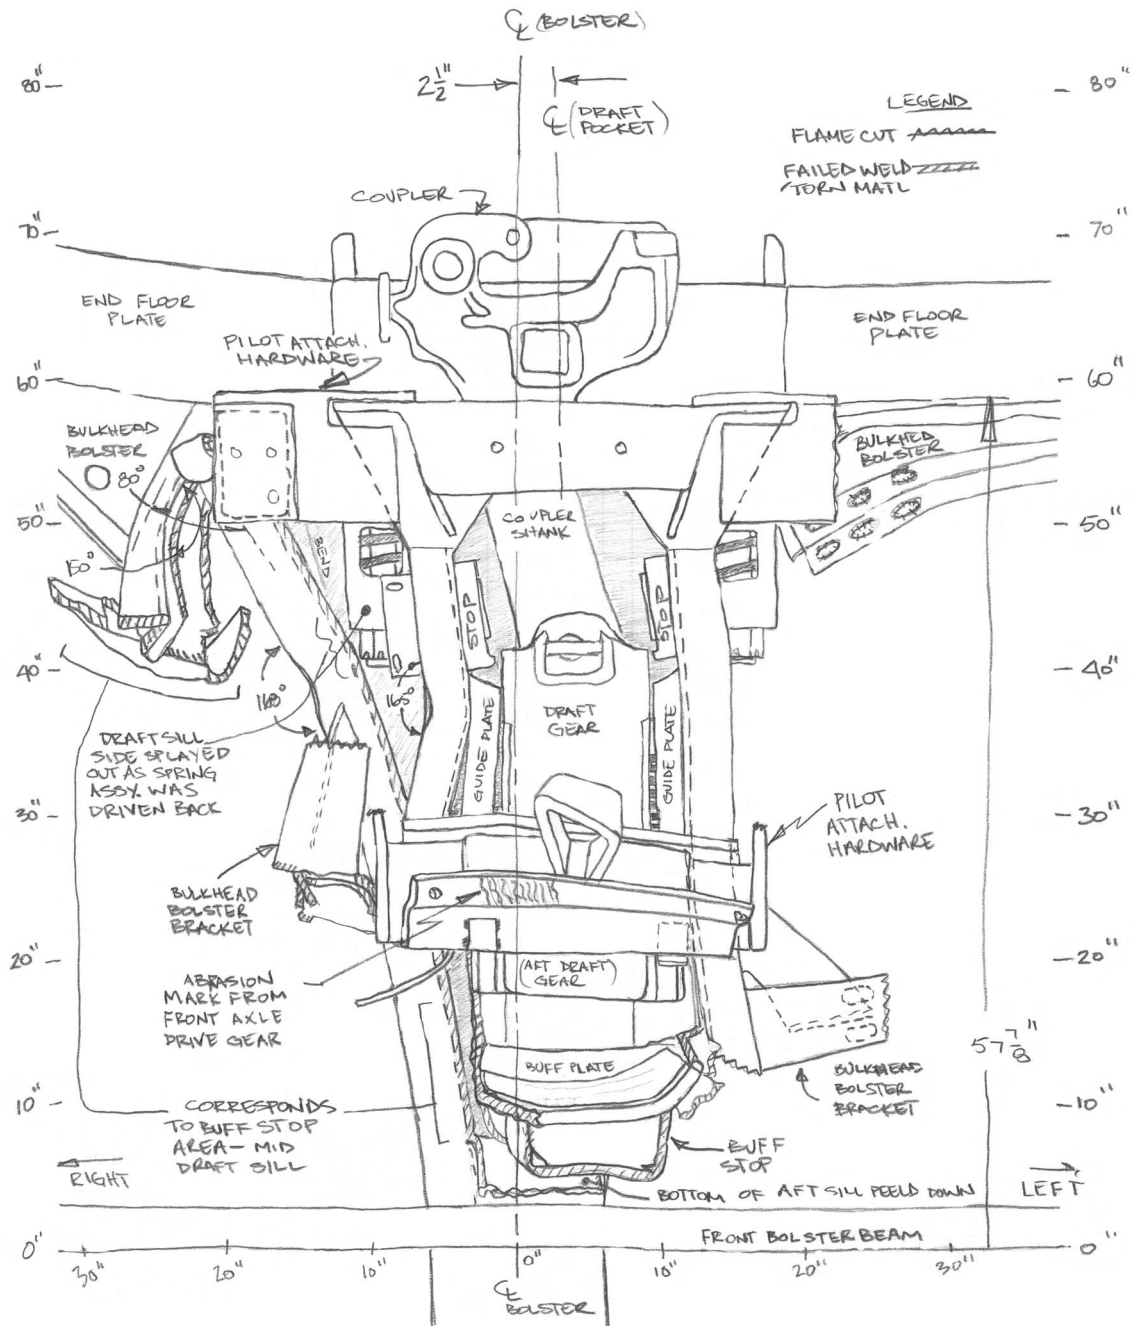
Figure 4. Sketch from Below Draft Sill Collapse

The draft sill suffered the most significant collapse of all major structural components. This is expected since most of the other longitudinal structural components are not continuous through the vestibule region. As such, the draft sill would absorb the most crash energy of any single component. The collapse mode was similar to that seen in the single car test: the coupler was forced back as it impacted the wall, pushing the draft gear aft, which subsequently failed the connection of the buff stop to the draft sill—this was the primary initiation point for the gross failure of the draft sill. The portion of the draft sill forward of the buff stop acted mostly like a rigid body driven down and back while the aft part of the draft sill collapsed. The front portion of the draft sill was pushed to the right side by about 2.5 inches (0.0635 m), which promoted an asymmetric collapse of the aft portion of the draft sill (see Figure 4).

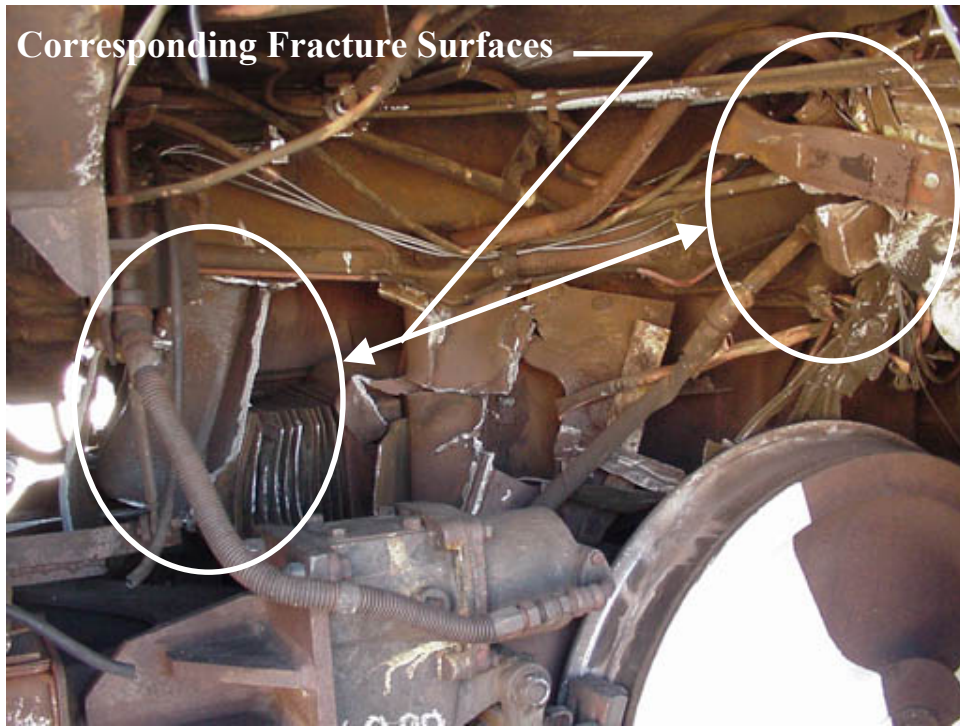
Figure 5. Right-side Draft Sill Collapse, Just After Test

The right side of the aft draft sill folded back on itself and fractured off from the forward section, as the forward part was driven down and back. This fractured section is noted in Figure 4 above (note the right side is shown on the left side of the sketch since it is viewed from below) and may also be seen in Figure 5. The fractured welds and torn steel surfaces in Figure 5 appear as light gray lines, in contrast to the otherwise rust-colored steel.

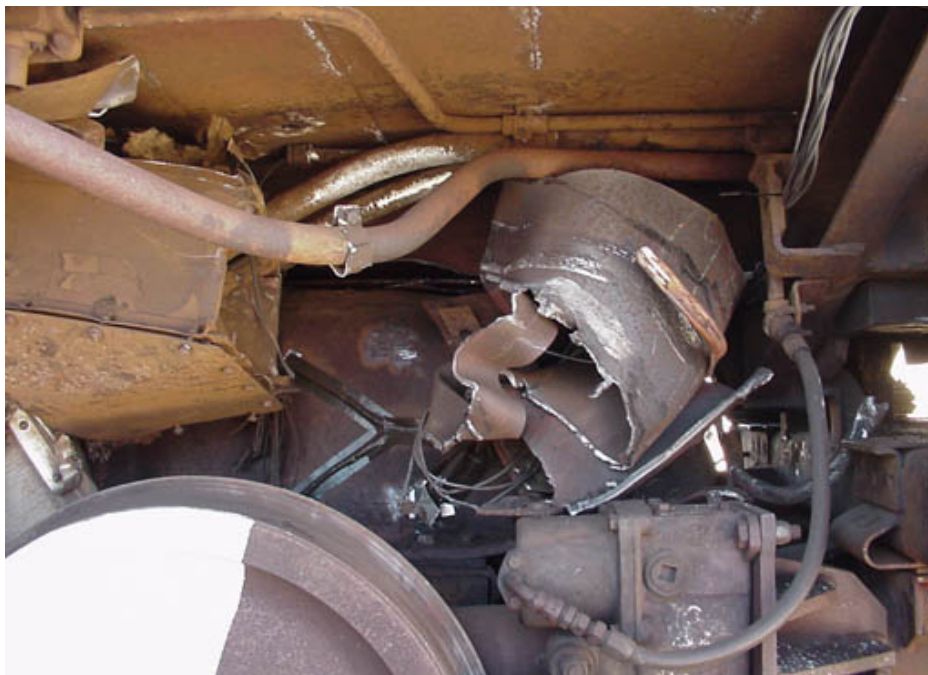
Figure 6. Left-side Draft Sill Collapse, Just After Test

The left sidewall of the aft draft sill was cut by the forward part of the draft sill and folded like a ribbon along the side of the collapsed draft sill. A picture of the folded sidewall is shown in Figure 6, which was taken before the material was removed so that the car could be moved away from the test site.

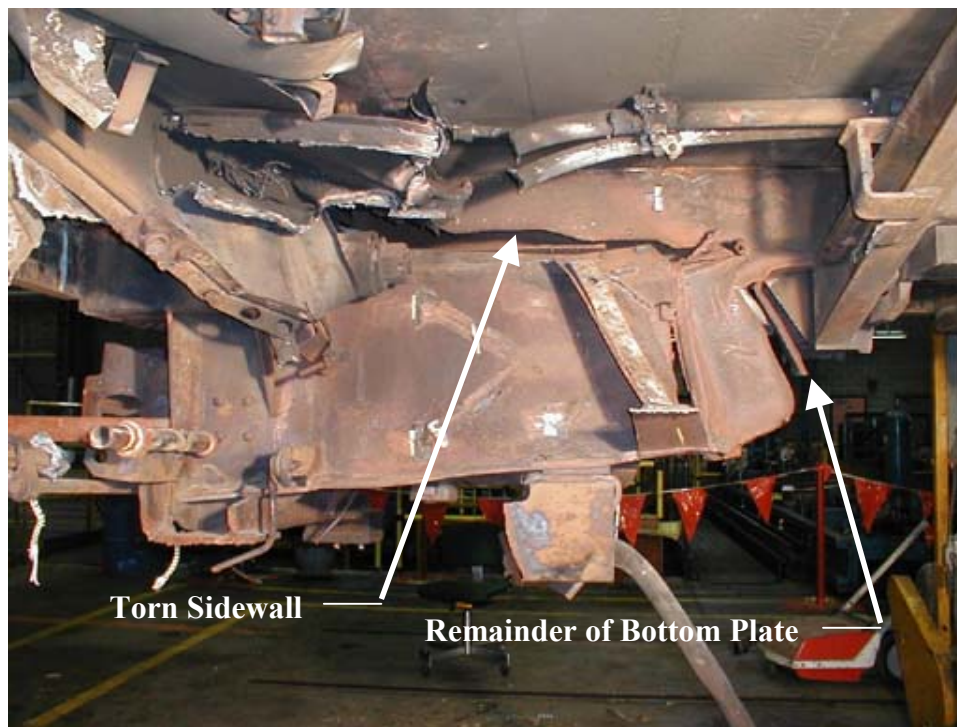
Figure 7. Left Side of Draft Sill During Postmortem Inspection (After Truck Removal)

Some of the material seen in Figures 5 and 6 was removed after the test to facilitate moving the damaged car from the test site. The right side of the draft sill had only minor amounts of material removed but large sections such as the left side and bottom aft plate were removed and not retained for later inspection. As a result, these pieces were not available to be studied and documented in this program. It is fairly clear what occurred to the left sidewall from Figure 6 above and by inspection of the remainder of the draft sill. Though the bottom plate of the draft sill that runs from the buff stop to the bolster beam was not retained, it appears to have failed in a manner similar to the single car test. The welds connecting the bottom plate and sidewalls failed as the buff stop was driven back and the plate was driven down below the truck. There is evidence of the bottom plate being thrust downward in Figure 7 below. Also shown in Figure 7 is the left side of the draft sill after the deformed sidewall had been cut away.

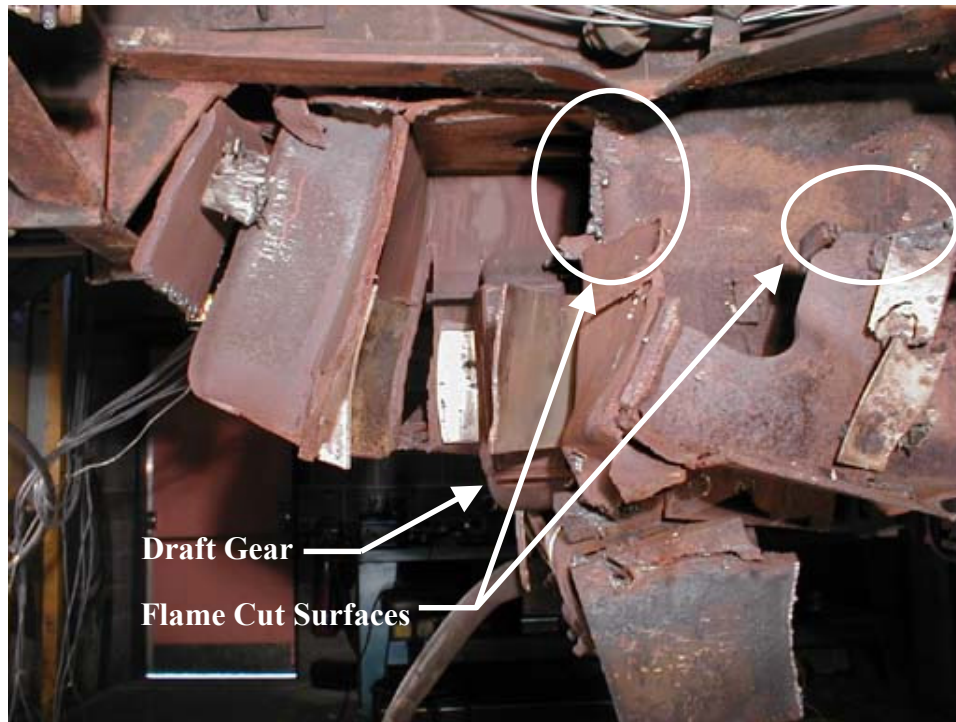
Figure 10. Right-side Draft Sill

A corresponding photograph of the right side of the draft sill is shown in Figure 10. In this figure, the truck had been removed and some nonstructural equipment surrounding the draft sill had been removed to gain better views of the draft sill collapse. Compared to Figure 5, one can see some material was cut away on the side of the draft sill just forward of the opening where the rear of the draft gear is positioned. This material was cut after the test and was not available for inspection during this investigation.

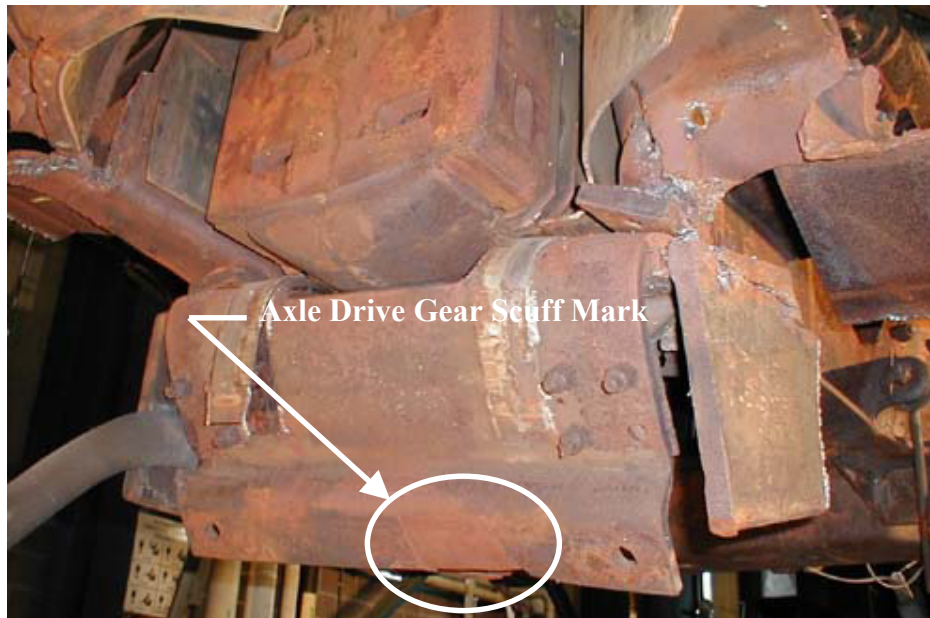
Figure 11. Pilot Attachment Hardware Detail—Axle Interaction

Also seen in the figures and sketches is the bent pilot attachment hardware, attached to the bottom of the draft sill below the draft gear. Prior to the detailed postmortem some material was cut away from this component as well and was not available for inspection. The post-test inspection of the pilot attachment hardware found evidence of interaction with the front axle on the forward truck. Normally, this hardware would sit well above and forward of the axle but, as the draft sill collapsed, it was driven down and rode over and behind the axle. Figure 11 shows a detailed photograph of the mark made on the pilot attachment hardware by a drive gear on the most forward truck axle.

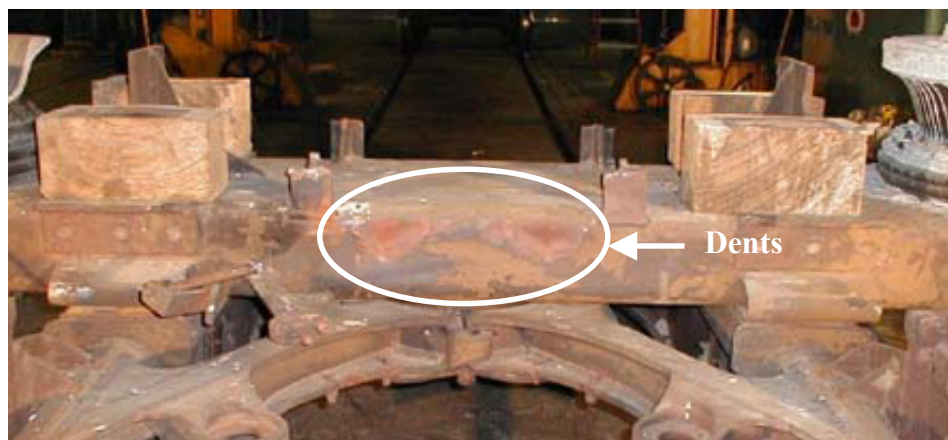
Figure 12. Dents on Truck Beam from Impact with Body Bolster

Evidence was found of an impact between the truck bolster beam and the forward body bolster beam. It is not clear at what time during the collision event the truck beam contacted the body beam. One possibility is that the contact occurred early in the crash as the truck continued forward while the underframe decelerated rapidly during the initial crash pulse. The initial deceleration of the truck is produced only by the loads transmitted through the traction rods until the bolster beam contacts the body bolster. The other possibility is that the contact damage occurred late in the collision event as the buff stop contacted the body bolster, creating a load path to the collision wall and more rapid deceleration of the forward bolster structure. The first scenario seems more likely. Accelerometer data could probably be scrutinized to determine the sequence of events. Figure 12 and Figure 13 shows details of the dents left on the truck beam and the forward body bolster beam, respectively, as a result of their impact.

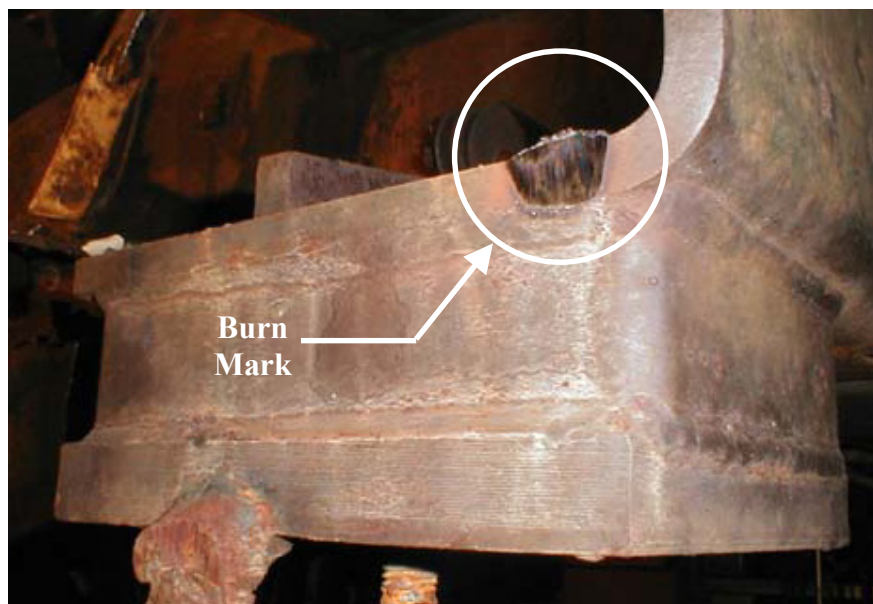
Figure 14. Evidence of Contact Between Draft Sill Pilot Mount and Front Right Wheel

As a result of the deformation of the draft sill, the right-side pilot forward attachment block below the draft pocket came into contact with the right forward wheel. As shown in Figure 14, there is a wheel burn on the pilot block from the right forward wheel. There was a corresponding polish mark on the inside of the right front wheel. This occurred due to the downward and lateral shift of the forward draft sill section during the vehicle collapse. Though this would place the front wheels very near the front of the impact face, review of high-speed film from the test suggests the wheels did not impact the wall.

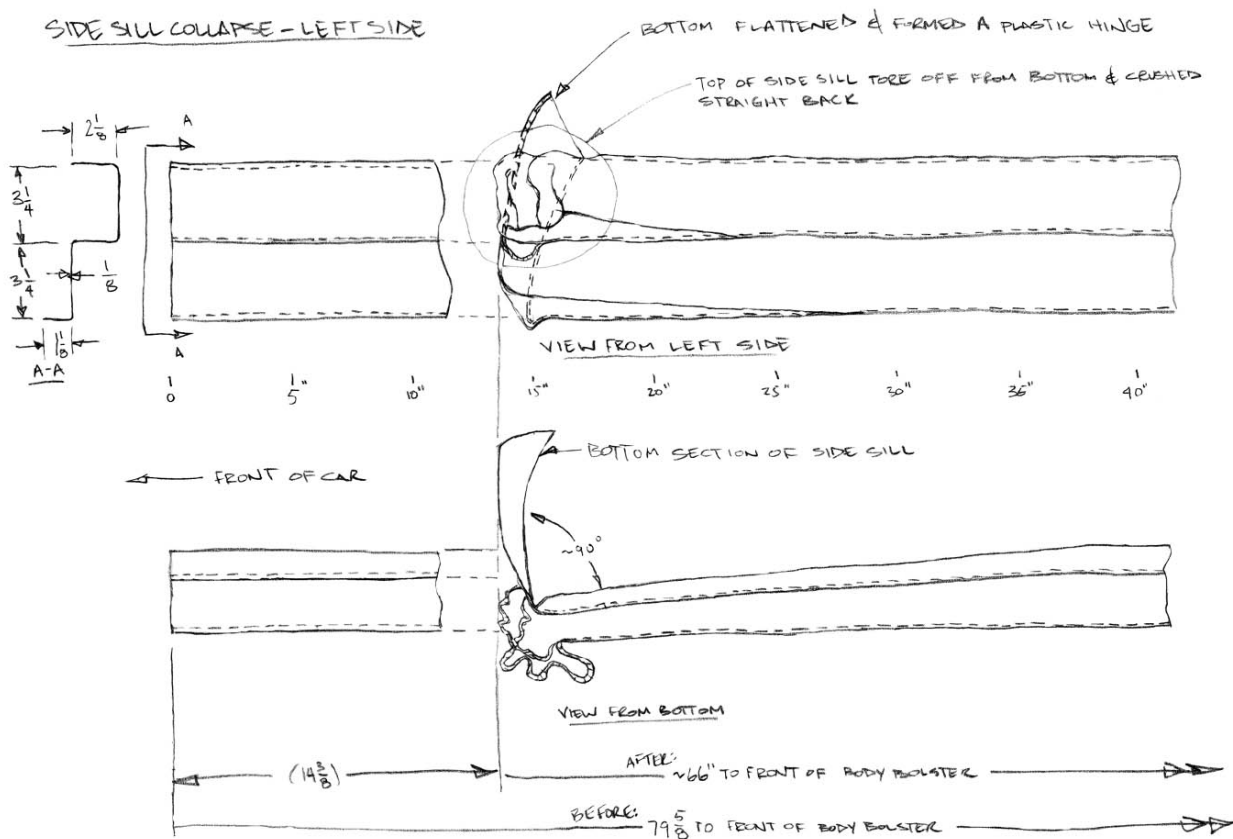
Figure 15. Sketch of Left-side Sill Collapse

The response of the side sills was asymmetric. As seen in Figure 15, the left side sill mostly crushed straight back, with the lower part of the side sill shearing off and bending inward. The collapse response of the crushed side sill section featured relatively short wavelength buckling. Overall reduction in length of the left side sill was $14 \frac{3}{8}$ inches (0.365 m).

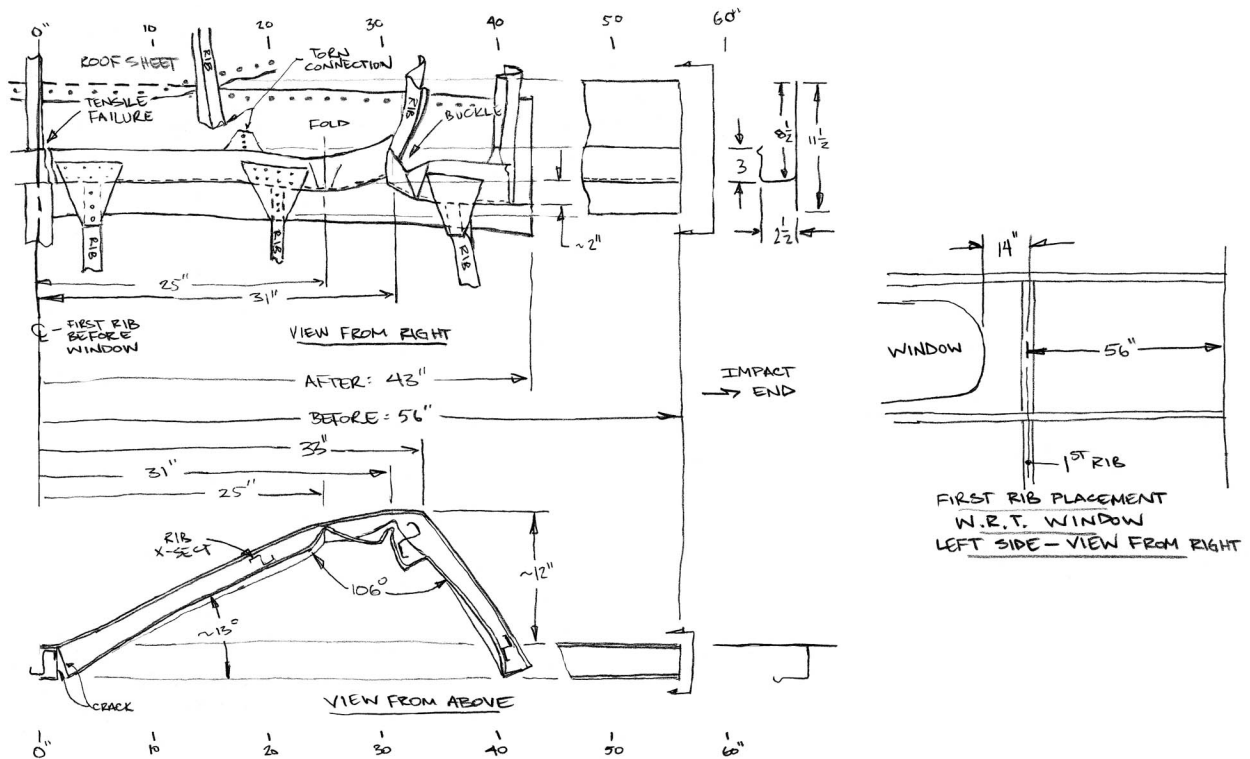
Figure 18. Sketch of Left Cant Rail Damage

Figure 18 and Figure 19 show that both right and left side cant rails developed fractures just forward of the window frame. The fractures developed at a point of high bending stress as the sidewalls aft of the bulkhead buckled out and the stiffer window frame sections remained straight. A close-up photograph of the fracture on the right-side cant rail is shown in Figure 22. It appears that the crack runs through a spot weld, at which there was probably a stress concentration that initiated the failure. The fracture on the left side cant rail was nearly identical in character and location.

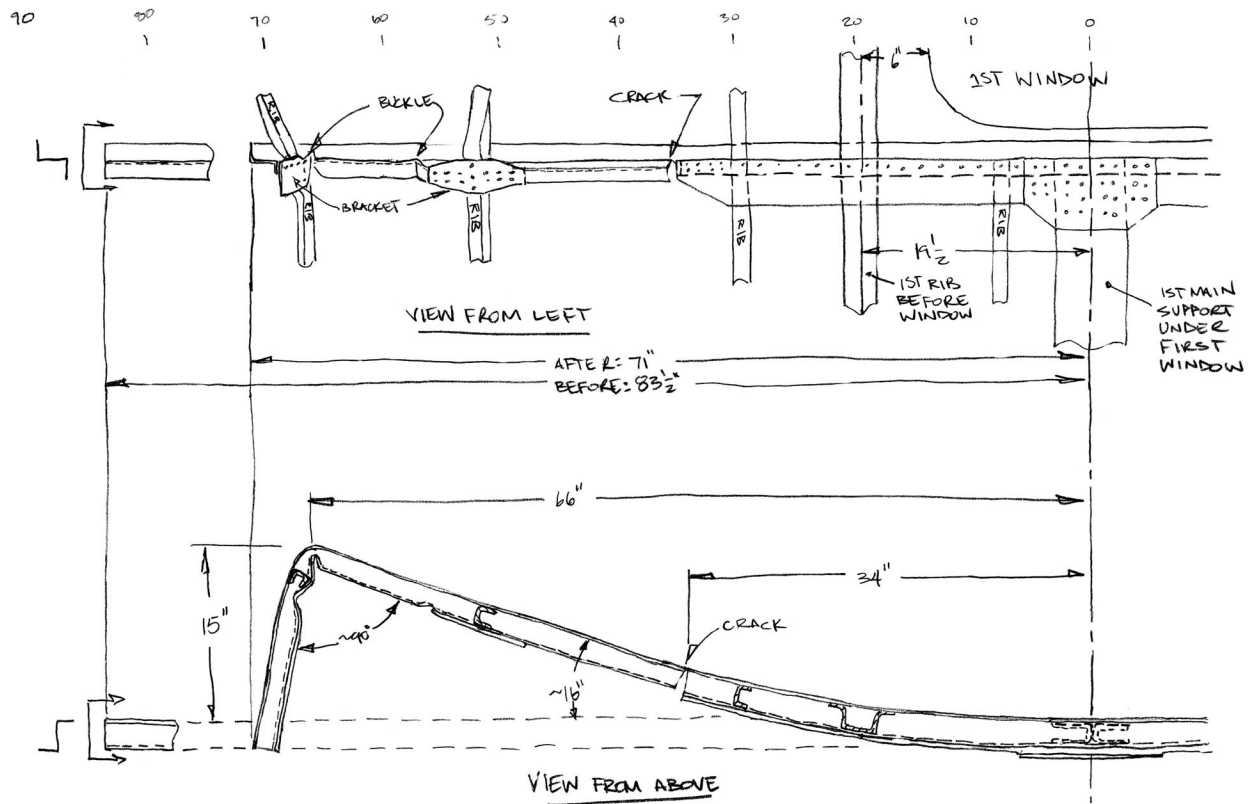
Figure 24. Sketch of Right-side Belt Rail

Similarly, Figure 24 shows that the right-side belt rail buckled out 15 inches (0.381 m) and was deflected back 12½ (0.318 m) inches. One major difference between the two belt rails is that the point of outward deflection was located farther aft on the right side than on the left side. This is because the right-side sill detached from the floor rails and allowed deflection of the sidewall to extend farther back than on the left side, whose side sill remained attached to the floor structure and crushed longitudinally.

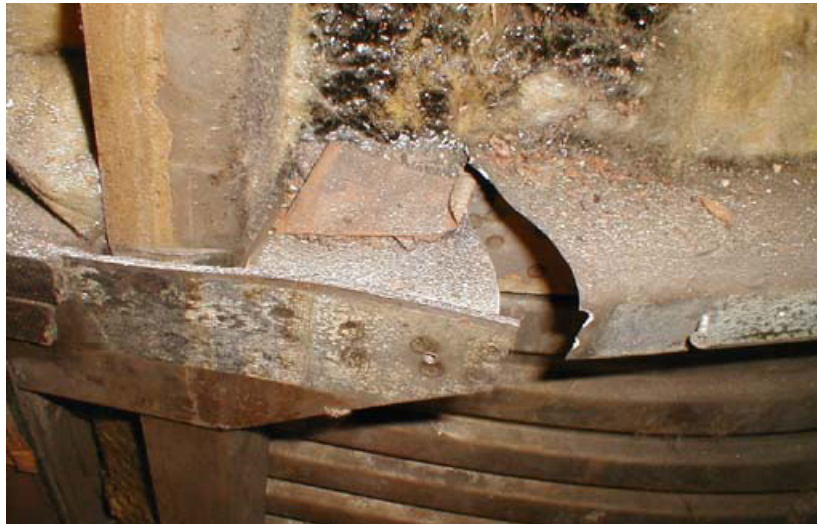
Figure 25. Left-side Belt Rail—Crack Detail Just Forward of Window Frame

Cracks in both belt rails were seen like those in the cant rails. The locations of the fractures are nominally the same as those in the cant rails. Figure 25 shows a close-up of the cracked left-side belt rail. Note that the fracture runs through two spot welds, which were probably the initiation points of the failure.

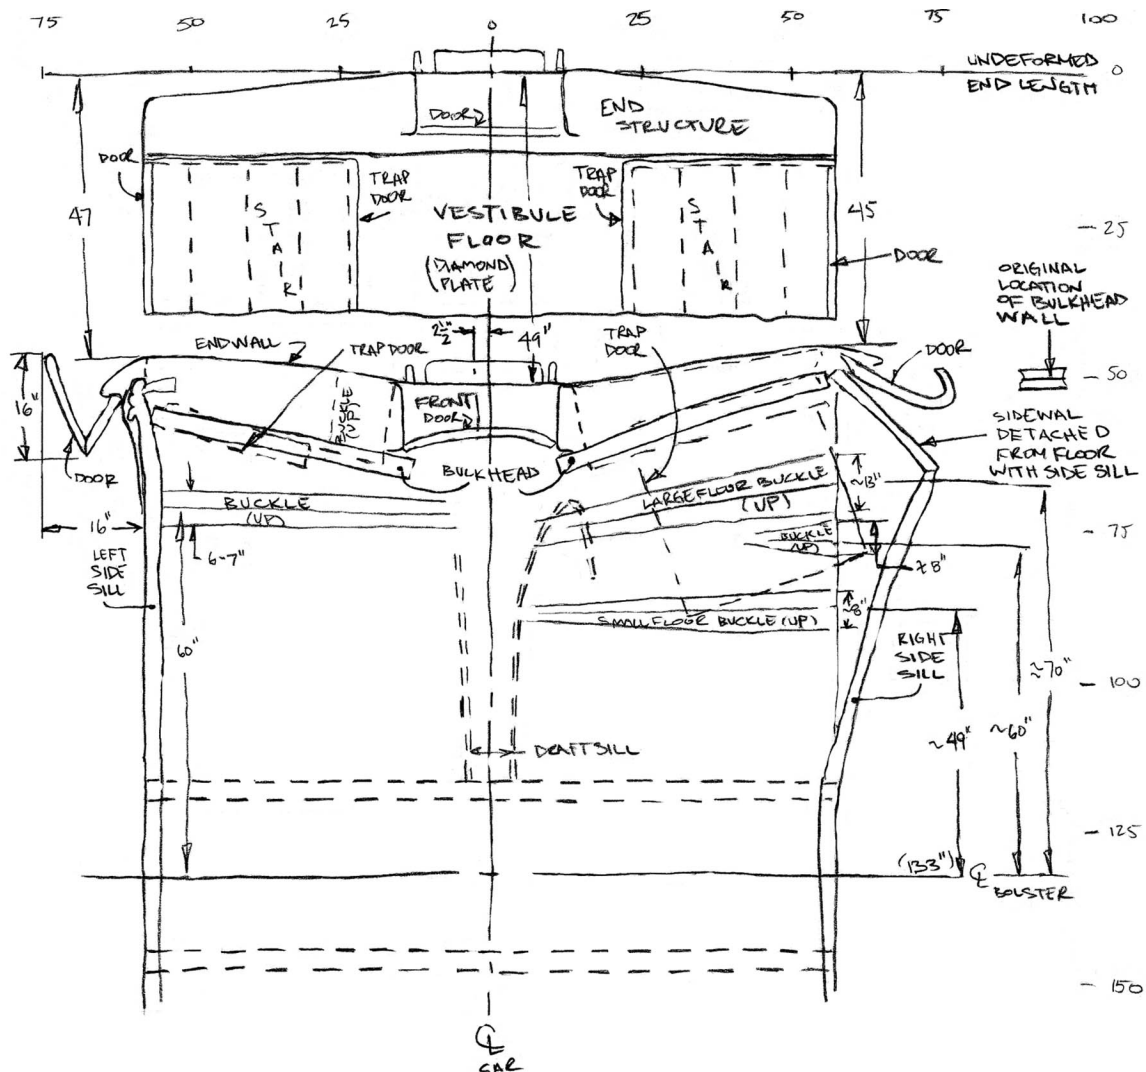
Figure 29. Sketch of Crush at Floorline, as Viewed from Above

Figure 29 shows a top view of the vehicle crush in the impact zone. The deformations shown in the sketch correspond to those at the carbody floor line. The sketch shows how the impact surface was deformed into a nearly planar surface to conform to the impacted wall. Floor buckling is also noted.

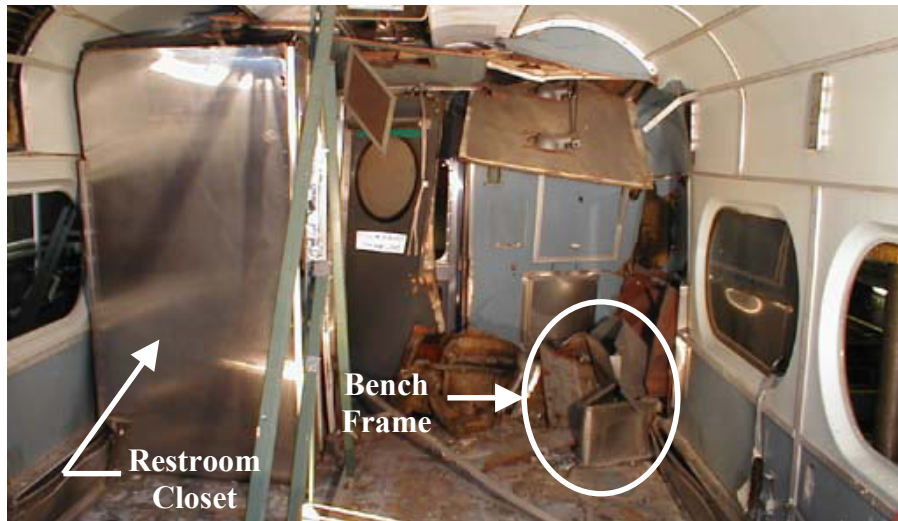
Figure 30. Internal View Looking Forward at Crush Zone

Figure 30 shows the internal damage behind the bulkhead wall at the impacted end. The restroom closet on the left side of the car was pushed back past the leading edge of the first window. The closet, which is only weakly screwed into the surrounding paneling, moved back as a unit and would have impacted any seats installed between it and the window frame. Further occupant space was compromised on the right side where a bench is mounted along the right wall just aft of the bulkhead wall. The bench frame was seriously distorted and a major floor buckle occurred directly under the bench.

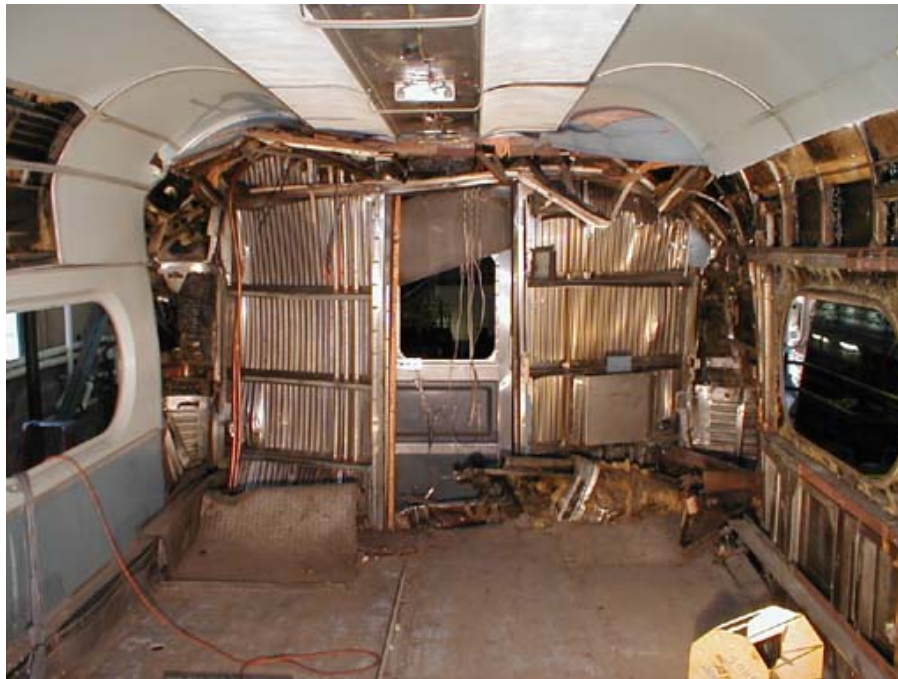
Figure 31. Internal View Looking Forward of Crushed End After Material Removal

To gain better access to primary structural members and to assess overall structural damage, non-structural elements were removed inside the car between the first window frame and the bulkhead wall. Figure 31 shows the view from inside the impact end after the material was removed. One can see that the bulkhead wall remained mostly intact while the sidewalls aft of the bulkhead wall buckled outward.

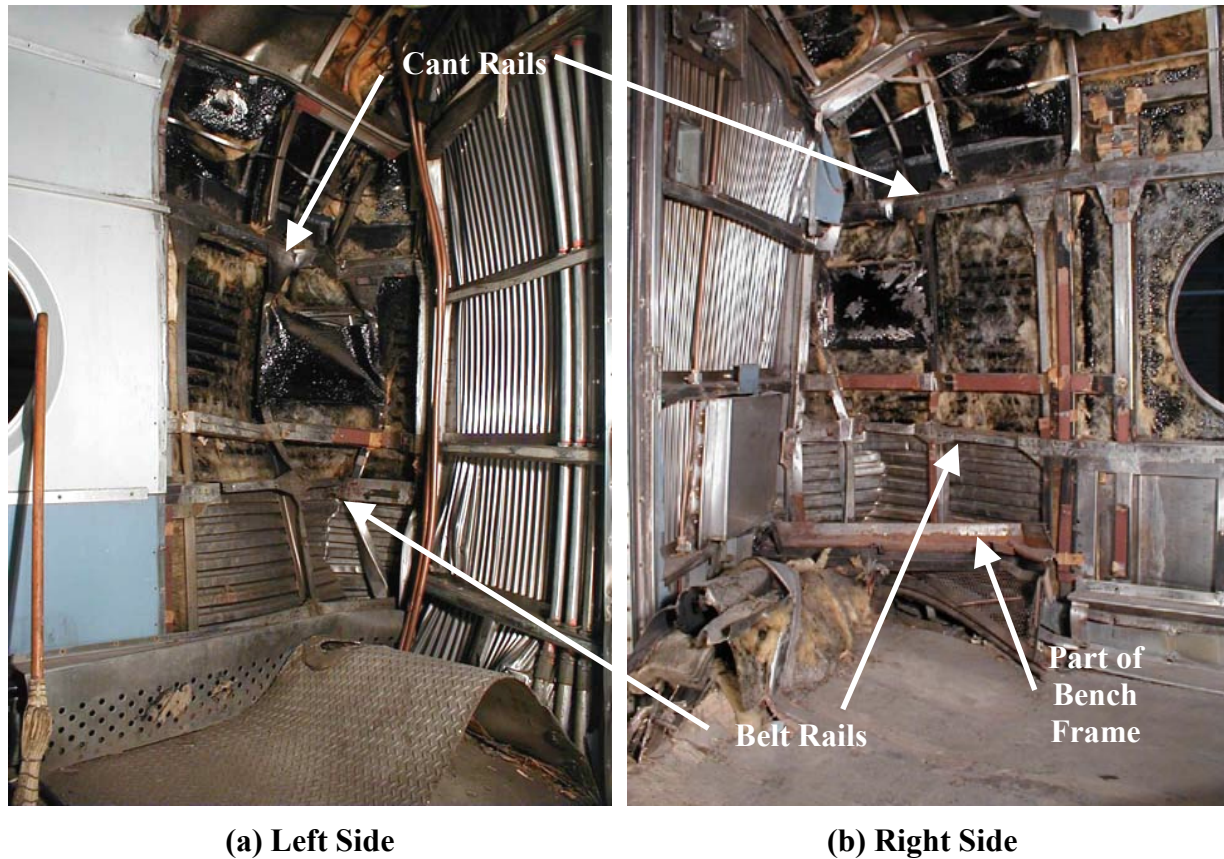
Figure 32. Outward Buckling of Superstructure Between Bulkhead and Window Frame

buckled diamond plate in the left-side photograph is the floor of the restroom closet. Like the closet, it was not well tied into the overall structure. The floor buckle in the right-side photograph involves deformations of the underframe structures.

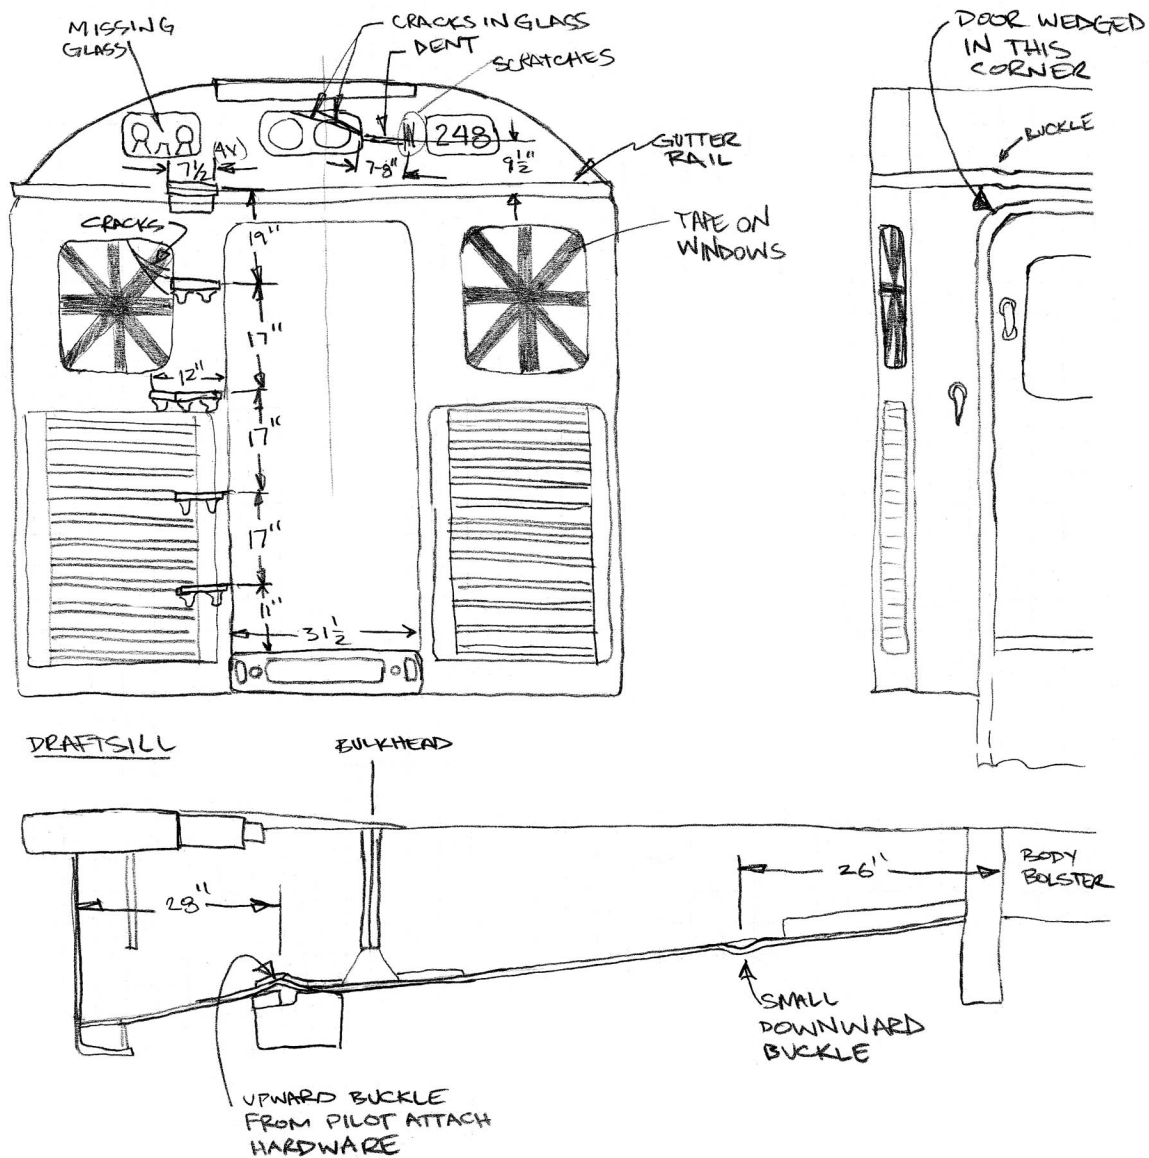
Figure 33. B-End Damage Documented During Post-test Inspection

The non-impact, B-end of the lead test vehicle was inspected for test-induced damage. Figure 33 describes the major evidence of damage on the B-end of the vehicle found during the post-test inspection.

Some minor buckling was found on the right-side draft sill flange. From the nature of the damage, it appeared to have been induced prior to the test. Review of photographs taken of the draft sill before it was crash tested confirmed this observation.

The right-side vestibule door was also found to be stuck in its frame. There was evidence on the doorframe of some distortion, including a small buckle on the rain gutter above the doorframe. After applying a considerable amount of force, a person could open the door and shut it fully again in the doorframe. It is unclear whether this damage was a result of superstructure distortion induced during the crash test or if the damage was pre-existing. Review of the high-speed film showed some twisting of the carbody during the test but it is not clear if this impact response was sufficient to cause the door to jam in its frame.

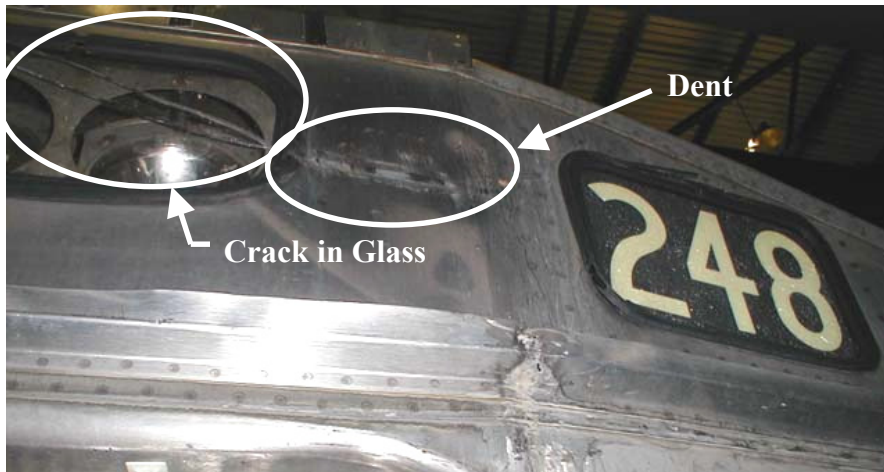
Figure 34. Evidence of B-End Impact Above Gutter Rail

Further evidence of damage was seen on the B-end face above the gutter rail, as shown in Figure 34. The mark in the steel seems to be from a step plate or some other horizontal surface. At first it was suspected that steps on the opposing face of the trailing car impacted the lead car. However, upon further investigation, this could not have been the case. First, the cars were coupled with the B-end of the lead car facing the A-end of the trailing car and the A-end of Pioneer cars do not have steps. Second, review of the high-speed film and video did not show evidence of contact at the top of the car bodies. For these reasons, it is believed that the damage was pre-existing or occurred subsequent to the test as the vehicles were re-railed and moved.

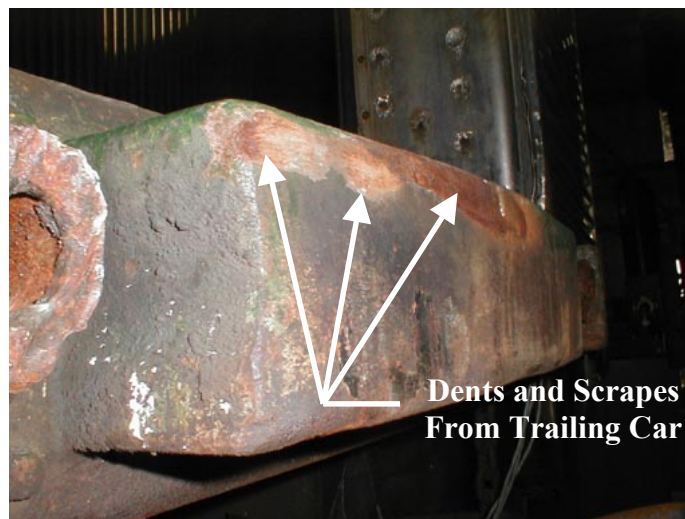
Figure 35. Evidence of B-End Impact on Buffer Beam

Review of the high-speed video shows that the two cars did impact each other at the buffer beam. The buffer beam of the trailing car overrode the buffer beam of the lead car and slid off as the coupled connection rebounded. Figure 35 shows the resulting minor damage to the lead car buffer beam.

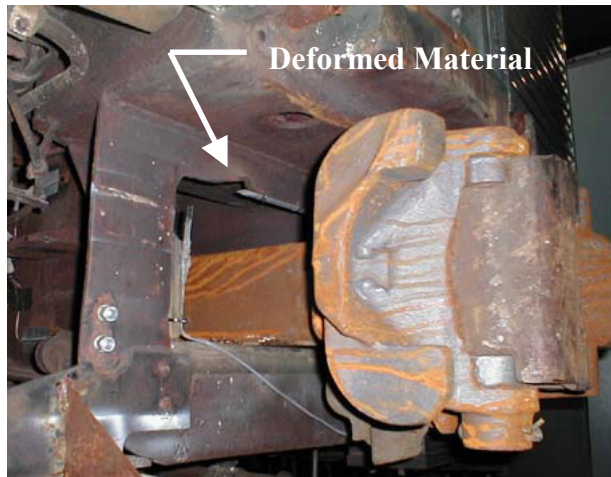
Figure 36. B-End Draft Pocket Damage

There is further evidence of some slight damage to the draft pocket of the B-end, as shown in Figure 36. This appears to have occurred during the collision as the coupler was driven back and impacted the front face of the draft pocket.

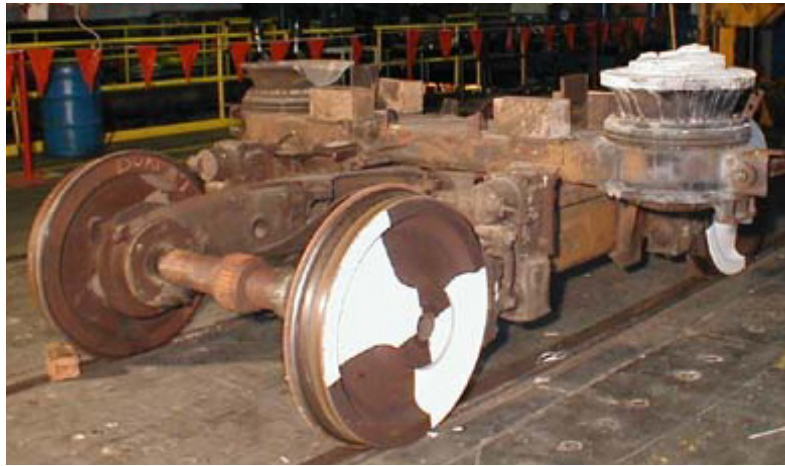
Figure 38. Forward Truck (Detached) from Left Side Looking Aft

Figure 38 below shows the detached front truck. Note that the left-side suspension bell was filled with concrete, as were both bells on the rear truck. A fracture in the right-side bell may also be seen in the figure. There was evidence of past repairs to the bell in the form of welds. It is not clear if this damage was a result of the collision test.
