U.S. Department  
of Transportation

**Federal Railroad  
Administration**

## **In-Track Demonstration of Laser-Treated Rail to Reduce Friction and Wear**

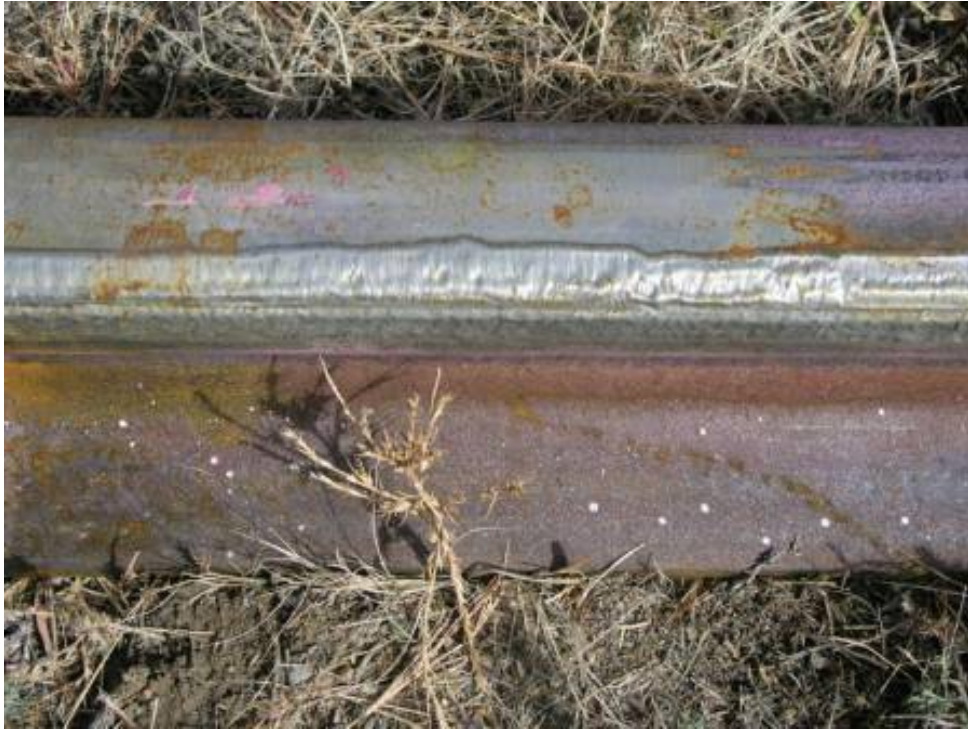
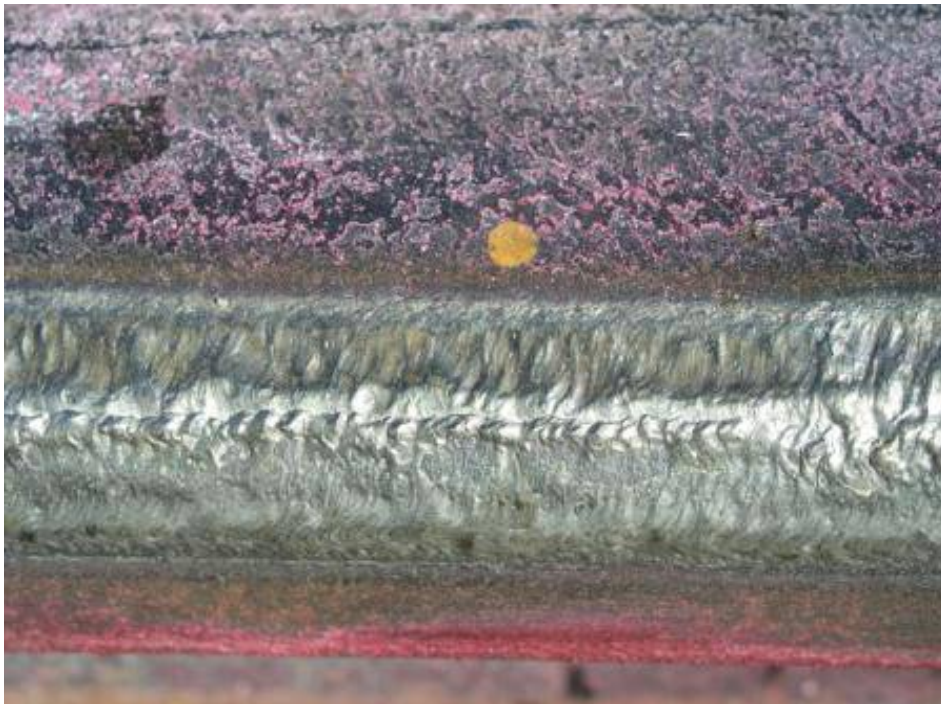
Before installation at FAST, the rail was inspected for any major cracking. Figures 3 and 4 show the rail before installation and that the laser-treated surface had a rough appearance.

**Figure 3. Overall View of Laser-Treated Rail Before Installation**

**Figure 4. Closeup of Laser-Treated Rail Before Installation**

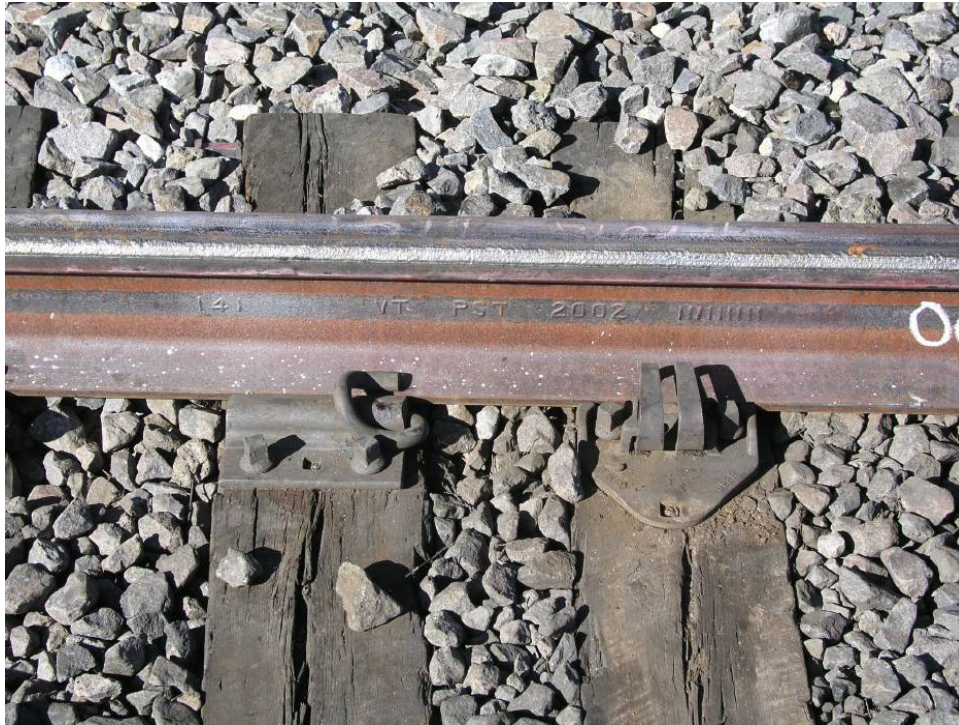
**Figure 5. Laser-Treated Test Rail as Installed in Section 07 at FAST Before Train Operation**

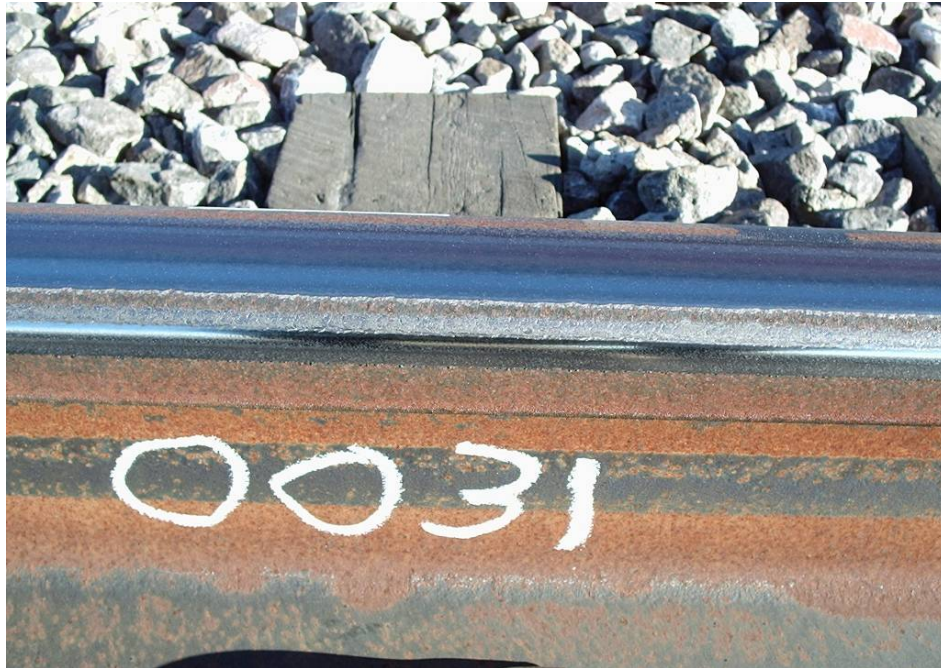
**Figure 6. Control Rail After 1.2 MGT. Compare with Figures 14 and 15, Same Location After 5.6 MGT**

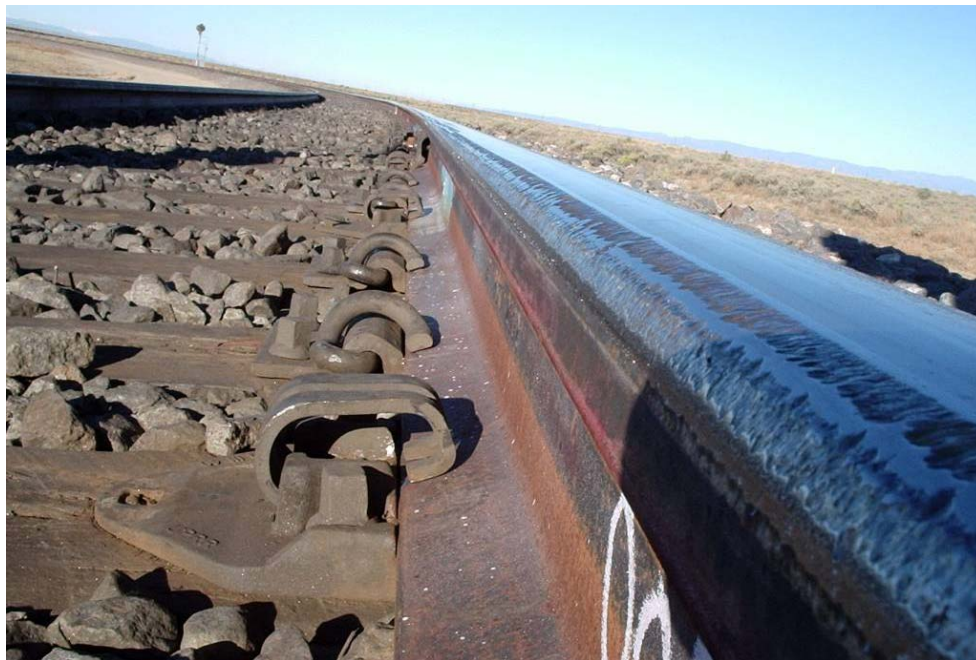
Figures 7 through 12 show the laser-treated rail surface conditions after 1.2 MGT of traffic. In Figure 7, note the smoothed gage corner, where most of the wheel contact appears to have occurred as compared to Figures 3 and 4, which show the gage corner before operating any trains and show no wear on the rail.

**Figure 7. View Along Gage Corner, Looking in the Clockwise Direction After 1.2 MGT**

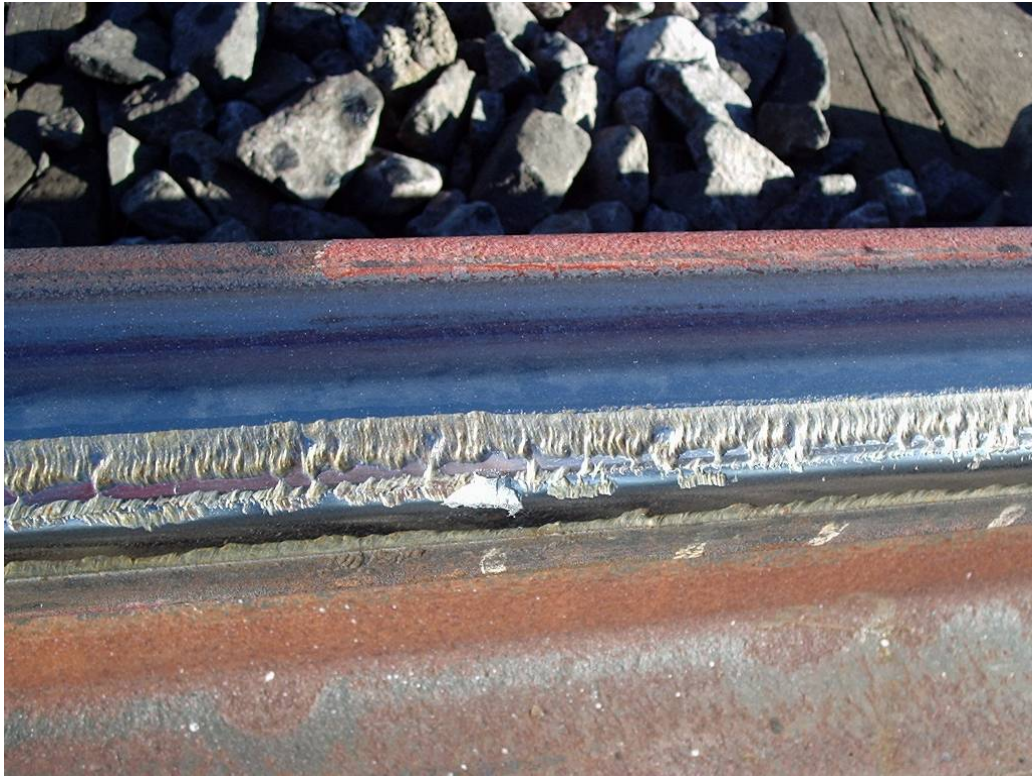
**Figure 8. Typical Chip Noted on Gage Corner of Laser-Treated Trail After 1.2 MGT**

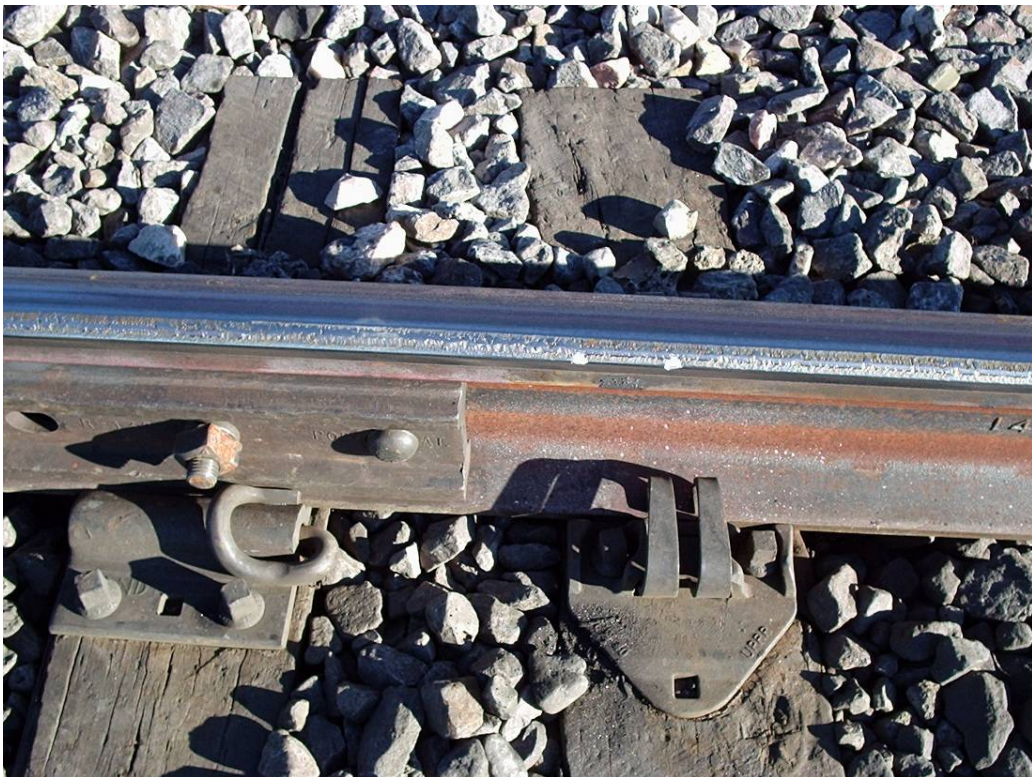
**Figure 9. Two Chips on Gage Corner of Laser-Treated Rail After 1.2 MGT  
Compare with Figure 17 at the Same Location After 5.6 MGT**

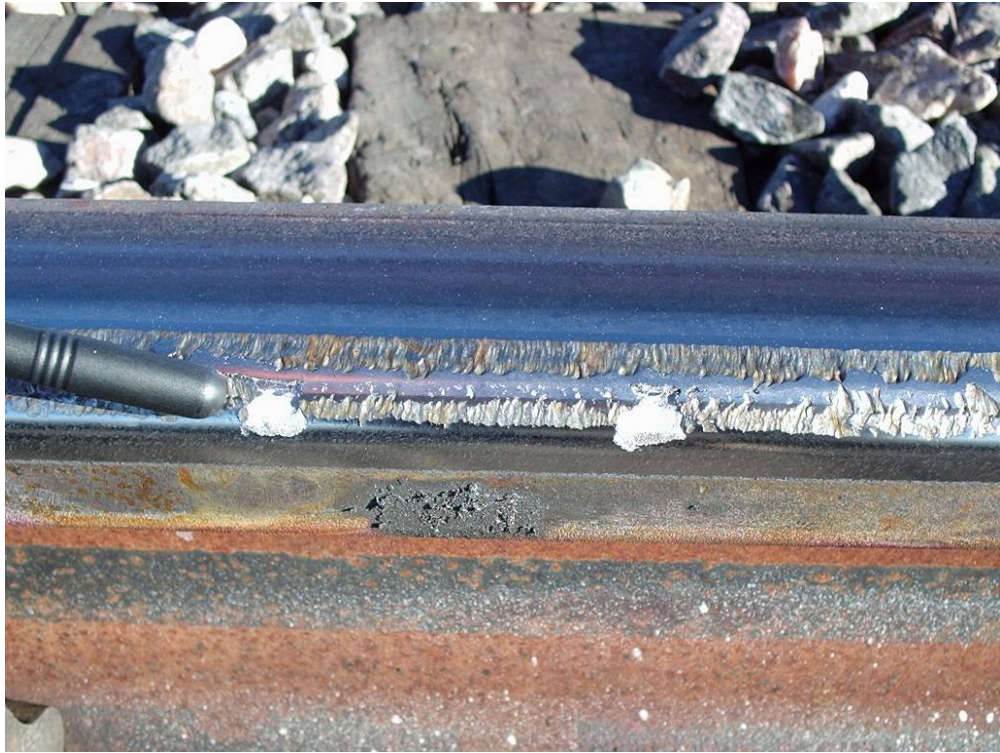
**Figure 10. Closeup of the Same Location as Shown in Figure 9 After 1.2 MGT. Compare with Figure 17 on the Same Location After 5.6 MGT to Show Growth in Size of Spalling**

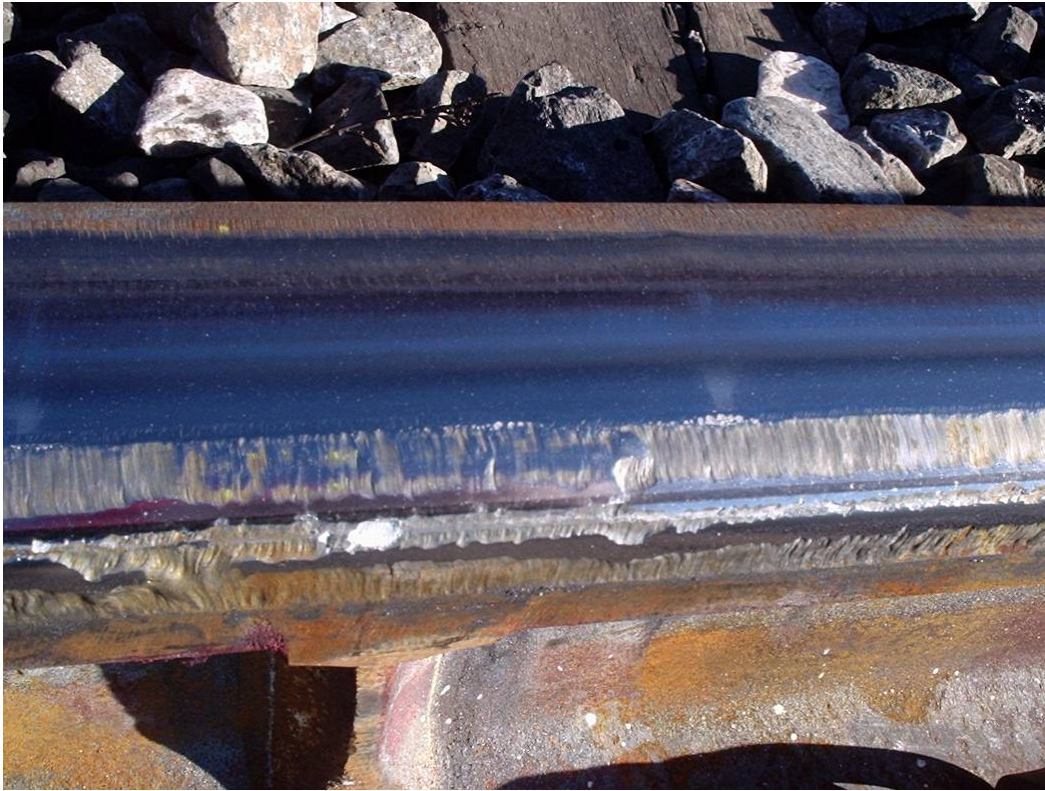
**Figure 12. Closeup View of Thermite Weld (as Shown in Figure 11) in Laser-Treated Section After 1.2 MGT. Compare with Figure 20 at the Same Location After 5.6 MGT**

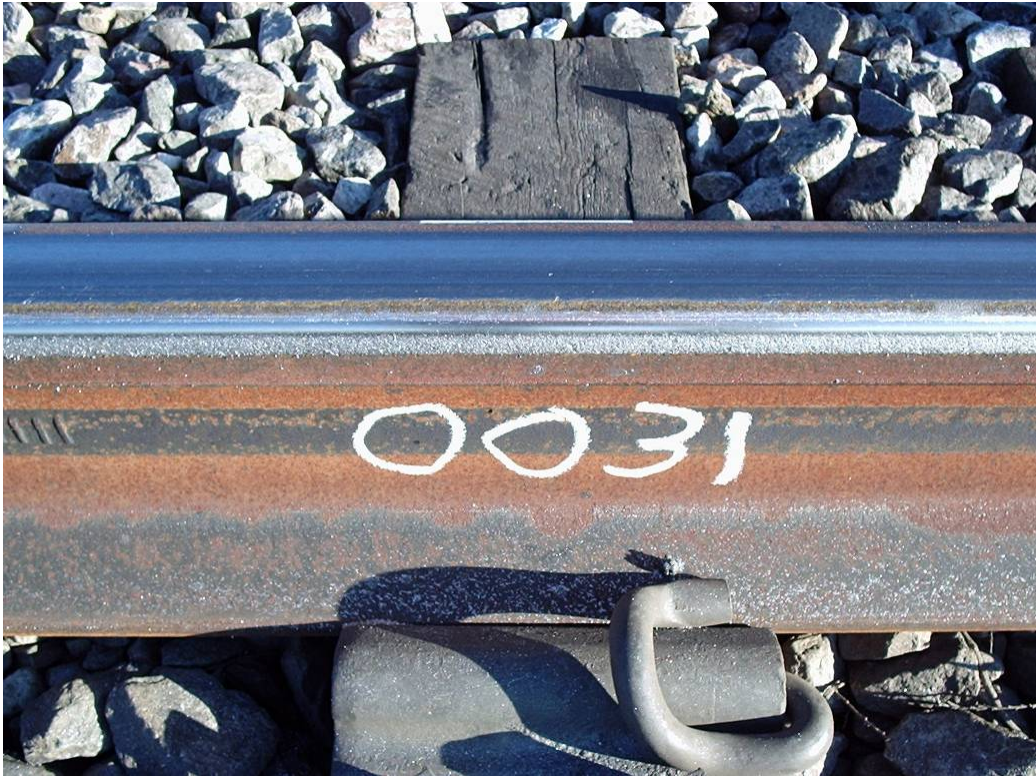
**Figure 14. Control Rail Showing Rough Gage Face from Dry Operation.  
Shiny Gage Corner After 5.6 MGT**

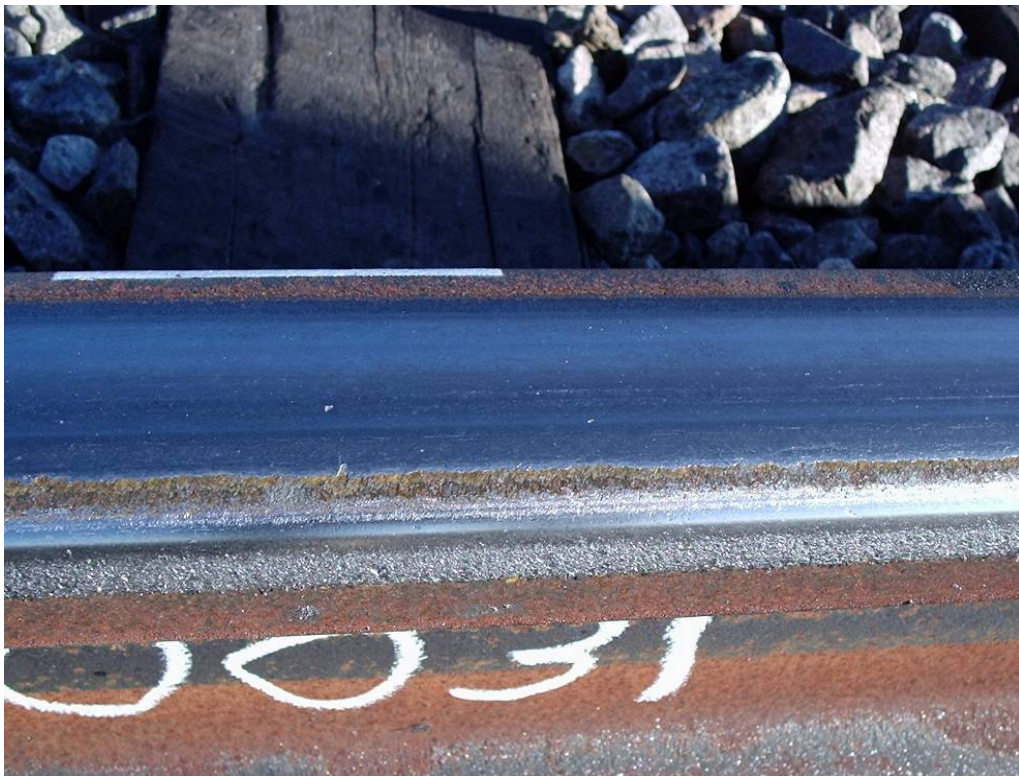
**Figure 15. Control Rail Closeup Showing Dry Surfaces.  
No Pitting or Spalling After 5.6 MGT**

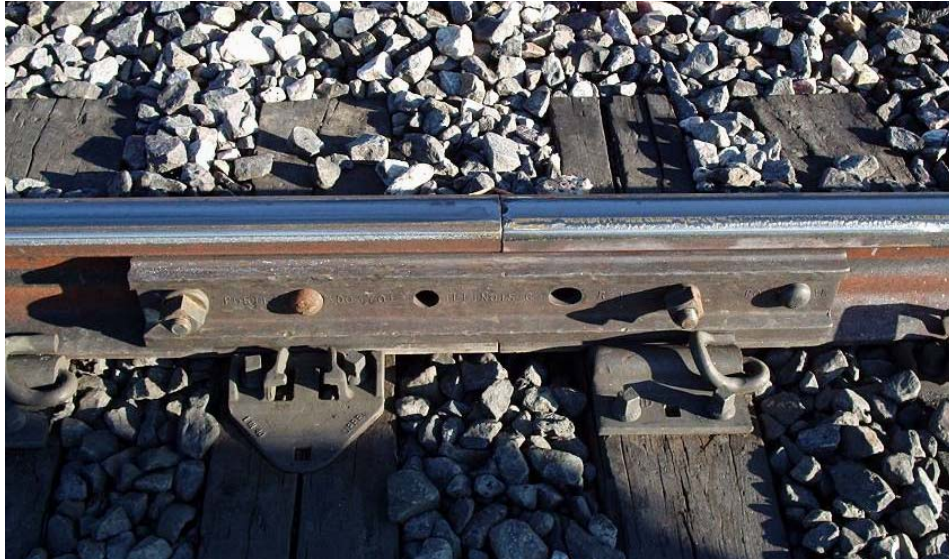
As a concern existed that the surface condition might develop fatigue failures early in the test, the laser-treated rail was initially bolted in place, with the intent to weld it at both ends to the adjacent rail if no problems occurred. Figure 16 shows the appearance of the mechanical joint at the junction between the control and laser-treated rails after 5.6 MGT. As seen, the left side (center rail) shows no cracking and a smooth surface. The treated rail, to the right of the joint, is rough and shows signs of cracking.

**Figure 16. Junction of Control Rail to Laser-Treated Rail.  
Left Side is the Control Rail; Right Side is Laser-Treated Rail**

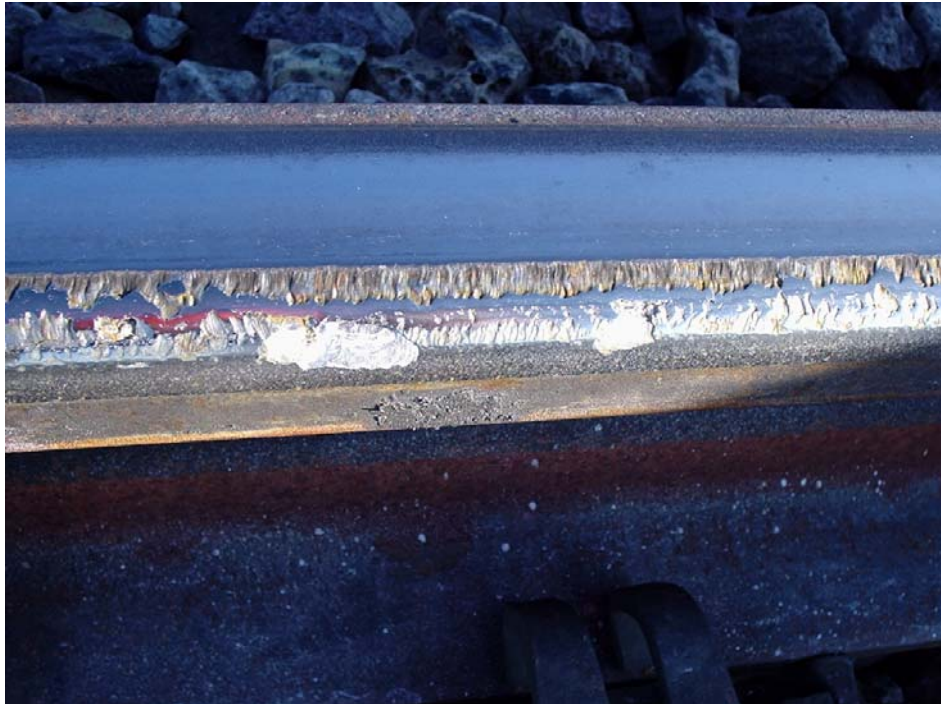
Figures 17 through 20 show various locations along the laser-treated rail after 5.6 MGT. Figure 18 shows the smooth gage corner from contact with wheels but with large valleys and rougher surface of laser-treated area. Figure 19 shows spalling at the center and each side of the thermite weld; compare with the same location shown in Figure 11 after 1.2 MGT.

**Figure 17. Laser-Treated Rail After 5.6 MGT Showing Two Spalls. Compare with Same Location as Shown in Figures 9 and 10 After 1.2 MGT**

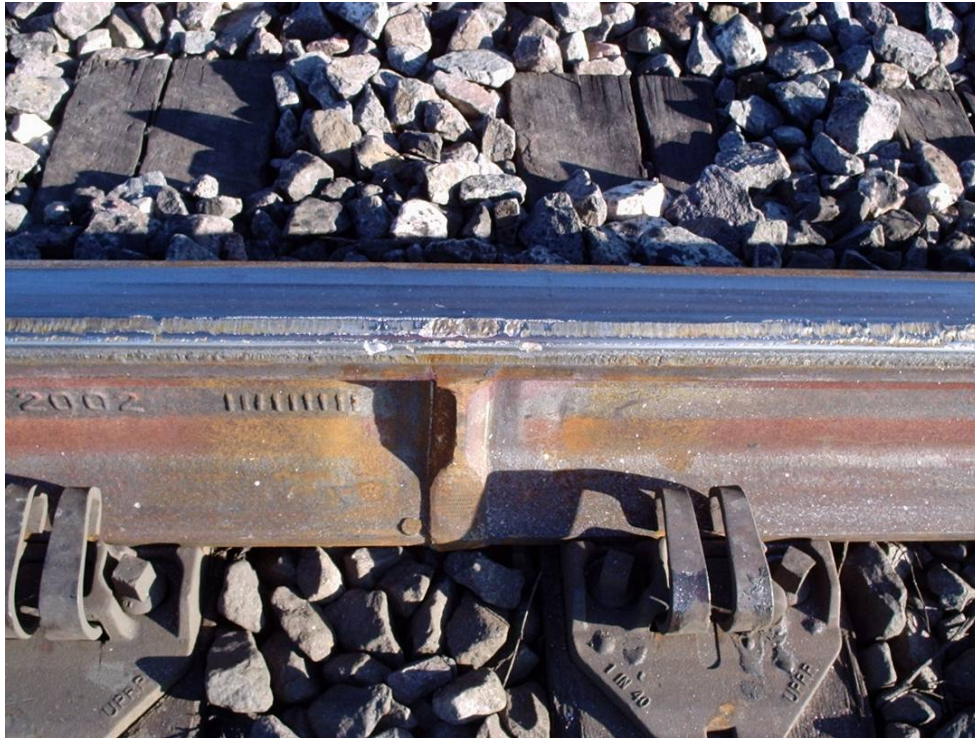
**Figure 19. Thermite Weld on Laser-Treated Rail Segment After 5.6 MGT**

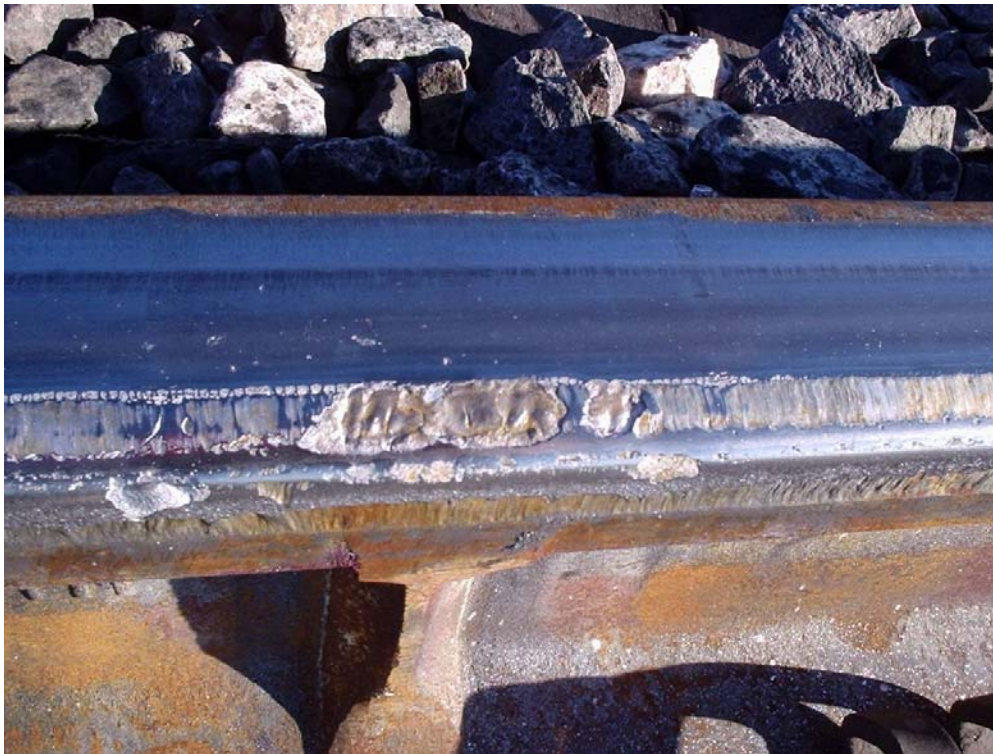
**Figure 20. Close View of Spalls At and Near Thermite Weld After 5.6 MGT. Compare with Same Location as Shown in Figure 12 After 1.2 MGT**

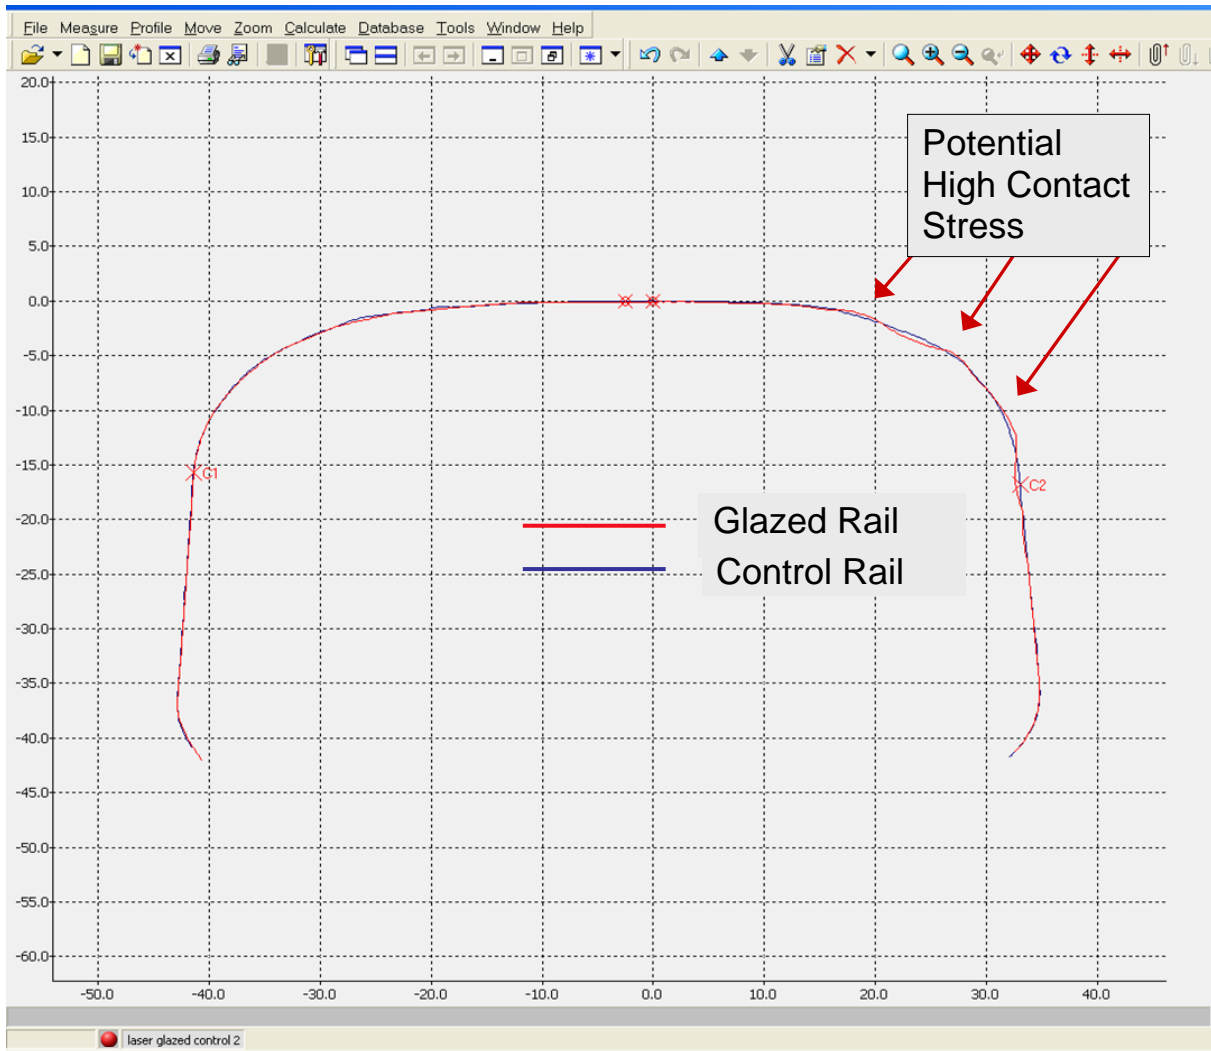
One issue that may have accelerated the development of spalls and chipping is that the laser treatment appears to have very slightly altered the rail's profile. Examination of Figure 21 shows an overlay between a new 141 AB rail and the laser-treated 141 AB rail sections. The profile of the glazed/treated rail has minor bumps that are higher than the original profile. These locations likely make more frequent contact with passing wheels and would create much higher contact stresses until they are worn down or away. During the brief 5.6 MGT of exposure to traffic, it appears that many of these bumps resulted in chips and spalls.

**Figure 21. Overlay of Control (untreated) and Laser-Treated Rail**

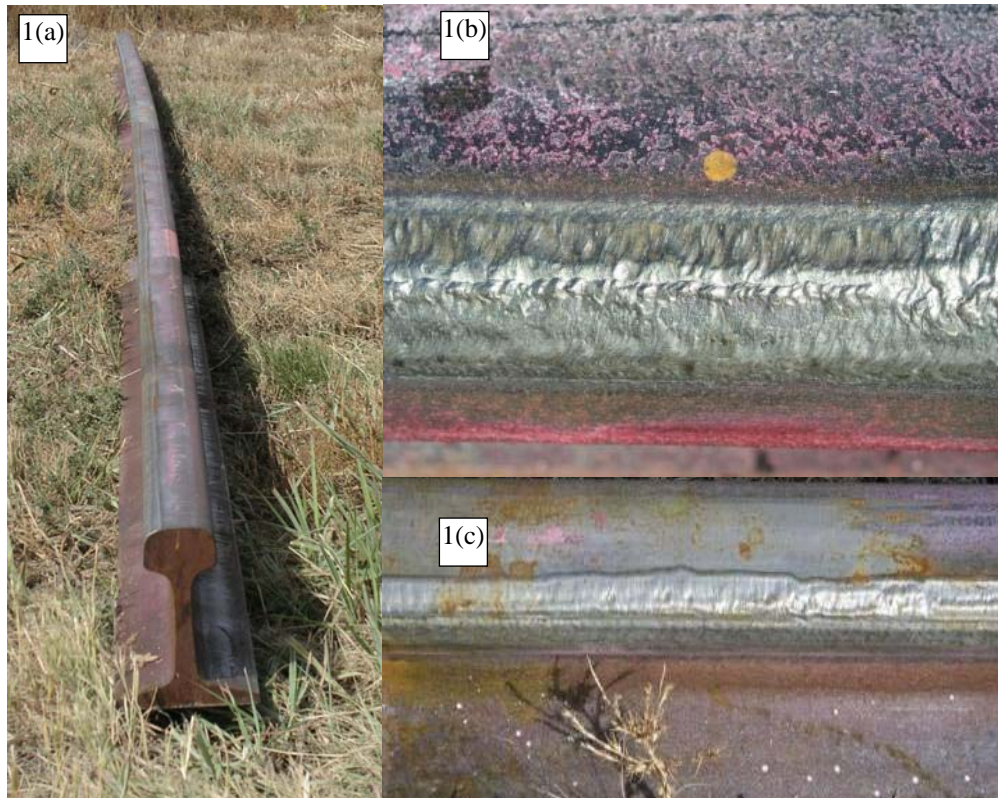
**Figure A-1. Figure 1(a). Laser-Glazed Treated Rail, Figure A-1(b). Rough, and Figure A-1(c). Uneven Glazed-Treated Gages for the Untested Rail**

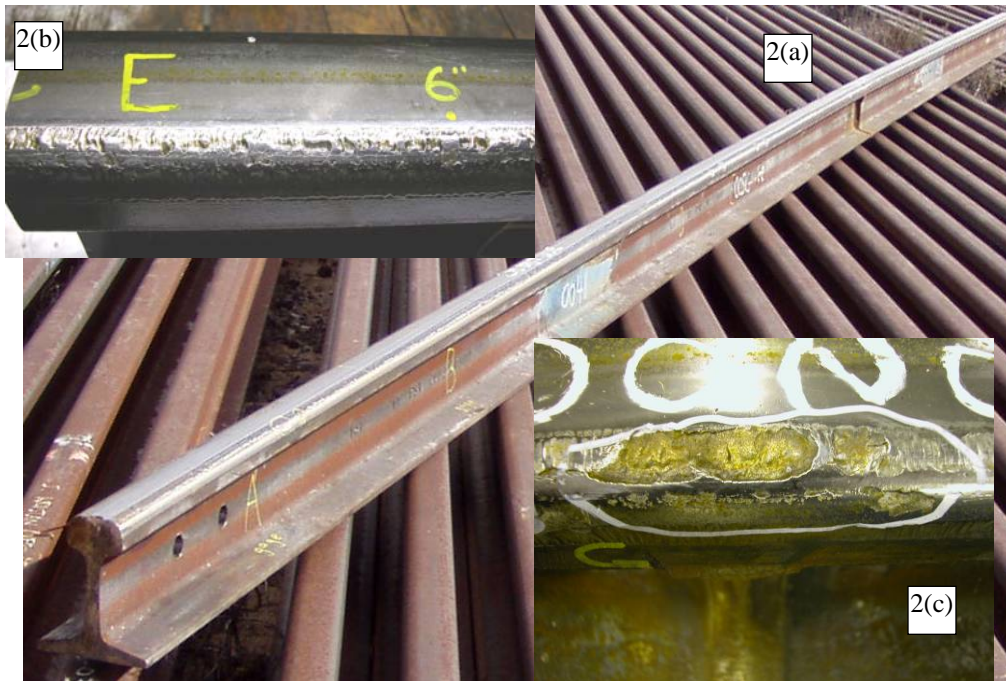
**Figure A-2. Figure A-2(a) Rail Removed from FAST Facilities After Approximately 5.6 MGT of HAL Traffic, Figure A-2(b). Macro-Picture Showing Severe Wear, and Figure A-2(c). Macro-Picture Showing Shelling Regions of the Laser-Glazed Rail**

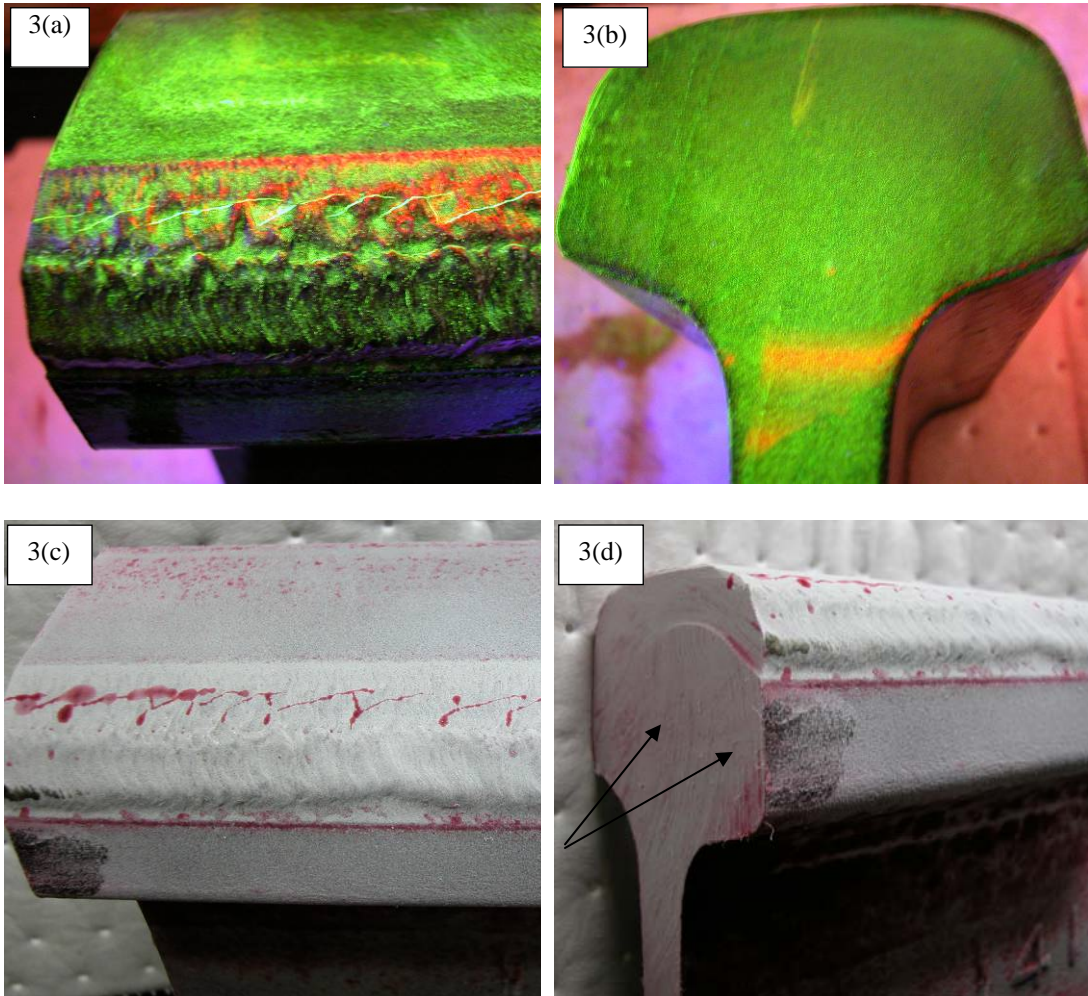
**Figure A-3. Figures A-3(a) and 3(b). Macro-Pictures of the Laser-Glazed Rail Analyzed with Magnetic Particles. Figures A-3(c) and 3(d). Liquid Penetrant (Arrows in 3(d) Show Damage Caused with the Cutting Tool)**

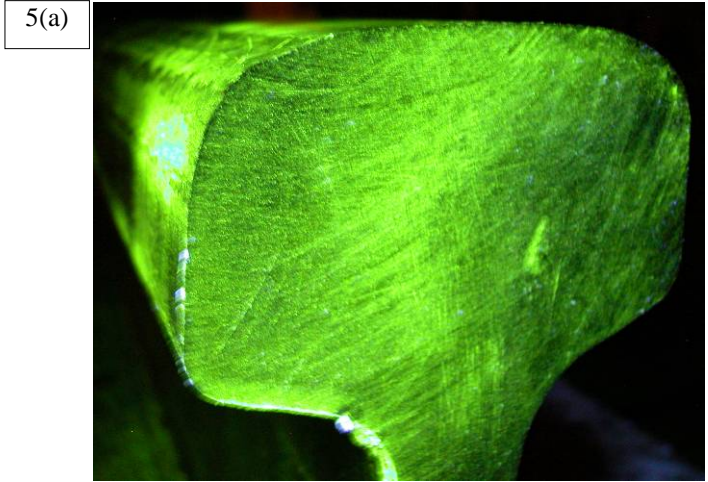
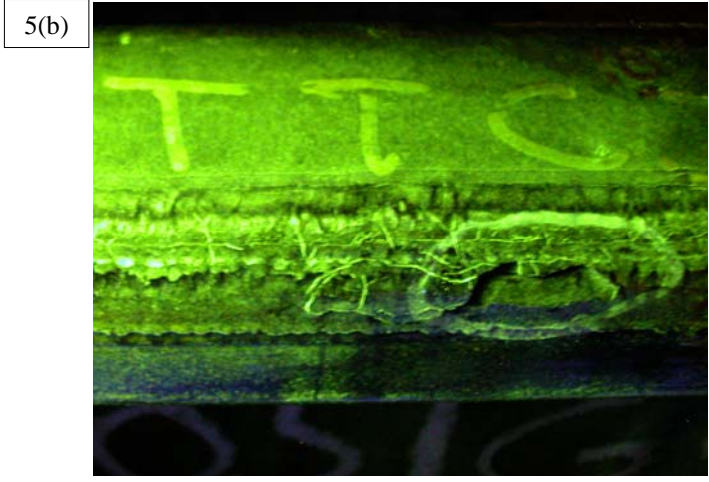
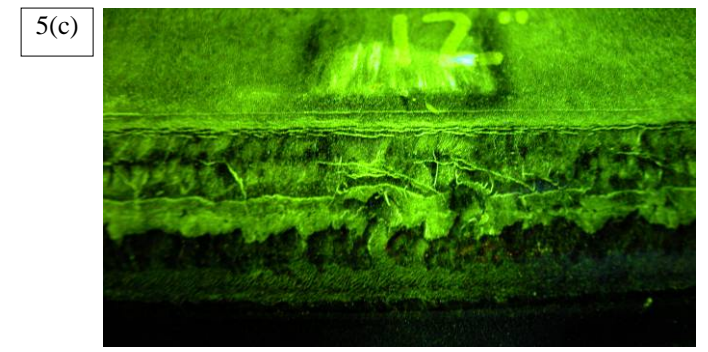
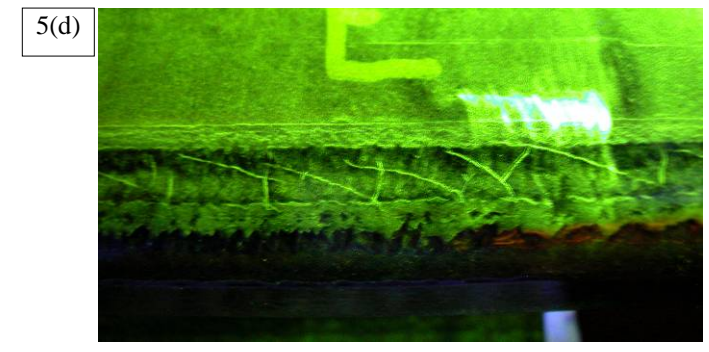
The damage revealed by the NDT of the laser-glazed treated rail removed from FAST shows more severe damage at the gage corners when compared to the non-service tested rail. This damage is the result of increased susceptibility of the laser-glazed treated regions to cracking and shelling. Figure A-5 shows pictures of the magnetic particle analysis of the gage regions and the cross section of the rail. In the cross section of the rail, no cracks were revealed by the NDT methods used.

**Figure A-5. Photographs of Magnetic Particles Analysis of Various Sections of Laser-Glazed Rail After Removal from FAST at Approximately 5.6 MGT of HAL Traffic Showing No Cracks in Cross Section of Rail.**  
**Figure A-5(a). Section Showing Shelling at the Gage Corner of the Rail.**  
**Figure A-5(b). Extended Cracks Along the Gage Corner of the Rail.**  
**Figures A-5(c) and A-5(d). Compare with Laser-Glazed Non-Service Tested Rail that Presents a Less Severe Damage**

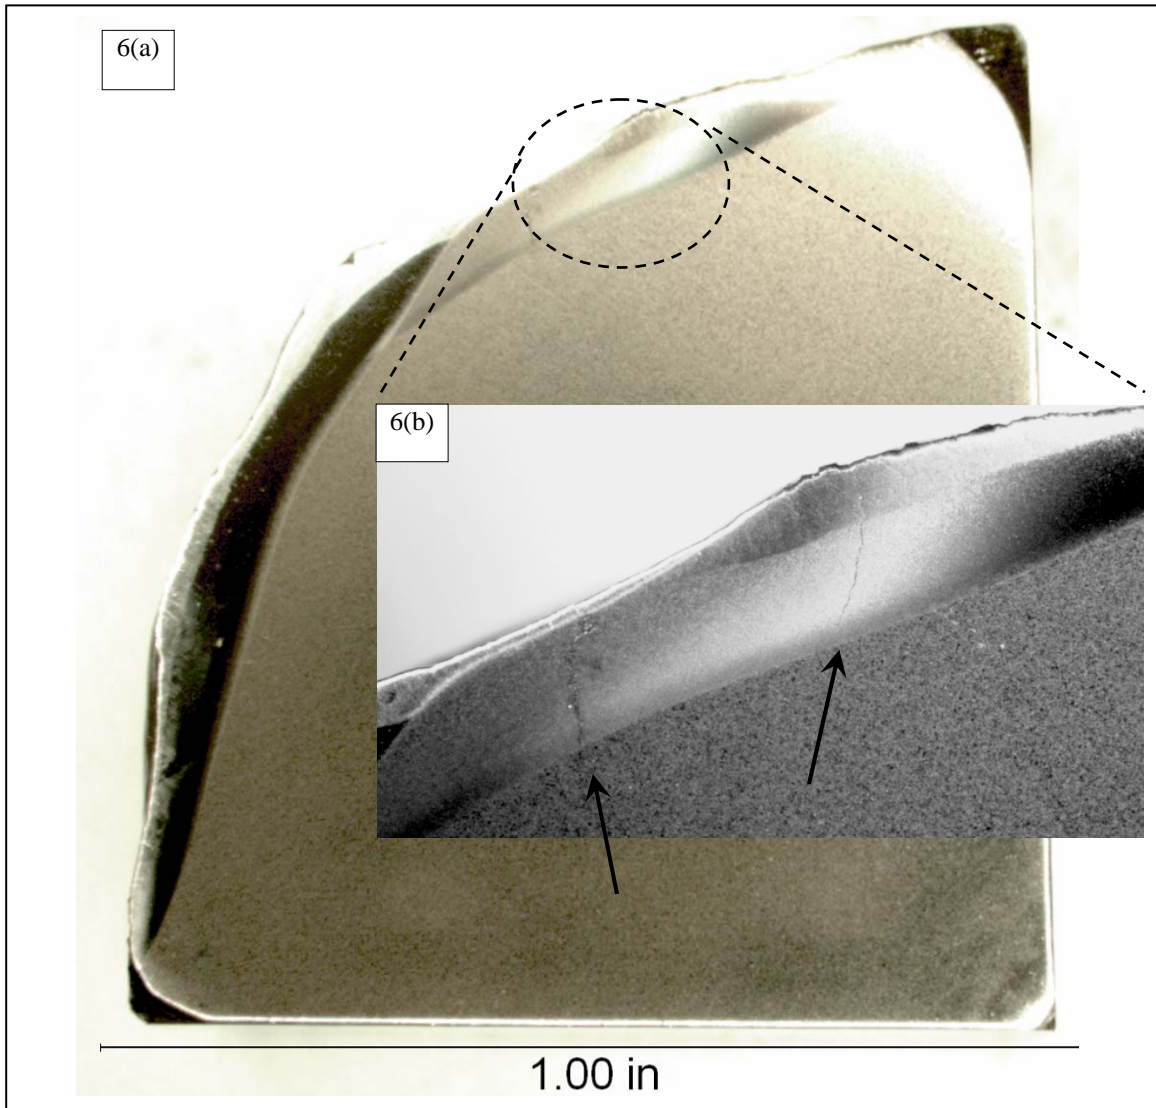
Figures A-6(c) and 6(b) show that for the non-service tested rail, the macrographs of the laser-glazed (gage, Figure A-6(b)) and (field, Figure A-6(c)) sections of the rail. The macrographs were taken at magnifications of 3.5x for Figure A-6(a), 45x for Figure A-6(b), and 3.5x for Figure A-6(c). In the gage side of the rail, cracks were found along the glazed regions. In all cases, the cracks did not propagate past the interface between the glazed region and the parent rail material. In contrast, the field side of the rail did not have cracks present.

**Figure A-6. Macrographs of Laser-Glazed Treated Rail at Gage Corner Showing Cracks Across Glazed Areas. Arrows Point to Cracks.**  
**Figure A-6(a). Macrograph with 3.5x Magnification**  
**Figure A-6(b). Macrograph with 45x Magnification**

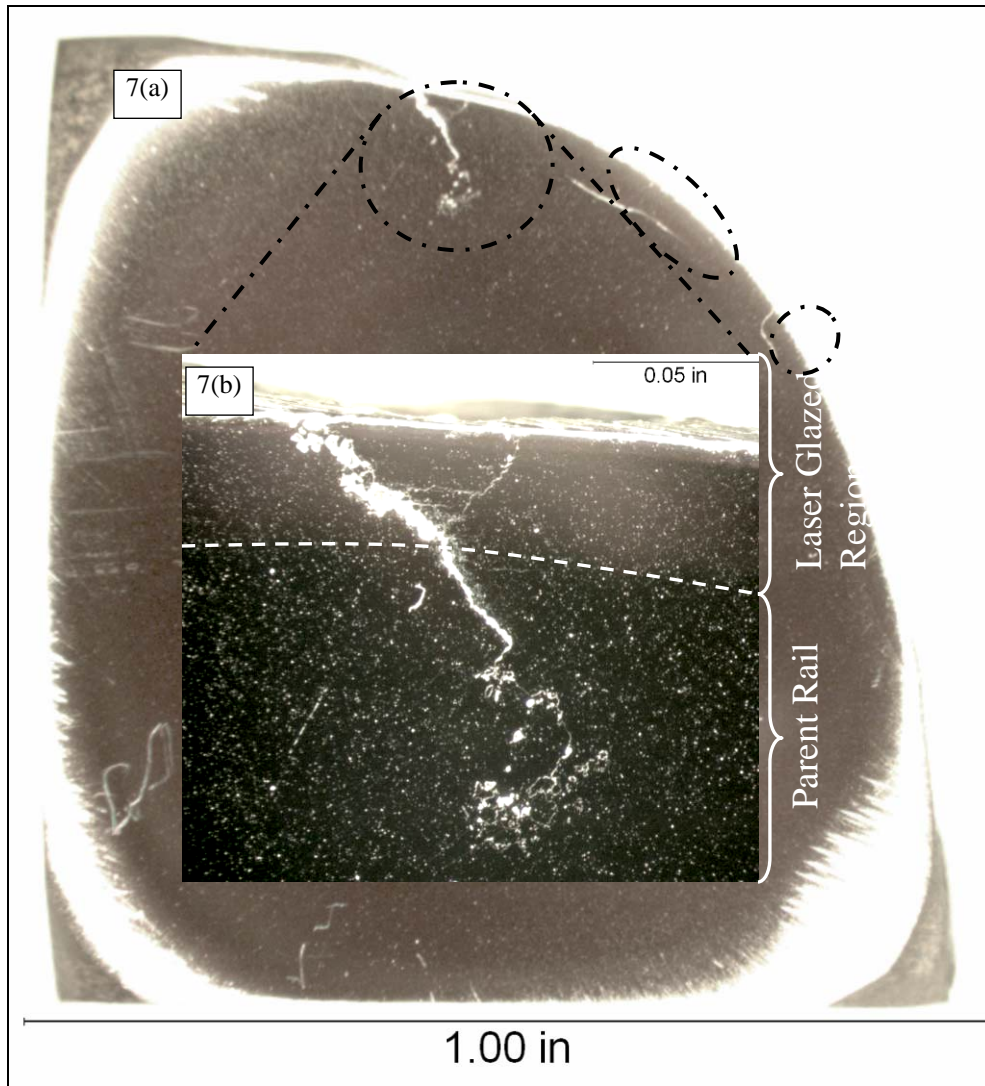
Figure A-7 shows macrographs with magnifications at 3.5x (Figure A-7(a)) and 45x (Figure A-7(b)) of the gage side of the laser-glazed rail removed from FAST after approximately 5.6 MGT of HAL traffic. Cracks were observed at the gage region within the glazed areas. The circled areas show the cracks on the glazed region and parent rail material. Comparing Figures A-7(a) and 7(b) with Figures A-5(b) through 5(d), it is clear that an increase in the severity of the damage observed in the gage corner of the rail increased under HAL traffic. The stereoscopic analysis further confirms the previously mentioned damage on the microstructure of the laser-glazed rail. In addition, not only were perpendicular cracks to the glazing region identified, but also the cracks going into the parent rail branched, resulting in a web of cracks. The branched cracks can act as stress concentrators that promote premature failure of the rail particularly under cyclic fatigue conditions. Figure A-6(b) shows that the samples extracted from the field side from the non-service and service-tested samples did not contain areas with cracks or other damage associated with the laser-glazing process.

**Figure A-7. Macrographs of the Laser-Glazed Treated Rail Removed from FAST After Approximately 5.6 MGT of HAL Traffic**

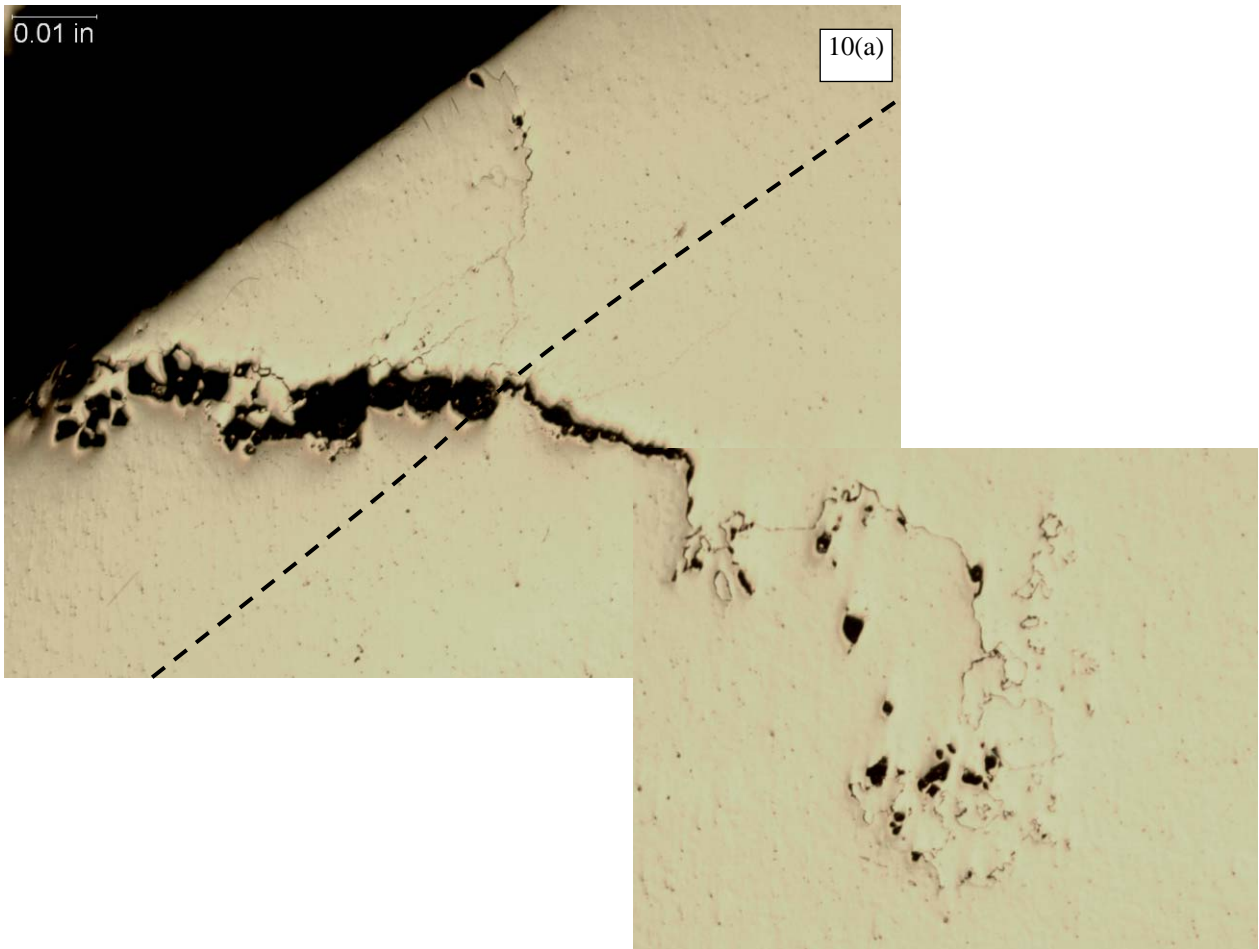
Figure A-10 shows the polished microstructures of the glazed region of the service-tested rail. The number, location, and severity of the cracks observed on the gage sides for the service-tested rail (5.6 MGT of HAL traffic at FAST) has increased considerably. For instance, Figure A-10(a) shows a crack that ended at the interface between the glazed region and the parent rail material and a crack that ramified into the parent rail material. Figure A-10(b) shows a crack along the glazed region of tested rail removed from FAST after approximately 5.6 MGT of HAL traffic. This crack was likely created from the shelling of the glazed treated surface under HAL traffic. Figure A-10(c) shows a crack across the laser-glazed region where both laser-glazed treatments overlap. In both ends the crack ramified (arrows indicate the interface). It is a good example of the possible residual stresses created due to the glazing treatment that created regions highly susceptible to cracks. This is further assisted by the martensite formation. The above-mentioned residual stresses promote susceptibility to crack formation, in particular to cracks in the gage surface and the interface between the glazed regions and the parent rail material. This accelerates the progress of shelling.

**Figure A-10(a). A Crack Ending at the Interface Between the Glazed Region and Parent Material and a Crack that Ramified Into the Parent Rail Material**
