U.S. Department  
of Transportation

**Federal Railroad  
Administration**

## **In-Track Demonstration of Laser-Treated Rail to Reduce Friction and Wear**

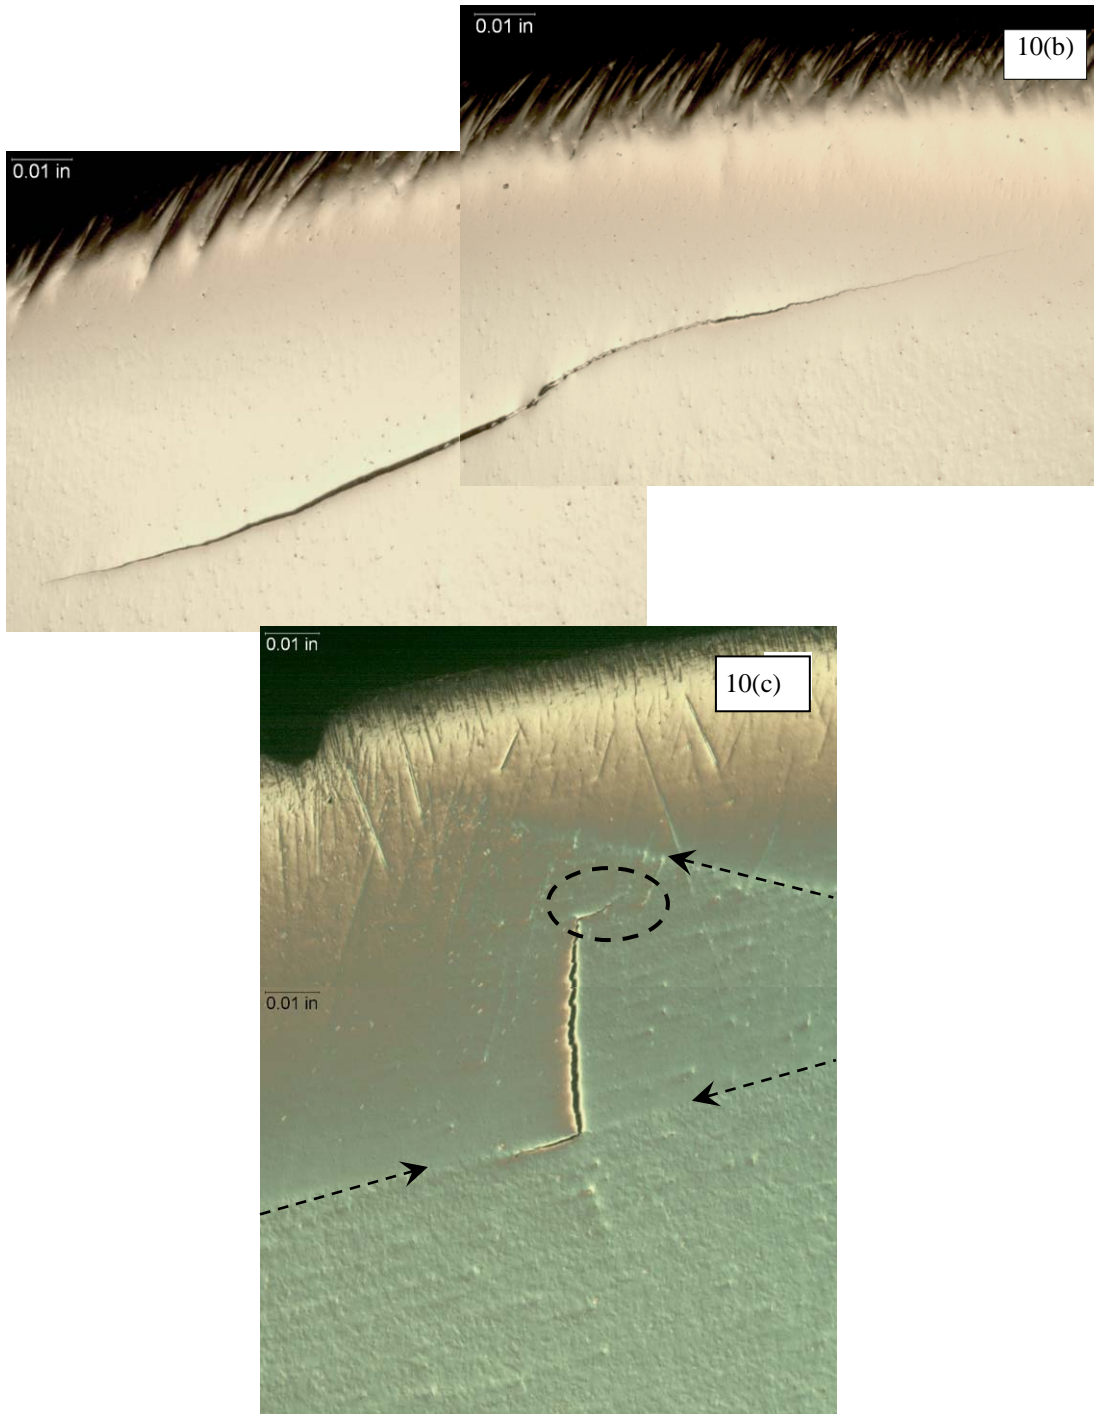
**Figure A-10(b). A Crack Along the Glazed Region.  
Figure A-10(c). A Crack Across the Laser-Glazed Region  
Where Both Laser-Glazed Treatments Overlap**

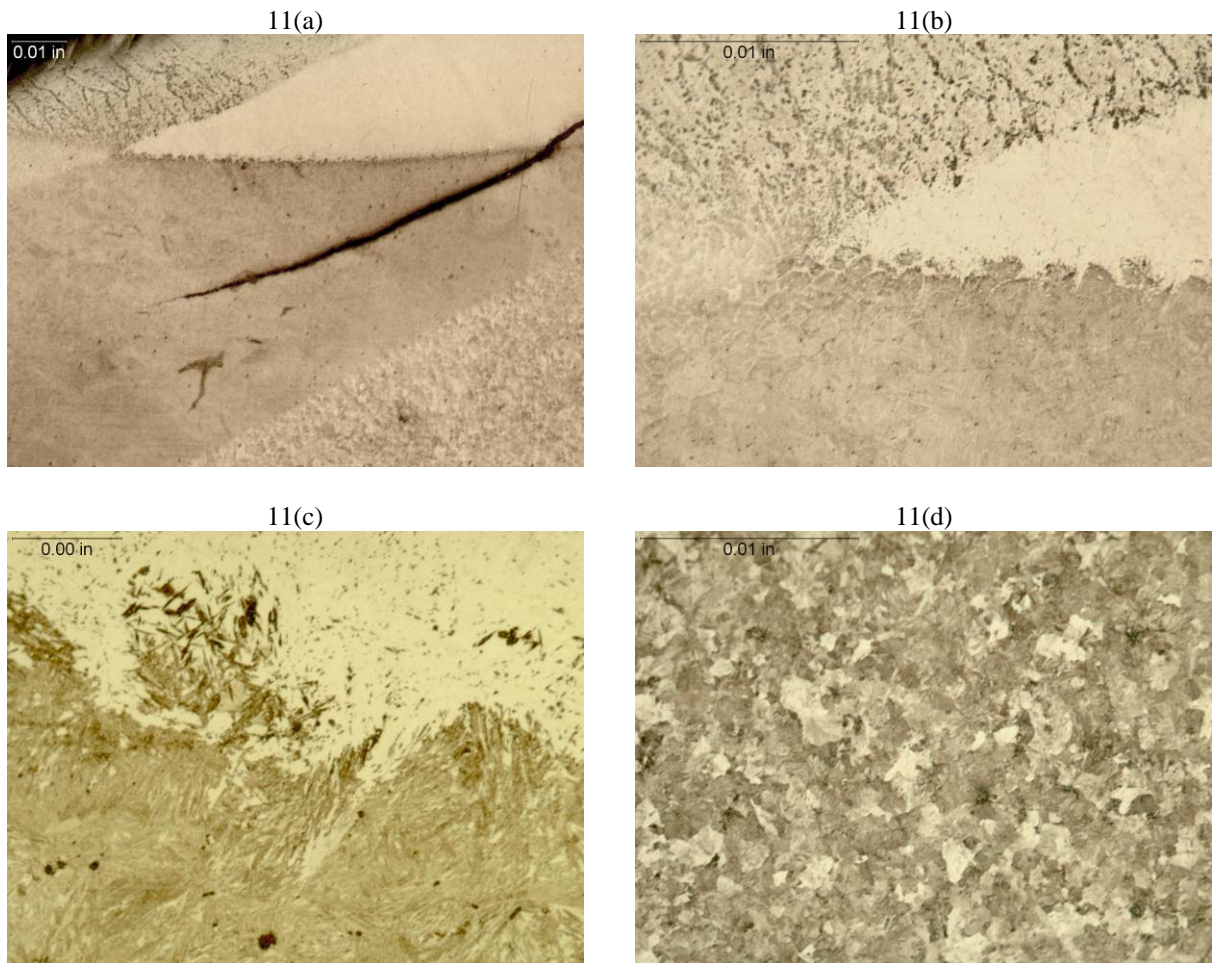
Figure A-11 shows the etched microstructure of the glazed regions and parent rail materials for the rail removed from service after approximately 5.6 MGT of HAL traffic. Micrographs in Figure A-11 are magnified areas of the micrographs shown in Figure A-9(b) after etching. Figure A-11(a) shows micrographs on the etched microstructure of the various phases that form in the microstructure. The regions where sequential glazing treatments overlap present sections with sharp edges acting as stress concentrators. These build up stresses that can be detrimental and can compromise the integrity and service characteristics of the rail, resulting in crack formation (Figure A-11(b)). Figure A-11(c) shows sharp needles of lath martensite that formed at the interface between the glazed region and the parent rail material. The microstructure of the parent rail material is comparable to the non-glazed rail (field section) that is fully pearlitic.

**Figure A-11. Micrographs of the Etched Microstructure of the Service-Tested Glazed Rail.**  
**Figure A-11(a). Affected Regions of the Rail by the Glazed Treatment (50x).**  
**Figure A-11(b). Overlapping of Both Glazed Treatments (200x).**  
**Figure A-11(c). Zones Showing Sharp Laths of Martensite (1,000x).**  
**Figure A-11(d). Pearlitic Regions of the Parent Rail Material (200x)**

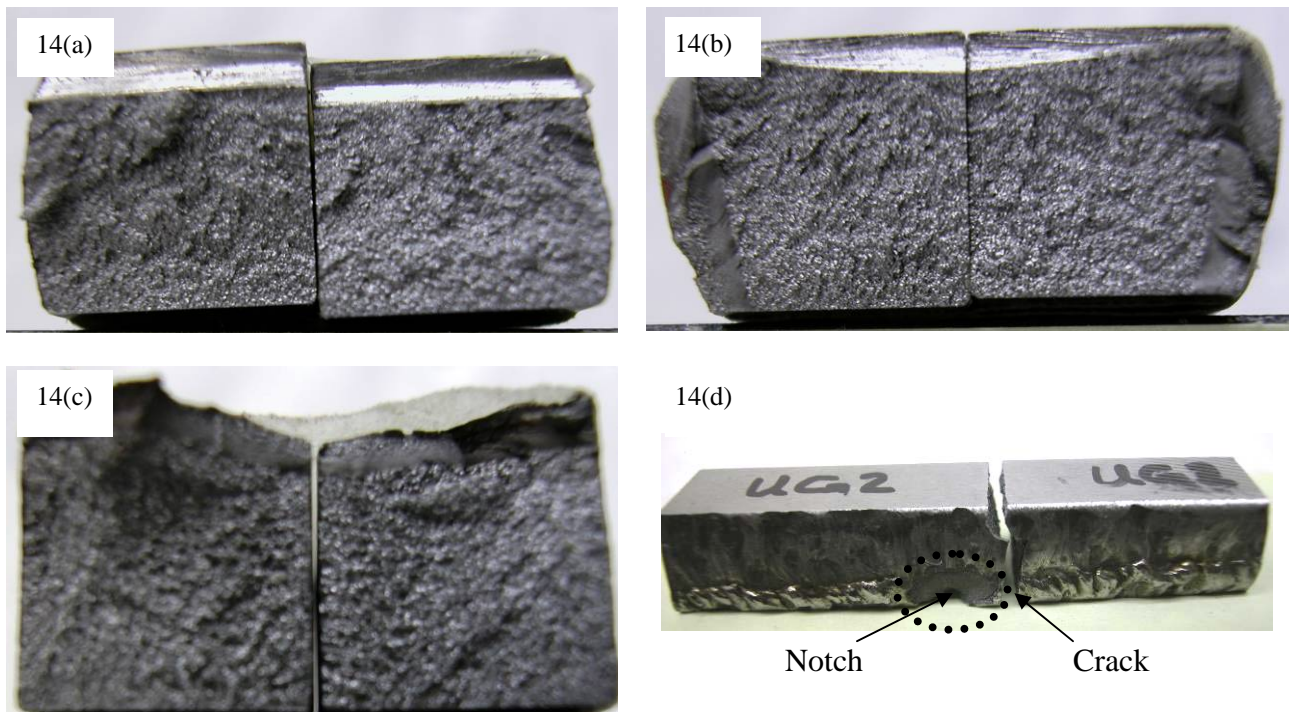
**Figure A-14. Pictures of Selected Charpy Tested Samples Showing Fresh Fractures**

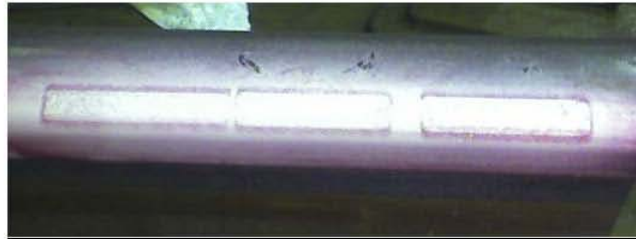
As shown in Photograph 3. Dye Penetrant testing was used on preliminary test glazing passes to check for cracks. There were no cracks observed.

Photograph 3: Dye Penetrant Testing Single Tracks
