HISTORY OF COAL MINE ELECTRICAL FATALITIES SINCE 1970

Richard L. Reynolds
Mine Safety and Health Administration
Pittsburgh, Pennsylvania

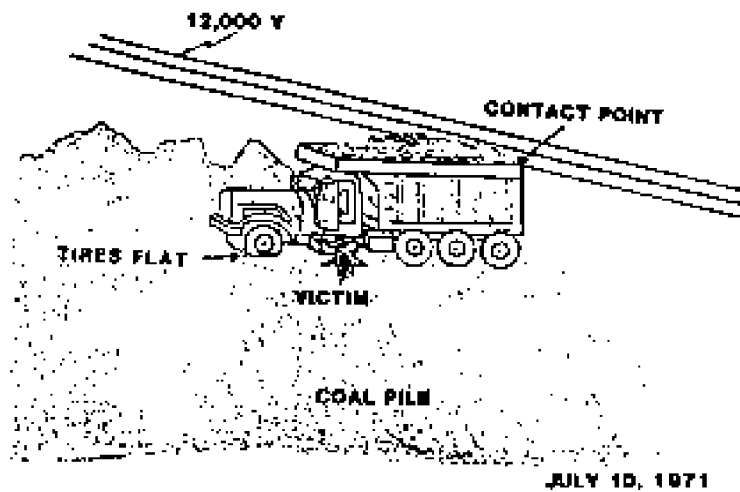
Figure 6. Truck Accidents

In most cases the trucks are in the process of dumping coal or refuse. The process usually becomes so routine that the driver never notices the overhead lines. As materials are dumped, the dumping surface moves resulting in the truck eventually being in a position where it can contact the overhead lines.

In the truck accident shown the driver had been told that the lines were present. He had positioned his truck three times before stopping the truck to check the truck's position in relation to the lines. He was electrocuted as he exited the truck to check the clearance.

1. Design the mine plant to avoid bare high-voltage conductors around parking lots and storage areas.
2. Never store or stock pile material under overhead high-voltage lines.
3. Have the management official who is responsible for overseeing the work examine the work site before work is performed. The management official should personally observe all work when it is possible for any part of the equipment to come within 50 feet of the line.
4. Train the operators of trucks, cranes, and drill rigs to examine the work site before beginning work.

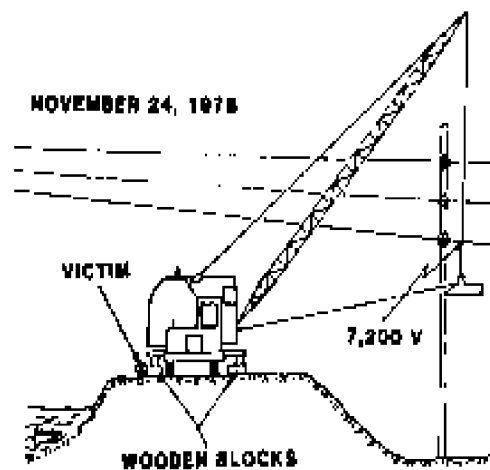
Figure 7. Crane Accidents

This accident happened while the out riggers were being set. The crane boom was positioned to lift the opposite side outrigger so it could be blocked. During this procedure the wire rope contacted the overhead line causing the person blocking the outrigger to be electrocuted. This accident happened twice at different mines.

A situation common to most of the crane accidents was that the victims were preoccupied with a task unrelated to the overhead lines and were either unaware or forgot that the lines were present.

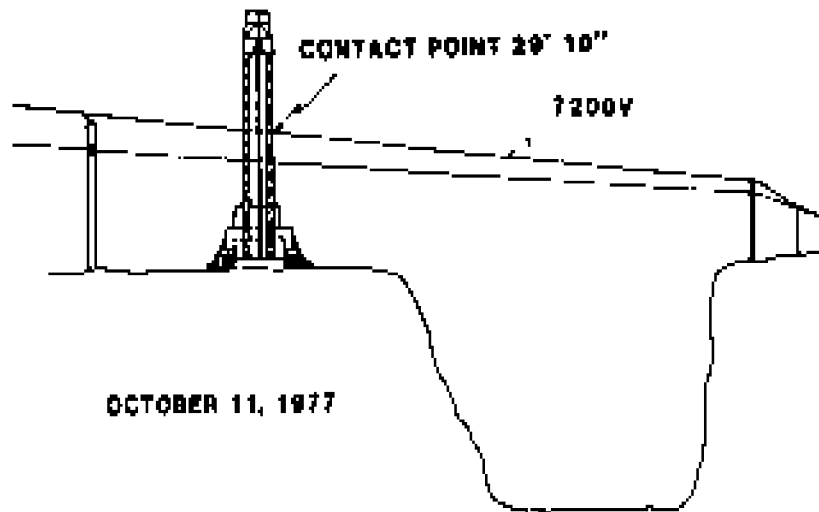
Figure 8. Drill Rig Accident

The electrocutions associated with drill rigs usually happened when the victim raised the mast into the lines without knowing the lines were present or while the rig was being moved with the mast in the vertical position. Figure 8 illustrates the case when a drill rig was moved with the mast in the vertical position.

In this accident the victim had drilled three rows of blasting holes and was positioning the rig to drill the fourth row of holes. The victim was apparently unaware that the mast had contacted the lines and was electrocuted as he left the truck.

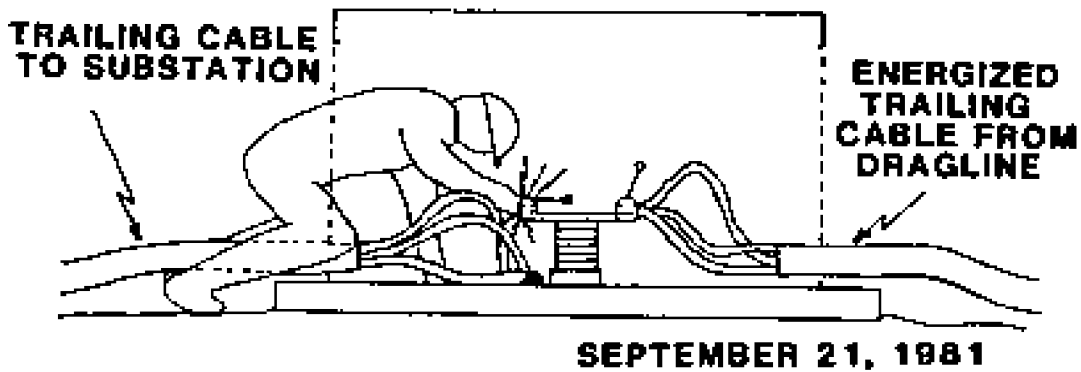
Figure 9. Back Feeding Fatality

In this particular case the trailing cable from the substation was de-energized. However a generator on board the dragline was backfeeding power to the junction box. The victim was unaware of this and received a fatal shock as he was attempting to connect the trailing cable at the junction box.

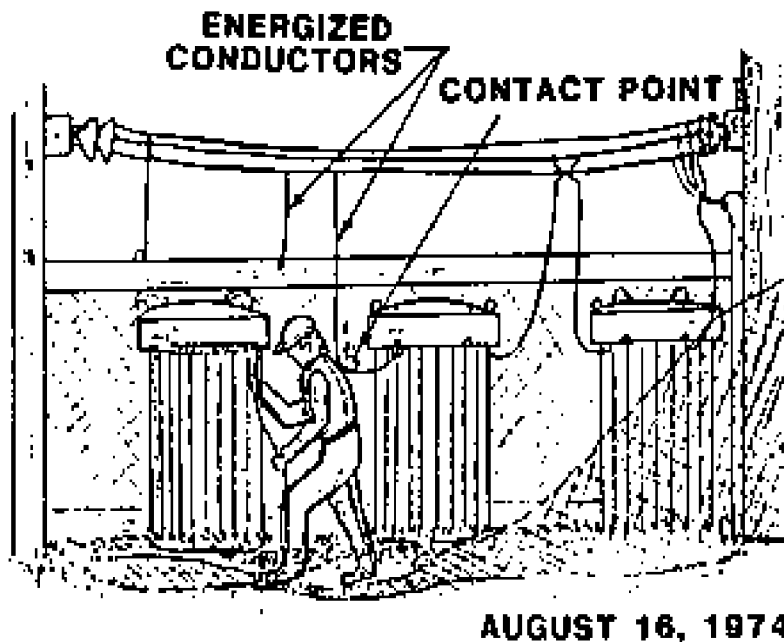
Figure 10. Exposed Energized Parts

Because substations are kept locked and posted with warning signs, poor design and installation of equipment and conductors is sometimes permitted to exist in these locations.

As can be seen in this example high-voltage conductors were so close to the working surface that a miner was electrocuted when he contacted a conductor with his back. All energized exposed live parts should be at least 8 feet 6 inches above the working surface to prevent accidental contact should a person trip, fall, or inadvertently back into them. A locked fence with warning signs prevents exposure of unauthorized personnel to the hazards but can not prevent accidental contact between competent authorized personnel and the energized parts.

Improved designs must be implemented for substations. It is essential that all bare energized parts be maintained at a height to keep them out of reach of any person who should enter a substation. A distance of 8 feet 6 inches has become the accepted distance in almost all industries as well as the mining industry. A well designed substation must have only grounded metal frames and adequately insulated parts within reach of any person whether he is qualified, certified, registered or not. This rule should be followed since a very knowledgeable and experienced individual can accidentally fall or back into bare energized parts if they are not positioned out of reach.

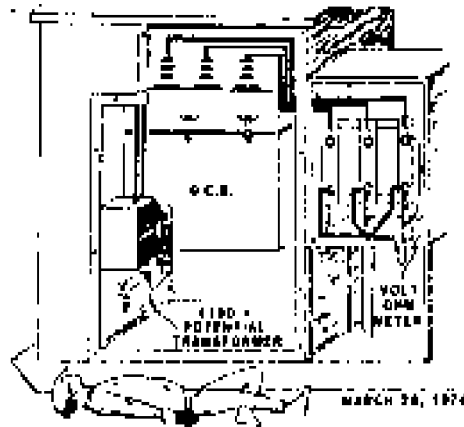
Figure 11. Troubleshooting Energized Equipment

Figure 11 depicts a situation where the victim was troubleshooting an energized substation when he came in contact with a fuse holder for a potential transformer.

Although testing and troubleshooting energized equipment is necessary in some cases, it must be conducted with the utmost care. A single mistake during these procedures can be fatal and therefore only the leading qualified personnel should be permitted to perform these tasks.

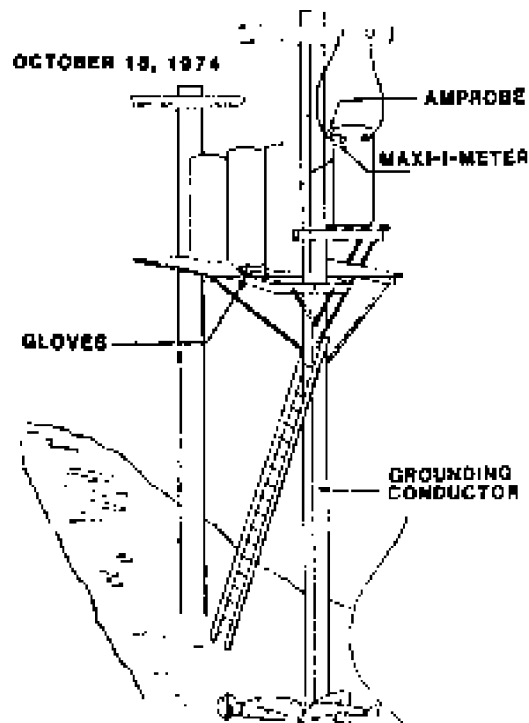
Figure 12. Reading Current

The victim was taking a current reading on a transformer primary. The transformer station was mechanically well constructed with no apparent electrical shock hazards present. However, when the victim contacted the meter case which was in contact with an insulated 4160 volt conductor, he received a fatal shock from the case of the meter. During the investigation of the fatality it was discovered that a bare connector on the transformer bushing resulted in the meter case being energized to 4160 volts. It is imperative that proper care be taken when making measurements on power systems.

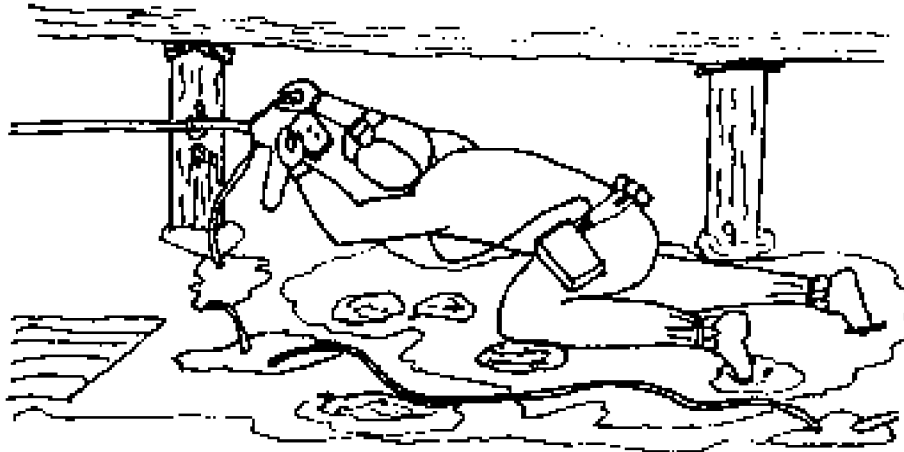
Figure 17. 120 Volt Fatality

This accident occurred in 1970, it is an example of some of the worst conditions in which electric circuits were being used and repaired. The victim attempted to troubleshoot an open splice with a neon circuit tester while positioned on his knees in approximately 4 inches of water with 28 inches of vertical clearance. The circuit supplied power to a 240 volt single phase pump which was running intermittently. In the process of trying to locate the problem the victim contacted a bare lead and was electrocuted.

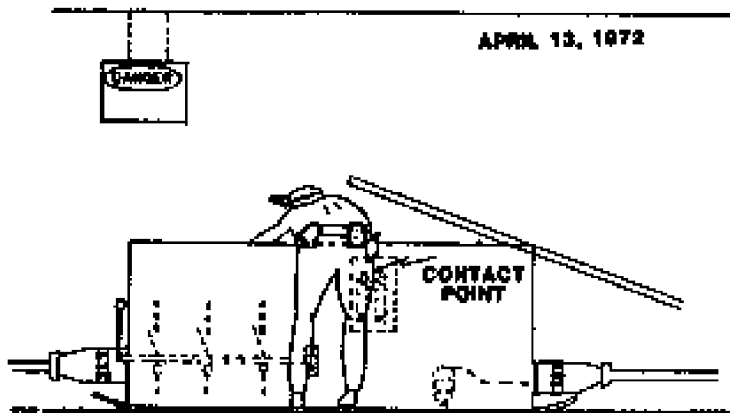
Figure 18. Unintentional Direct Contact

Many of the electrocutions are the result of the victim reaching into a compartment containing energized parts and accidentally contacting one of them. In this particular accident the victim, after being cautioned that the switchgear was energized, took the cover off the enclosure, reached in with a screwdriver in his right hand, and accidentally contacted a high-voltage fuse for a potential transformer with his sleeve.

High-voltage and low-voltage power circuits should be segregated from each other and from control circuits in all electric equipment such as power centers, distribution boxes, switchgear, etc.

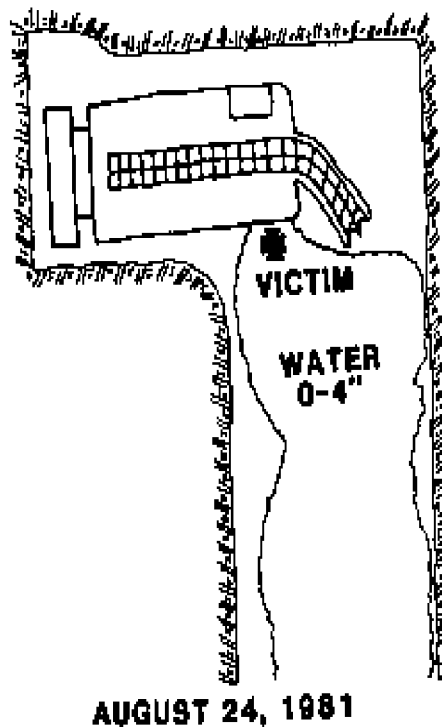
Figure 19. Low Voltage Unintentional Direct Contact

As in the previous accident the victim was reaching into a compartment containing energized parts. As he was checking for possible broken parts behind a line starter, his right hand contacted an energized 480 Vac phase conductor. He had exposed himself to a high probability for a fatal shock since he was on his knees wearing wet leather boots. He did not have knee pads or insulating gloves and the floor was covered with water up to where he was kneeling. This accident happened as recently as 1981 and these conditions are not unusual for the conditions in which electrical maintenance is performed.

Test points should be brought out to a test panel to facilitate an accessible and safe means for measuring voltage during testing and trouble-shooting when it is necessary for the equipment to be energized.

Where possible, electrical adjustments should also be mounted on a test panel. Where adjustments cannot be brought out they should be located away from energized parts and guarded to prevent accidental contact with energized parts when adjustments are being made.

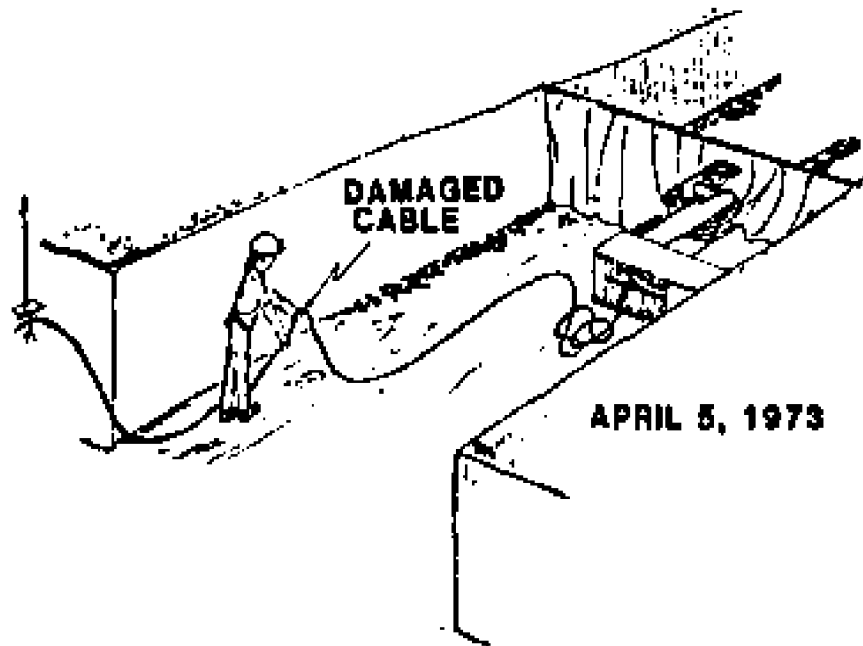
Figure 20. Handling Energized Trailing Cable

The victim was a section foreman with 12 years mining experience. He was assisting in the moving of a roof bolting machine when he contacted a damaged place in the trailing cable with his hands. He was not wearing gloves and his hands and leather shoes were wet.

The accidents involving handling of trailing cables and splices were responsible for eleven percent of the underground fatalities. These types of accidents could be reduced by a close inspection of trailing cables at the beginning of each shift. However, even a visual inspection of each cable, as time consuming as it would be, could not detect some of the damaged places. The use of cable handling devices and protective insulating gloves could reduce these fatalities but have not been a method which is universally practiced in the industry. Because these precautionary methods have not worked, methods which involve redesign of the system to prevent the shock exposure need to be considered. A system design method of reducing if not eliminating these accidents is the use of shielded trailing cables. This type of cable could be used to confine the shock hazard within the cable jacket and initiate the ground fault protection when the cable is damaged.

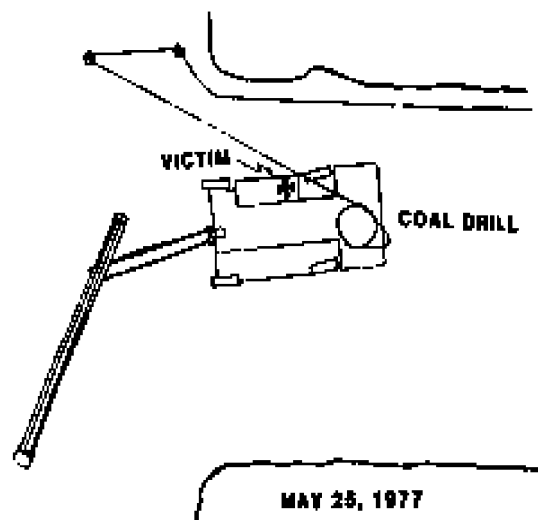
Figure 21. Exposed Conductor in Trailing Cable

In this accident the drill operator was positioning the drill in a manner which caused the trailing cable to backspool across the machine near the operator's compartment. The victim was guiding the cable with his right hand while seated in the operator's compartment. His hand came in contact with a bare place in the cable which had become exposed as a result of severe carbon tracking. The victim was electrocuted as a result of this contact.

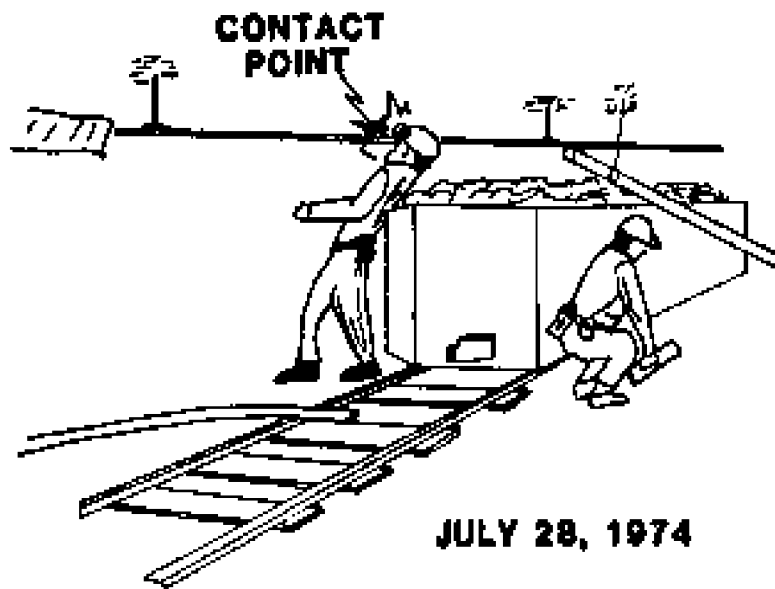
Figure 22. Trolley System Fatalities

This accident occurred while the victim was in the process of repairing a waterline which passed over an energized trolley wire. No temporary guarding was used and the circuit was not de-energized before work began. The victim's head contacted the trolley wire while he was in the process of performing the repairs. In this case as in many of the other contacts with the trolley wire, the victim knew that the circuit was energized but he felt that he could work close to the wire without contacting it.

To prevent these contact-type accidents it is necessary to provide for a trolley system design which will minimize exposure of the miners to the trolley wire. Two improvements which are indicated from the fatality data are better placement and guarding of the trolley wire. The wire should be positioned so that it will not be over any person while he is riding in a trolley vehicle.

Since the procedure of temporarily guarding trolley wire has not been effective enough to eliminate fatalities while work is being performed near the trolley wire, permanent guarding should be installed along the entire length of the trolley wire and on any uninsulated feeder wire. By installing the guarding for the entire length of the trolley wire the inclination to work near the trolley wire without guarding it is eliminated.
